# Robotized Inspection and Health Monitoring in the Gran Sasso National Laboratory

**Abstract.** The Gran Sasso National Laboratory (LNGS) is the largest underground research center in the world devoted to neutrino and astroparticle physics. It is located in galleries below about 1400 meters of rock mass. In this environment, inspection and monitoring actions are challenging for the maintenance and the safety of the infrastructures and they require a combined use of different strategies. The paper address issues related to the structural safety of the whole environment by proposing solutions for inspection and monitoring of different areas and elements, such as the gallery vaults, the structures of the experimental prototypes, the plants and the machinery. A generic framework is discussed to evidence the features of each specific solution and the interaction between different systems. Tunnel structural healthy is the most difficult to evaluate because the vaults are coated by not removable panels which waterproof and insulate the environment. Therefore, specific solutions are proposed for the inspection and monitoring of the vaults which are visible only in the interspace realized

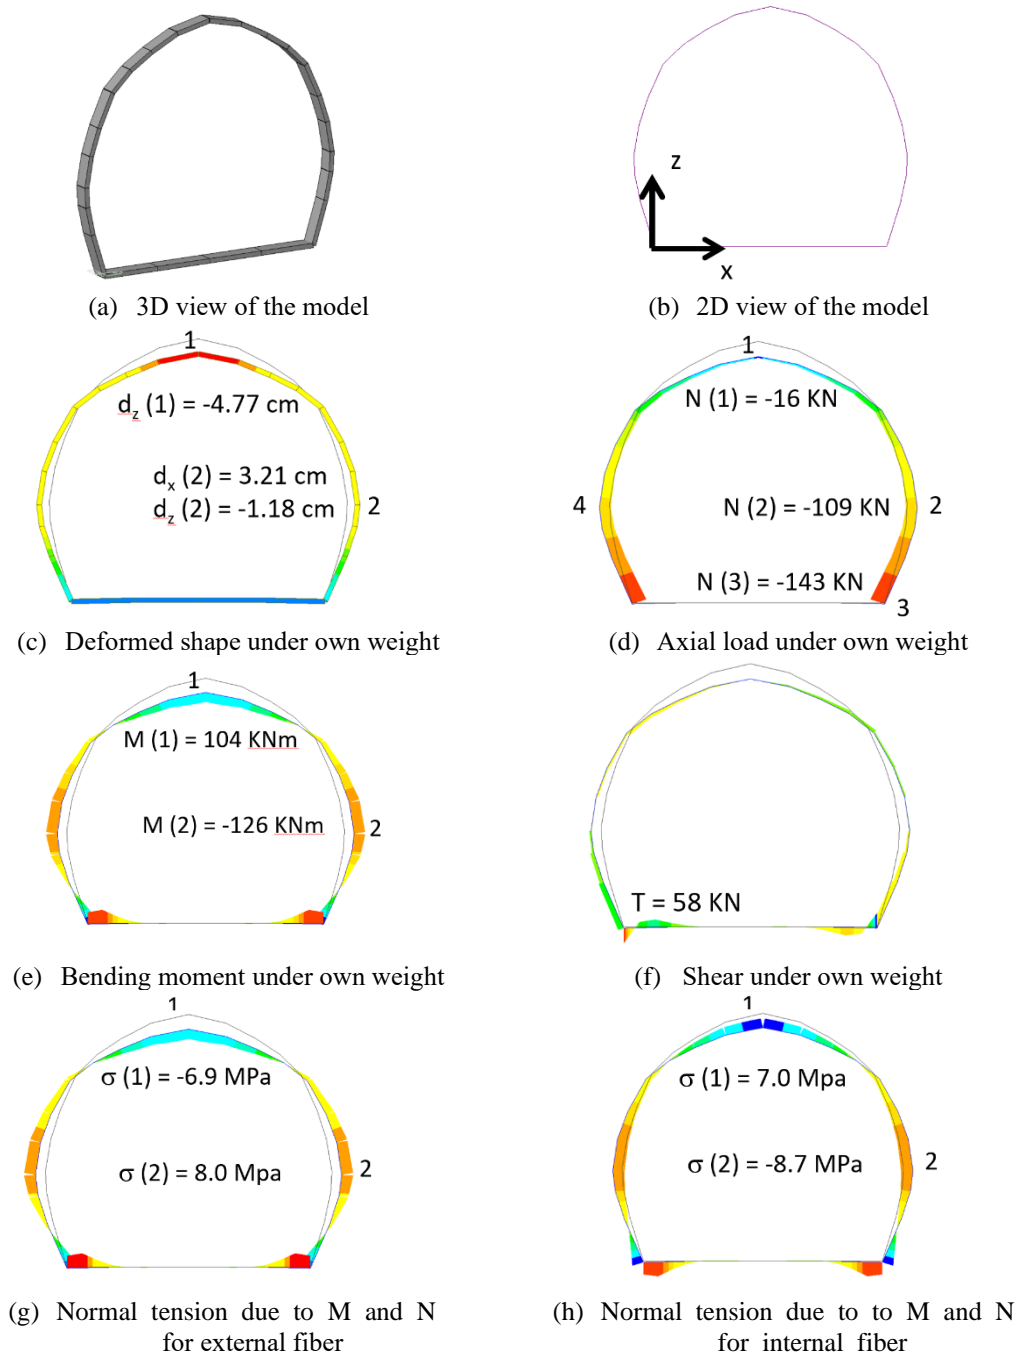
Fig. 3 Numerical modeling of the transversal cross section.

Generally, the effects caused by seismic actions on the tunnels showed deformations on both longitudinal and transversal direction. The latter naturally affects the initial shape of the tunnel's cross sections and can depend by the factors as the properties of structure, surrounding rock and soil and ground shaking, Hashash *et al.* A preliminary static analysis could be performed through the implementation of a one-dimensional finite element model representative of a transversal cross section of the LNGS underground tunnels. Beam elements (based on the Timoshenko theory) are used to describe the curved geometry of the vault; the section of the beam is rectangular (30 cm height and 1 m width). Moreover, it is right to underline that, in some small zones of the concrete ring, the thickness increases up to 40/50 cm. Anyway, the idealization of the structure has brought to a model with a constant thickness of 30 cm. A first simple linear one-dimensional elastic model is shown in Figs. 3a and 3b. The bottom beam of the model is considered constrained on elastic soil and the coefficient adopted is  $10 \text{ kg/cm}^2$  (reasonably value for a rocky soil). As well explained previous, such reinforced concrete coating has no load-bearing function and so the results related to the displacements and stresses are due only to the self-weight. The contribution of the anchorages has not been modeled to simulate an unfavorable limit situation in which all the anchorages lose their functionality (e.g. fracture or loss of friction). The deformations obtained with these models can be considered as limit values which require further observations and experimental tests that aimed to evaluate the conditions of the vaults. Based on above consideration, the results reported in Figs. 3c-3f are related to a load case in which only the self-weight of the elements is taken into account. The main parameters selected to implement the numerical model are reported in the below Table 1. This analysis allows to identify the critical points of the galleries that need to be inspected to assess the actual conditions of the structure (points 1, 2 and 4 in Fig 3d). These locations will correspond to the positioning of the sensors in the subsequent structural monitoring system. It can be observed that the maximum displacement value ( $-4.77 \text{ cm}$  in z-direction) occurs at keystone, while a swelling of the vault ( $3.21 \text{ cm}$  in x-direction) occurs at 5 m height. It is right to observe that, under the self-weight, the horizontal distance between two points, placed at the same quote for each lateral side (points 2 and 4, see figure 3d), show a spacing. In real conditions, the swelling, even in the case of total interruption of the action of anchorages, is still reasonably constrained by the surrounding rock. The normal stress is only compression (maximum value  $143 \text{ kN}$ ). Due to bending

moments at keystone, the fibers stretched are inside the vault, while at 5 m height they are out of the vault (Fig. 3e). Moreover, the normal tensions, due to bending moment and axial force, assume a value around 33% of the characteristic strength of the concrete.

Section	Rectangular, base = 100 cm, height = 30 cm
Material	Concrete C25/30, cylindrical characteristic strength 25 MPa Specific Weight $\gamma = 2500 \text{ kg/m}^3$ Elastic modulus = 31475 MPa (Lunardi, 1990) Poisson coefficient $\nu = 0.2$
External constraints	The base beam has been modelled ad a beam on elastic soil for w hich has been adopted K-Winkler of $10 \text{ kg/cm}^3$

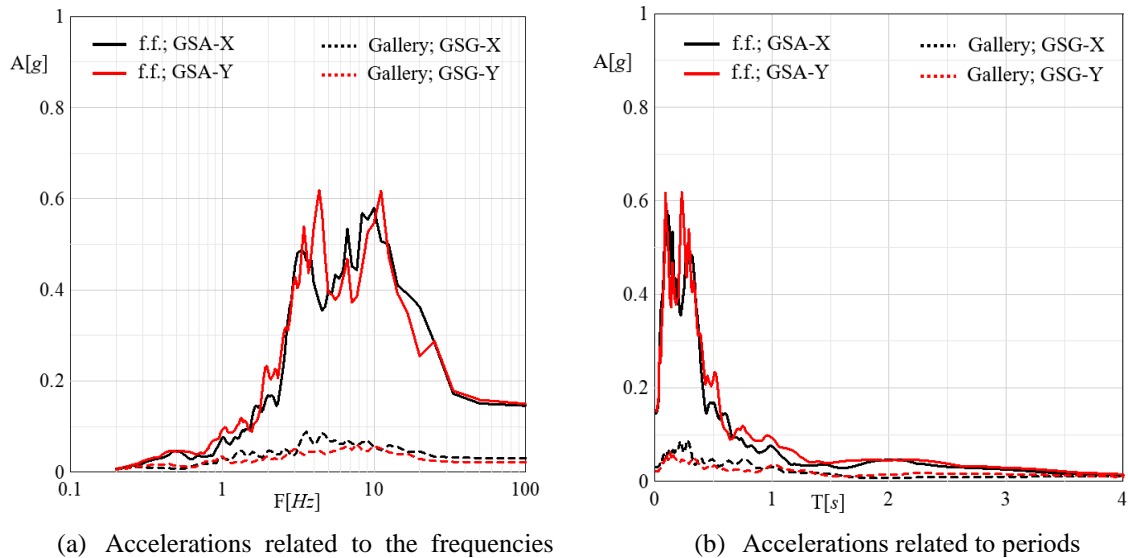
Fig. 4 Response spectra in terms of accelerations of the measurements recorded during the L'Aquila 2009 Earthquake in the stations GSA (external to the mountain) and GSG (inside the Gallery). f.f.: free field, Gallery: inside the Gallery. X and Y are both horizontal directions orthogonal to each other.

Due to its function the main points, on which to collocate the sensors, have been individualized through the evidences of a numerical model representative of a transversal section under self-weight. After that, other loading effects to be considered could be the seismic one. However, the Gran Sasso mountain has a strong attenuation power of the seismic swarm, see De Luca G *et al.* (1998). This phenomenon has been also experimentally checked during the L'Aquila 2009 Earthquake. Indeed, the processing of the measurements recorded during such earthquake by two accelerometer stations placed one inside the gallery (named GSA) and the other one external to the mountain (i.e. in free field, named GSA), both on the soil, showed a strong attenuation up to a tenth as demonstrated by the spectral accelerations reported in the below Fig 4. Therefore, the structural monitoring system has been thought, mainly, to follow the degradation of the material. Other information related to the processing of such measurements can be found in Potenza and Gattulli (2011).

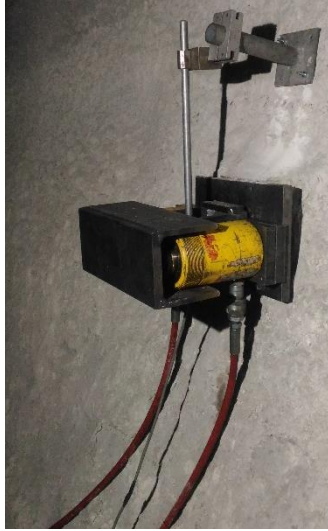
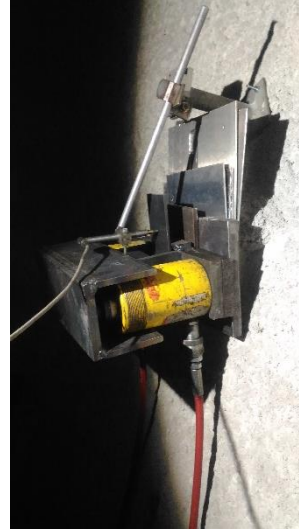
(a) Load test instrumentation, view 1

(b) Load test instrumentation, view 2

Fig. 8 Non-extraction load tests carried out on the anchorages reachable by human operators: 20-ton hydraulic jacks were connected to the head of the tie rod by means of a supplied sized metal structure to evaluate the existence of an operating load.
