Research Notes

Mapping and consolidation work at Santa Rosa Xtampak, Campeche

CAMPECHE (Antonio Benavides C., INAH), BERLIN (Iken Paap, Ibero-Amerikanisches Institut IAI – SPK). 2018 saw different advances for the comprehension of the ancient Maya society at Santa Rosa Xtampak (SRX). This ancient city was founded several centuries BC, reached its apogee during the Late Classic (approx. 700–1000 AD) and was later abandoned around 1200 AD.

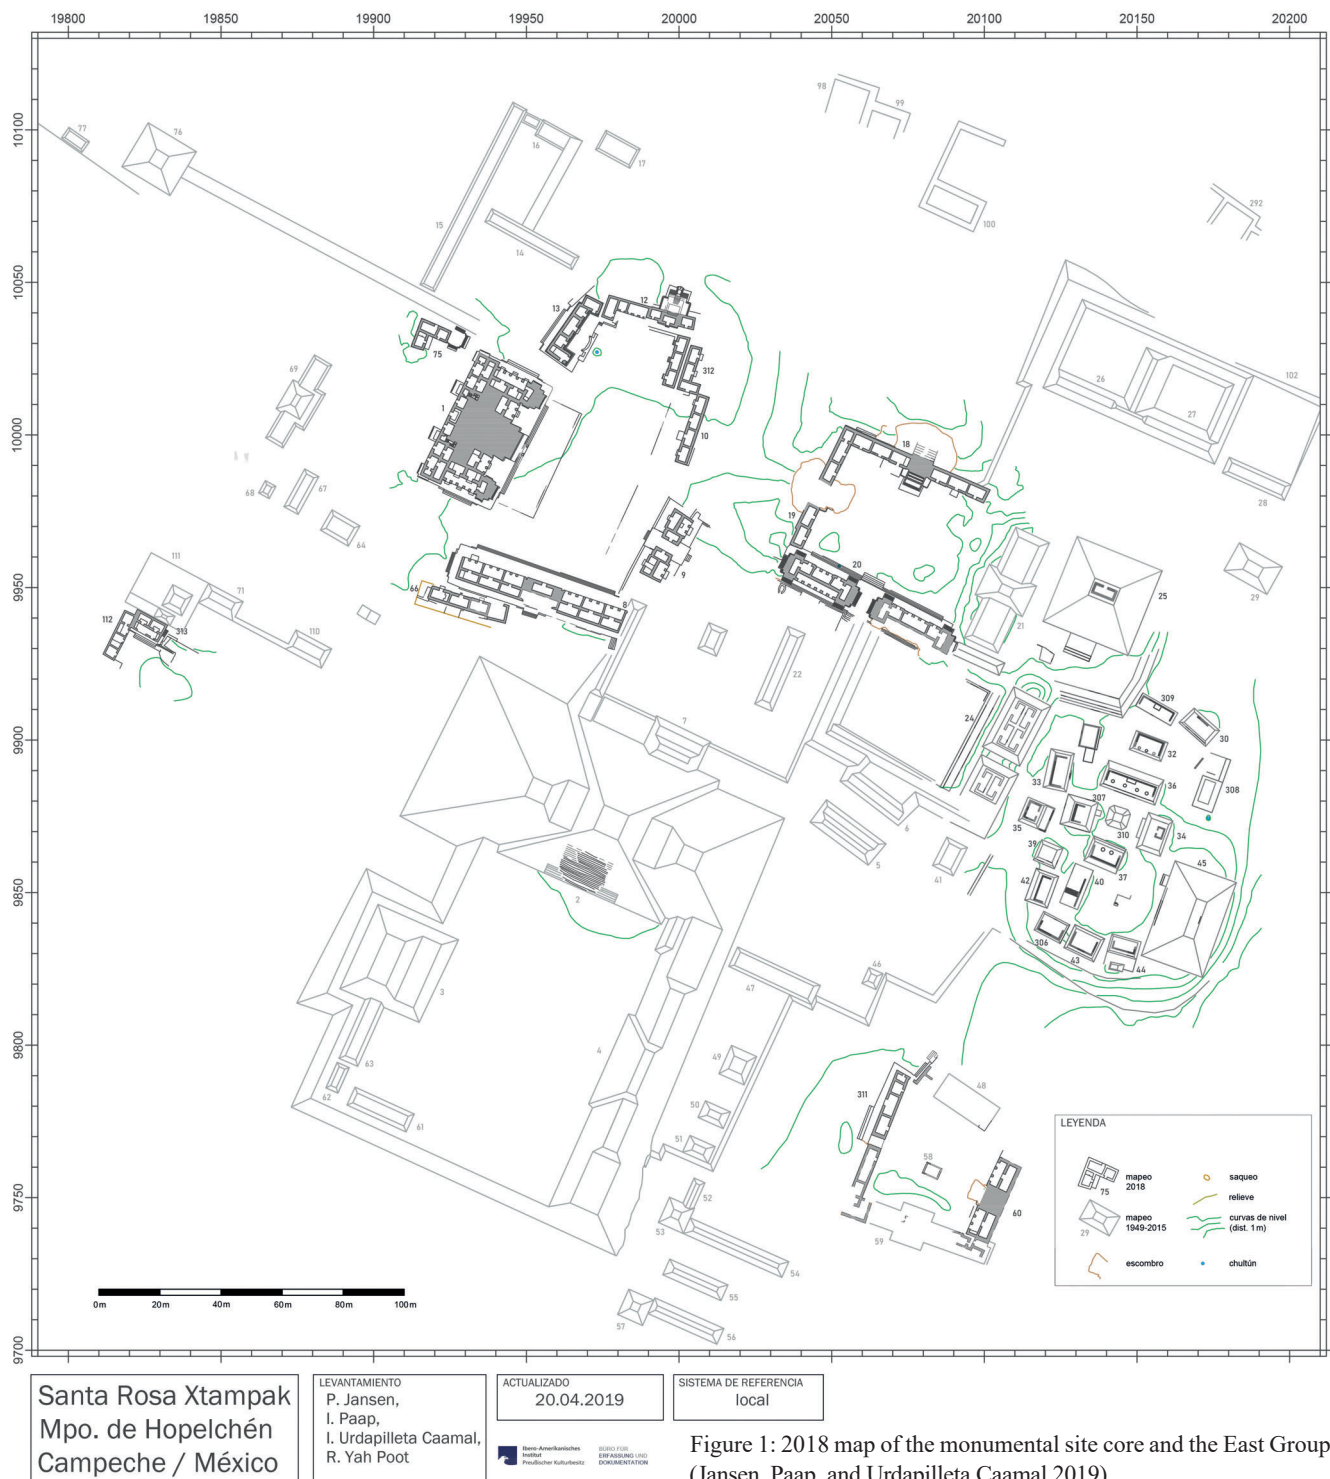
All the consolidated structures at the site core were re-mapped in 2018 to correct the existing maps (Figure 1). Fieldwork was carried by Philipp S. Jansen (Berlin), Iken Paap (Berlin), Ivan Urdapilleta Caamal (Campeche) and Rolando Yah Poot (Teabo). We worked by means of an electronic total station and a laser scanner. In several cases we had to

complement our data with photos taken with a drone in 2017 and 2018 or with the results of previous research. The latter applies especially to the “Palace” (Structure 1), where we used Hohmann’s (2017: 26, Fig. 22) data to draw the interior rooms not reached by the scanner.

In the course of the analysis of the new data, it turned out that the spatial placement of the mapped structures – especially the distances between them – differ considerably from the previous maps:

The Cuartel is located 15 m further east, with reference to the Palace main plaza. The Southwest Group has to be moved 27 m to the southwest, the main staircase of the Great Pyramid was recorded 7 m further south and the Southeast Group 23 m further southeast.

Consequently, the existing map degrades to an extent that can no longer be corrected by means of isolated and marginal adjustments and must be considered with extreme reserve and caution.

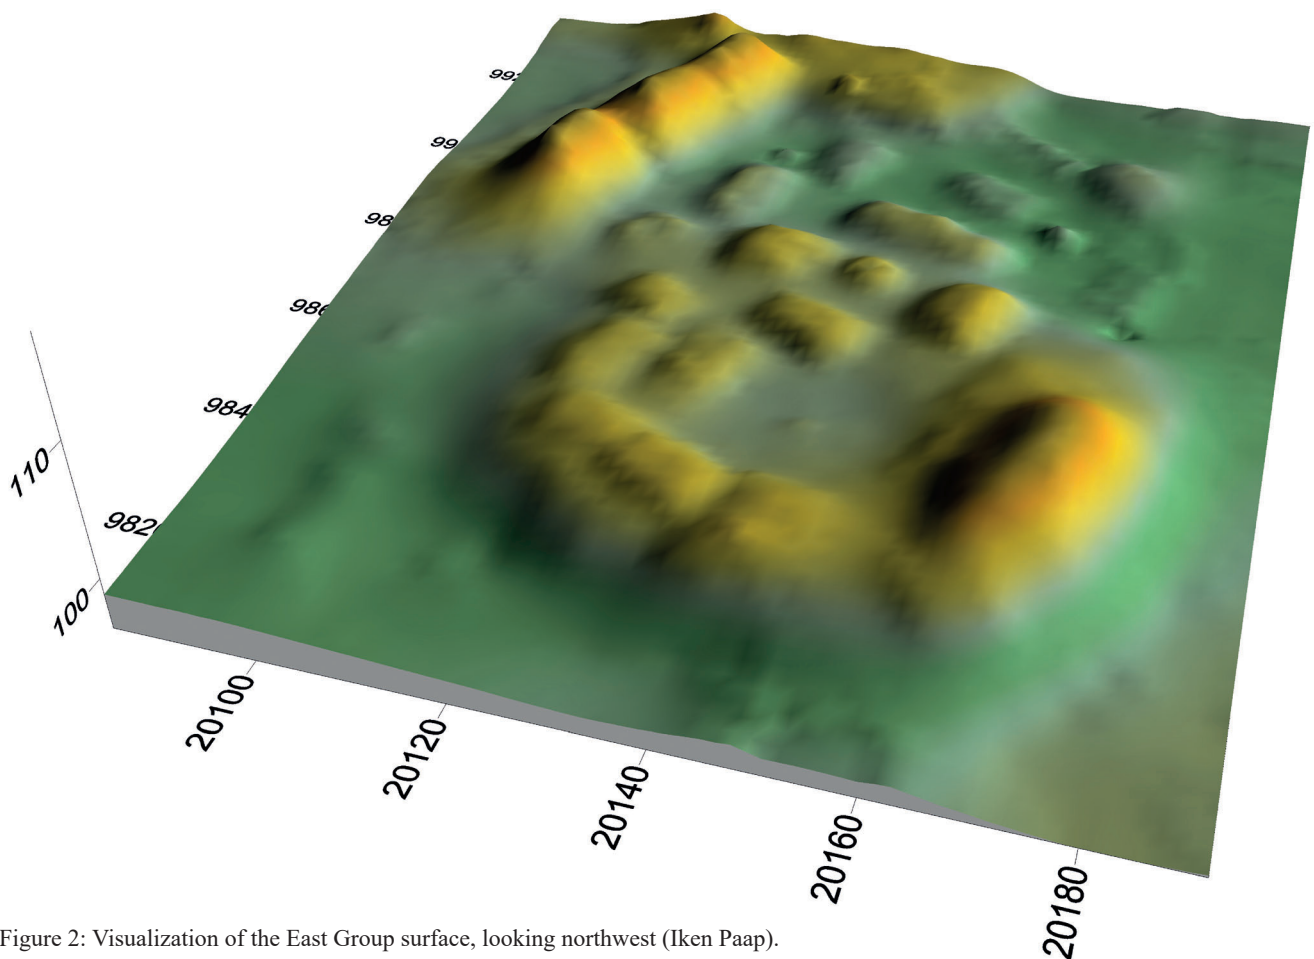
The East Group was first described by DeBloois (1970: 36–37). In 2018, we achieved a complete 3D documentation of the East Group and registered 19 structures in the area east of Building 24 and south of Pyramid 25 (Figure 2).

Figure 2: Visualization of the East Group surface, looking northwest (Iken Paap).

On the surface we encountered some ceramic fragments, seemingly of Terminal Classic contexts. Between and above the platforms are a few carved stones, as described by DeBloois. Those that stood out on account of their size and/

or shape (corners, capitals, columns, moldings, etc.) were documented in the mapping. It is worth mentioning that in the whole investigated area no *metates* or *pilas* were found.

In the eastern part of the group, two meters from the south side of Structure 308, we documented a chultun with an opening of 60 cm in diameter. Its water catchment system (ring, etc.) was not preserved.

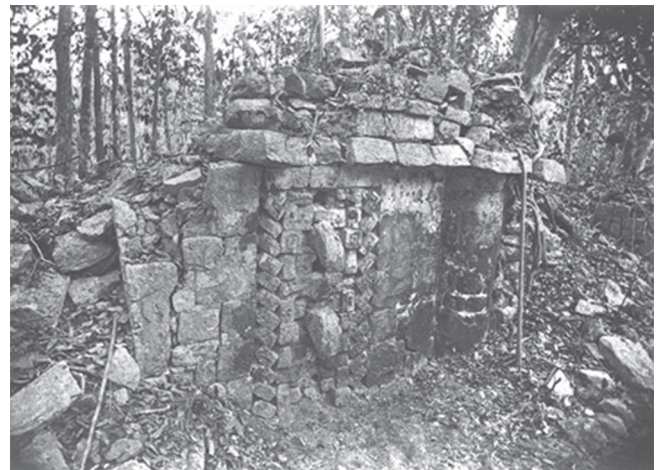
Figure 3: The 'Building with the Serpent heads', photo from Teobert Maler, 1981 (courtesy of Ibero-Amerikanisches Institut – SPK, Berlin).

An excavation program to restore abandoned structures also began in 2018. The field season helped to solve conservation problems affecting Structure 66, located just south of Structure 8 – the building that closes the Palace main plaza on its southern side. Structure 66 is 20.50 m long by 4.60 m wide. It was first reported by Teobert Maler (1997: 217, Plate 169), who named it the Building with the Serpent Heads, alluding to the mosaic stone elements preserved on the central part of the northern façade (Figure 3).

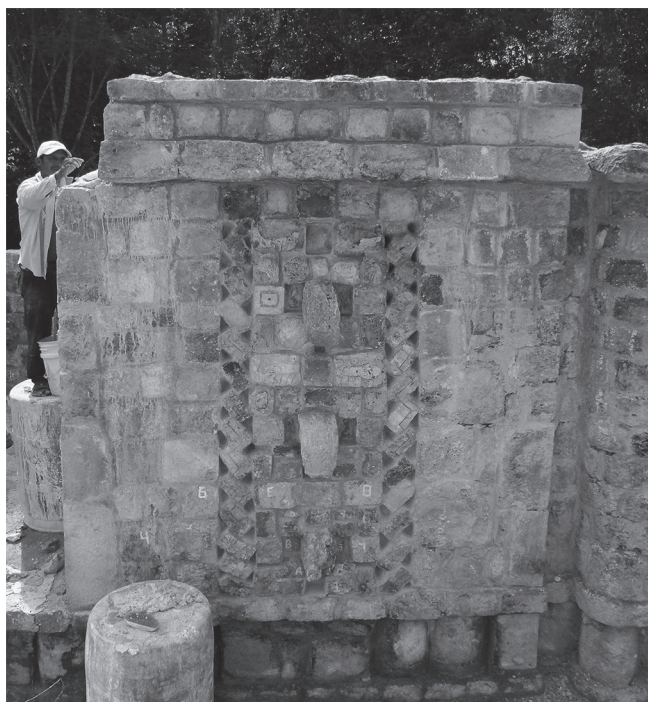
Figure 5: Restored masks on the northern façade of Structure 66 (photo: Antonio Benavides Castillo).

eyes, earrings, brows, mouths, antennae, most of which are now eroded or lost. The smaller blocks are square, some used to form the earrings and others to adjust the mosaic. Mouths and eyes were represented with square sunken sections. The biggest stones were used to form the down-curved snouts of the masks. Red paint is still evident in some sections.

To restore this façade, we used the very useful photographs made by Teobert Maler in 1891 (1997: Plate 169) and by Harry Pollock in 1936 (1970: 60, Fig. 82). Analysis of these photographs helped us to identify the still existing blocks and those that had collapsed (Figure 5). The nearest masks to be compared are located around 150 meters away, at the southern side of the northern Cuartel range, where we find very similar elements.

The central room is a little broader than the others; around 6.50 m instead of 5.80 m. It was also cleaned and consolidated with new limestone mortar. The entrance on the northern façade is flanked by three masks on each side. The left and right sides of the masks have diagonal blocks forming the mat motif.

The 2.20 m high by 1 m wide representation is an ingenious mosaic of veneer stones of different dimensions originally covered by stucco applications in order to form details like
