## **The August 21, 2017 Isola di Ischia (Casamicciola) Earthquake: Coseismic Effects**

*Version 3.10.2017*

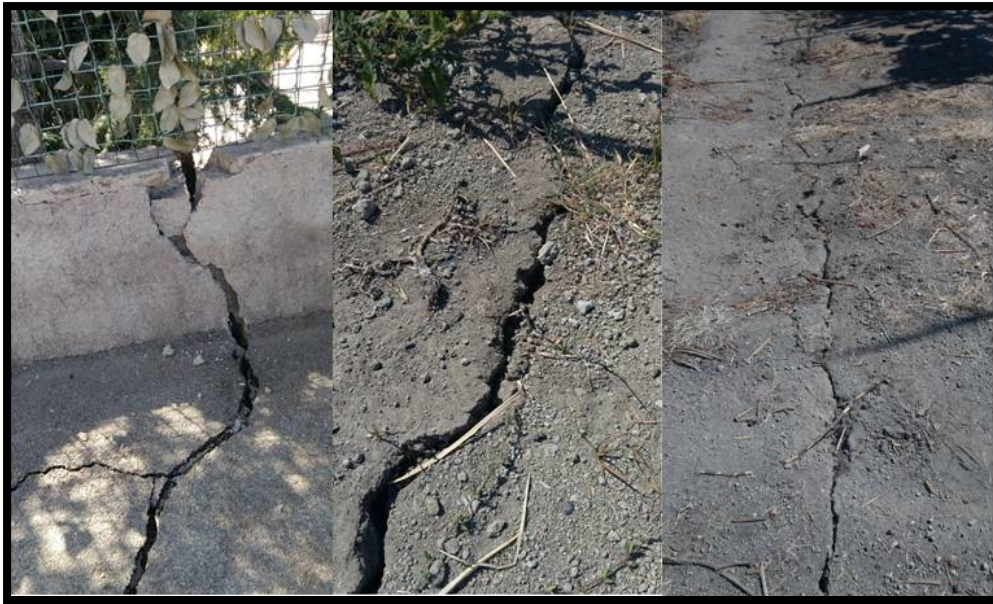
In via Crateca, Fango locality (Lacco Ameno) surface fractures developed in the ground and along some roads with lengths up to some tens of meters. In addition, some fractures in the soil showed openings of about 3 cm, and in some cases a vertical component of appreciable displacement with lowering of the ground northward (Picture 1).

Picture1: Coseismic fractures in via Crateca, Fango locality (Lacco Ameno).

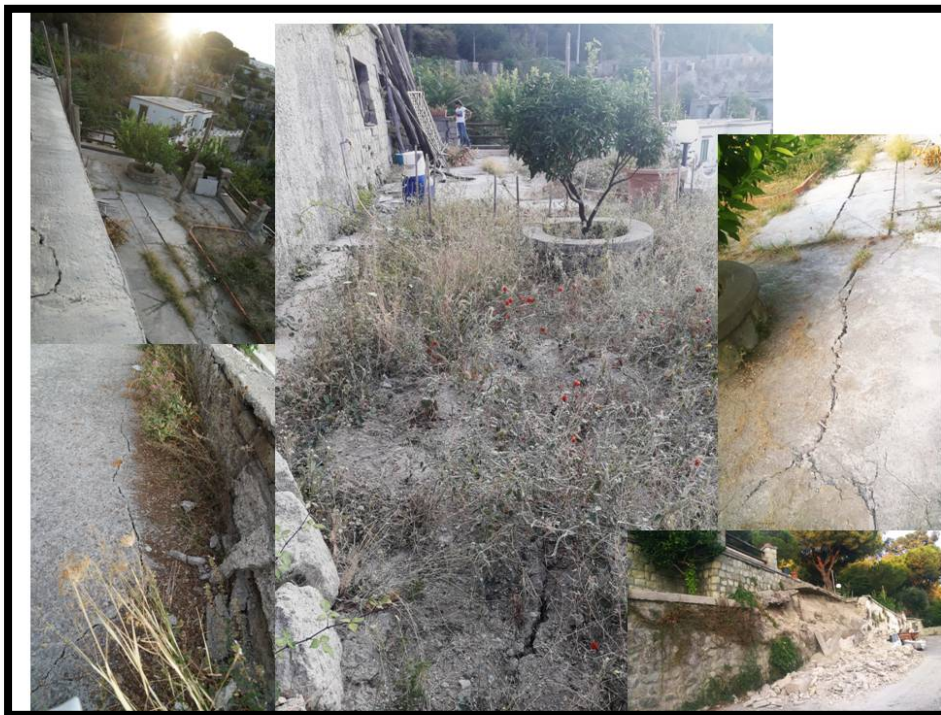
Some examples of a system of parallel surface coseismic fractures breaking both manufactures, ground and road pavement were recorded in via Montecito (Casamicciola) (Picture 2).

Picture 2: System of parallel surface coseismic fractures and drywall sliding in via Montecito (Casamicciola).

Collapse phenomena of drywalls and modest gravitational phenomena such as small size sliding of a few m<sup>3</sup>, besides small landslides in volcanoclastic deposits with direction of movement from S to N were observed in the investigated area (Picture 2 and 3).

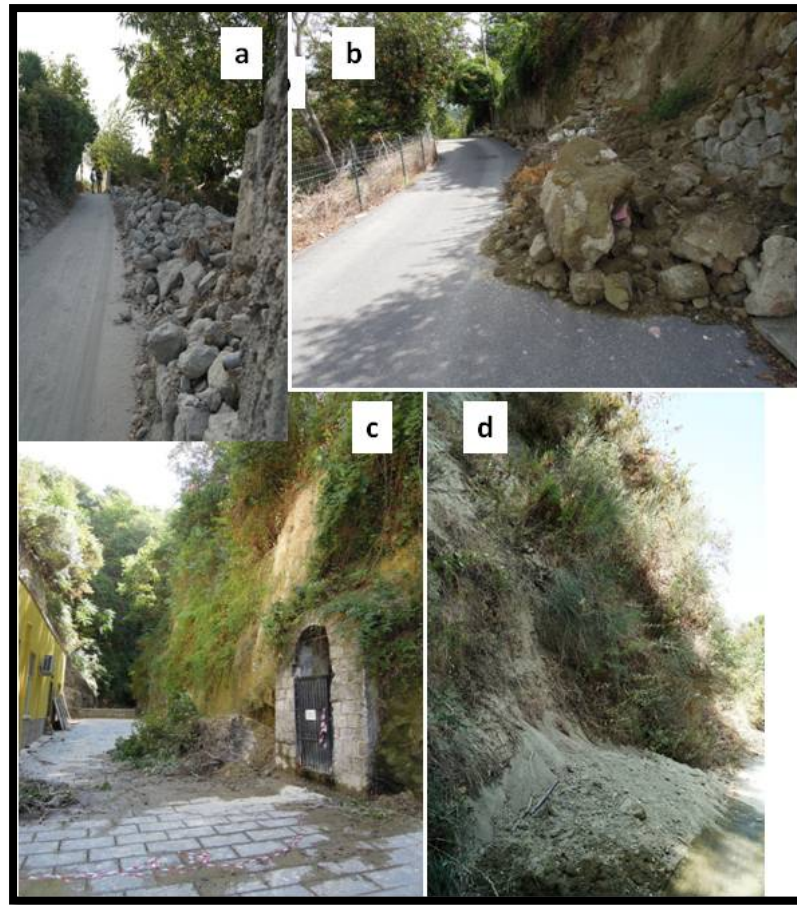
Picture 3: Collapse phenomena of drywalls at Casamicciola, in via dei Carri, (a), and in via Nizzola (b); Small landslides in volcanoclastic deposits in via Nizzola (c) and in via S. Barbara (d).

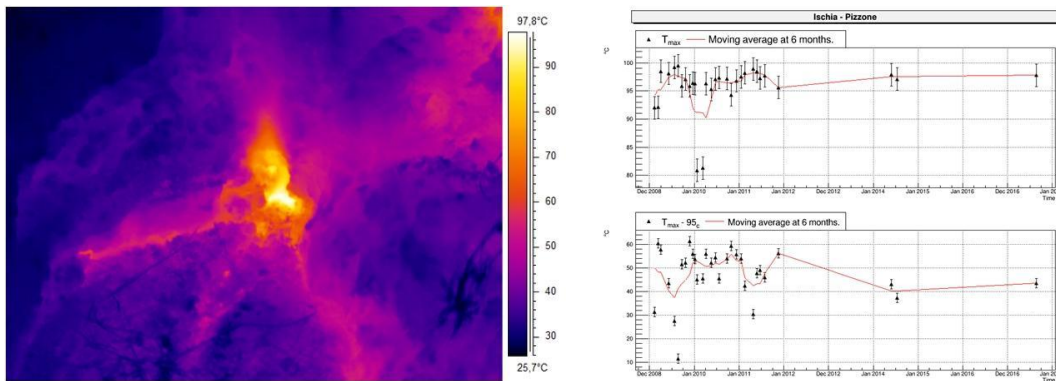
Fig. 3. Pizzone: Thermal images on August 24th. The diagram on the right shows the trend of maximum temperatures from 2008 as acquired by thermal images.

Along the Montecito fault system, striking E-W at the base of the Mt. Epomeo northern slope, there are the fumarolic fields of Montecito (Pantane zone) and one of Pizzone more to the west. On both these fumarolic fields, thermal camera and thermocouple measurements were carried out. The recorded temperature of 98°C is consistent with measurements performed between 2008 and 2014 (Figure 2 and 3).
