Study on Discharge Current Phenomena of Epoxy Resin Insulator Specimen

Waluyo, Ngapuli I. Sinisuka, Suwarno, Maman A. Djauhari

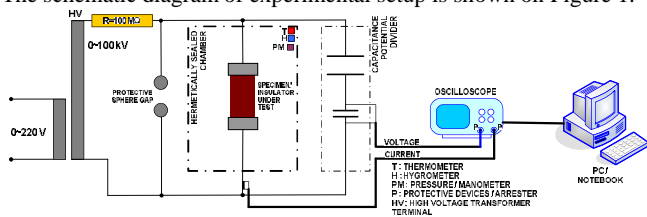
Fig. 1. Schematic diagram of experimental setup

The measurements of discharge current and applied voltage waveforms used a two-channel storage digital oscilloscope. The measured data could be recorded and transferred to a computer with USB and could be saved in softcopy form, read and saved in Excel. The schematic diagram of experimental setup is shown on Figure 1.

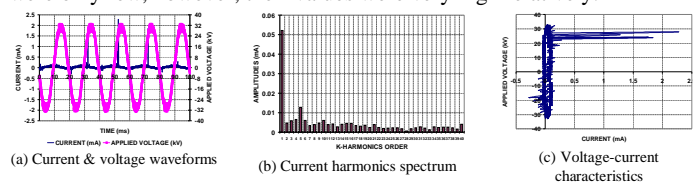
Fig. 2. Typical waveform of low RH clean specimen

Figure 2 shows discharge current phenomenon of epoxy resin specimen on 23.9°C, 70%, 32.9 kV_{max} of temperature, humidity and applied voltage amplitude respectively, and without pressure. This is sample of low RH typical condition. Figure 2(a) is discharge current and applied voltage waveforms on such condition. It is seen that the current would discharge suddenly when applied voltage wave closed to the peaks. It is stated that to reach a discharge, it was necessary a threshold. For this condition, the clean epoxy resin specimen still had capacitive property. Thus, the discharge condition did not change the epoxy resin specimen significantly. In other word, the clean epoxy resin specimen had capacitive property, although in a discharge condition. Figure 2(b) shows harmonics frequency spectrum of discharge current of Figure 2(a). Besides the fundamental frequency, the other harmonics were visible explicitly. Nevertheless, the second highest was still fifth harmonics. Figure 2(c) is the characteristics of applied voltage to discharge current. It is seen that the flash points were only few, however, their values were very high relatively.

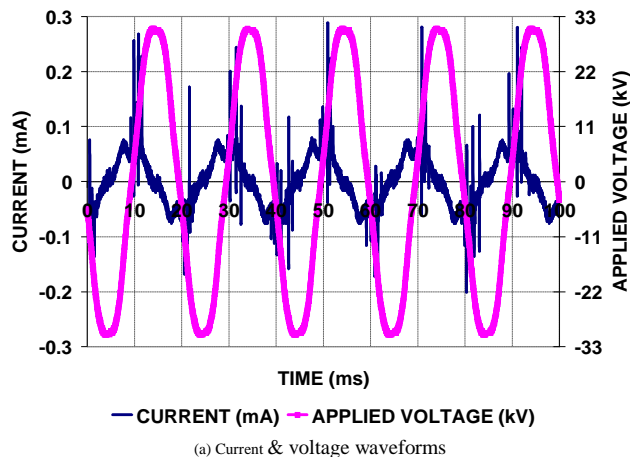
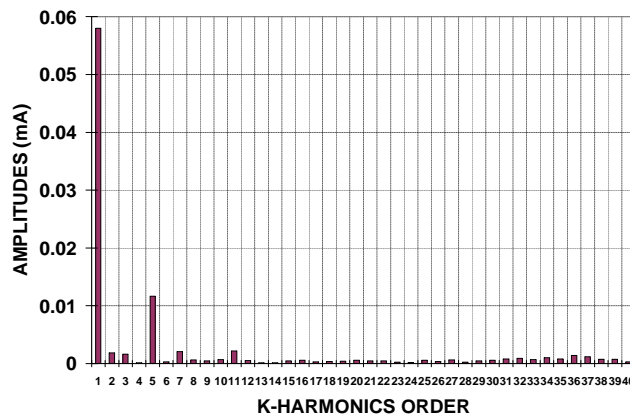
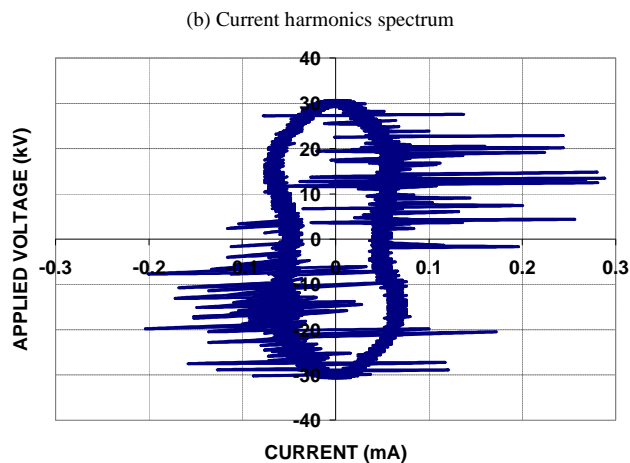
Fig. 3. Typical waveform of high RH clean specimen

Figure 3 shows discharge current phenomenon of epoxy resin specimen on 26.4°C, 99%, 30.6 kV_{max} of temperature, humidity and applied voltage amplitude respectively, and without pressure. This is sample of high relative humidity typical condition. Figure 3(a) is discharge current and applied voltage waveforms on such condition. It is seen that the intermittent discharge current was occurrence suddenly and significantly more rather than that on low humidity. It was easier to discharge on high humidity rather than on low humidity condition. Thus, the threshold voltage would be reduced. This case was caused by the existence of grains of water droplet on the surface of epoxy resin specimen. These water droplets raised quantity of discharges. However, the magnitudes of current discharge and applied voltage reduced explicitly. For this condition, the clean

epoxy resin specimen still had capacitive property. Thus, the discharge condition did not change the epoxy resin specimen significantly. Figure 3(b) shows harmonics frequency spectrum of discharge current of Figure 3(a). Besides the fundamental frequency, the fifth harmonics was visible explicitly, as second highest of harmonics. Other harmonics were not visible significantly. Figure 3(c) is the characteristics of applied voltage to discharge current of high humidity clean epoxy resin specimen. It is seen that the flash points increased, compared to the flash points on low humidity. This case was caused by some water droplets on the specimen surface.

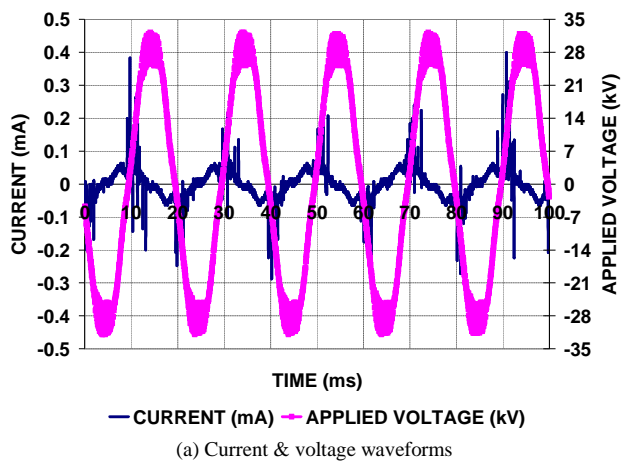
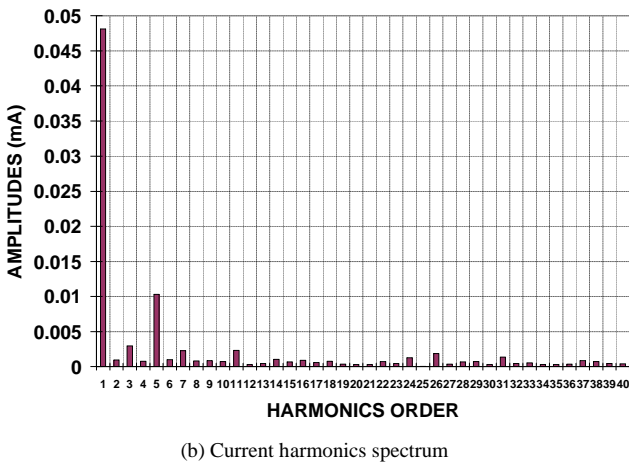
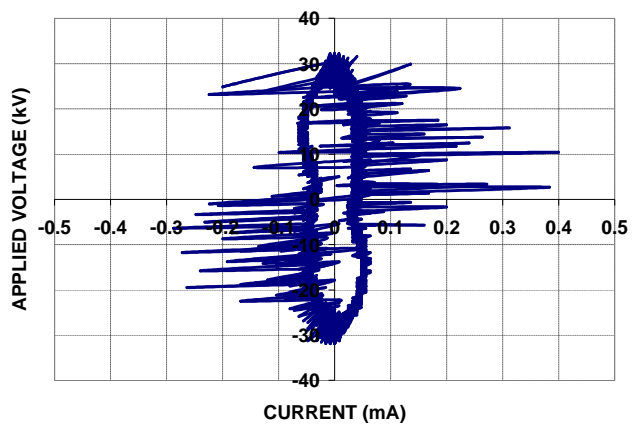
(c) Voltage-current characteristics
 Fig. 4. Typical waveform of low pressure clean specimen

Figure 4 shows discharge current phenomenon of epoxy resin specimen on 26°C, 92%, -16 kPa and 30.6 kV_{max} of temperature, humidity, pressure and applied voltage amplitude respectively. This is sample of low pressure typical condition. Figure 4(a) is discharge current and applied voltage waveforms on such condition. It is seen that the intermittent discharge current was occurrence suddenly and significantly more rather than that on low humidity. Nevertheless, the peaks of discharge current points were higher than that on high humidity. For this case of low pressure, the highest peak discharge current point was 0.4 mA, whereas for high humidity case, the highest peak discharge current point was 0.288 mA. Thus, the influence of low pressure was higher than the influence of high humidity. It is stated that it was easier to discharge on low pressure rather than on high humidity conditions. Thus, the threshold voltage would be reduced on low pressure. This case was caused supposedly by particle of air surrounding the specimen reduced, and furthermore, they were easier to discharge. Nevertheless, for this condition, the clean epoxy resin specimen still had capacitive property. It had capacitive property, although in a low pressure discharge condition.

Figure 4(b) shows harmonics frequency spectrum of discharge current of Figure 4(a). Besides the fundamental frequency, the fifth harmonics was visible explicitly, as second highest of harmonics. Third harmonics was visible significantly enough, as third highest of harmonics. The lower of pressure, the more visible of third harmonics. Figure 4(c) is the characteristics of applied voltage to discharge current of low pressure clean epoxy resin specimen. It is seen that the flash points increased, compared to the flash points on low humidity or high humidity.

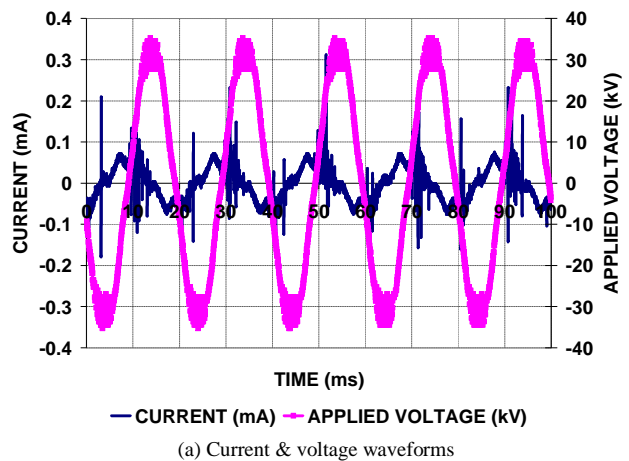
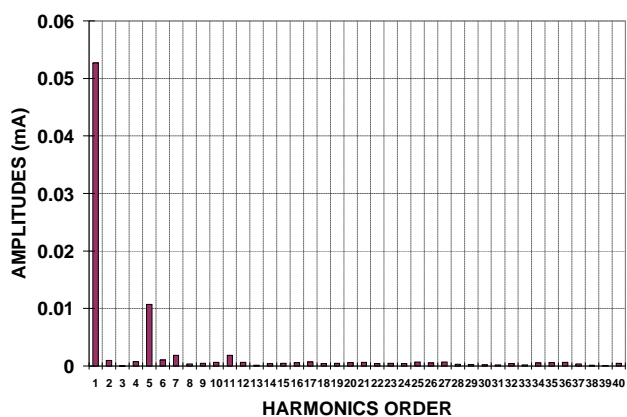
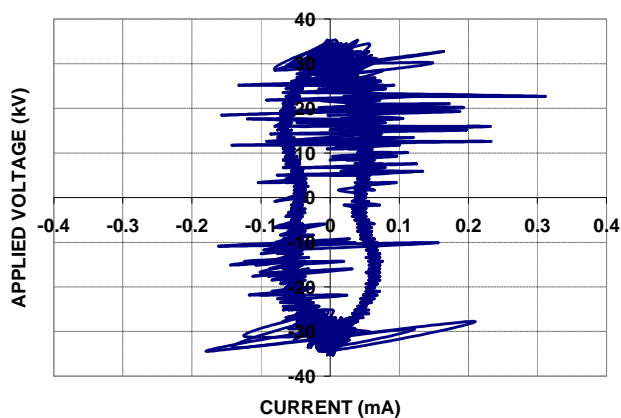
Fig. 5. Typical waveform of high pressure clean specimen

Figure 5 shows discharge current phenomenon of epoxy resin specimen on 27.4°C, 99%, +17 kPa and 35.3 kV_{max} of temperature, humidity, pressure and applied voltage amplitude respectively. This is sample of high pressure typical condition. Figure 5(a) is discharge current and applied voltage waveforms on such condition. It is seen that the intermittent discharge current was occurred significantly less than that on high pressure. Besides that, the applied voltage amplitude increased to reach a discharge condition. As sample of applied voltage amplitude, for this case, from 30.6 kV_{max} on -16 kPa of pressure, became 35.3 kV_{max} on +17 kPa of pressure. On other hand, the peak discharge point was lower, from 0.4 mA became 0.312 mA. It is stated that the increasing of pressure, it caused made higher of applied voltage amplitude to make discharge process, and on other word the current discharge point would reduce. It was more difficult to discharge on high pressure rather than that on low pressure. Thus, the threshold voltage would be increased on high pressure. This case was caused supposedly by particle of air surrounding the specimen increased, and furthermore, they were more difficult to discharge, due to be compressed. Nevertheless, for this condition, the clean epoxy resin specimen still had capacitive property.

Figure 5(b) shows harmonics frequency spectrum of discharge current of Figure 5(a). Besides the fundamental frequency, the fifth harmonics was visible explicitly. Figure 5(c) is the characteristics of applied voltage to discharge current of high pressure clean epoxy resin specimen. It is seen that the flash points were less compared to that on low pressure.

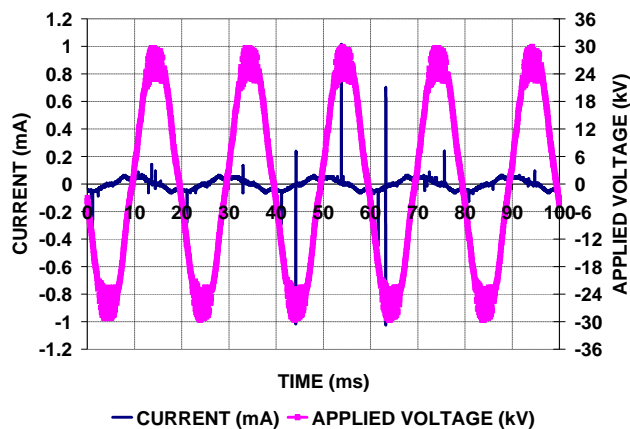
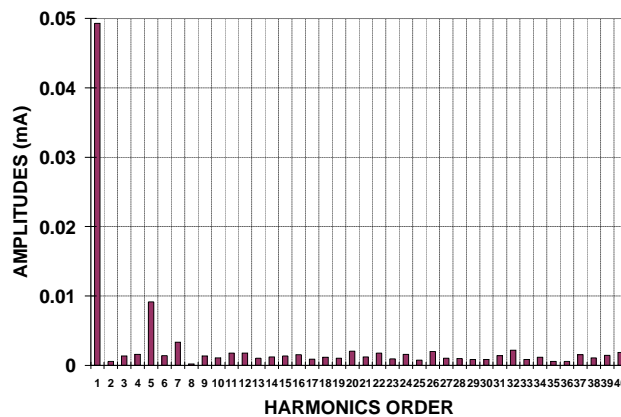
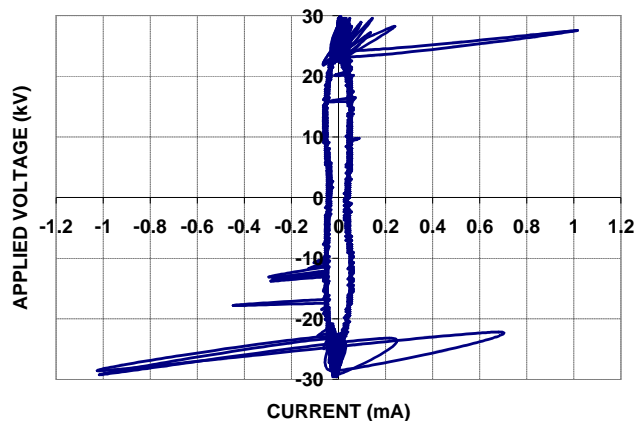
Fig. 6. Typical waveform of low RH lightly polluted specimen

6(c) is the characteristics of applied voltage to discharge current of low humidity for this specimen. It is seen that the flash points were same, but the peak discharge current values were higher compared to that low humidity clean specimen.

Figure 6 shows discharge current phenomenon of lightly artificial contaminated epoxy resin specimen on 26.3°C, 68% and 35.3 kV_{max} of temperature, humidity and applied voltage amplitude respectively, and without pressure. This is sample of low humidity typical condition. Figure 6(a) is discharge current and applied voltage waveforms on such condition. It is seen that the intermittent discharge current was occurred slightly to increase compared to that on low humidity of clean specimen. However, the peak discharge current significantly increased, for this applied voltage amplitude, it became +1.01 mA and -1.01 mA for positive and negative peaks. It is stated that the existence of contaminant, it caused made higher of peak discharge current, both for positive and negative values. It was easier to discharge due to existence of contaminant on the specimen. The threshold voltage would be reduced due to existence of contaminant. This case was caused by particle of contaminant on specimen surfaces. Nevertheless, for this condition, the clean epoxy resin specimen still had capacitive property.

Figure 6(b) shows harmonics frequency spectrum of discharge current of Figure 6(a). Besides the fundamental frequency, the fifth harmonics was visible explicitly, and other harmonics were also visible. However, they were far lower than third harmonics. Figure

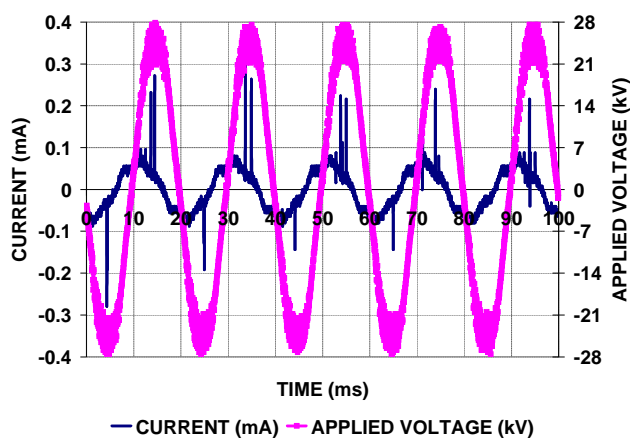
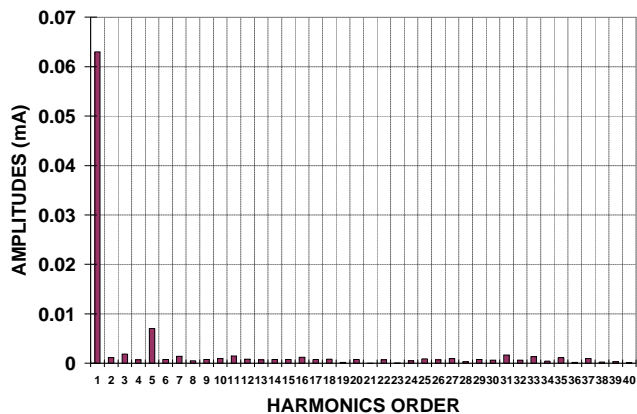
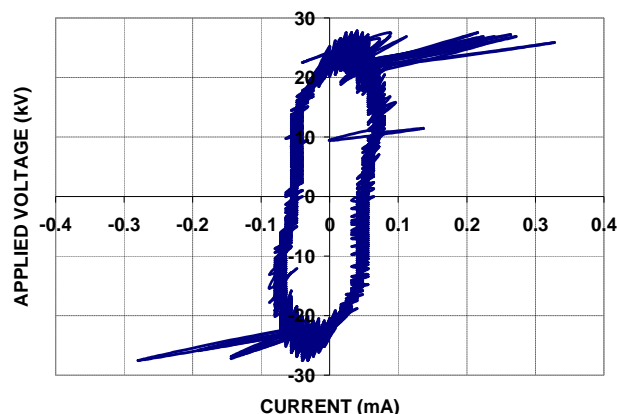
Fig. 7. Typical waveform of high RH lightly polluted specimen

Figure 7 shows discharge current phenomenon of lightly artificial contaminated epoxy resin specimen on 26.3°C, 99% and 27.9 kV_{max} of temperature, humidity and applied voltage amplitude respectively, and without pressure. This is sample of high humidity typical condition. Figure 7(a) is discharge current and applied voltage waveforms on such condition. It is seen that the intermittent

discharge current was occurred slightly to increase compared to that on low humidity of slightly contaminated specimen. However, the peak discharge current reduced, became 0.33 mA on this condition compared to previous 1.01 mA. This was also caused the applied voltage was lower than the previous on low humidity. Thus, it was easier to discharge due to high humidity. The threshold voltage would be reduced due to the grains of water droplets. This case was caused by particle of contaminant and water droplets on the specimen surfaces. Nevertheless, for this condition, the specimen still had capacitive property.

Figure 7(b) shows harmonics frequency spectrum of discharge current of Figure 7(a). Besides the fundamental frequency, the fifth harmonics was visible explicitly, and other harmonics were also visible slightly. However, they were far lower than third harmonics. Figure 7(c) is the characteristics of applied voltage to discharge current of high humidity for this specimen. It is seen that the flash points increased slightly, but the peak discharge current values were higher compared to that high humidity clean specimen.

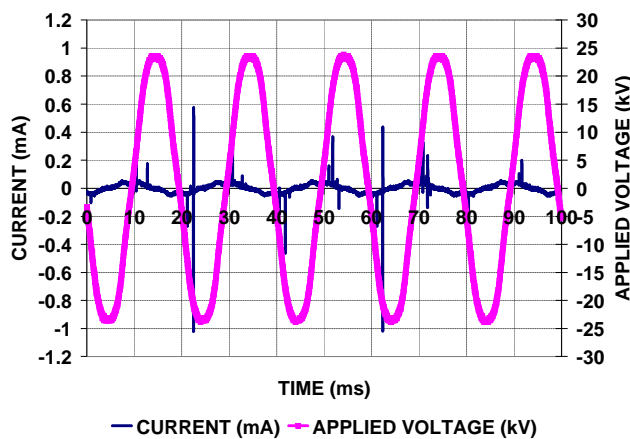
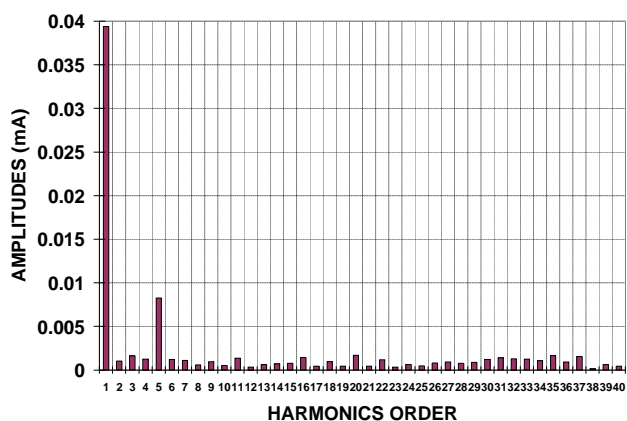
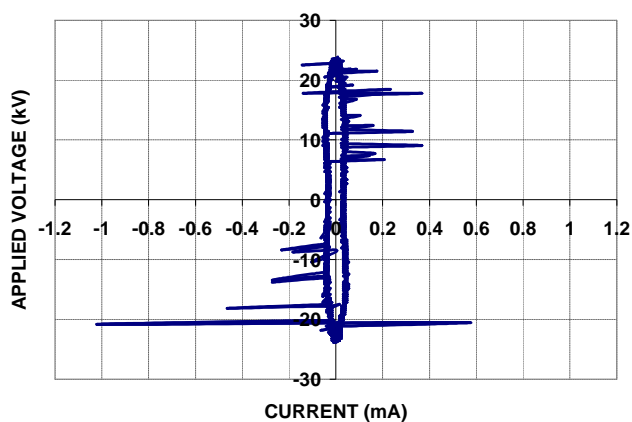
Fig. 8. Typical waveform of low pressure lightly polluted specimen

Figure 8 shows discharge current phenomenon of epoxy resin specimen on 26.5°C, 67%, -18.2 kPa and 34.8 kV_{max} of temperature, humidity, pressure and applied voltage amplitude respectively. This is sample of low pressure typical condition. Figure 8(a) is discharge current and applied voltage waveforms on such condition. It is seen that the intermittent discharge current was occurrence suddenly and similar, but the peak discharge current points were lower than that on normal pressure. For this case of low pressure, the highest peak discharge current point was +0.374 mA and -1.01 mA. Thus, the influence of low pressure was significantly high. It was easier to discharge on low pressure rather than on high humidity conditions. Thus, the threshold voltage would be reduced on low pressure. This case was caused supposedly by particle of air surrounding the specimen reduced, and furthermore, they were easier to discharge. Nevertheless, for this condition, the lightly artificially contaminated epoxy resin specimen still had capacitive property. Thus, the discharge condition did not change the epoxy resin specimen significantly. It had capacitive property, although in a low pressure discharge condition.

Figure 8(b) shows harmonics frequency spectrum of discharge current of Figure 8(a). Besides the fundamental frequency, the fifth harmonics was visible explicitly, as second highest of harmonics. Other harmonics were visible slightly enough. Figure 8(c) is the characteristics of applied voltage to discharge current of low pressure lightly artificially contaminated epoxy resin specimen. It is seen that the flash points increased, compared to the flash points on low humidity lightly artificially contaminated specimen.

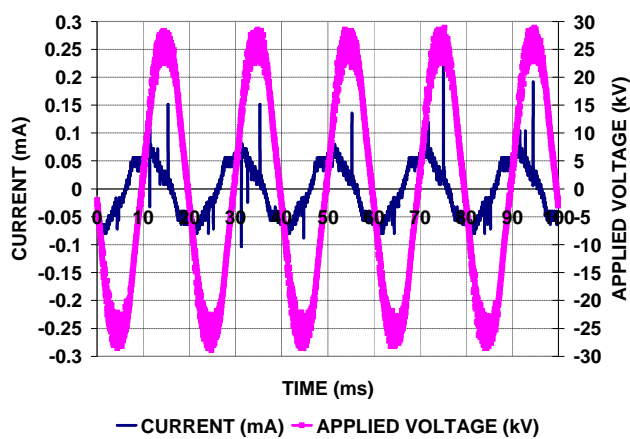
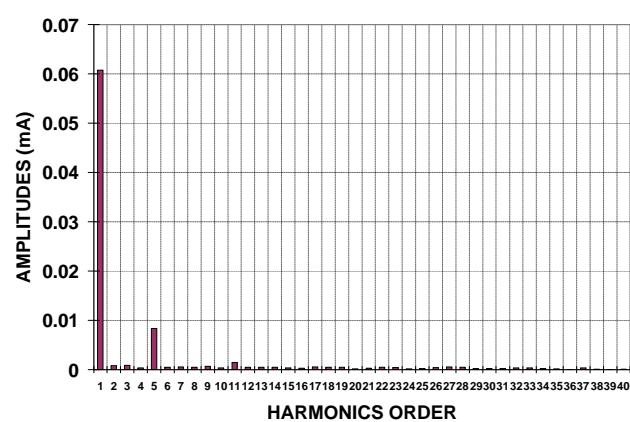
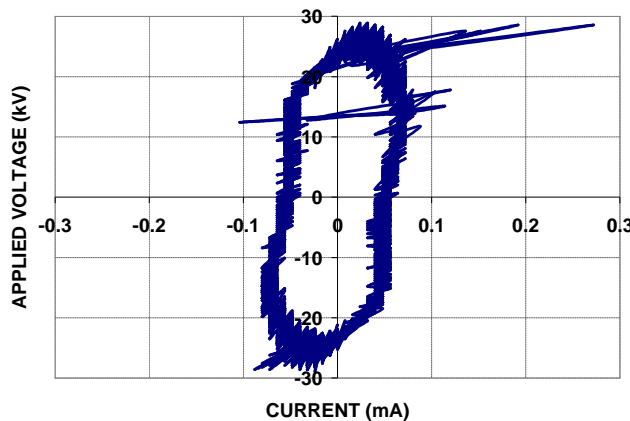
Fig. 9. Typical waveform of high pressure lightly polluted specimen

Figure 9 shows discharge current phenomenon of epoxy resin specimen on 27.5°C, 93%, +19.2 kPa and 28.2 kV_{max} of temperature, humidity, pressure and applied voltage amplitude respectively. This is sample of high pressure typical condition. Figure 9(a) is discharge current and applied voltage waveforms on such condition. On this condition, the peak discharge current point was 0.27 mA. It was more difficult to discharge on high pressure rather than that on low pressure. This case was caused supposedly by particle of air surrounding the specimen increased, and furthermore, they were more difficult to discharge, due to be compressed. Nevertheless, for this condition, the specimen still had capacitive property.

Figure 9(b) shows harmonics frequency spectrum of discharge current of Figure 9(a). Besides the fundamental frequency, the fifth harmonics was visible explicitly, and other harmonics were not visible. Figure 9(c) is the characteristics of applied voltage to discharge current of high pressure clean specimen.

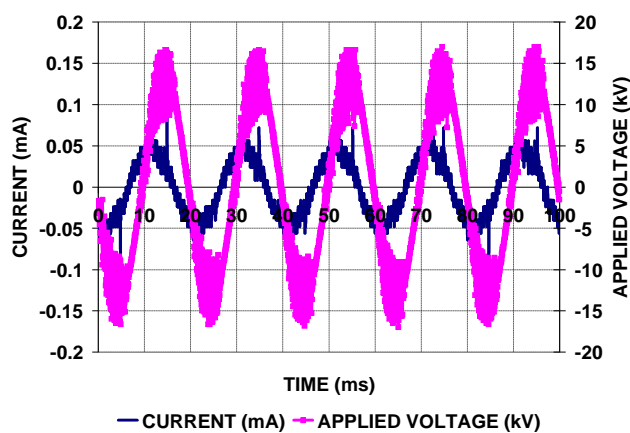
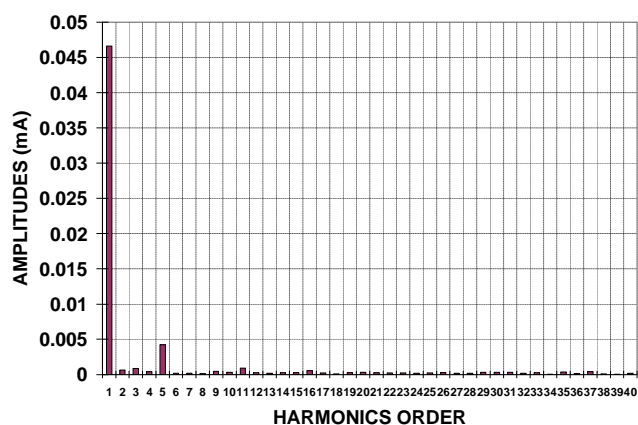
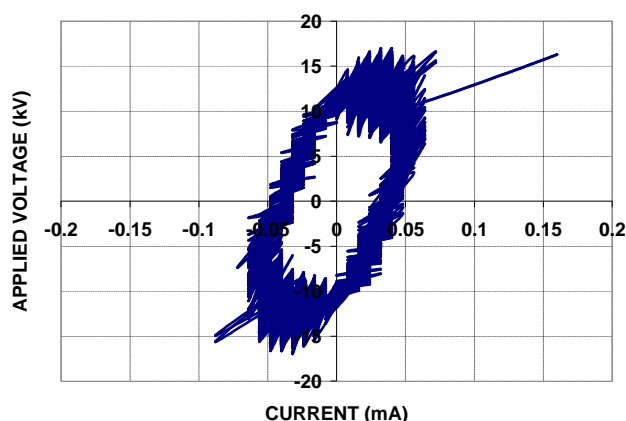
Fig. 10. Typical waveform of low RH heavily polluted specimen

Figure 10 shows discharge current phenomenon of heavily artificial contaminated epoxy resin specimen on 44.2°C, 69% and 16.6 kV_{max} of temperature, humidity and applied voltage amplitude respectively, and without pressure. This is sample of low RH typical condition. Figure 10(a) is discharge current and applied voltage

waveforms on such condition. It is seen that the intermittent discharge current was occurred slightly to increase compared to that on low humidity of clean specimen. It is stated that the existence of contaminant, it caused made higher of peak discharge current, both for positive and negative values. Although on this condition, the discharge current points were low, due to the applied voltage was also low. It was easier to discharge due to existence of contaminant on the specimen. Of course, the threshold voltage would be reduced due to existence of contaminant. This case was caused by particle of contaminant on specimen surfaces. Nevertheless, for this condition, the specimen still had capacitive property.

Figure 10(b) shows harmonics frequency spectrum of discharge current of Figure 10(a). Besides the fundamental frequency, the fifth harmonics was visible explicitly, but other harmonics were not visible significantly. However, they were far lower than fifth harmonics. The third harmonics was visible slightly. Figure 10(c) is the characteristics of applied voltage to discharge current of low humidity heavily artificial contaminated specimen. The peak discharge current values were lower due to the applied voltage was lower too.

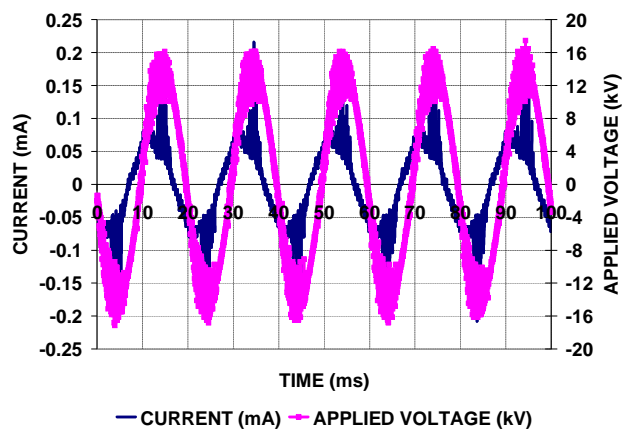
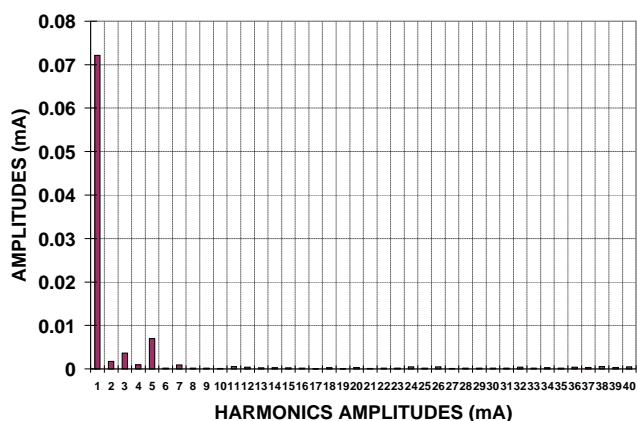
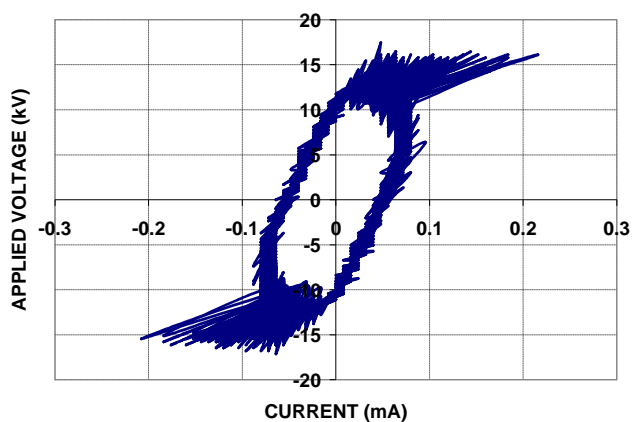
Fig. 11. Typical waveform of high RH heavily polluted specimen

Figure 11 shows discharge current phenomenon of heavily artificial contaminated epoxy resin specimen on 30.2°C, 99% and 16.1 kV_{max} of temperature, humidity and applied voltage amplitude respectively, and without pressure. This is sample of high humidity typical condition. Figure 11(a) is discharge current and applied voltage waveforms on such condition. It is seen that the intermittent discharge current was occurred significantly to increase compared to that on low humidity of slightly contaminated specimen. However, the peak discharge current increased, became 0.22 mA on this condition compared to that previous low humidity. This was also caused the applied voltage was lower than the previous on slightly contaminated specimen. Thus, it was easier to discharge due to high humidity. The threshold voltage would be reduced due to the grains of water droplets. This case was caused by particle of contaminant and water droplets on the specimen surfaces. Nevertheless, for this condition, the specimen still had capacitive property.

Figure 11(b) shows harmonics frequency spectrum of discharge current of Figure 11(a). Besides the fundamental frequency, the fifth harmonics was visible explicitly as second highest amplitude. Besides that, the third harmonics was also visible significantly, as third highest harmonics. Figure 11(c) is the characteristics of applied voltage to discharge current of high humidity heavily artificial contaminated epoxy resin specimen. It is seen that the flash points increased significantly.

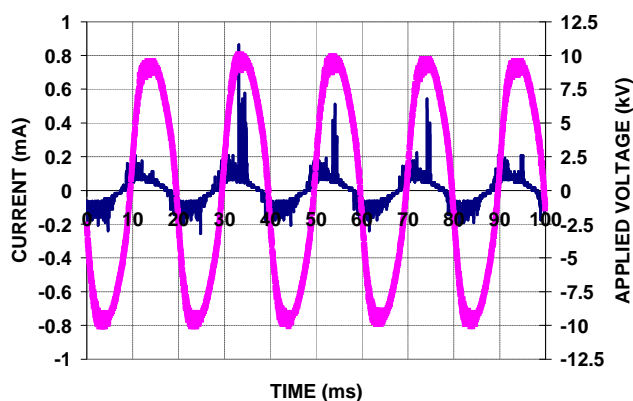
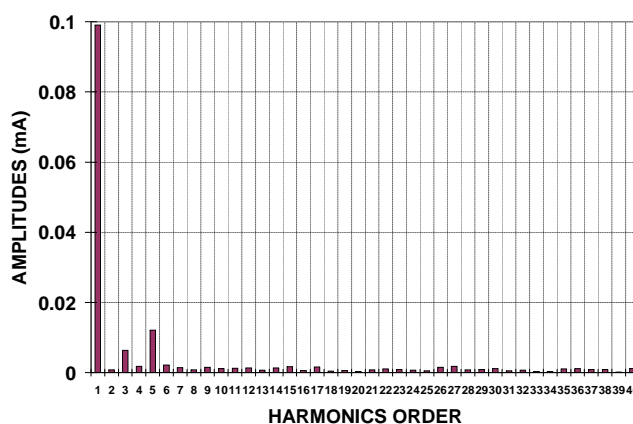
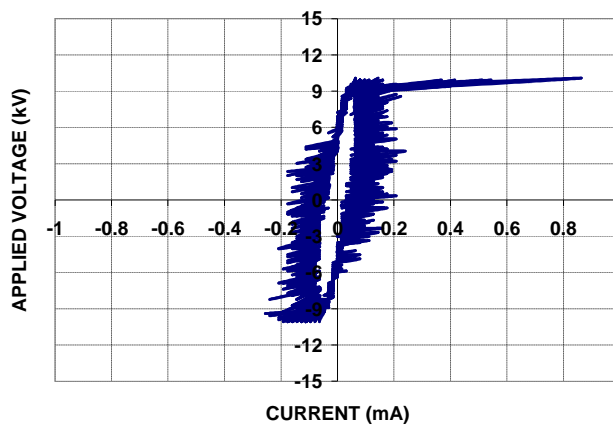
Fig. 12. Typical waveform of low pressure heavily polluted specimen

Figure 12 shows discharge current phenomenon of heavily artificial contaminated low pressure epoxy resin specimen on 26.1°C, 88%, -19.8 kPa and 9.9 kV_{max} of temperature, humidity, pressure and applied voltage amplitude respectively. This is sample of low pressure typical condition. Figure 12(a) is discharge current and applied voltage waveforms on such condition. It is seen that the intermittent discharge current was occurrence suddenly and more frequently than the previous. The peak discharge current points could reach 0.864 mA. Thus, the influence of low pressure was significantly high. It was easier to discharge on low pressure rather than on high humidity conditions. Thus, the threshold voltage would be reduced on low pressure. This case was caused supposedly by particle of air surrounding the specimen reduced, and furthermore, they were easier to discharge. Nevertheless, for this condition, the specimen still had capacitive property. Thus, the discharge condition did not change the epoxy resin specimen significantly. It had capacitive property, although in a low pressure discharge condition. Figure 12(b) shows harmonics frequency spectrum of discharge current of Figure 12(a). Besides the fundamental frequency, the fifth harmonics was visible explicitly, as second highest of harmonics. The third harmonics was visible significantly enough. On this condition, the third harmonics was third highest amplitude, after fundamental and fifth harmonics. Figure 12(c) is the characteristics of applied voltage to discharge current of low pressure heavily artificial contaminated epoxy resin specimen. It is seen that the flash points and their amplitudes increased, compared to the flash points on low humidity of specimen.

Figure 12(b) shows harmonics frequency spectrum of discharge current of Figure 12(a). Besides the fundamental frequency, the third harmonics was visible explicitly, and followed by fifth harmonics. This case is different from other spectra, that after fundamental frequency, the second highest amplitude was fifth harmonics. Figure 12(c) is the characteristics of applied voltage to discharge current of high pressure the specimen on this condition. It is seen that the flash points were more compared to the flash points on low pressure.

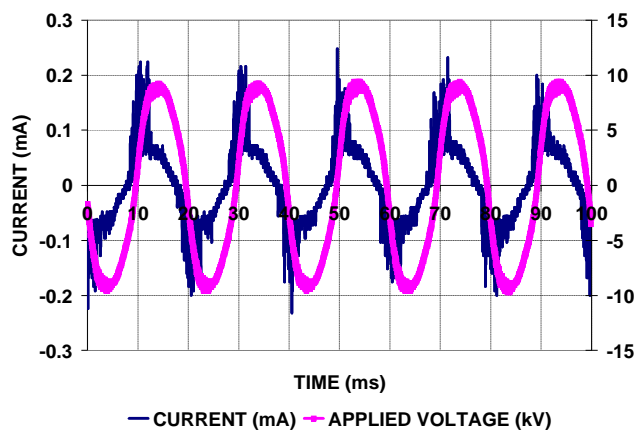
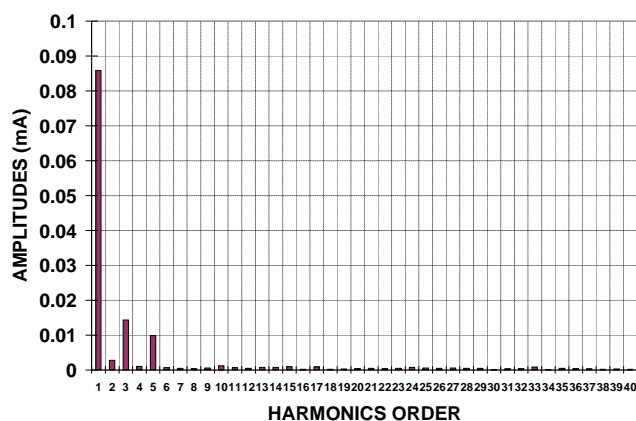
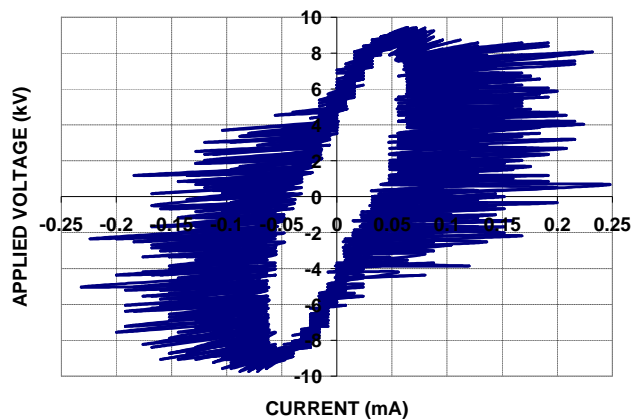
Fig. 13. Typical waveform of high pressure heavily polluted specimen

Figure 13 shows discharge current phenomenon of epoxy resin specimen on 28.4°C, 93%, +19 kPa and 9.4 kV_{max} of temperature, humidity, pressure and applied voltage amplitude respectively. This is sample of high pressure typical condition. Figure 13(a) is discharge current and applied voltage waveforms on such condition. It is seen that the intermittent discharge current was occurred significantly less than that on high pressure. On this condition, the peak discharge current point was 0.248 mA. It was more difficult to discharge on high pressure rather than that on low pressure. This case was caused

supposedly by particle of air surrounding the specimen increased, and furthermore, they were more difficult to discharge, due to be compressed. Nevertheless, for this condition, the specimen still had capacitive property.
