# Analysis of Highway Slope Failure by an Application of the Stereographic Projection

Chin-Yu Lee and Iau-Teh Wang

**Keywords**—slope stability analysis, Stereographic Projection, wedge Failure.

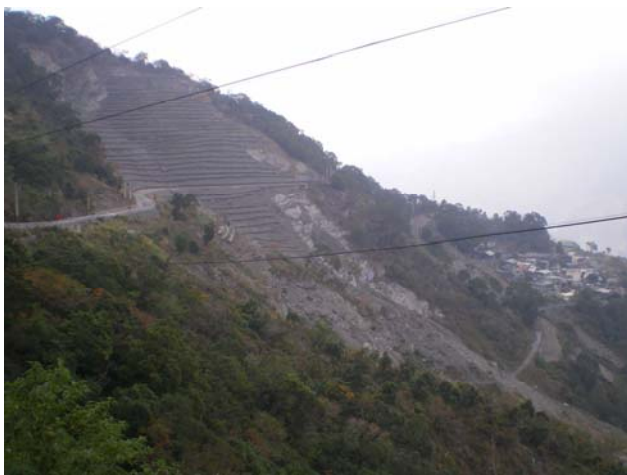
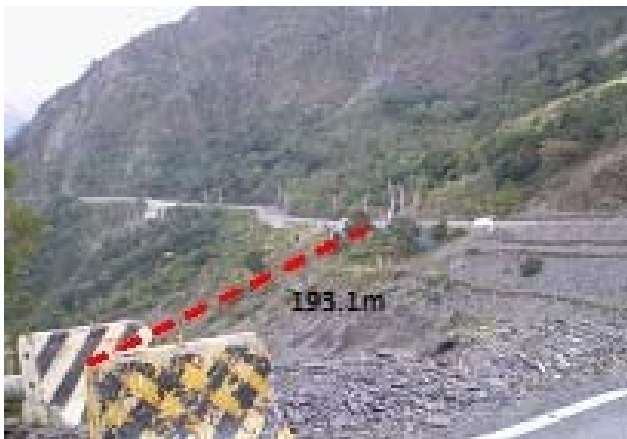
County, along which disasters such as slope collapse and sliding usually occur whenever there are typhoons or heavy rainfalls (Figure 1). Hence, in order to understand the slope collapse features of this sector of road, geological investigations in the collapse area in this research are based on site investigation and the evaluation of remote survey images. By applying this method, we can understand the landscape undulation, geological materials, geological structures, hydrological environment, and other main linear structures. Also, we can conduct slope stability analyses to better understand the sliding failure mechanism of the area of collapse by applying the Stereographic Projection Method, which is based on structural geology.

Fig. 1 Location of slope collapse and sliding

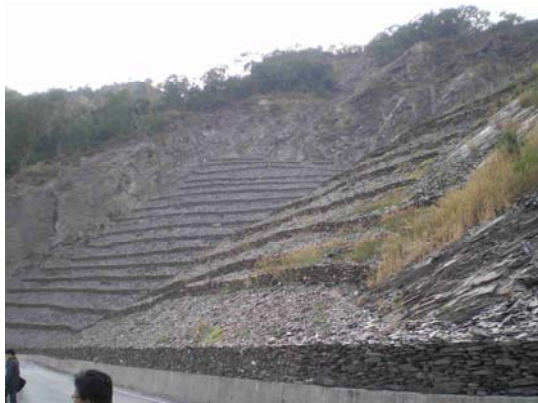
Picture 1

The main disaster location is situated at Point 46.2 km along Provincial Road No. 24 with the X-Y coordinate of (223202, 2515674) on the border between the tribes of Jilou and Ali. An extensive area of slopes is exposed to the air and failures occurred after several typhoons. Beneath the collapsed area is Ailiao North River. After the site investigation, it was found that several disasters such as serious roadbed loss happened along Provincial Road No. 24. A large collapse happened around Jilou Tribe close to the Point 46.4 km along the road. Continuous masonry rock parapets (Picture 1) were built with slate on the rock slopes. Although short retaining walls were built along the toe of the upper slope, collapse and rockfall still occurred. Construction of slope protection was also conducted on the lower slope with slate (Picture 2). However, it seems that some rocky parts were exposed on both sections. The cracking on that section of road is indicated in Picture 3, while undulation of the road surface is shown in Picture 4.

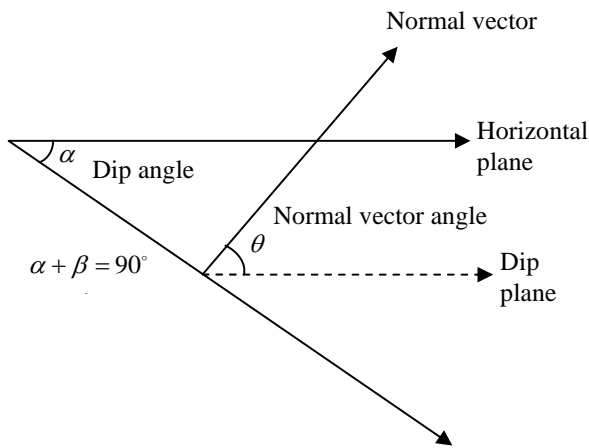
Figure 5 shows the recommended terminology for orientation is the dip and dip direction which are defined as follows,

1. Dip is the maximum inclination of a discontinuity to the horizontal ( $\alpha$ ).
2. Dip direction or dip azimuth is the direction of the horizontal trace of the line of dip, measured clockwise from north ( $\theta$ ).

Fig. 5 Isometric view of plane (dip and dip direction)

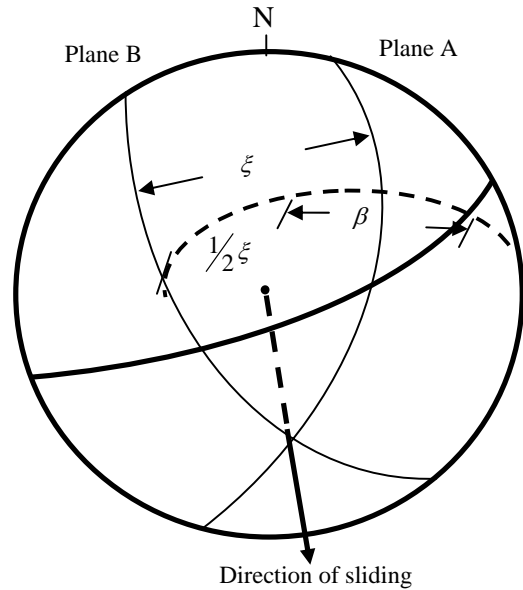
measured on the great circle containing the pole to the line of intersection and the poles of the two slide planes, the angles  $\xi$  and  $\beta$  are define in Figure 7 and Figure 8.

Fig. 8 Measurement of angles  $\xi$  and  $\beta$  [7]

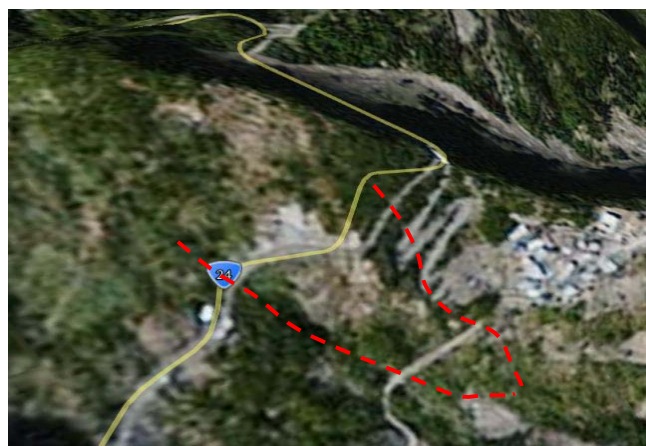
Small catchment areas are formed by the undulation of the landscape in this region (Figure 10). Figure 11 shows that the vertical distance of the collapse object's upper slope is 52.5m, while the tilting distance is around 85.1m. The angle of repose is 30° and the length of the side slope is about 163.3m. The dip angles are 23.1° on the left hand side, 36.5° in the middle, and 37.1° on the right hand side. It is evident that sliding continues to occur in this region because the angle on the left hand side is smaller than the angle of repose. Figure 12 shows that the vertical distance of the lower slope is 103m, and the tilting distance is approximately 191m. The dip angle of the slope is 32.1°, which is bigger than the angle of repose. Furthermore, the terrain of the areas along Ailiiao North River is cut by the river and meanders are formed. Also, the unstable situation of the side slope is probably caused by the depressurization of the valley. This phenomenon can result from the cracking of the short retaining walls and the road surface. Lastly, it can be judged that the cracking resulting from tension on the top of the upper slope is the key factor which will cause linear structural zoning collapse (Figure 13). Moreover, the geological materials are mostly slate with low weather resistant capabilities. It is possible that large scale collapse may occur if there are any inducements.

Fig. 10 Regional Small Catchment Area (Google Earth)

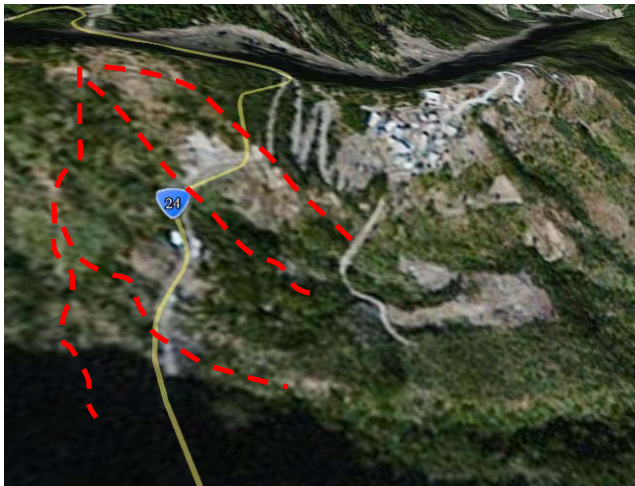
Fig. 13 Collapse Zone of Linear Structure (Google Earth)
