Influence and Interaction of Temperature, H₂S and pH on Concrete Sewer Pipe Corrosion

Anna Romanova, Mojtaba Mahmoodian, Morteza A. Alani

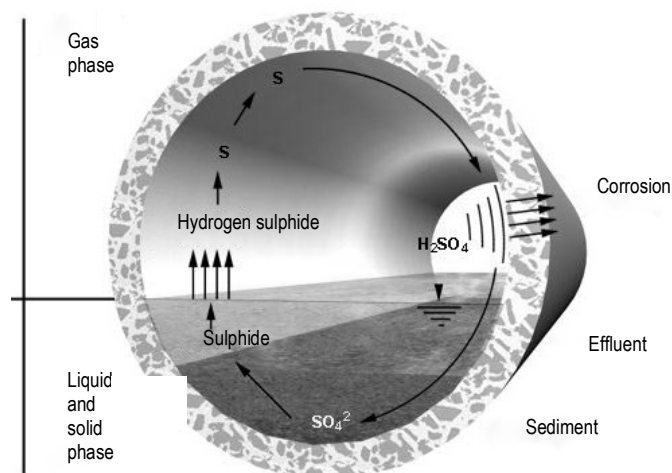
Fig. 1 Microbially induced concrete corrosion in sewer [19]

The process of sewer pipe corrosion has been studied since 1940th and a set of representative knowledge has been gained over years, which are referred to as microbially induced concrete corrosion (MICC) [12]. The bacteria class *Acidithiobacillus thiooxidans* [12]-[14] which are active in the effluent biofilm [15] convert sulphate to sulphide [16]. Some part of sulphide is released in atmosphere as gaseous hydrogen sulphide (H₂S) [16]. Further, the hydrogen sulphide is oxidised [17] to sulphuric acid (H₂SO₄), which subsequently attacks susceptible pipeline materials [18]. Fig. 1 demonstrates the chemical reaction of microbially induced concrete corrosion process in sewer pipe.

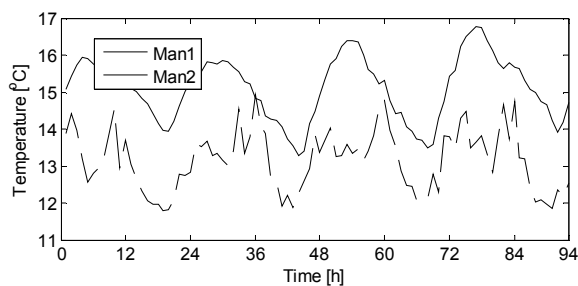
Fig. 1 Effluent temperature for Manhole 1 and Manhole 2 for a period of 4 days in the beginning of April shown in hours

The effluent temperatures for both manholes were found to follow very similar daily trend, however each of them has individual hourly pattern. Fig. 1 represents the data of effluent temperature recorded at a manhole 1 and manhole 2 in 5 days period in the beginning of April, where zero is set at 10am.

The data on Fig. 1 and for all other graphs was resampled to represent an average value for each given hour. Overall, in Feb-Apr the temperatures measurements minimum, maximum and mean for Man1 and Man2 were, 10.8°C, 17.1°C, 13.2°C and 11.6°C, 17.6°C, 15.1°C, respectively. In general the temperatures in Man2 are found to be higher and this is thought to be influenced by a closer location to the rising main, pumping station and generally the industrial sector which have larger use of hot water.

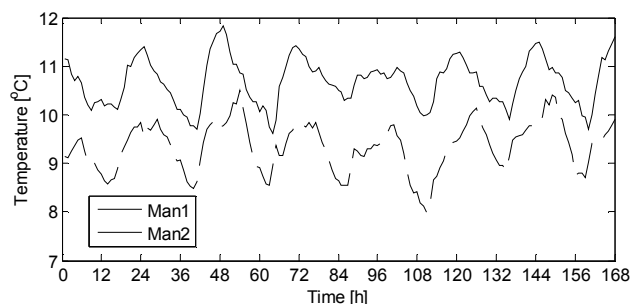
Fig. 2 Ambient temperature for Manhole 1 and Manhole 2 for a period of 1 week in the beginning of March shown in hours

The ambient temperatures for both manholes were found to follow overall an identical pattern. The general pattern of this behavior for both manholes is illustrated in Fig. 2, with zero set at midnight. From Fig. 2 it can be noted that the temperature in Man 1 is generally slightly lower for that compared with Man 2, with mean temperature values of 9.3°C and 10.6°C, respectively. Overall, in Feb-Apr the temperatures measurements minimum, maximum and mean for Man1 and Man2 were, 7.6°C, 12.9°C, 10°C and 8.7°C, 13.8°C, 11.2°C, respectively. The temperatures increased over the day with peak times at 11pm-4am after which they declined. This coincided with the discharge of overflow in the pumping station which generally takes place at midnight or when the chamber is full. However each manhole had manhole-specific minor pattern which is thought to be governed by house hold and industry activity in the area.

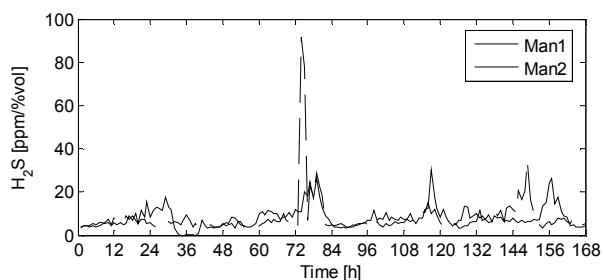
Fig. 3 Hydrogen sulphide concentration for Manhole 1 and Manhole 2 for a period of 1 week in the beginning of March shown in hours

The concentration of hydrogen sulphide for both of the manholes was measured with the sensor being placed in the middle of the manhole at 600mm above the effluent. The measurements of H₂S are presented on Fig. 3, where the data is shown for the same time period as in Fig. 2. From the figure it can be noted that the pattern of H₂S concentration is similar for both manholes even though they were located far apart and governed by different rising mains and pumping station conditions. Although, it should be noted that the operational time for all pumping stations in experimental area is the same. Graph identified large peak of H₂S at Manhole 1 at 91ppm/ % vol, where manhole 2 identifies only 29ppm/%vol. A similar peak tends to appear app. every 48h closer to midnight.

Overall, in Feb-Apr the measurements of the H_2S concentration minimum, maximum and mean for Man1 and Man2 were, 3, 134, 12 and 0, 168, 12, respectively. Even though the minimum and maximum values of both of the manholes varied, the mean of 12ppm/%vol was observed in both, whereas in most of the times a value of 3-5ppm/%vol was recorded.

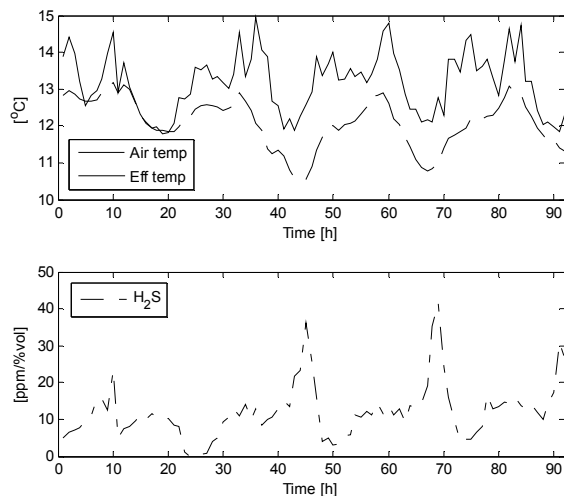
Fig. 4 Temperatures and hydrogen sulphide concentration for Manhole 1 for a period of 4days in April shown in hours

The interaction between parameters of ambient temperature, effluent temperature and concentrations of hydrogen sulphide was investigated. Fig. 4 demonstrates the recorded data for the above for first four days in April for Manhole 1, with zero starting at 10am.

The data suggests that there is a relation between the ambient and effluent temperatures as they follow the same hourly pattern (which is governed by the effluent temperature, which in turn is related to domestic and industrial activities) and daily trend (governed by effluent temperature and general temperature of air outside the manhole). Furthermore, it can be noted that the H_2S level peaks together with the general decrease in temperature inside the manhole in late evening and early morning hours (during this time the general household and industrial activity is minimal, the flow levels are low to

moderate which allows for gas build-up). Furthermore, there is an apparent 10h shift in H_2S level increase and decrease behavior compared to temperatures. The above findings were confirmed for both of the manholes during Feb-Apr period.
