Concrete Sewer Pipe Corrosion Induced by Sulphuric Acid Environment

Anna Romanova, Mojtaba Mahmoodian, Upul Chandrasekara, Morteza A. Alani

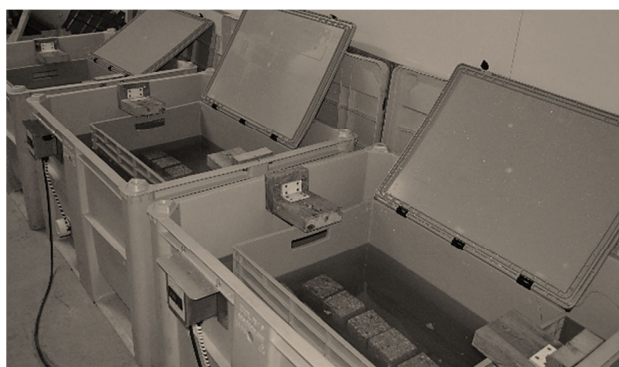
Fig. 1 Experimental set up of cubes being submerged into diluted sulphuric acid

A total number of 45 cubes, cut out from brand-new circular concrete pipe were used in these experiments. Each cube had a measurement of 100x100x100mm and was cut with diamond-blade rotating saw, however as the process of cutting a circular pipe is very challenging and labour consuming a tolerance of 10% in each side measurement of the cube was allowed for. A number of 15 cubes were fully submerged into 0.5 pH solution of sulphuric acid in each of the containers in Tanks 1, 2 and 3. Further they were extracted at different points in time and assessed using different techniques to account for the corrosion level. Fig. 1 demonstrates a setup of tanks, containers and cubes located in the environmental chamber.
