D1.2-Map and report of key climate-change hazards

Project acronym	SCORE
Project title	Smart Control of the Climate Resilience in European Coastal Cities
Starting date	01.07.2021
Duration	48 months
Call identifier	H2020-LC-CLA-2020-2
Grant Agreement No	101003534

Deliverable Information	
Deliverable number	D1.2
Work package number	WP1
Deliverable title	Map and report of key climate-change hazards
Lead beneficiary	UCC
Author(s)	Emilio Laíño Rebollido (UCC), Gregorio Iglesias (UCC)
Contributing partners	ITS, UCD, RED, TERO, TUKE, UA, NAIDER, UG, OAR, OEIRAS, SAMU, ZRS, ENT, PGC and ISTID
Due date	31/08/2022
Actual submission date	31/08/2022
Type of deliverable	Report
Dissemination level	Public

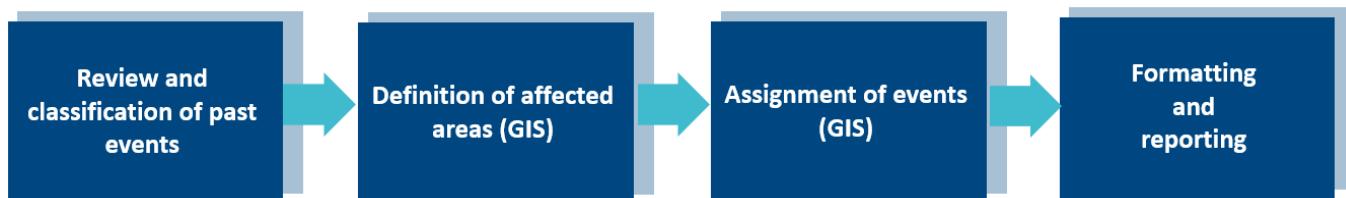
Figure 2: Workflow of the methodology to produce the maps.

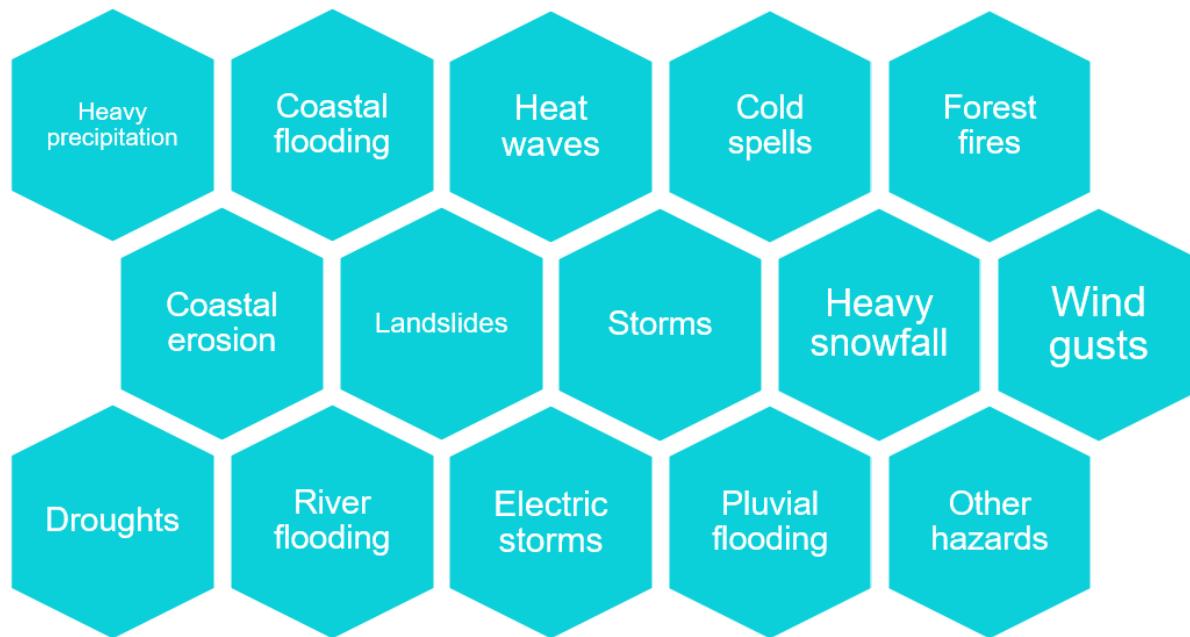
Figure 3: Overview of the climate-related events identified in Task 1.2.

Regarding the extreme climate events, they have been collected and summarised with the help of the Task 1.2 partners. The past events have been classified under a wide variety of categories, mainly based in the Sixth Assessment Report from the IPCC. Thus, the categories considered include heavy precipitation, coastal flooding, coastal erosion, pluvial flooding, river flooding, landslides, droughts, heat waves, cold spells, storms, heavy snowfall, electric storms, strong winds, forest fires, and other hazards as shown in Figure 3. The previous list is not exhaustive and additional categories could be included in the study in the case that they are detected to be of particular concern to a CCLL.

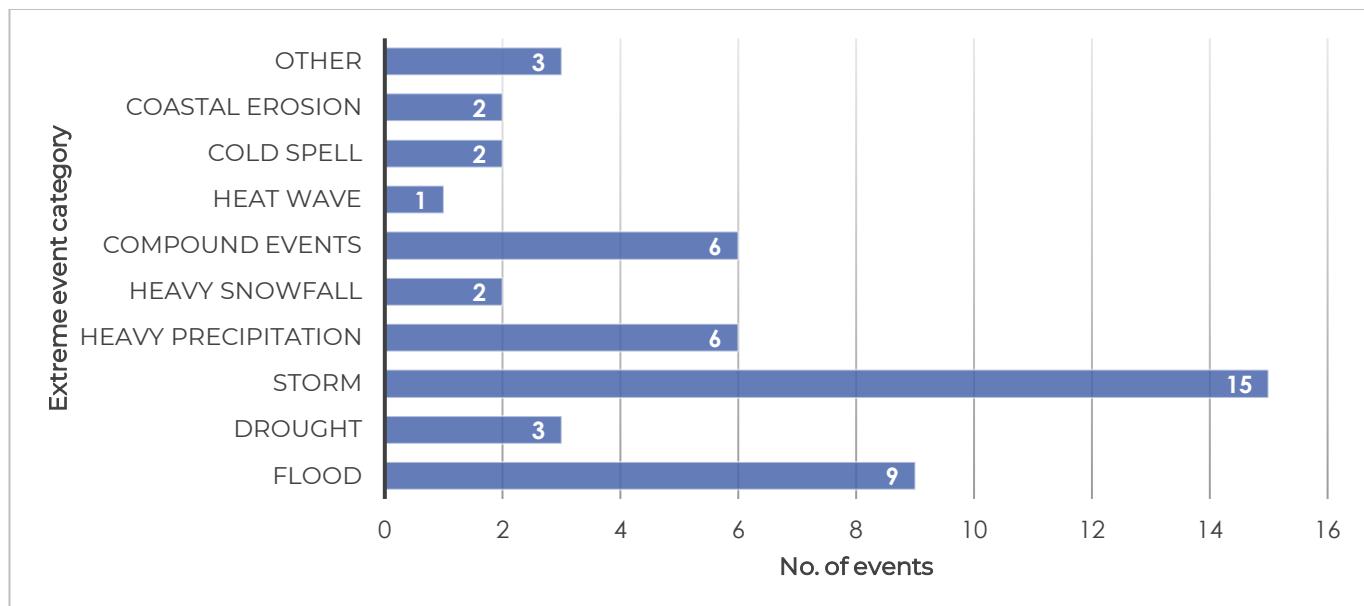
Figure 5: Number of past events recorded in Sligo by event category.

Storms are the most frequent extreme events, with fifteen (15) occurrences, followed by nine (9) flooding events. The less frequent extreme events are coastal erosion episodes, cold spells and heavy snowfalls, with two (2) occurrences each one, and heat waves, recorded only one (1) time. Moreover, three (3) events have been categorised under the “Other” label, and six (6) events have been also reported under the “Compound Event” category (see Table 5).

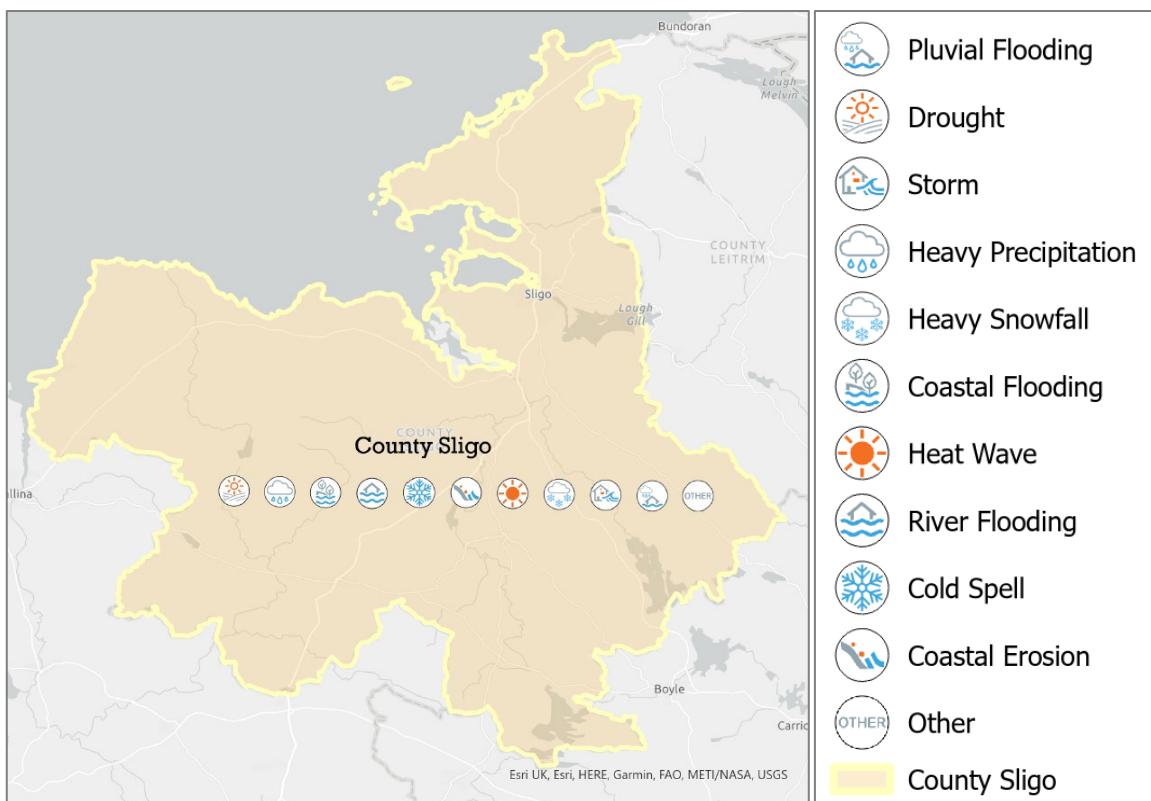
Figure 6: Schematic representation of key climate-related hazards identified in Sligo CCLL.

The climate events categories described previously have been represented in a GIS model. The full map can be found in the Appendix of this document (Sligo). A snapshot is represented in Figure 6.

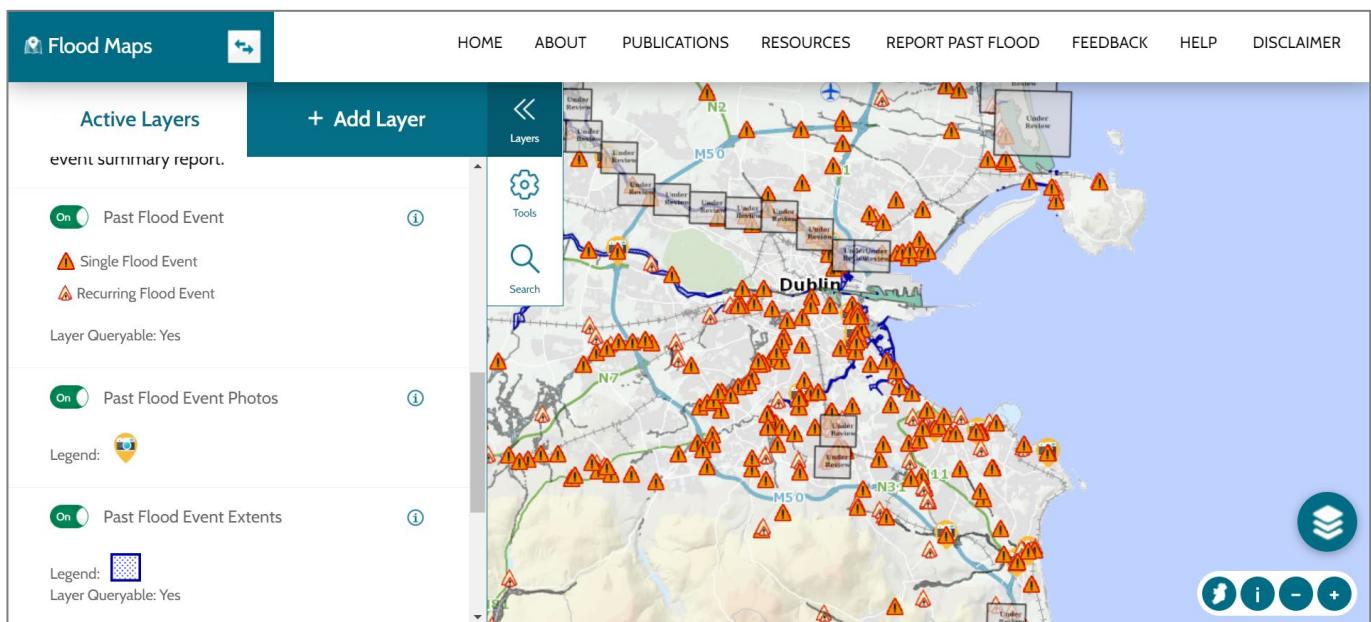
Figure 7: Snapshot of Flood Maps online map showing past flood events in Dublin, as identified by the Office of Public Works.

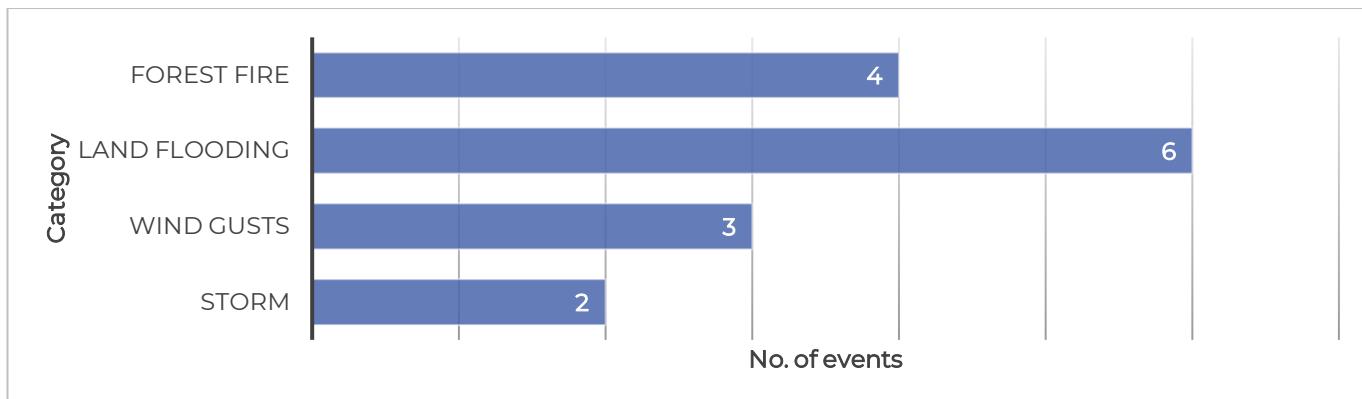
**Figure 8: Number of past events recorded in Vilanova i la Geltrú by category.**

In this context, Vilanova i la Geltrú CCLL has produced a list summarising the past extreme climate events occurred in the municipality, which can be found in the Appendix (see Vilanova i la Geltrú). In addition, Vilanova i la Geltrú CCLL has provided data on past forest fires occurred in Catalunya since 1986. The forest fires that affected Vilanova i la Geltrú have been extracted and included in the past events list and mapped. In summary, the total number of events identified is fifteen (15), including episodes of land flooding, storms, strong winds, and forest fires. The number of events by category is represented in Figure 8.

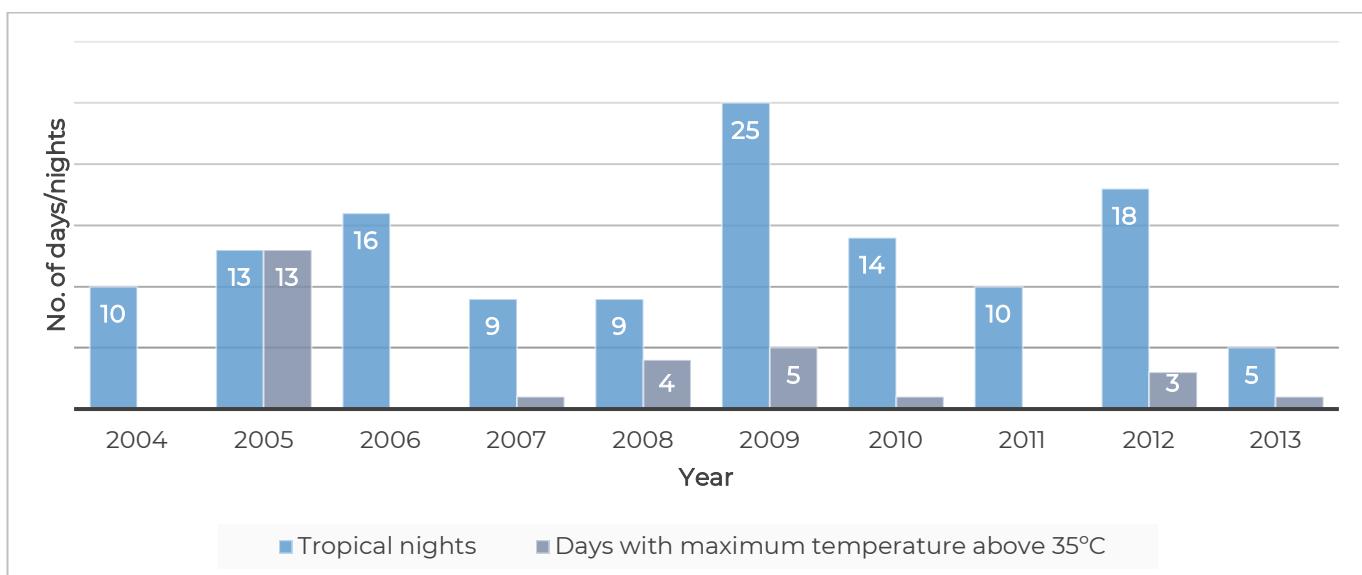
Figure 9: Evolution of the number of tropical nights and hot days at the Sant Pere de Ribes weather station (2004-2013). From: Vilanova i la Geltrú Climate Change Adaptation Plan.

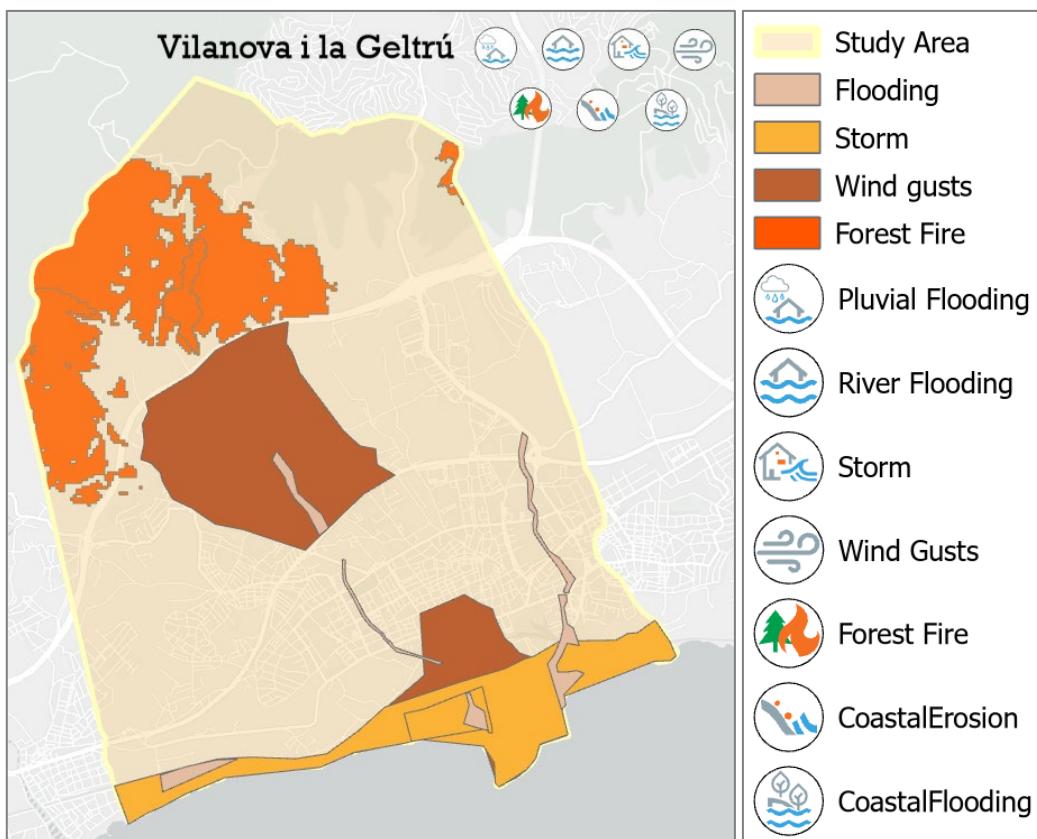
Figure 10: Key climate-related hazards identified in Vilanova i la Geltrú CCLL.

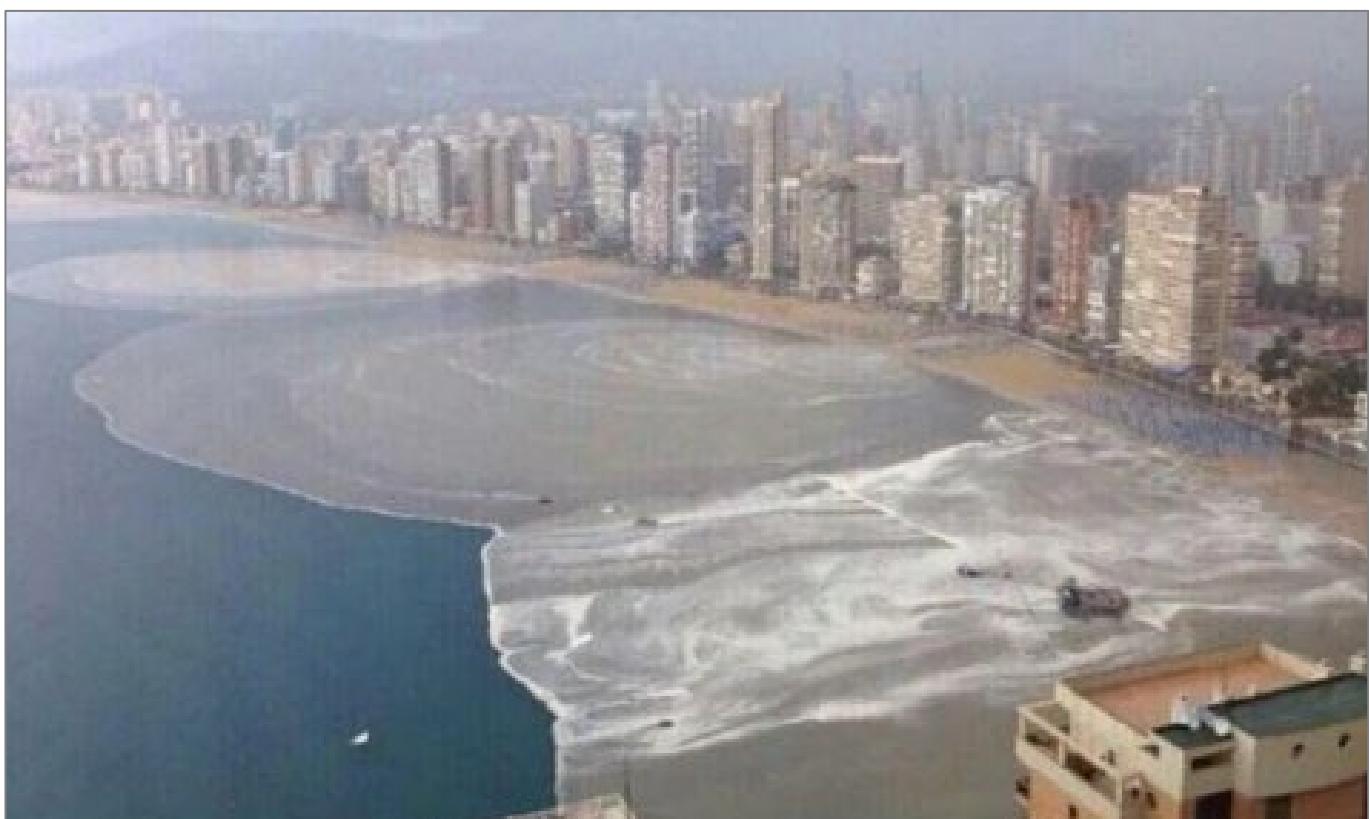
Figure 11: Storm causing coastal flooding over Benidorm on 05/10/2014. From METEORED¹⁰.

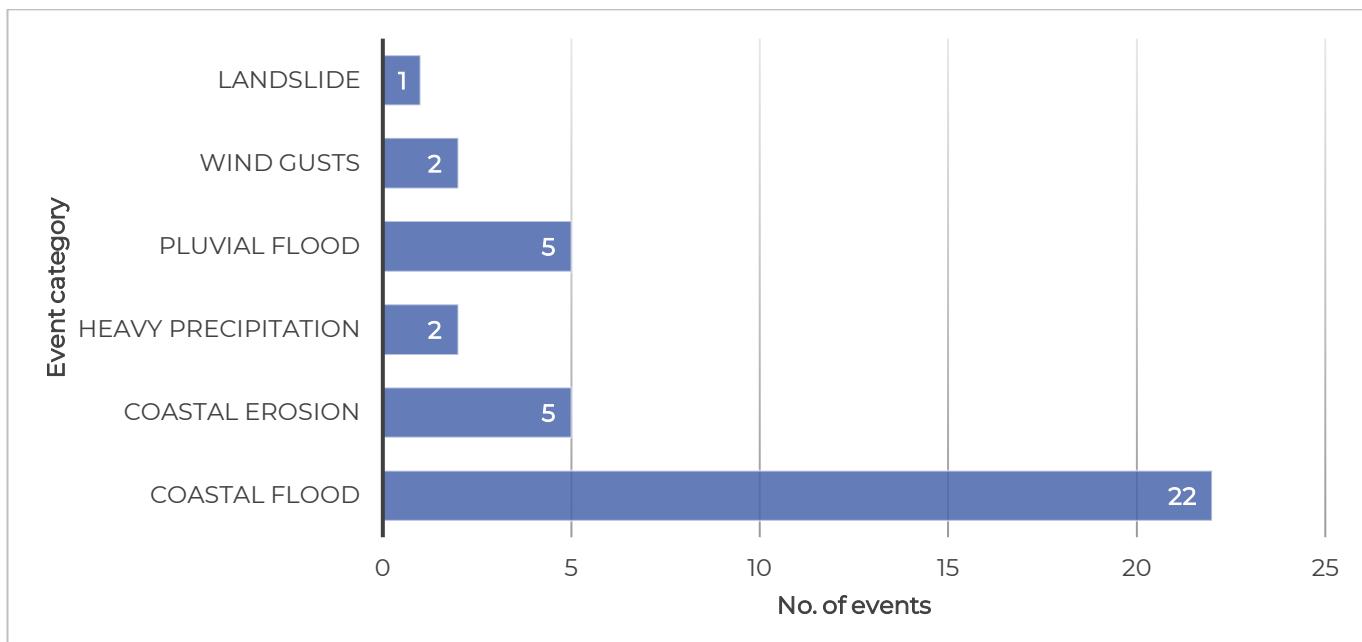
Figure 12: Number of past events recorded in Benidorm CCLL by category.

In summary, thirty-seven past events have been recorded in Benidorm for the period 1950-2020, including episodes of coastal flooding, coastal erosion, pluvial flooding, strong winds, landslides and heavy precipitation (Table 6). Five of them affected the whole area of Benidorm (heavy precipitation and pluvial flooding events). The remaining thirty-two, affected smaller areas, which have been defined in the GIS model. Levante Beach is the most affected area with seventeen occurrences of coastal flooding and coastal erosion. Poniente Beach has been affected ten times by either coastal flooding or coastal erosion. The data indicate that Cala Finestrat has been flooded twice by pluvial flooding. Two events of strong winds have been recorded in Terra Mitica theme park and IES Pere Maria Orts Institute. And, finally, one landslide occurred over the CV-70 road.

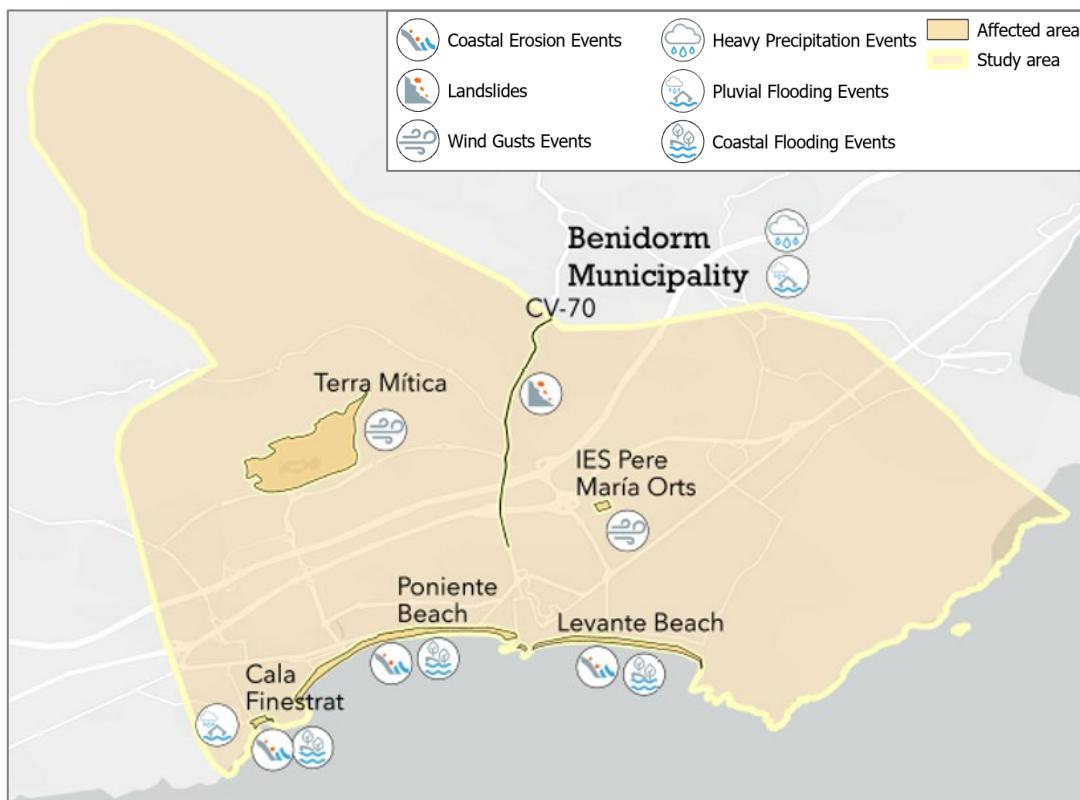
Figure 13: Schematic representation of key climate-related hazards identified in Benidorm CCLL

The affected areas have been represented in the GIS model. A summary of the geographical files produced can be found in Table 7. The study area (Benidorm municipality) has been derived from the Official Cartography of Valencian Community resources. The shapefiles representing the three beaches (Levante, Poniente and Cala Finestrat) were provided by Benidorm CCLL. The shapefiles representing the remaining areas (Terra Mitica theme park, IES Pere Maria Orts institute and CV-70 road) have been self-produced from satellite imagery.

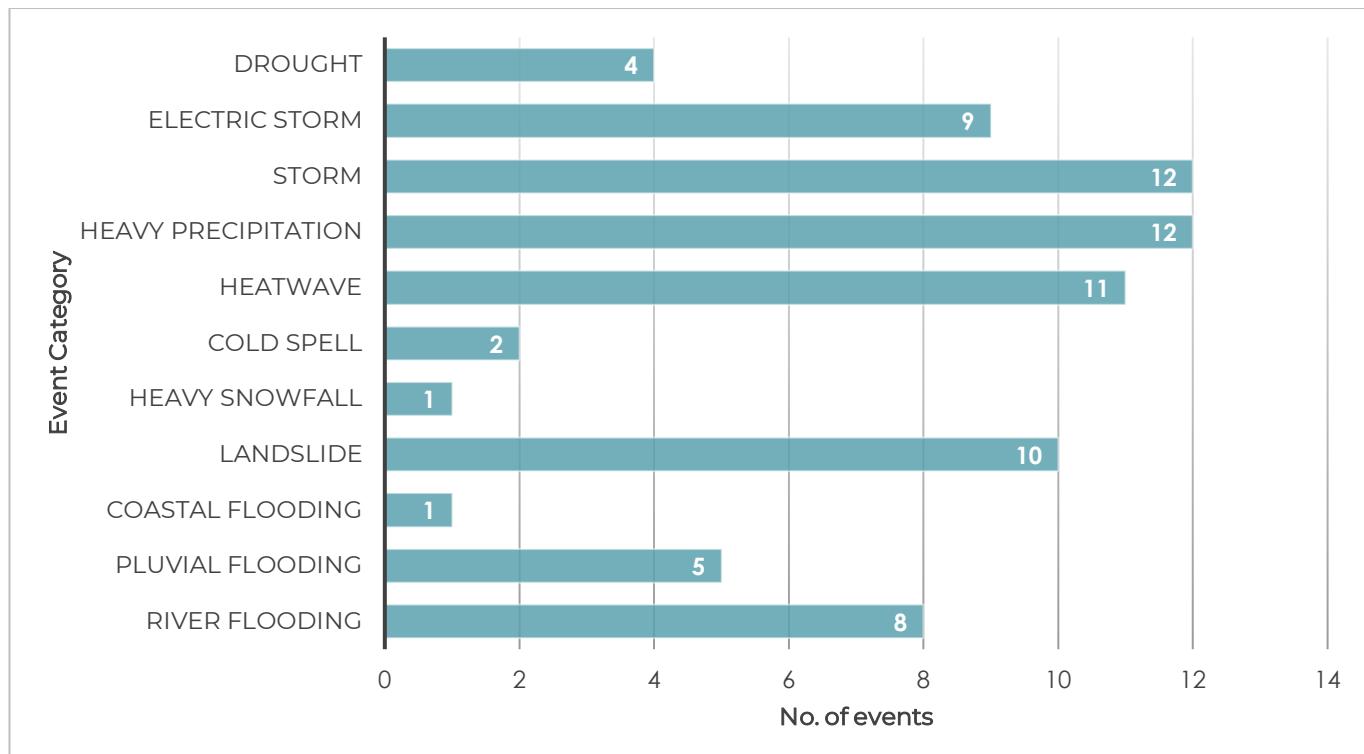
**Figure 14: Number of past events recorded in Oarsoaldea CCLL by category (1900-2022).**

In summary, seventy-five (75) past events have been collected in Oarsoaldea, including episodes of river flooding, pluvial flooding, coastal flooding, landslide, heavy snowfall, cold spell, heatwave, heavy precipitation, storm, electric storm, and drought (Table 9). Fifty (50) of them affected the whole area of Oarsoaldea, including heavy snowfall, cold spell, heatwave, heavy precipitation, storm, electric storm, and drought events. The remaining twenty-five (25), affected one or more of the municipalities included in Oarsoaldea, but not all the four. Each municipality has been analysed individually, so it has been counted how many times each municipality was affected by one of these last twenty-five (25) events. In this way, Erreenteria has been affected eleven (11) times by either river or pluvial flooding; Oiartzun six (6) times by river or pluvial flooding again; Pasaia has been the most affected municipality registering eighteen (18) events including river flooding, pluvial flooding, coastal flooding and landslides; and Lezo has been the less affected municipality only registering three (3) events of pluvial flooding or landslides.

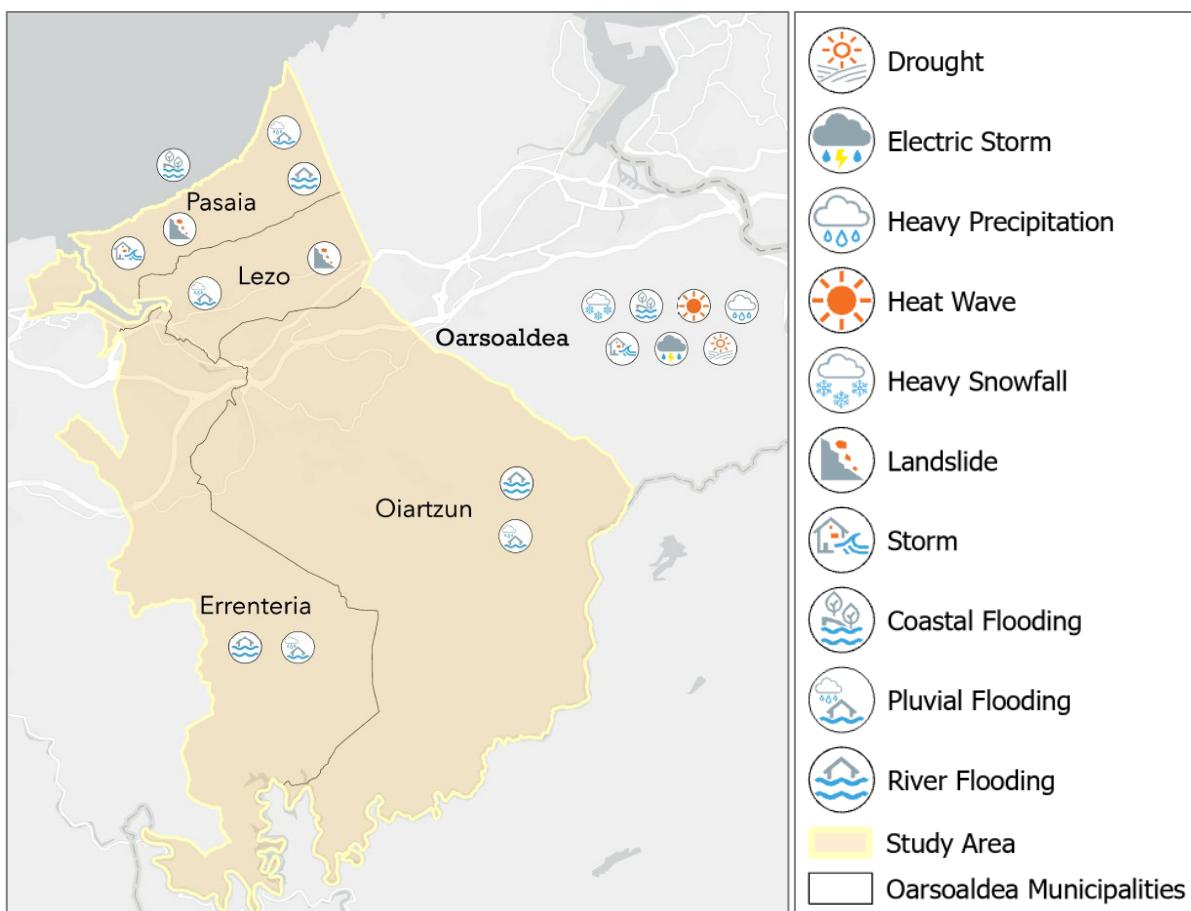
Figure 15: Schematic representation of key climate-related hazards identified in Oarsoaldea CCLL.

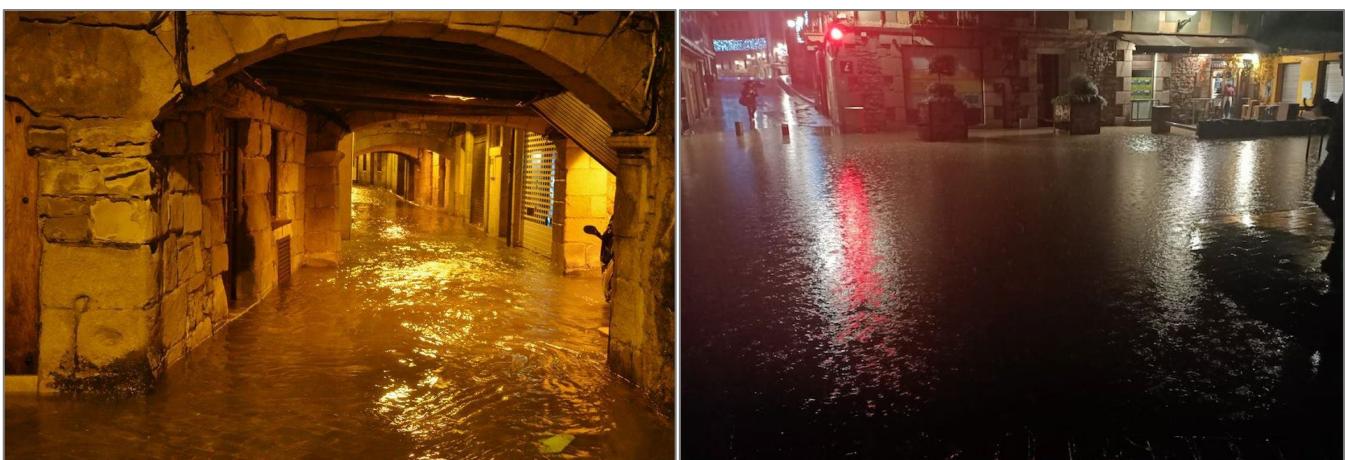
Figure 16: Coastal flood in Winter 2014 in Pasaia (left) and river flood in December 2021 in Erreenteria (right).

Photography for the coastal flooding affecting Pasaia in Winter 2014 and the river flooding occurred in Erreenteria December 2021 have been provided by Oarsoaldea CCLL. These pictures are presented in Figure 16.

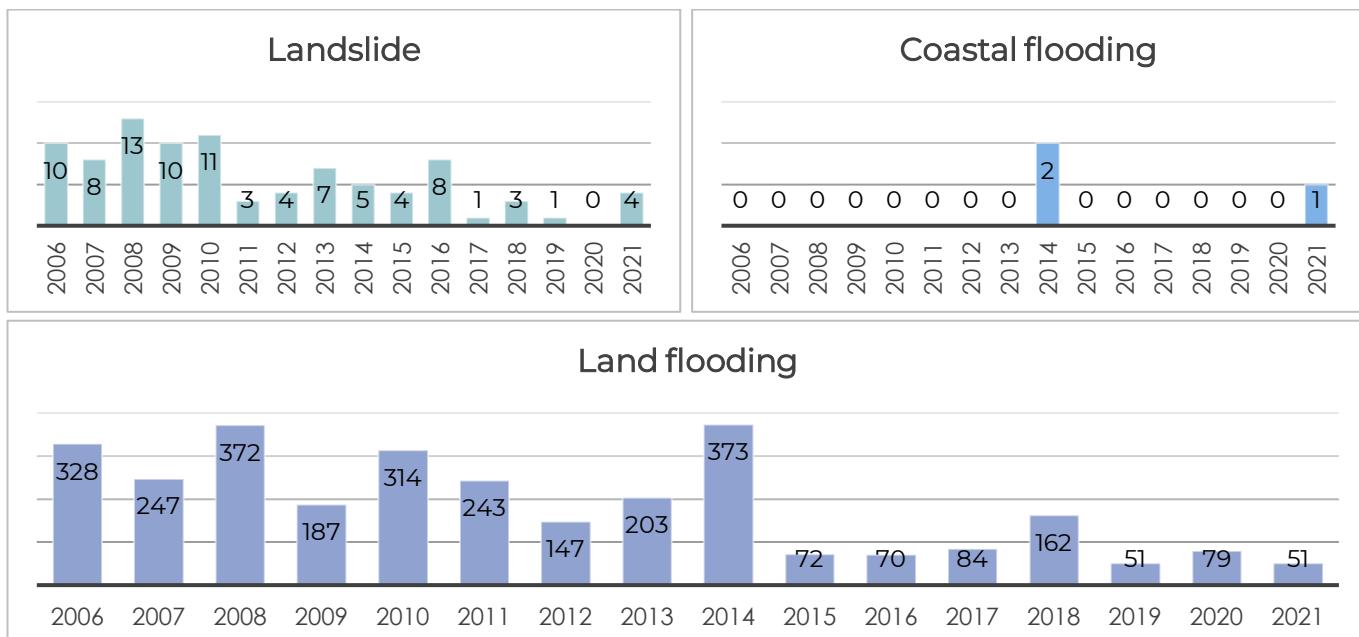
Figure 17: Number of occurrences by category recorded in the Civil Protection occurrences database in Oeiras CCLL for the period 2006-2021.

The Civil Protection occurrences database holds a record of a wide variety of natural and technological related hazards that have occurred in Portugal since 2006. In particular, the past events obtained from this dataset for Oeiras municipality are summarised in Table 11. The most frequent events are the episodes of flooding due the heavy rainfall, with over three thousand (~3000) occurrences. Moreover, ninety-two (92) landslides and three (3) coastal flooding episodes have been recorded. There have been not found events of strong winds, heavy snowfall, heat waves, cold spells, droughts or coastal erosion in this database for Oeiras. In addition, the number of occurrences by type and year for the entire municipality have been represented in Figure 17.

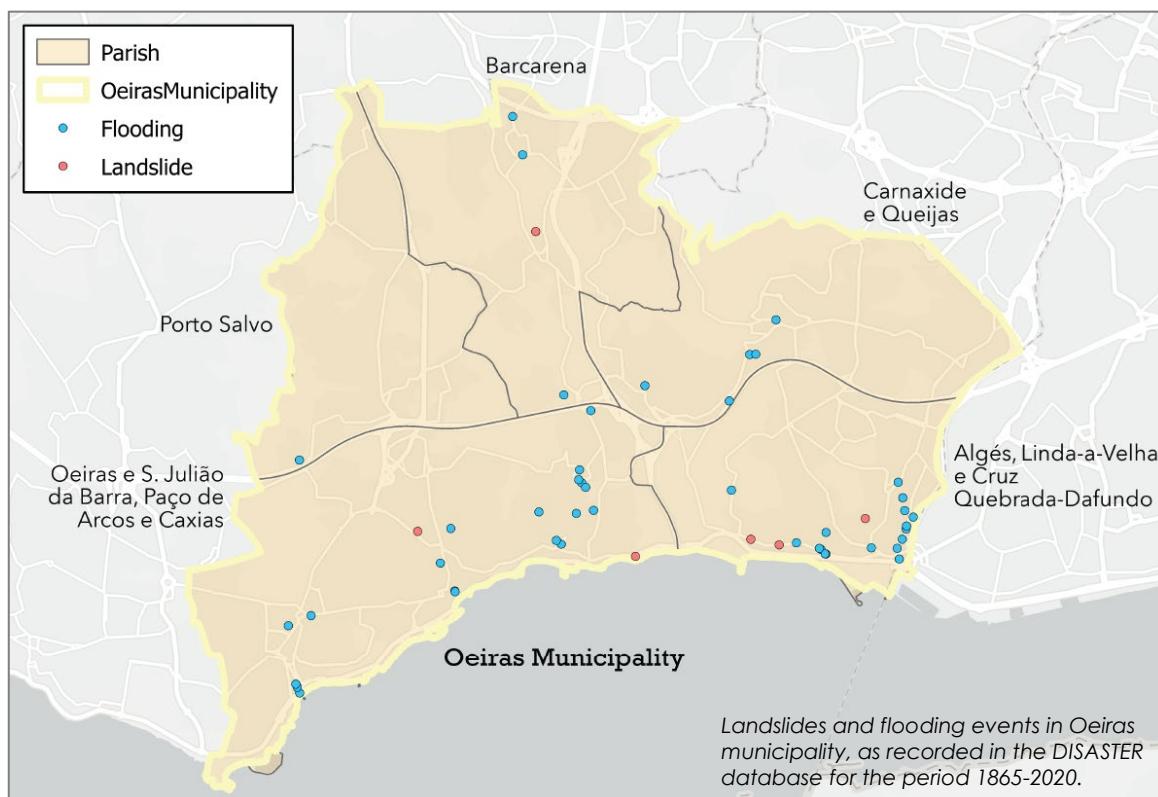
Figure 18: Map representing the landslides (red points) and flooding events (blue points) in Oeiras municipality recorded in the DISASTER database for the period 1865-2020.

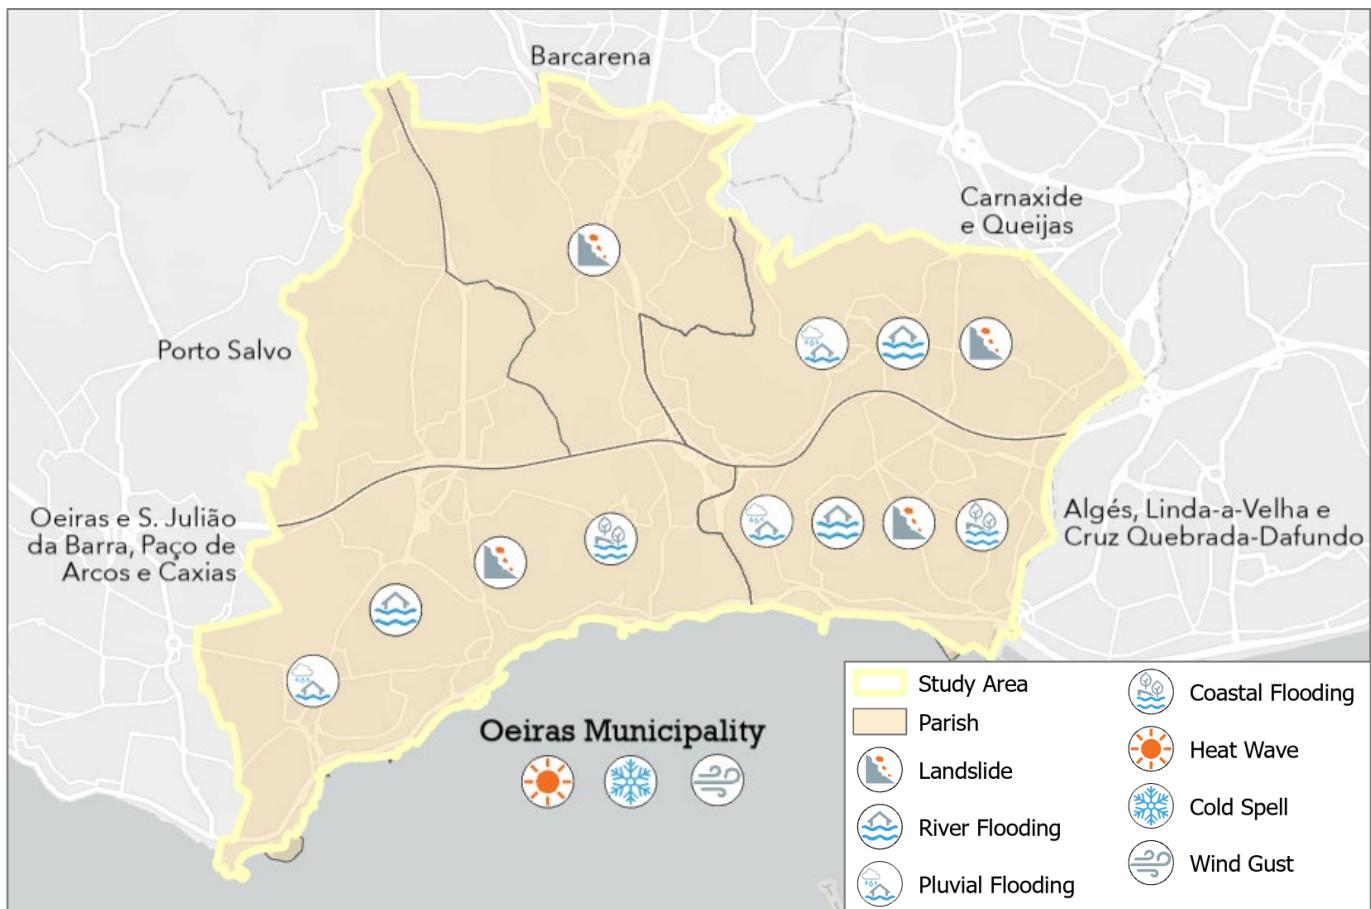
Figure 19: Schematic representation of key climate-related hazards identified in Oeiras CCLL.

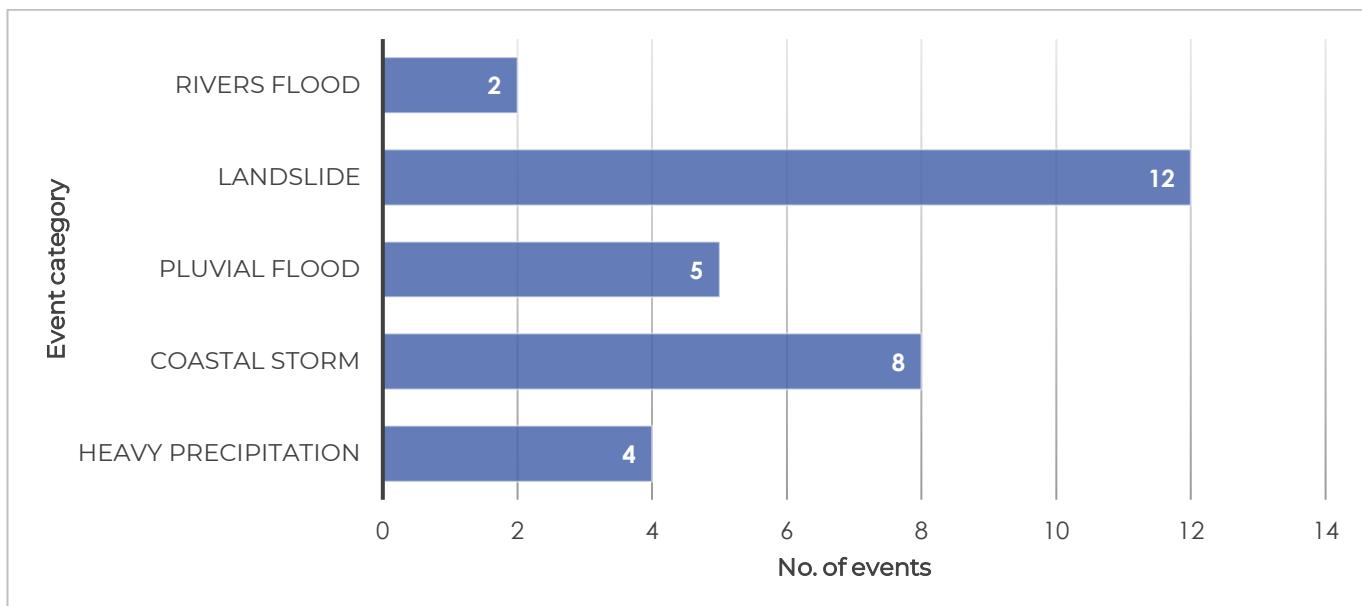
Figure 20: Number of past events recorded in Massa CCLL by category (1994-2021).

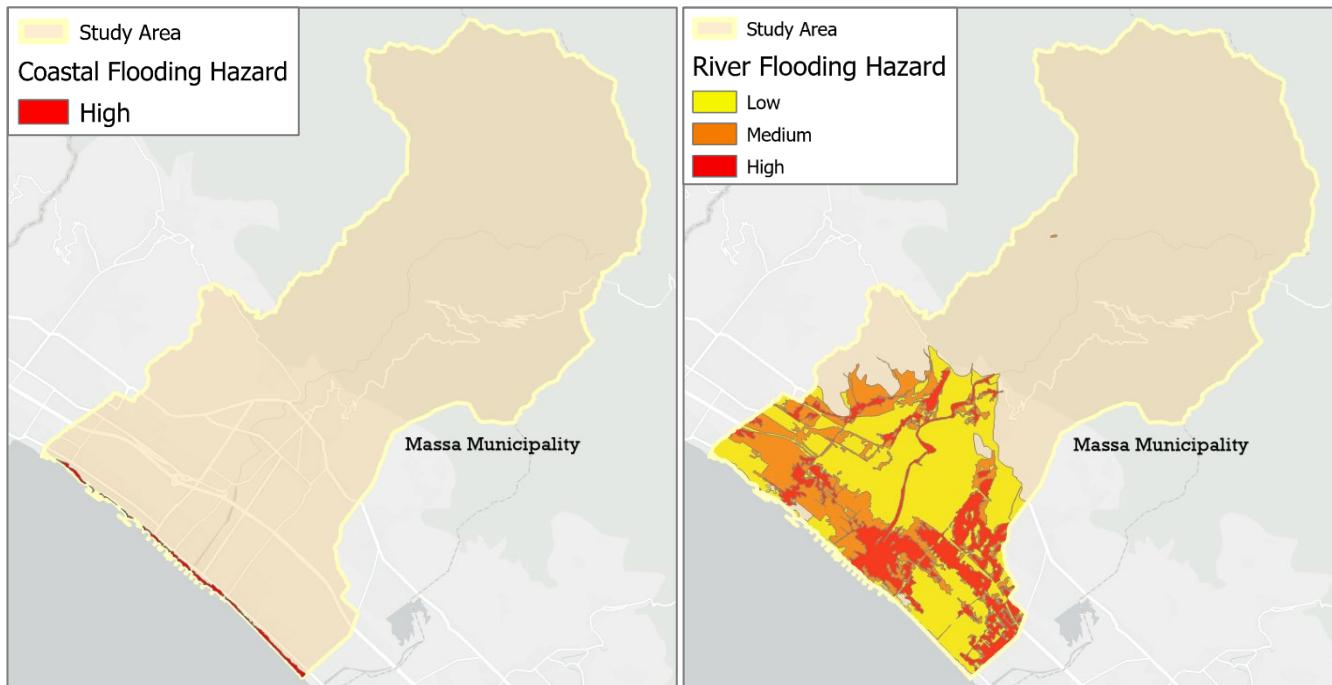
Figure 21: Coastal flooding (left) and river flooding (right) hazard in Massa municipality, according to the probability scenarios of low (yellow), medium (orange) and high (red) hazard. Data from: Autorità di bacino distrettuale dell'Appennino Settentrionale – “Mappa della Pericolosità da alluvione fluviale e costiera” (PGRA).

Furthermore, the District Basin Authority of the Northern Apennines (Autorità di bacino distrettuale dell'Appennino Settentrionale) have produced hazard maps on coastal flooding, river flooding and landslides, which are publicly available on a web-viewer^{19,20}.

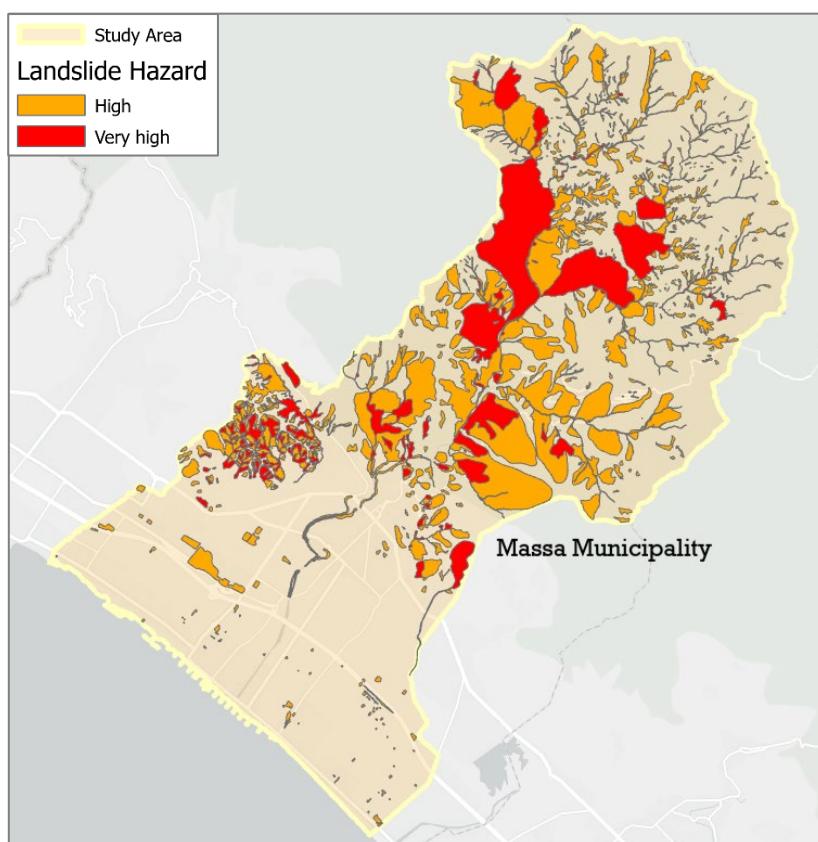
Figure 22: Landslide hazard map in Massa municipality, according to the probability scenarios of high (orange) and very high (red) hazard. Data from: Autorità di bacino distrettuale dell'Appennino Settentrionale – “Pericolosità geomorfologica del PAI bacini regionali toscani”.

Moreover, the landslide hazard information²³ displayed in Figure 22 has been downloaded from the “Plan on landslide and geomorphological risk” (PAI) at 1/10,000 scale, and the spatial reference system utilised is the ROMA40/OVEST.

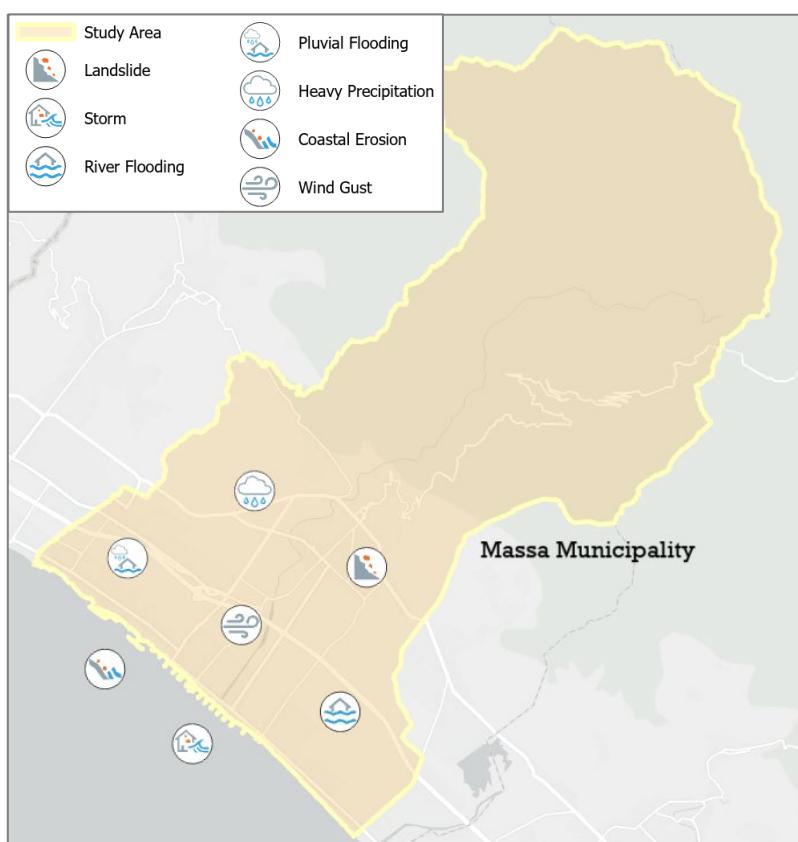
Figure 23: Schematic representation of key climate-related hazards identified in Massa CCLL.

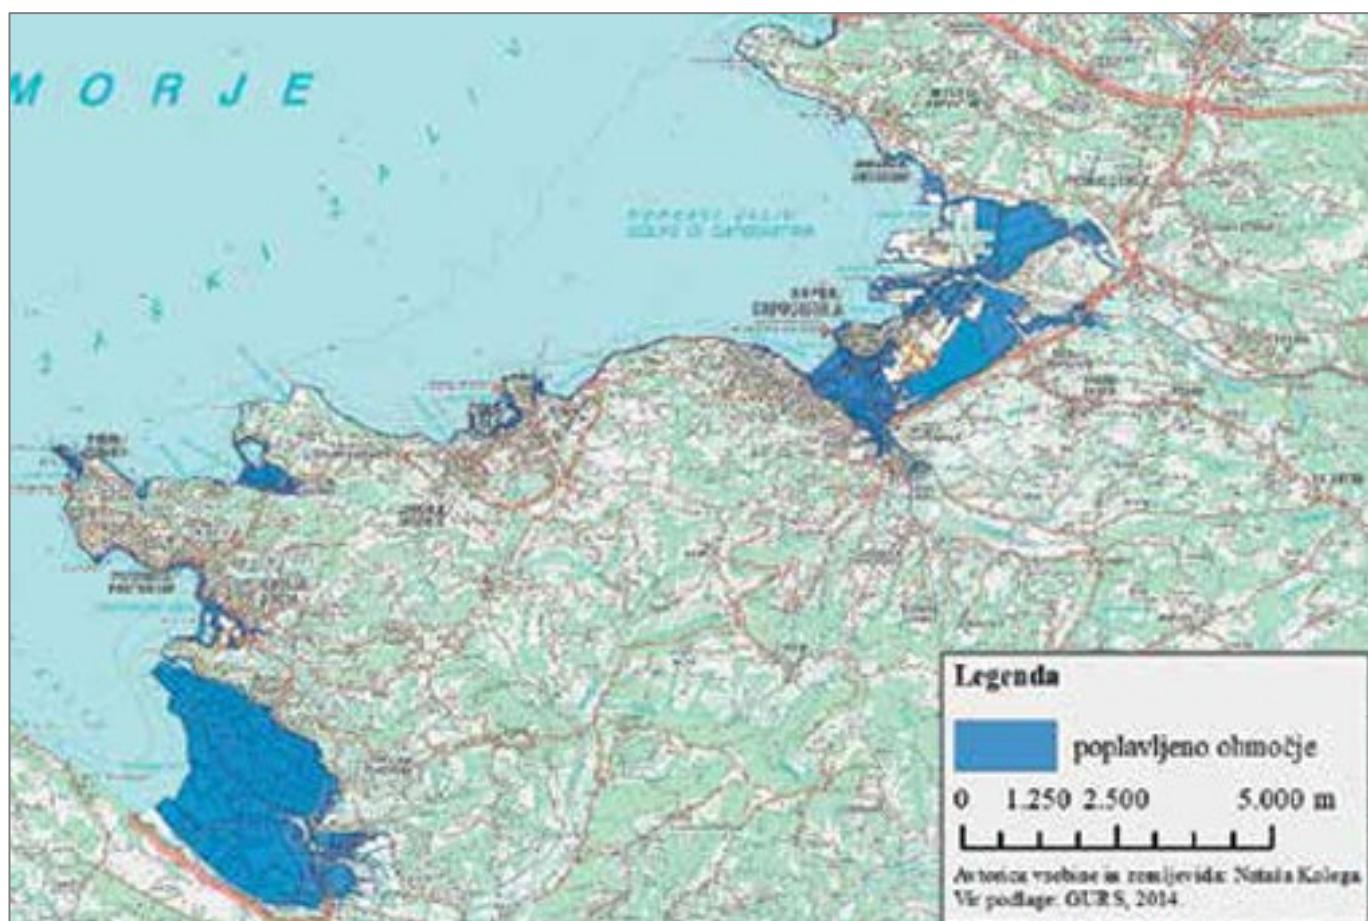
Figure 24: Flooded areas (blue) in case of rising mean sea level by 100 cm and high tide. From: Grubar et al. (2019).

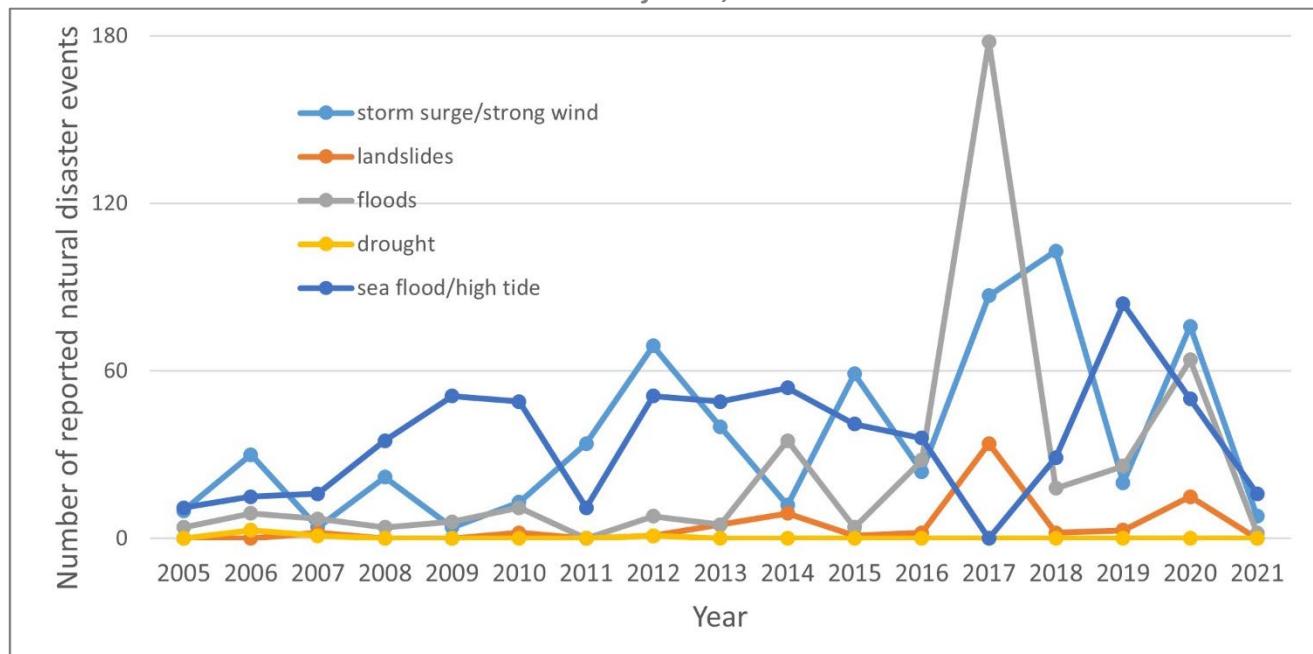
Figure 25: Yearly reported number of occurrences related to natural disaster events over the period 2005-2021 in the town of Piran, Slovenia.

The CCLL of Piran has provided a dataset containing occurrences (Civil Protection interventions) related to climate events in Piran since 2005. The list of occurrences has been extracted from the platform managed by the Administration of the RS for Civil Protection and Disaster Relief²⁴ in Piran. The total amount of occurrences recorded in the database is 1713, including episodes of coastal flooding, land flooding, strong winds, cold spells, droughts and
