D1.2-Map and report of key climate-change hazards

Project acronym	SCORE
Project title	Smart Control of the Climate Resilience in European Coastal Cities
Starting date	01.07.2021
Duration	48 months
Call identifier	H2020-LC-CLA-2020-2
Grant Agreement No	101003534

Deliverable Information	
Deliverable number	D1.2
Work package number	WP1
Deliverable title	Map and report of key climate-change hazards
Lead beneficiary	UCC
Author(s)	Emilio Laíño Rebollido (UCC), Gregorio Iglesias (UCC)
Contributing partners	ITS, UCD, RED, TERO, TUKE, UA, NAIDER, UG, OAR, OEIRAS, SAMU, ZRS, ENT, PGC and ISTID
Due date	31/08/2022
Actual submission date	31/08/2022
Type of deliverable	Report
Dissemination level	Public

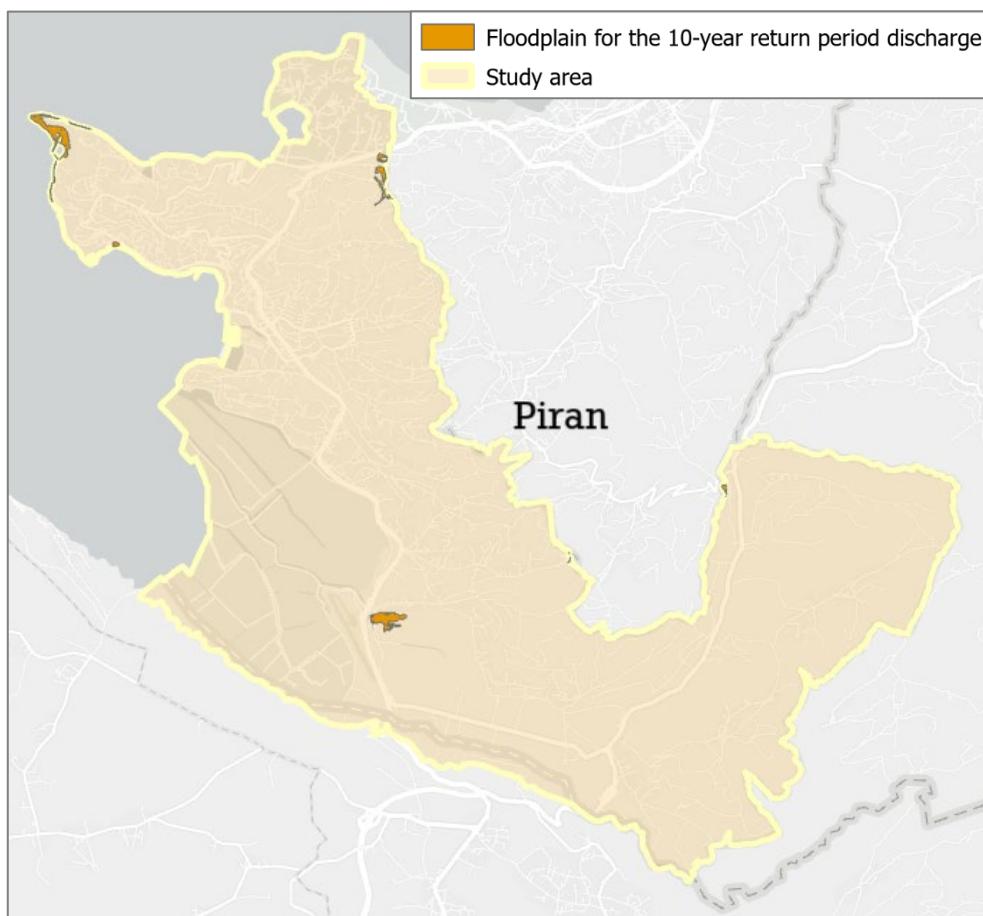
Figure 26: Floodplains for the 10-year return period discharge value. From: Ministry of the Environment and Spatial Planning – Directorate of the Republic of Slovenia for Water.

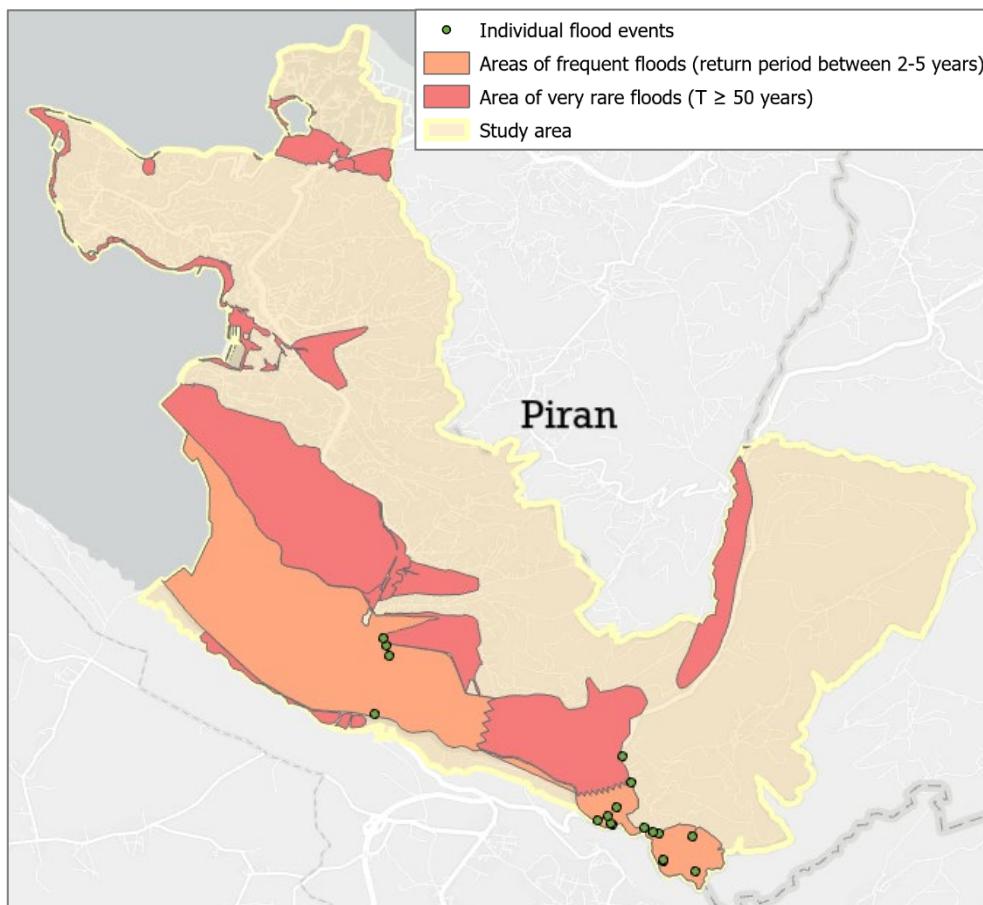
Figure 27: Area of frequent floods, areas of very rare floods, and past individual flood events. Data from: Ministry of the Environment and Spatial Planning – Directorate of the Republic of Slovenia for Water.

Similarly, Piran CCLL also provided a series of maps (Flood Cadastre Warning Map²⁸) containing data on:

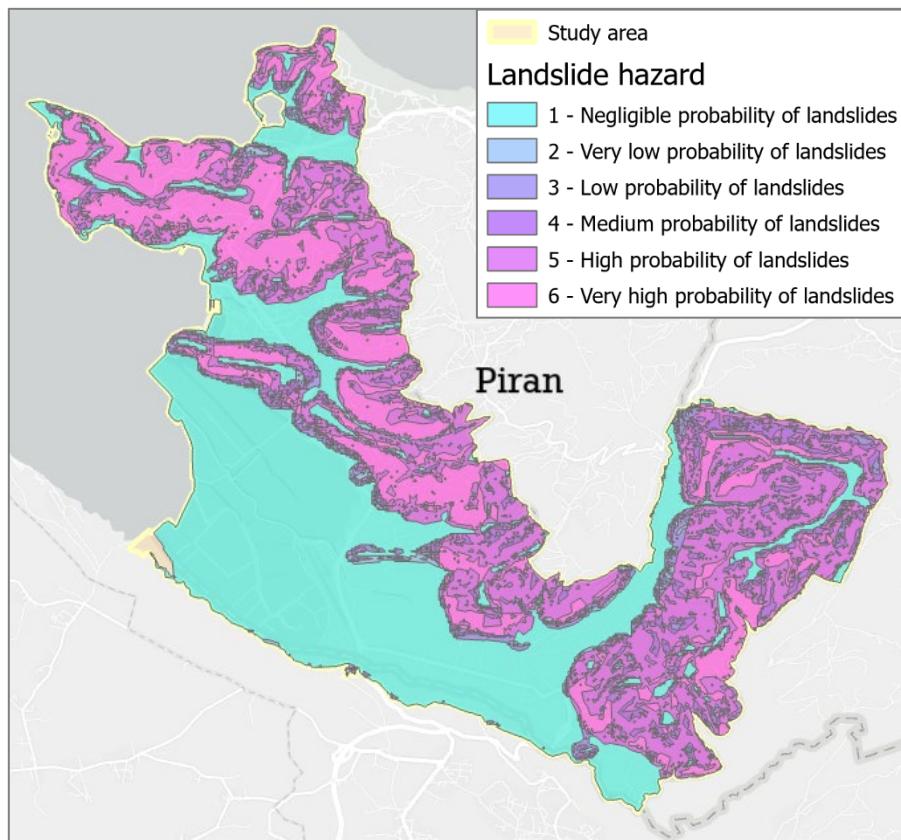
Figure 28: Landslide hazard map in Piran. Data from: Analiza Pojavljanja Plazov V Sloveniji In Izdelava Karte Verjetnosti Plazenj.

Besides, a landslide hazard map has been produced based on the information provided by Piran CCLL, according to the document *Analysis of landslide occurrence in Slovenia and preparation of landslide probability map²⁹* (*Analiza Pojavljanja Plazov V Sloveniji In Izdelava Karte Verjetnosti Plazenj*) (Figure 28). The probability scenarios include negligible, very low, low, medium, high and very high probability of landslides. The areas where a landslide is more likely to occur are in the mountains, whereas the probability of landslides is lower in the plains. More details about the probability levels can be found in the reference document.

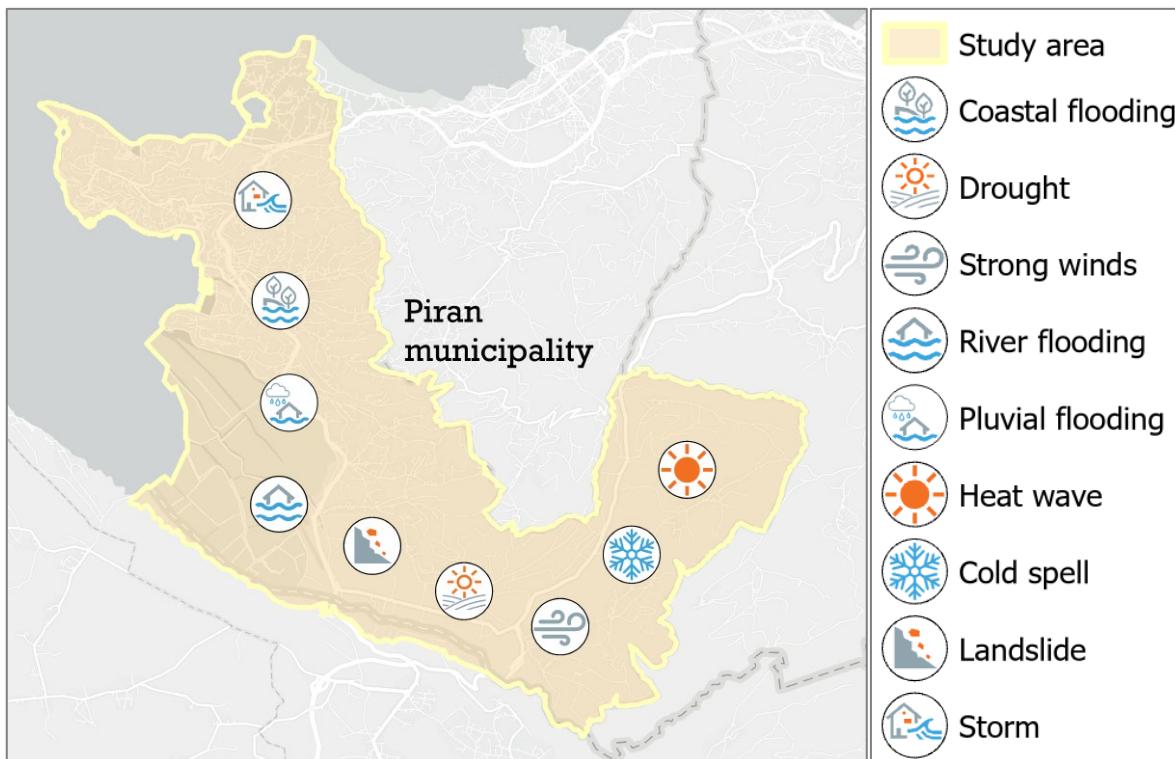
Figure 29: Schematic representation of key climate-related hazards identified in Piran CCLL.

Finally, the map summarising the key climate-related hazards identified in Piran can be found in Appendix I – maps, whereas an extract is shown in Figure 29.

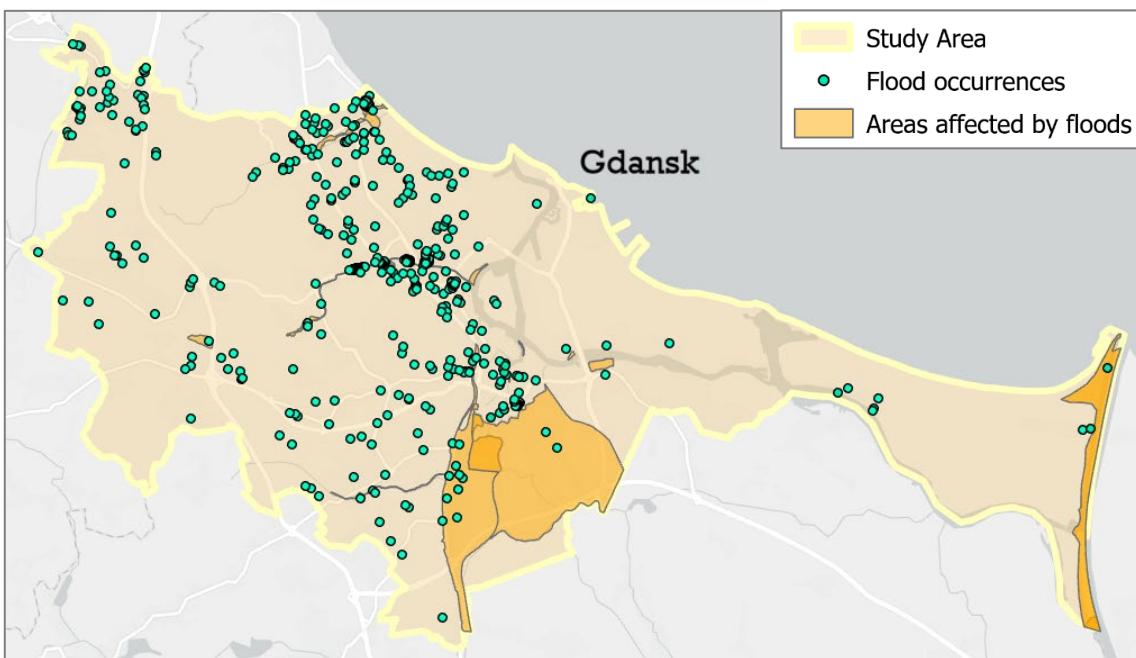
Figure 30: Geographical distribution of the flood notifications (1829-2017) in Gdańsk. Data from: Regional Water Management Board Gdańsk (Regionalny Zarząd Gospodarki Wodnej Gdańsk).

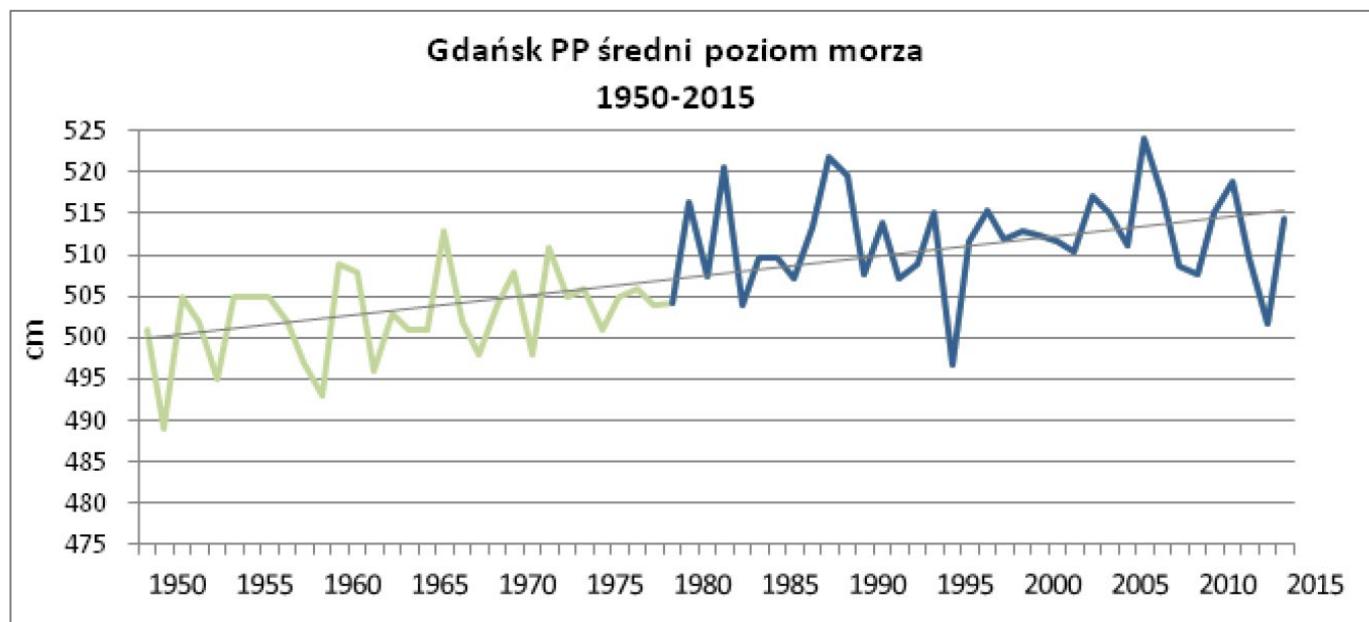
Figure 31: Mean sea level in the Northern Port of Gdańsk for the multi-year period 1955-2015 (Plan adaptacji do zmian klimatu miasta Gdańsk do roku 2030).

The document *Plan of adaptation to climate change in the city of Gdańsk until 2030* analyses, *inter alia*, the pluvial, river and coastal flooding events; the sea level rise; and the storm surge in Gdańsk. The main results of this study are summarised in the following lines.

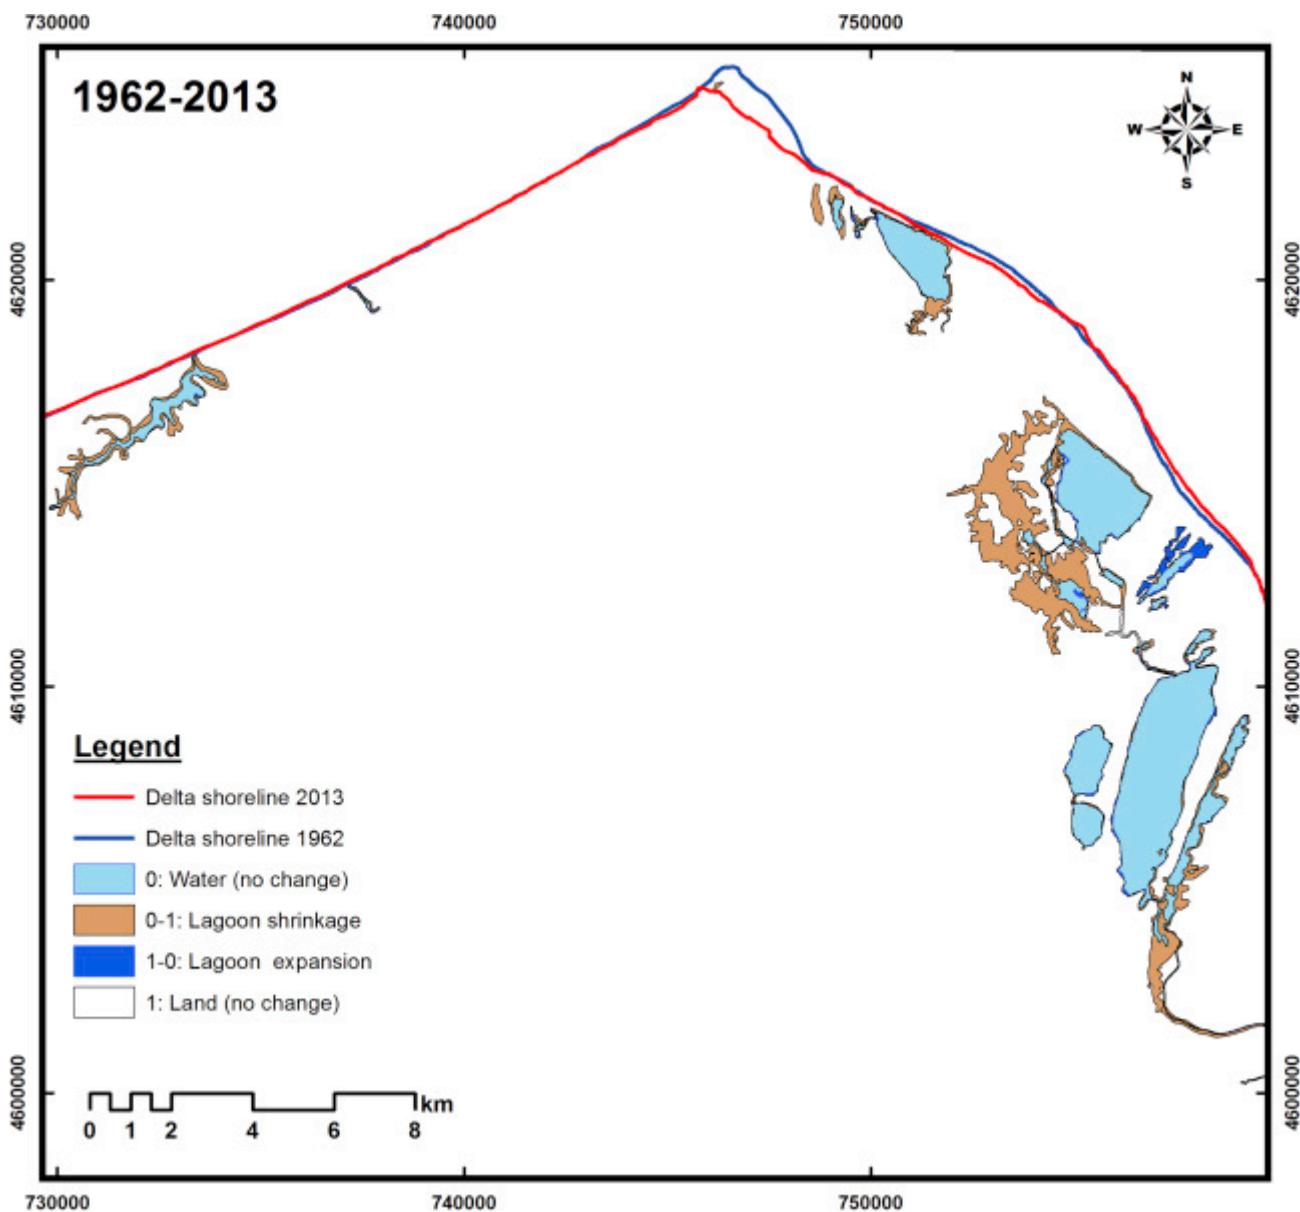
Figure 32: The Kizilirmak Delta shoreline changes and Kizilirmak Lagoon Series shrinkage and expansion areas (1962–2013). From: Ozturk & Sesli (2015).

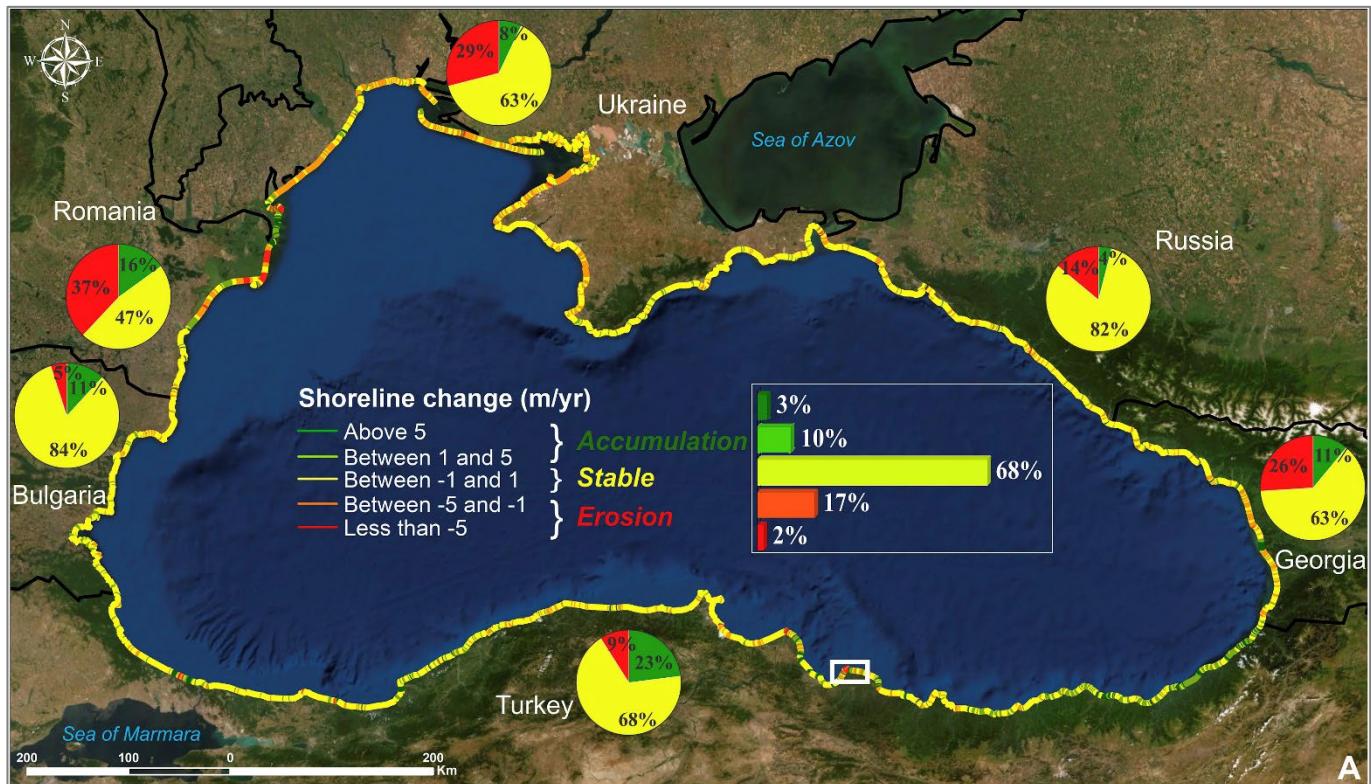
Figure 33: The relative ranking distribution and frequency of the shoreline change variable for the Black Sea coasts. From: Tătui et al. (2019).

Finally, the shoreline changes (among other parameters) of the Kızılırmak Delta are also analysed in *The Black Sea coastline erosion: Index-based sensitivity assessment and management-related issues*. In this article, Tătui et al. (2019) computed a Coastal Sensitivity Index (CSI) at 1-km spatial scale for more than 4,000 geographical sectors around the Black Sea, taking into consideration geological-geomorphological and physical characteristics of each sector through the following parameters: shoreline changes in the last 33 years; type of coast (coastal geomorphology and lithology); coastal slope (from shoreline to 20m depth); wave incidence; significant wave height during storm conditions; and relative sea level rise. The results for each parameter were aggregated into the CSI. The most sensitive sectors to erosion are superposed on the areas with relatively high storm waves and incidence angles, namely: the deltaic coastlines of the main deltas (Danube, Kızılırmak, Yesilirmak, Sakarya, Rioni, Enguri, Kodori, Chorokhi) of the Black Sea; and the low-lying areas along the lagoons, limans, coastal barriers and spits from Kalamitsky, Odessa and Karkinitsky Bays, Chornomorske – Yevpatoriya area (in Crimea), Taman – Anapa (in Russia) and Karasu – Karaburun (in Turkey) and the rocky areas Gelendzhik – Tuapse (in Russia), Sevastopol – Cape Meganom (in Crimea) and Inebolu – Eregli (in Turkey) (Figure 33). These highly sensitive sectors cover extensive areas along the coastlines of Russia (57%), Georgia (46%), Turkey (44%), Romania (43%) and Ukraine (35%).

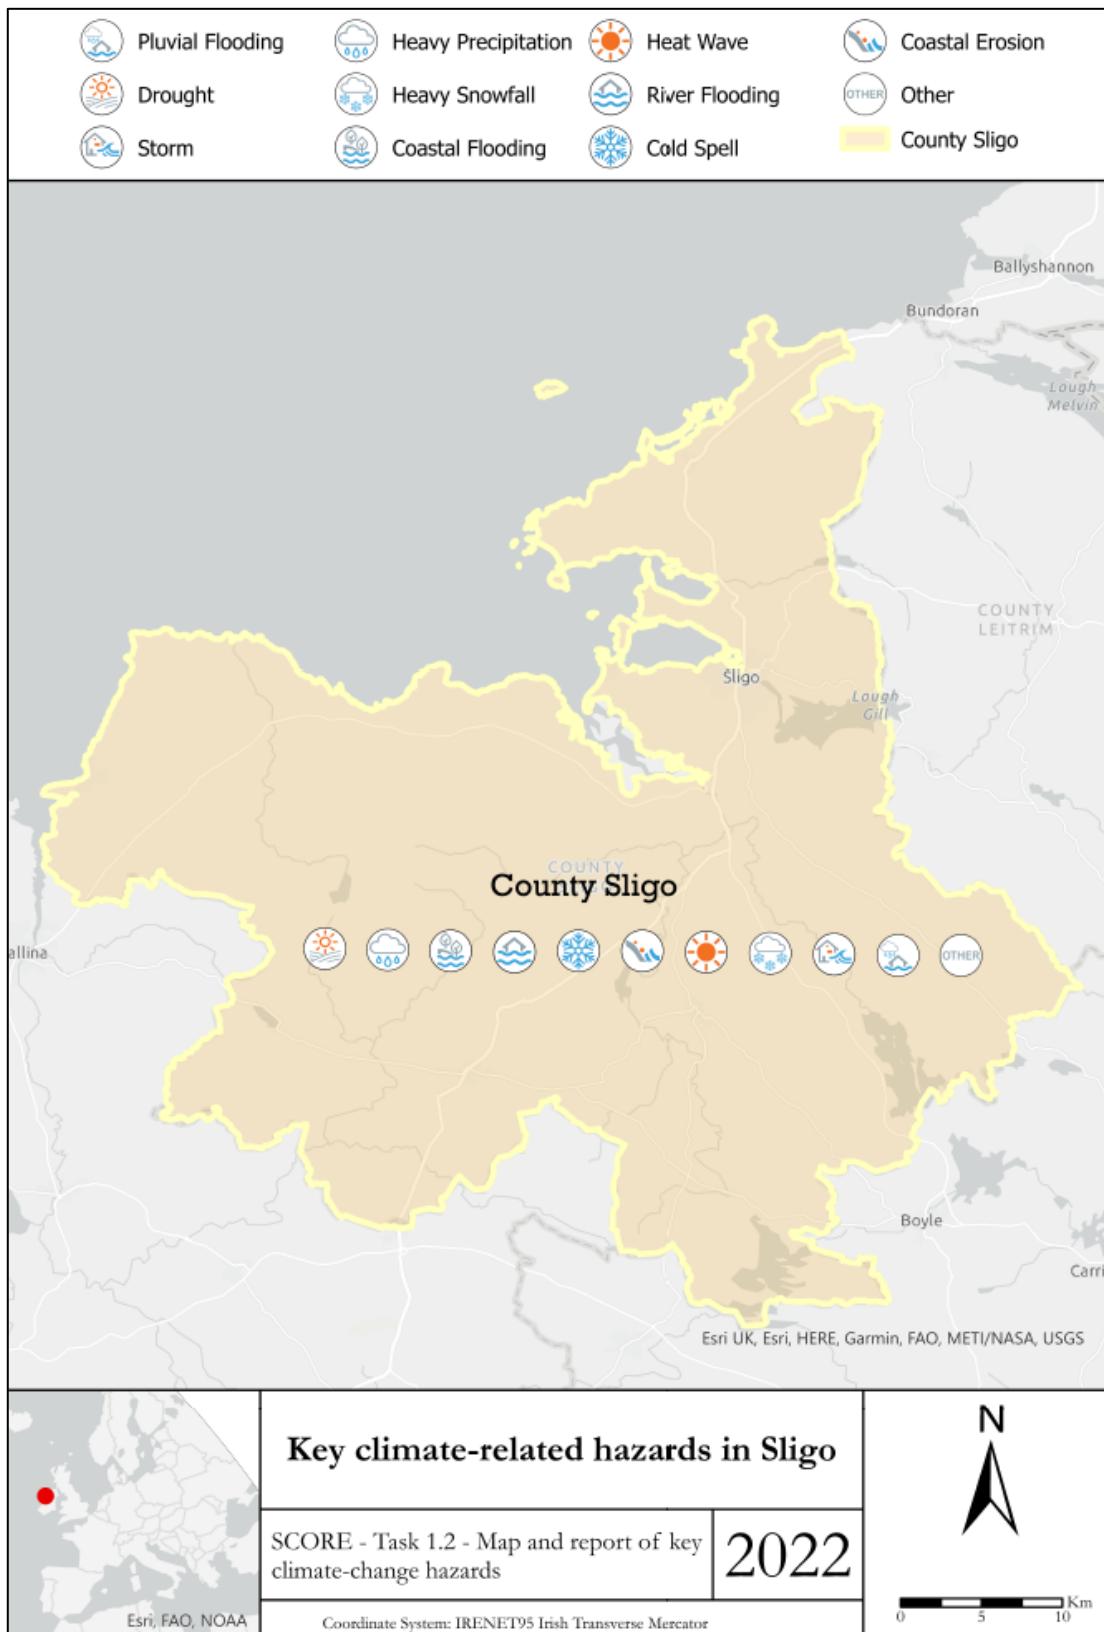
Figure 34: Schematic representation of key climate-related hazards in Sligo CCLL.

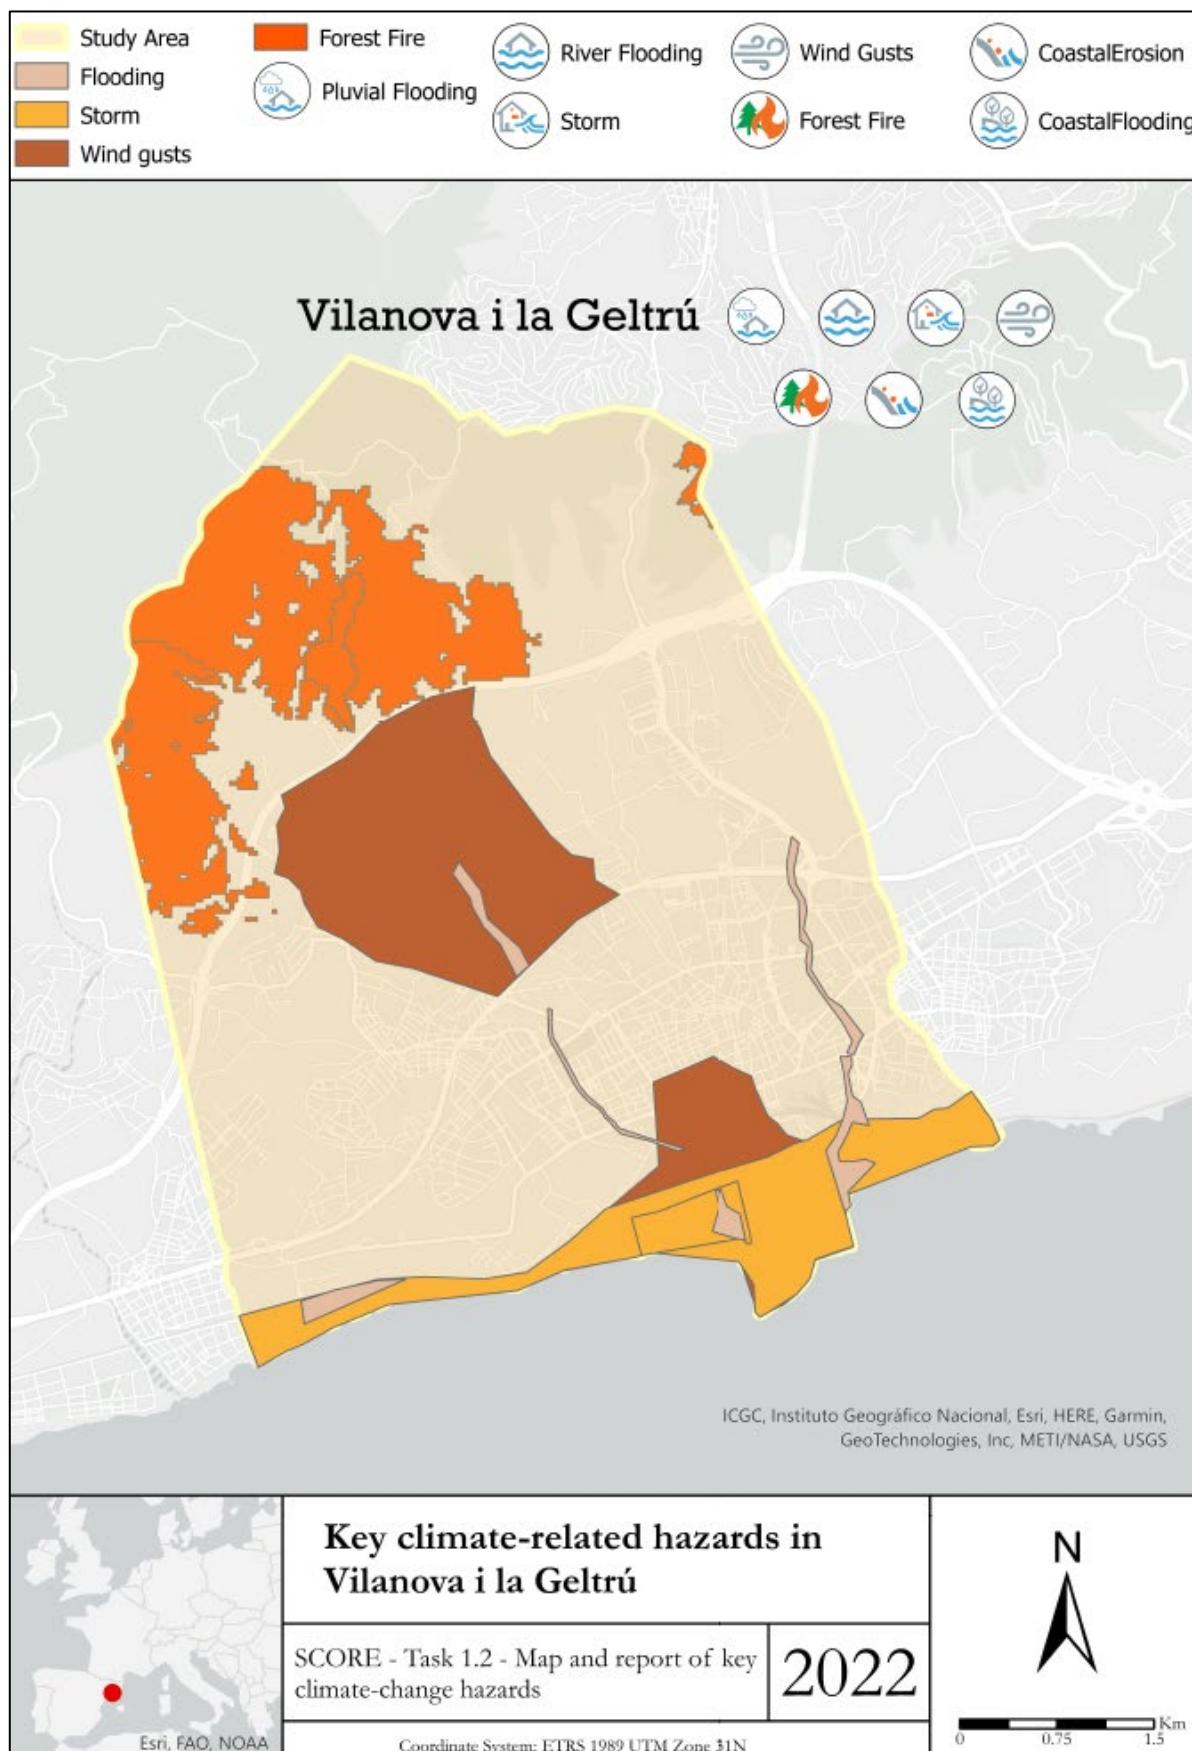
Figure 35: Schematic representation of key climate-related hazards and past climate events in Vilanova i la Geltrú CCLL.

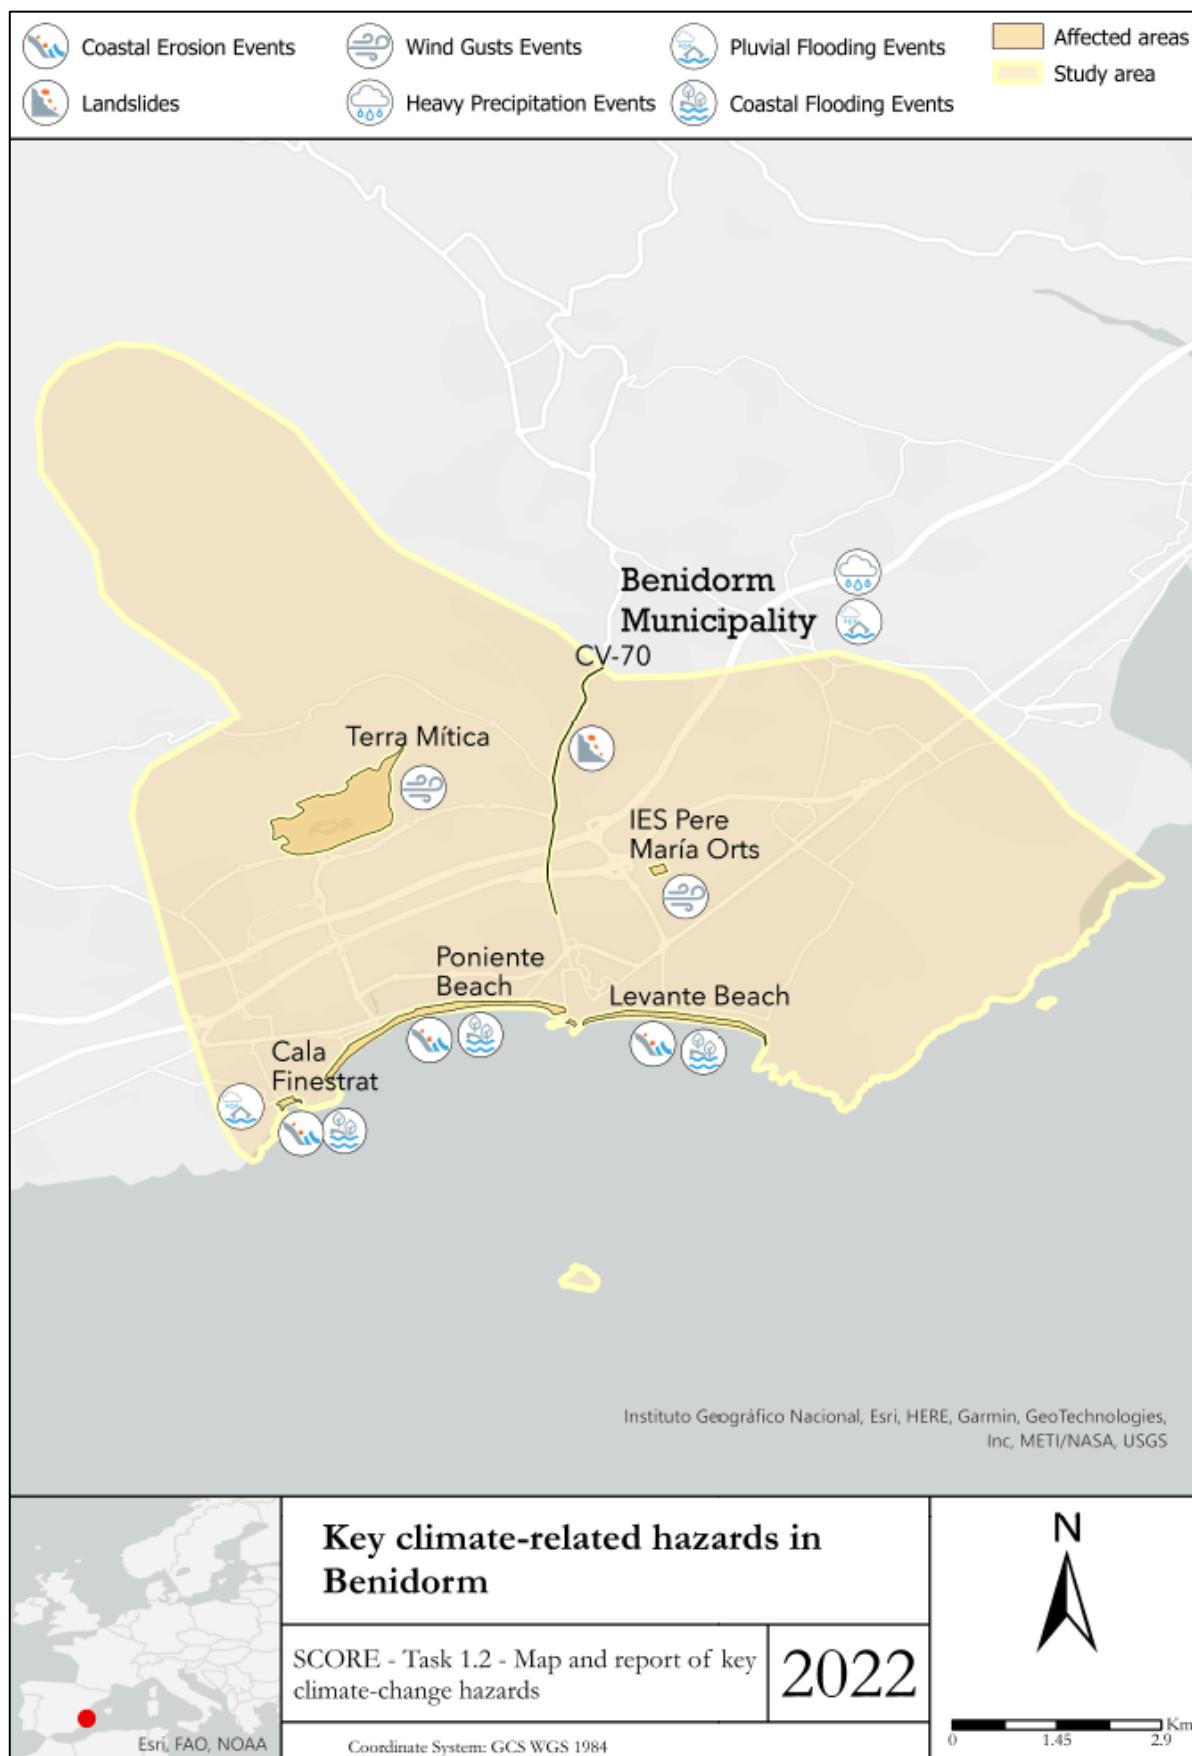
Figure 36: Schematic representation of key climate-related hazards in Benidorm CCLL.

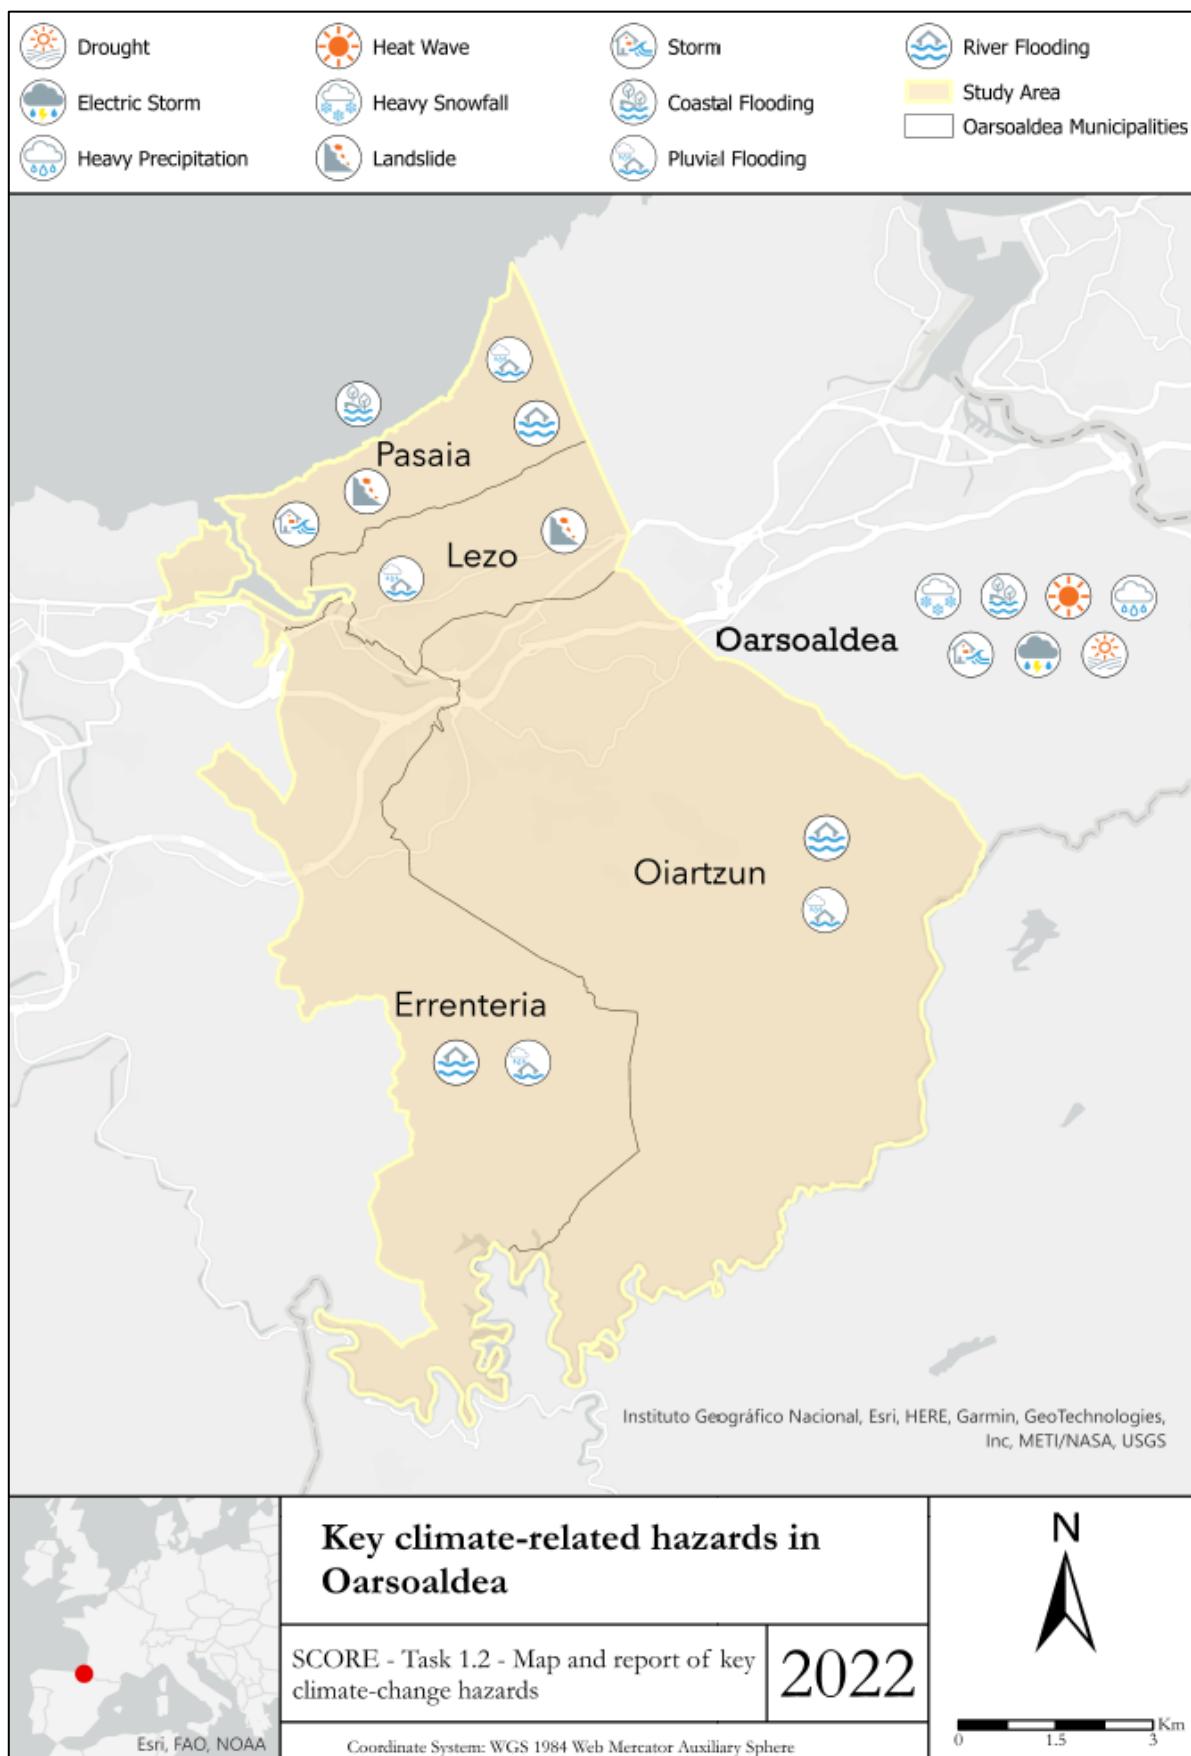
Figure 37: Schematic representation of key climate-related hazards in Oarsoaldea.

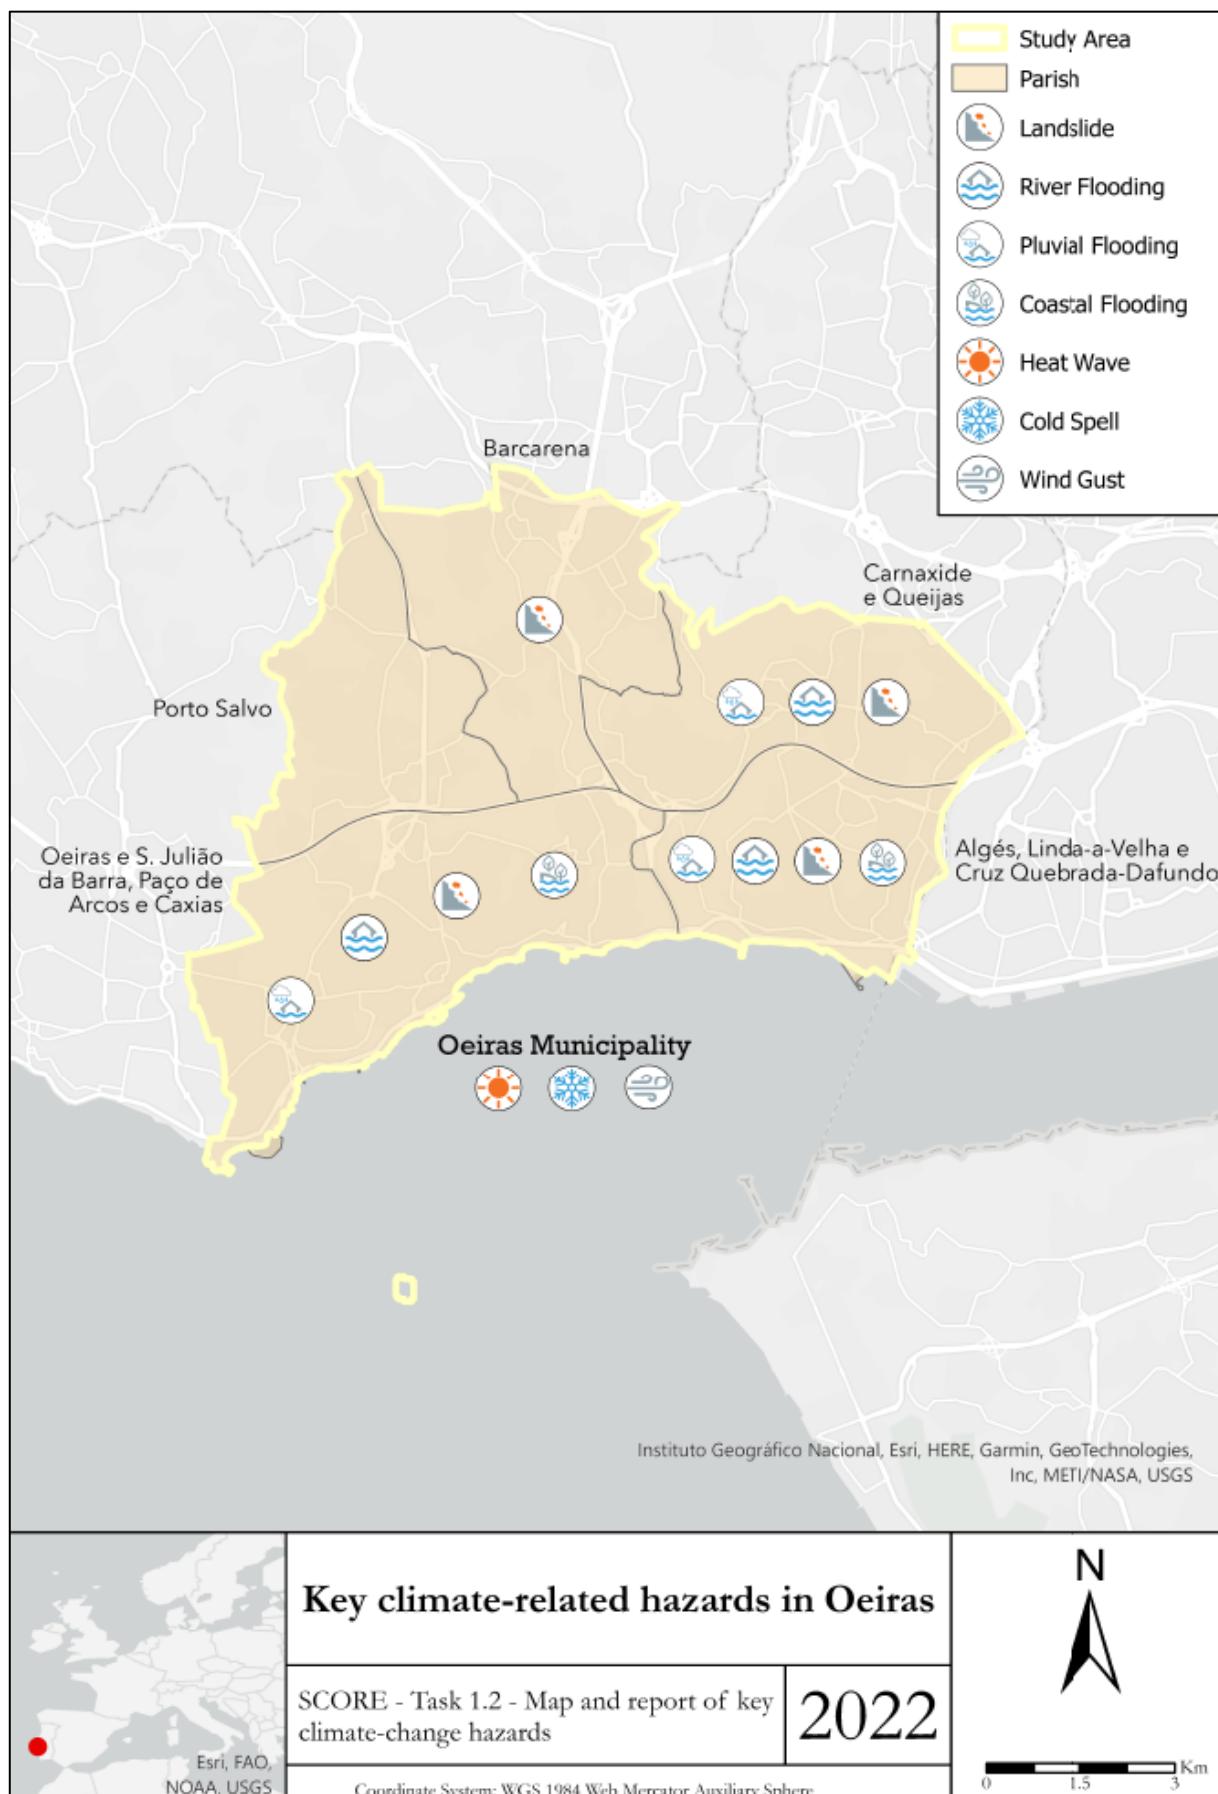
Figure 38: Schematic representation of key climate-related hazards in Oeiras CCLL.

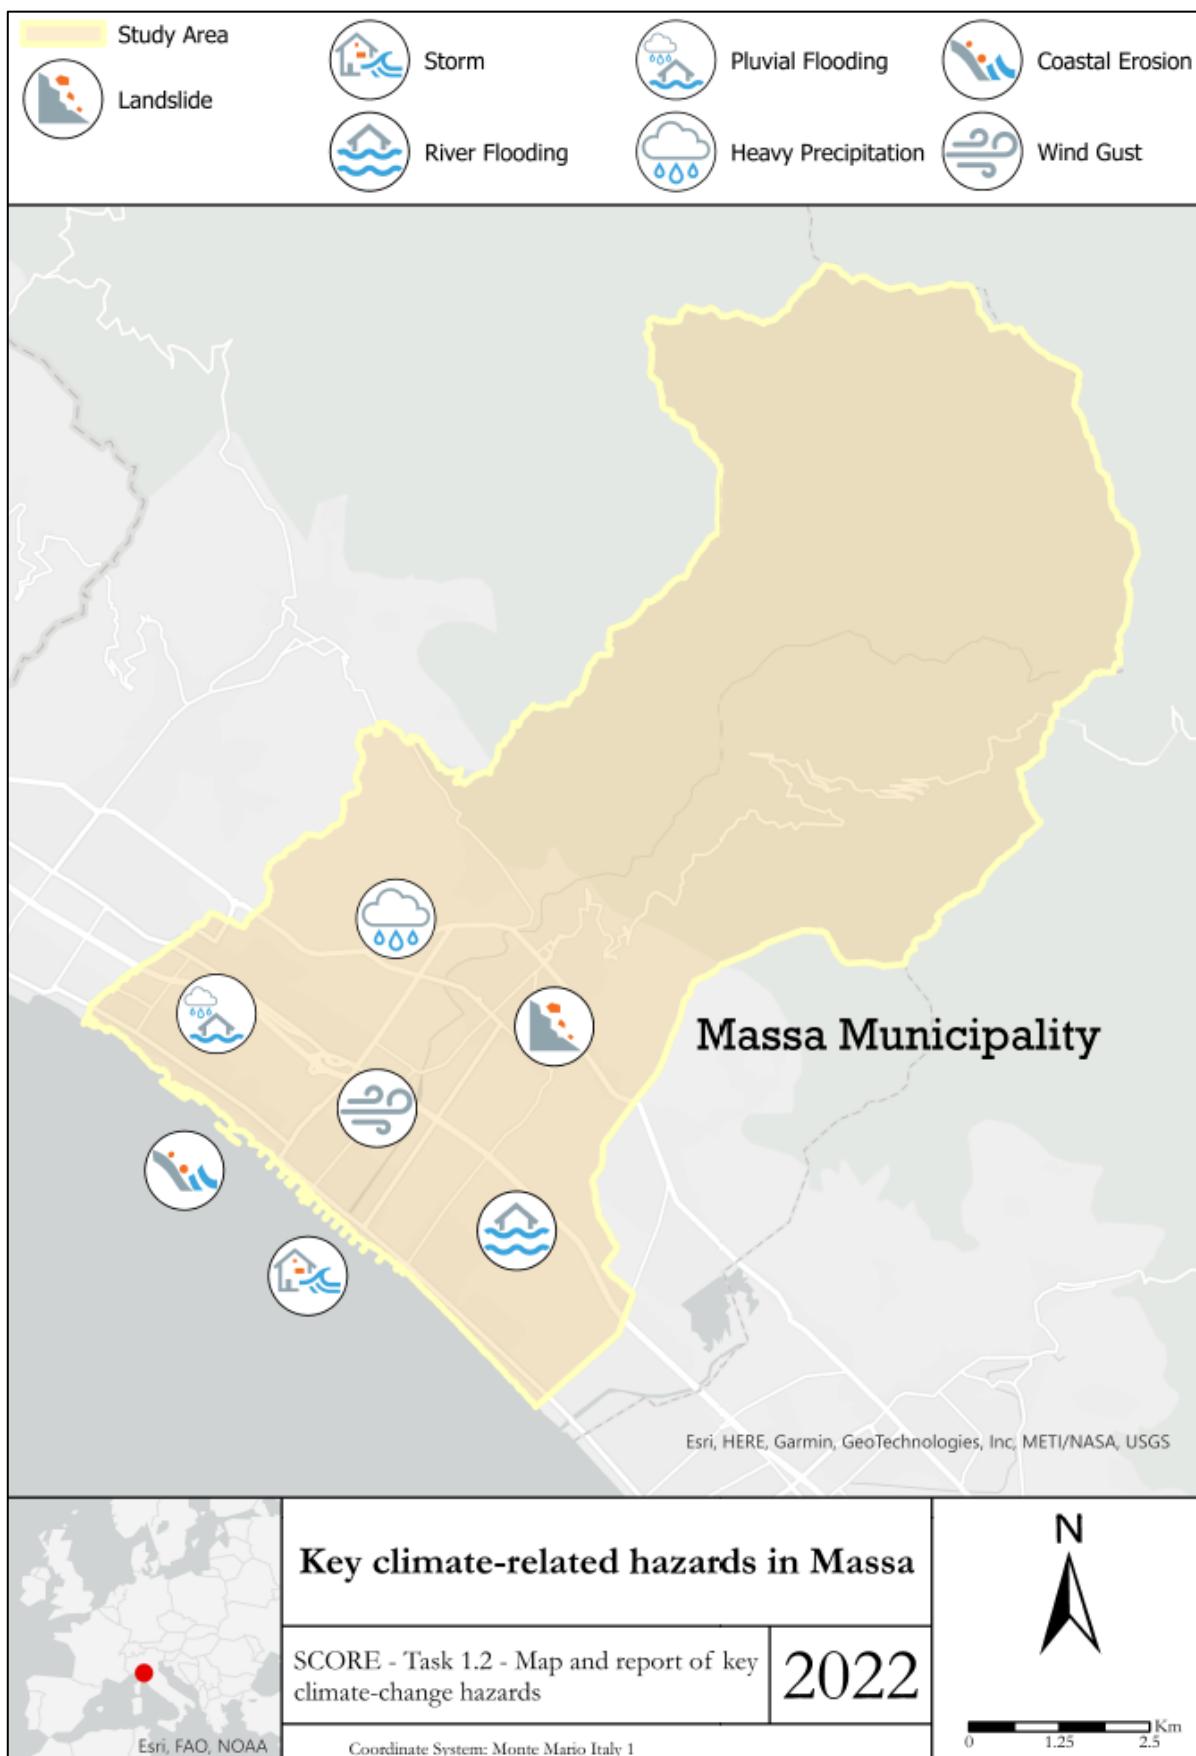
Figure 39: Schematic representation of key climate-related hazards in Massa CCLL.
