D1.2-Map and report of key climate-change hazards

Project acronym	SCORE
Project title	Smart Control of the Climate Resilience in European Coastal Cities
Starting date	01.07.2021
Duration	48 months
Call identifier	H2020-LC-CLA-2020-2
Grant Agreement No	101003534

Deliverable Information	
Deliverable number	D1.2
Work package number	WP1
Deliverable title	Map and report of key climate-change hazards
Lead beneficiary	UCC
Author(s)	Emilio Laíño Rebollido (UCC), Gregorio Iglesias (UCC)
Contributing partners	ITS, UCD, RED, TERO, TUKE, UA, NAIDER, UG, OAR, OEIRAS, SAMU, ZRS, ENT, PGC and ISTID
Due date	31/08/2022
Actual submission date	31/08/2022
Type of deliverable	Report
Dissemination level	Public

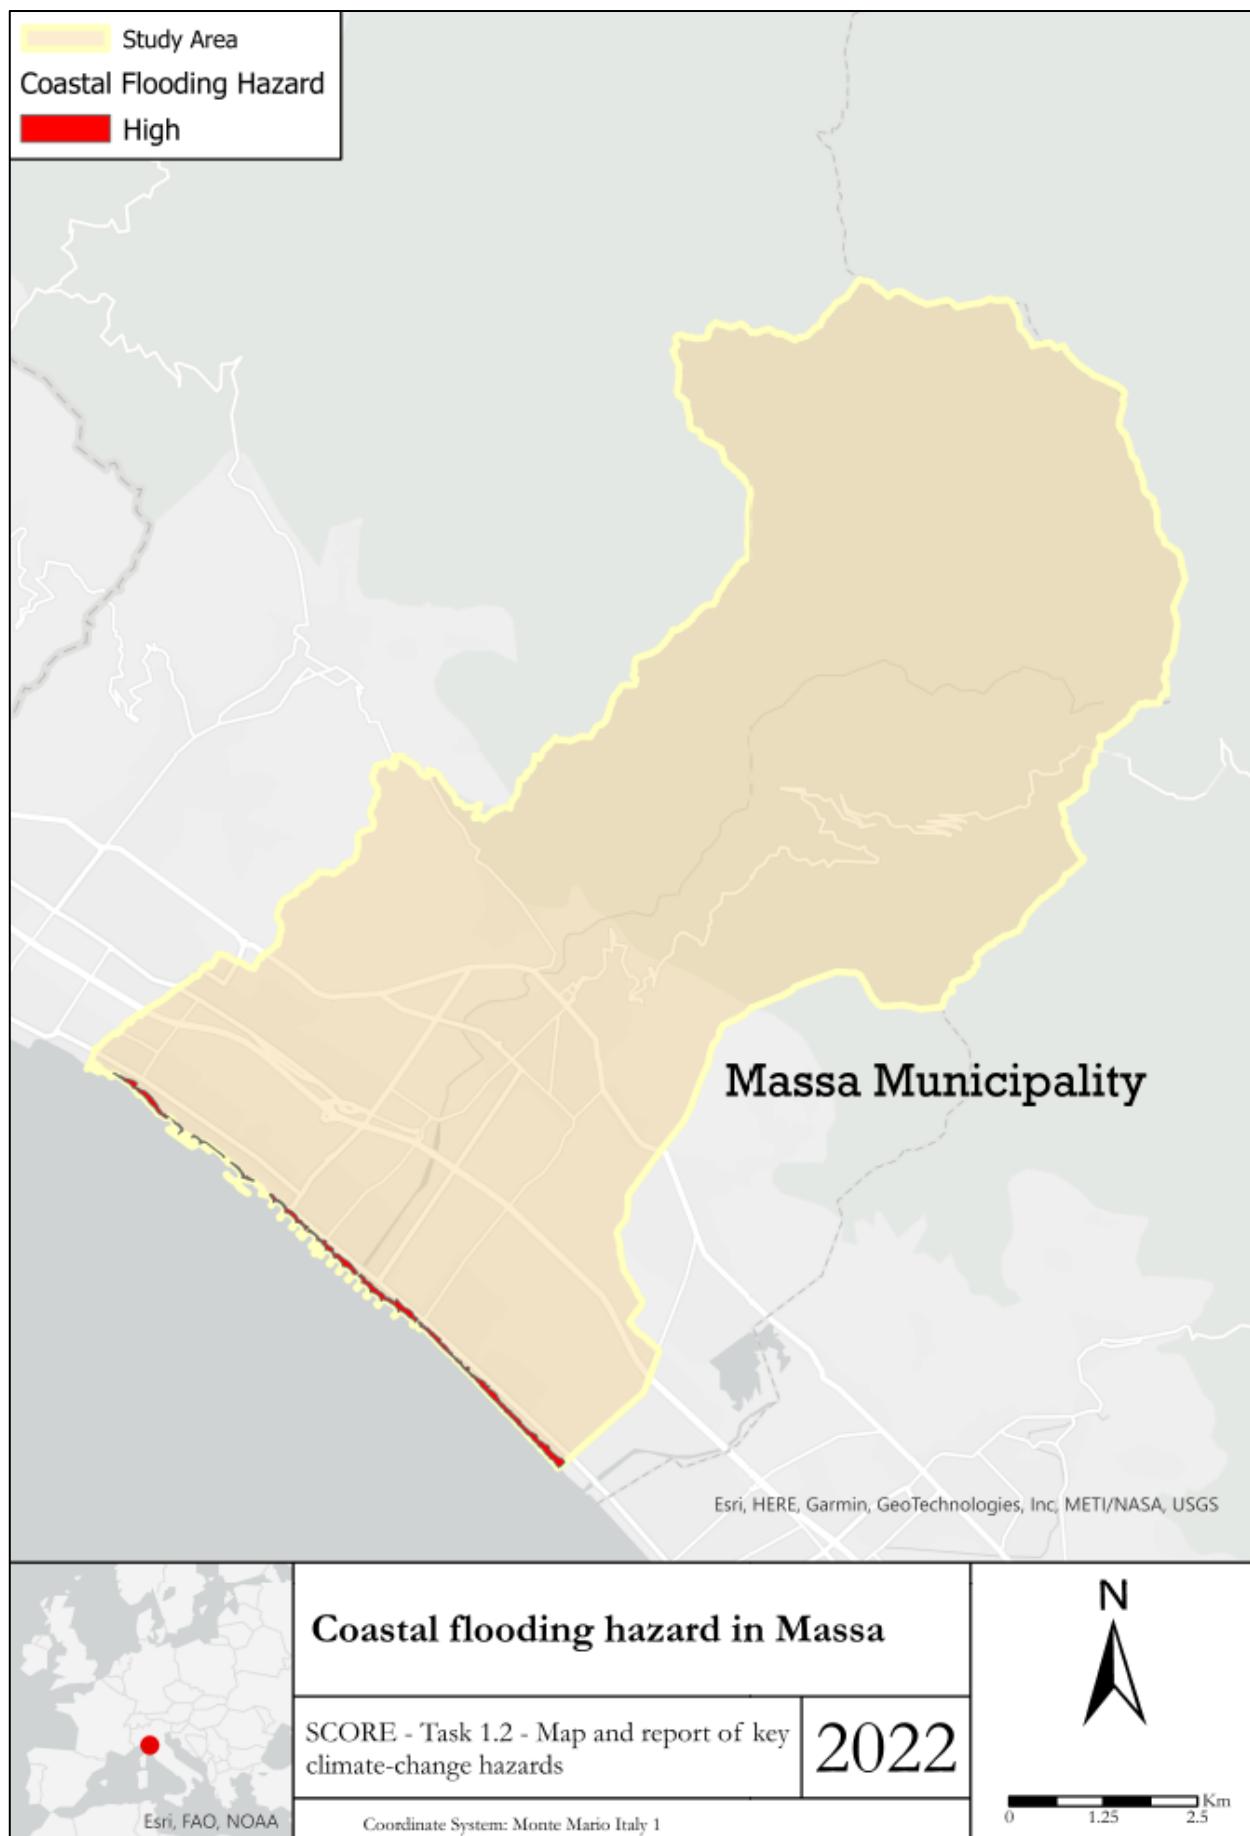
Figure 40: Map of the coastal flooding hazard in Massa CCLL.

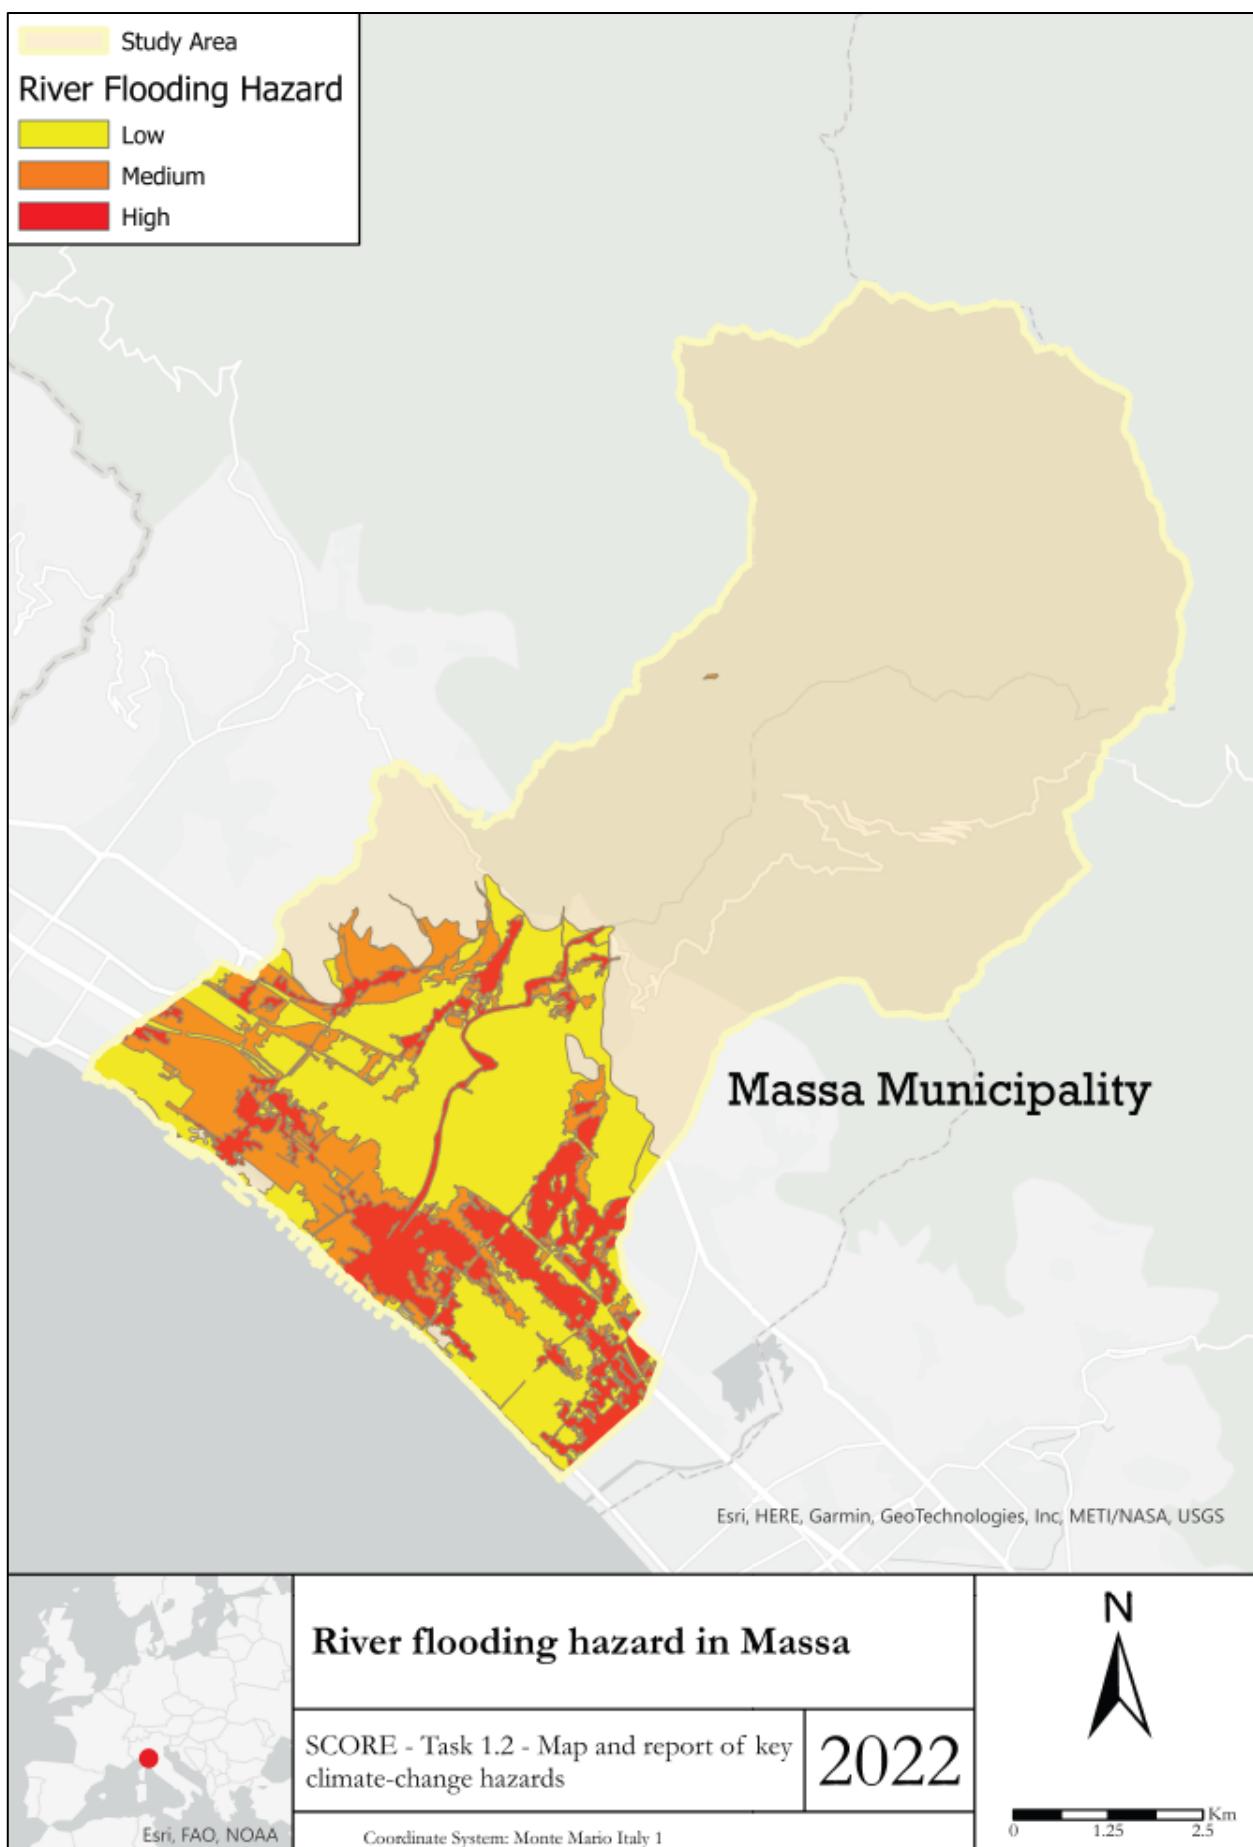
Figure 41: Map of the river flooding hazard in Massa CCLL.

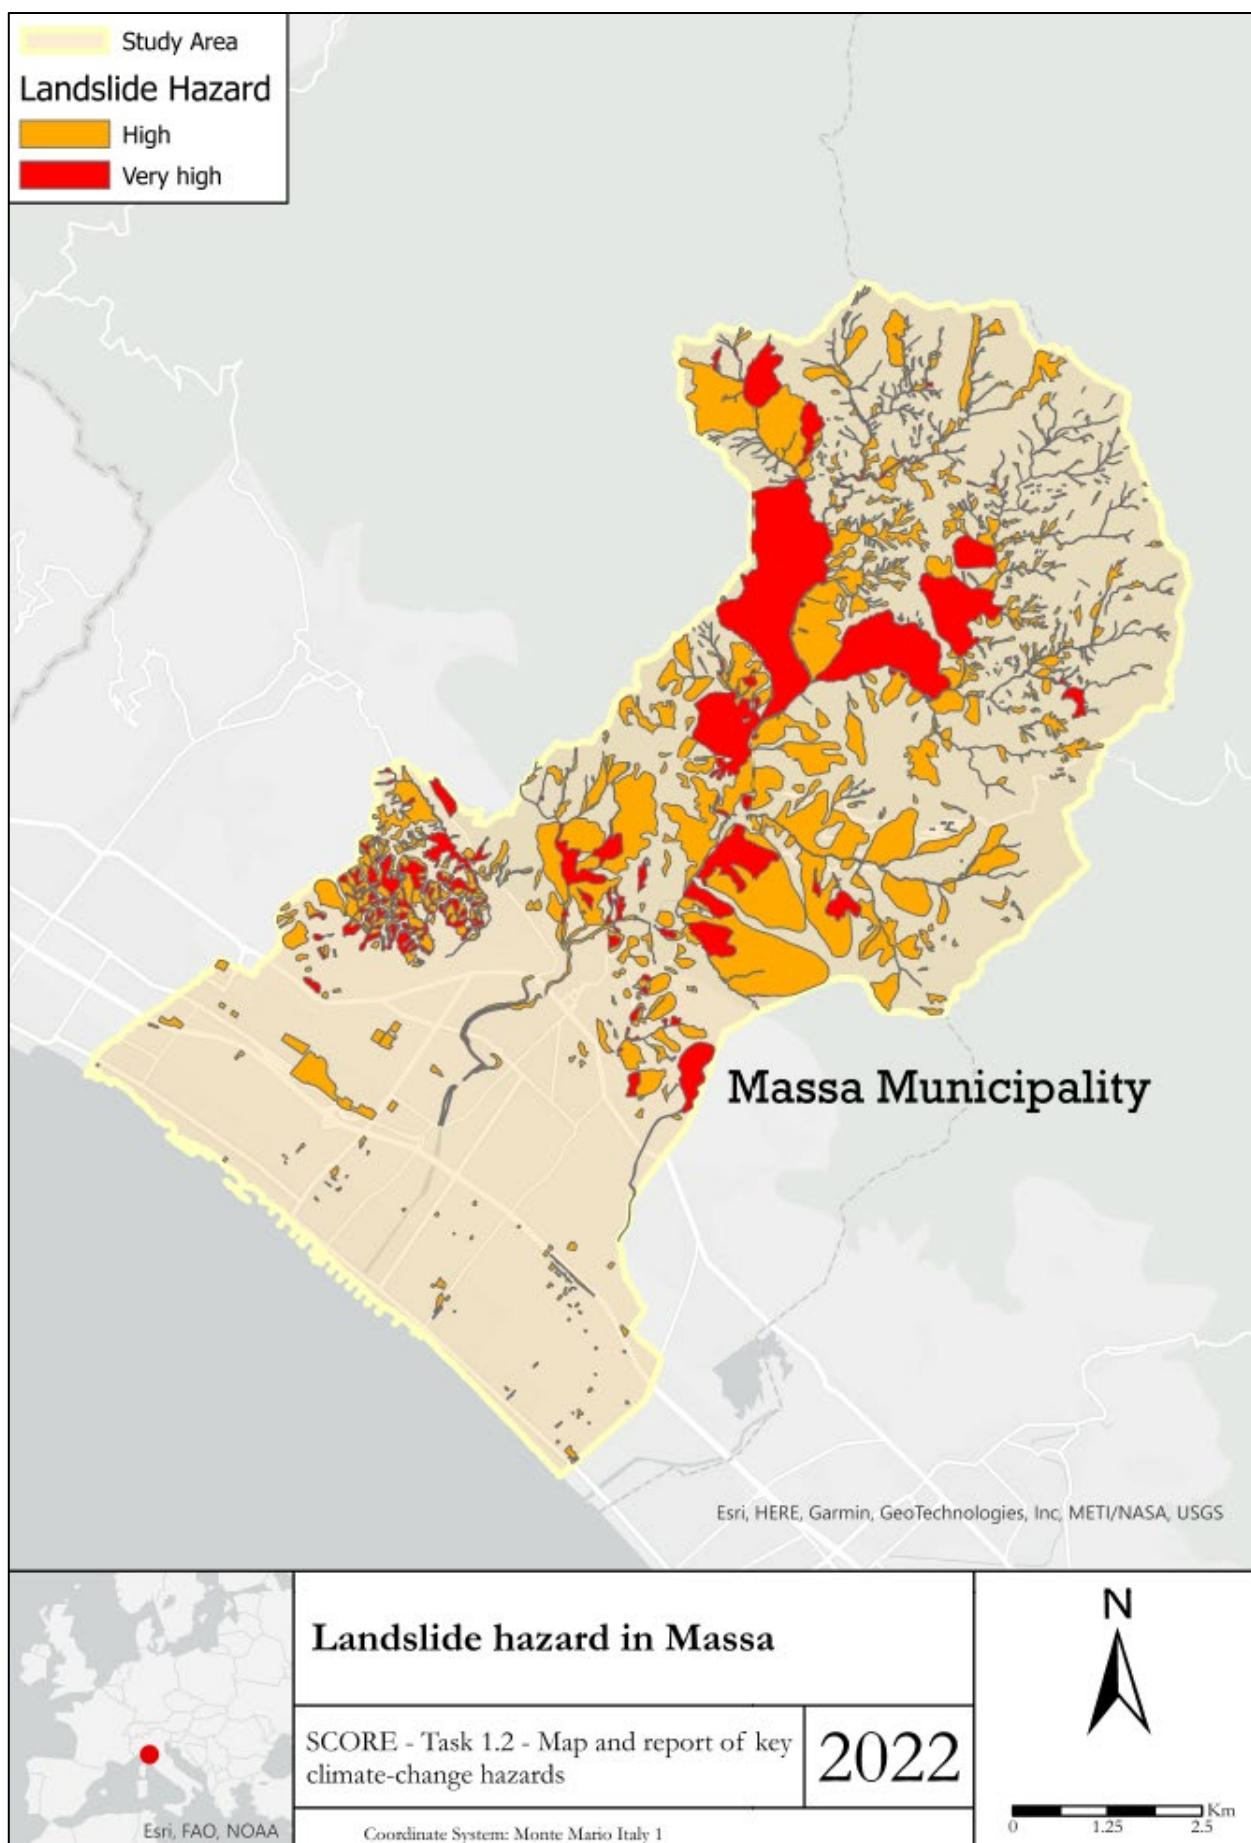
Figure 42: Map of the landslide hazard in Massa CCLL.

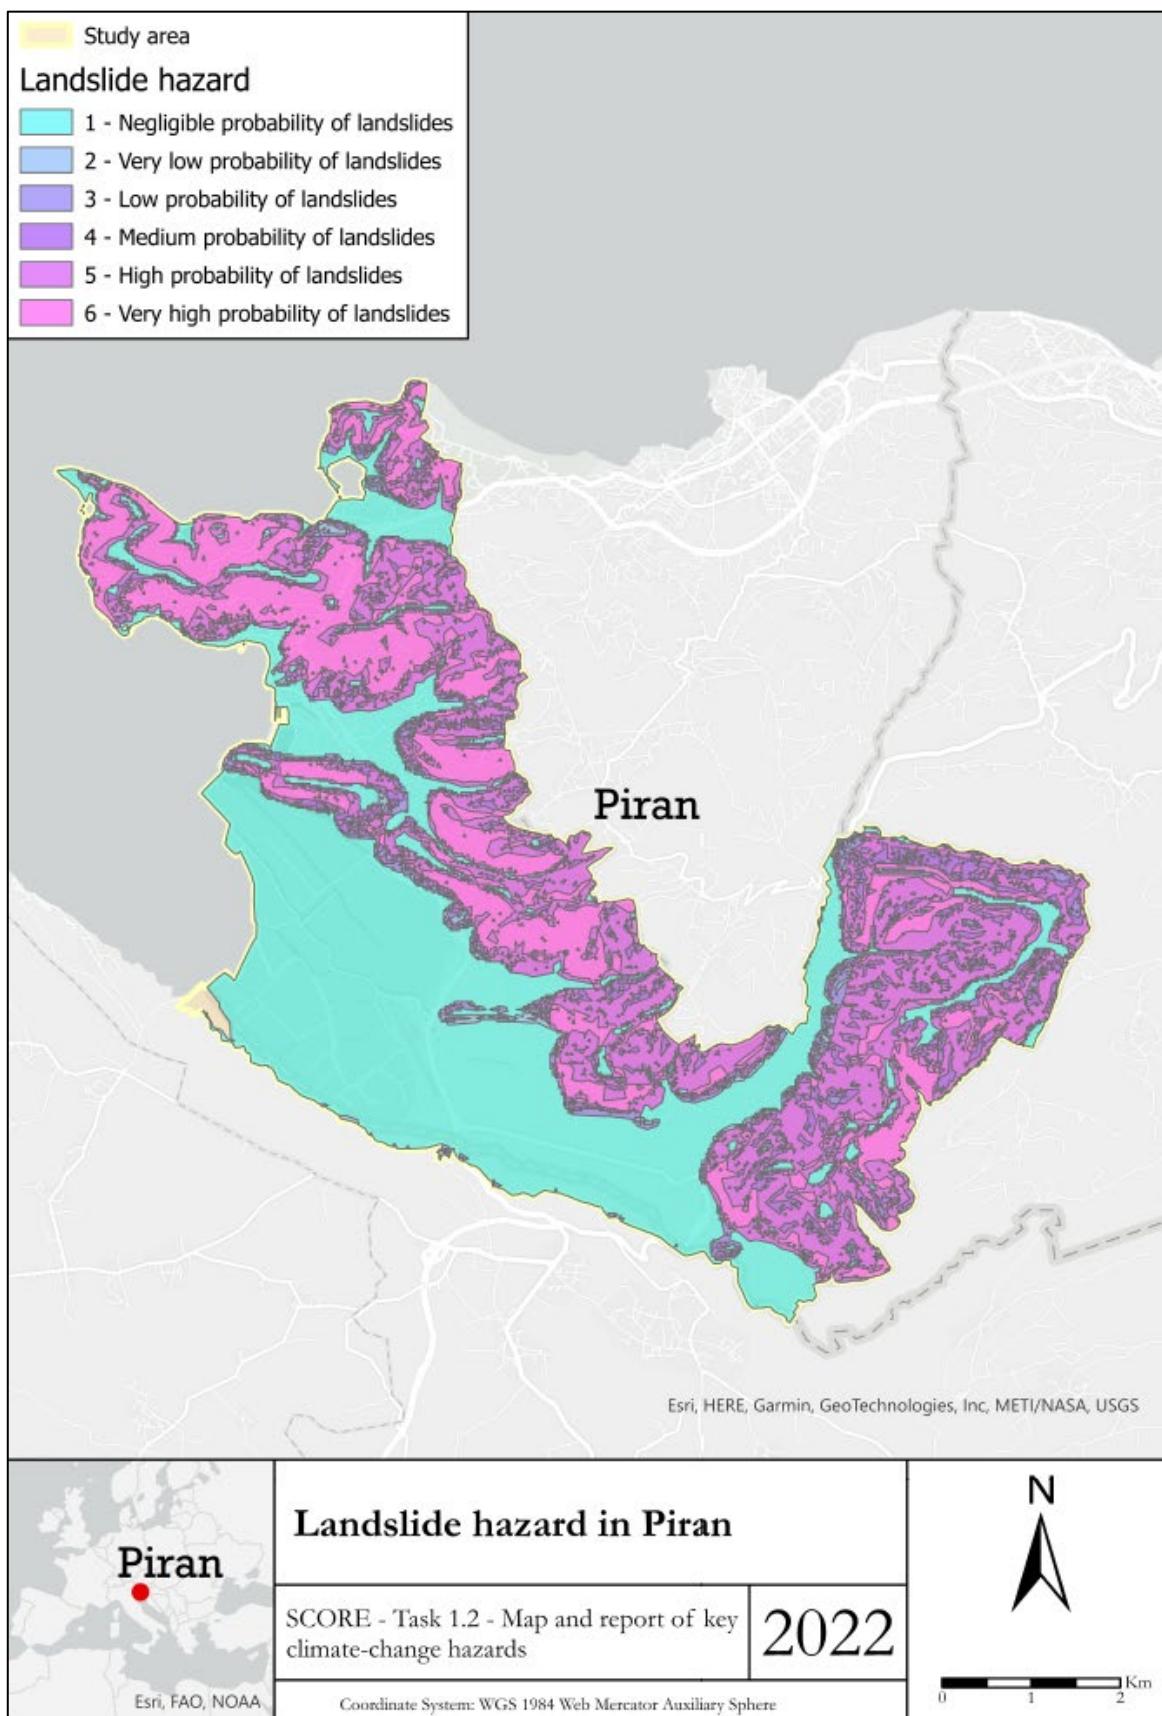
Figure 43: Map of the landslide hazard in Piran CCLL.

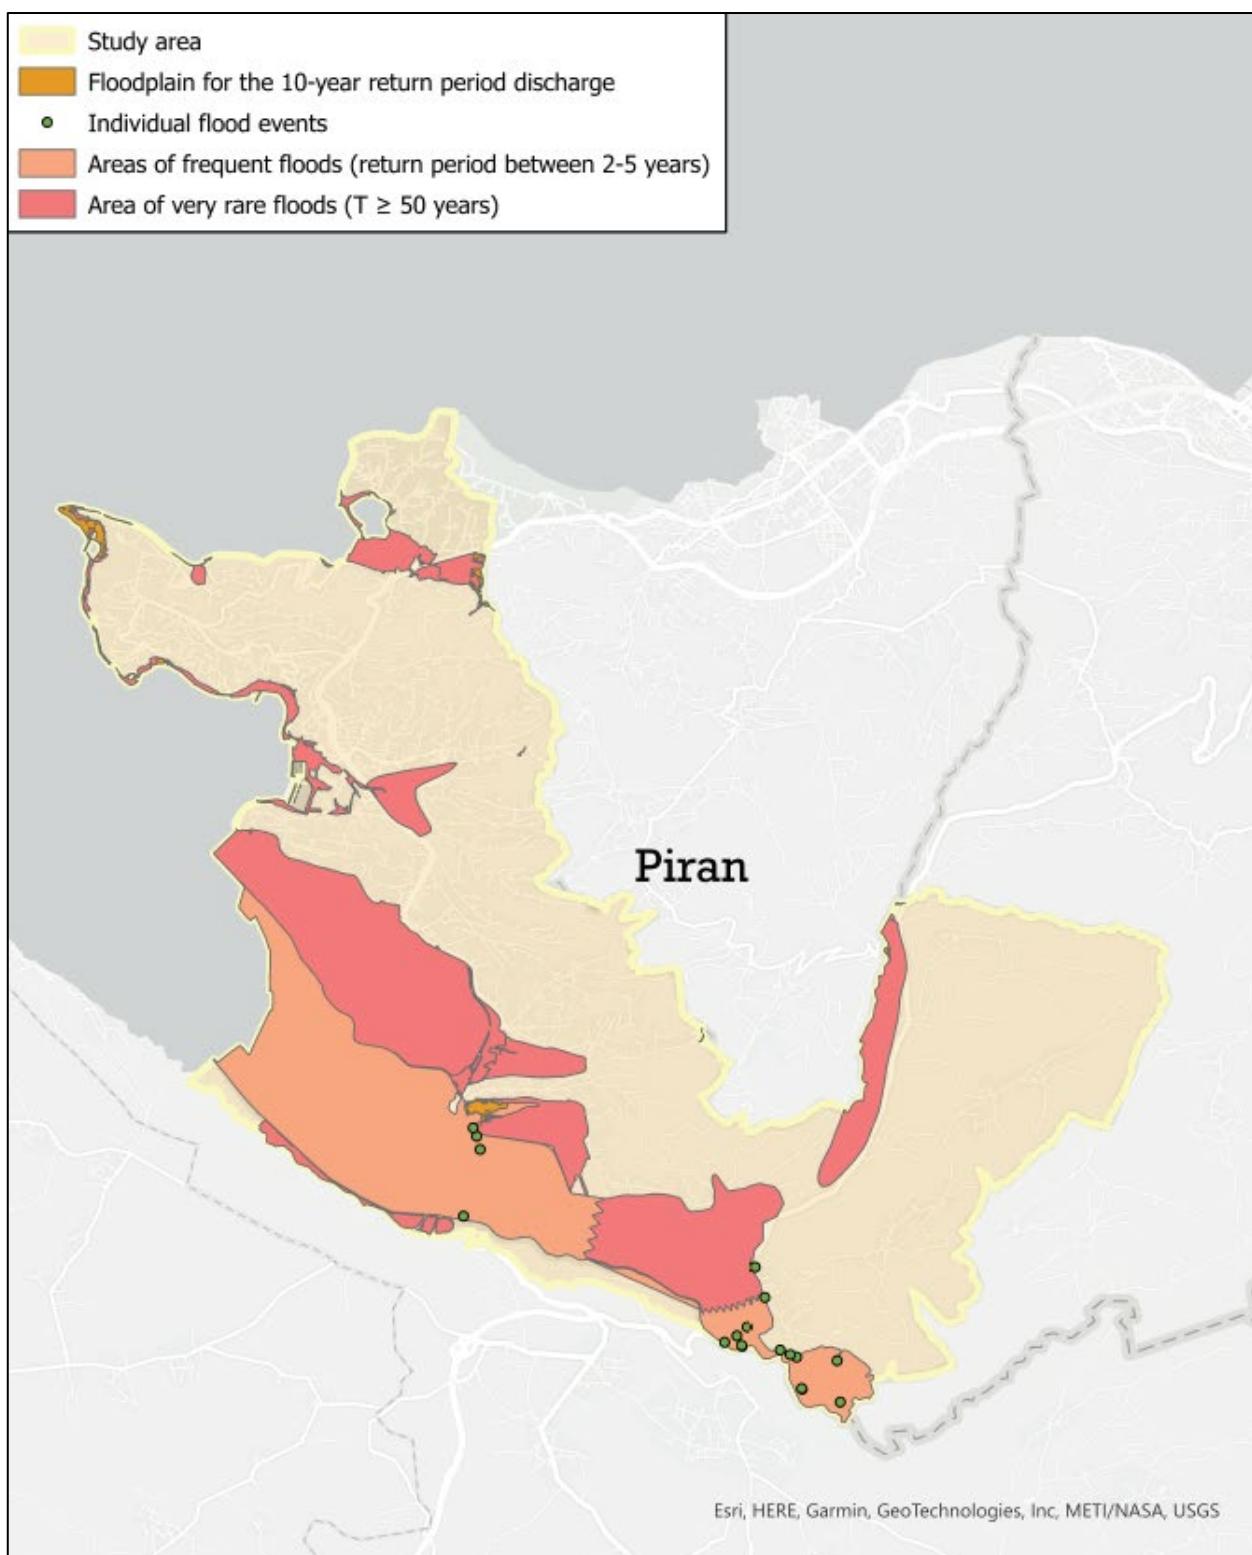
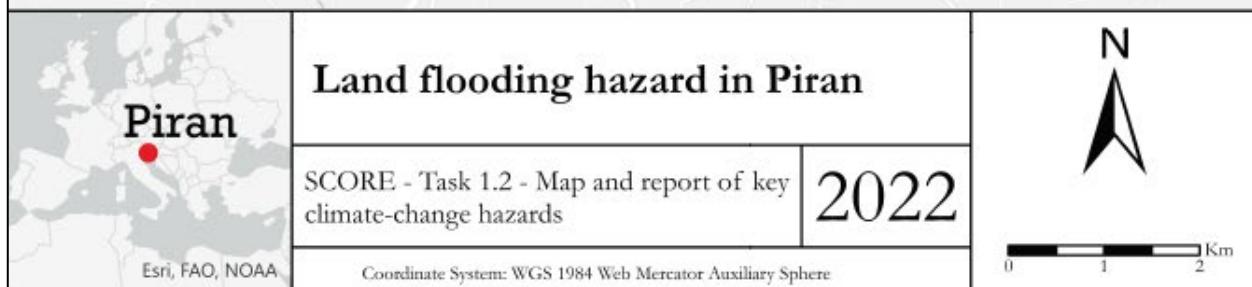
Figure 44: Map of the flooding hazard in Piran CCLL.

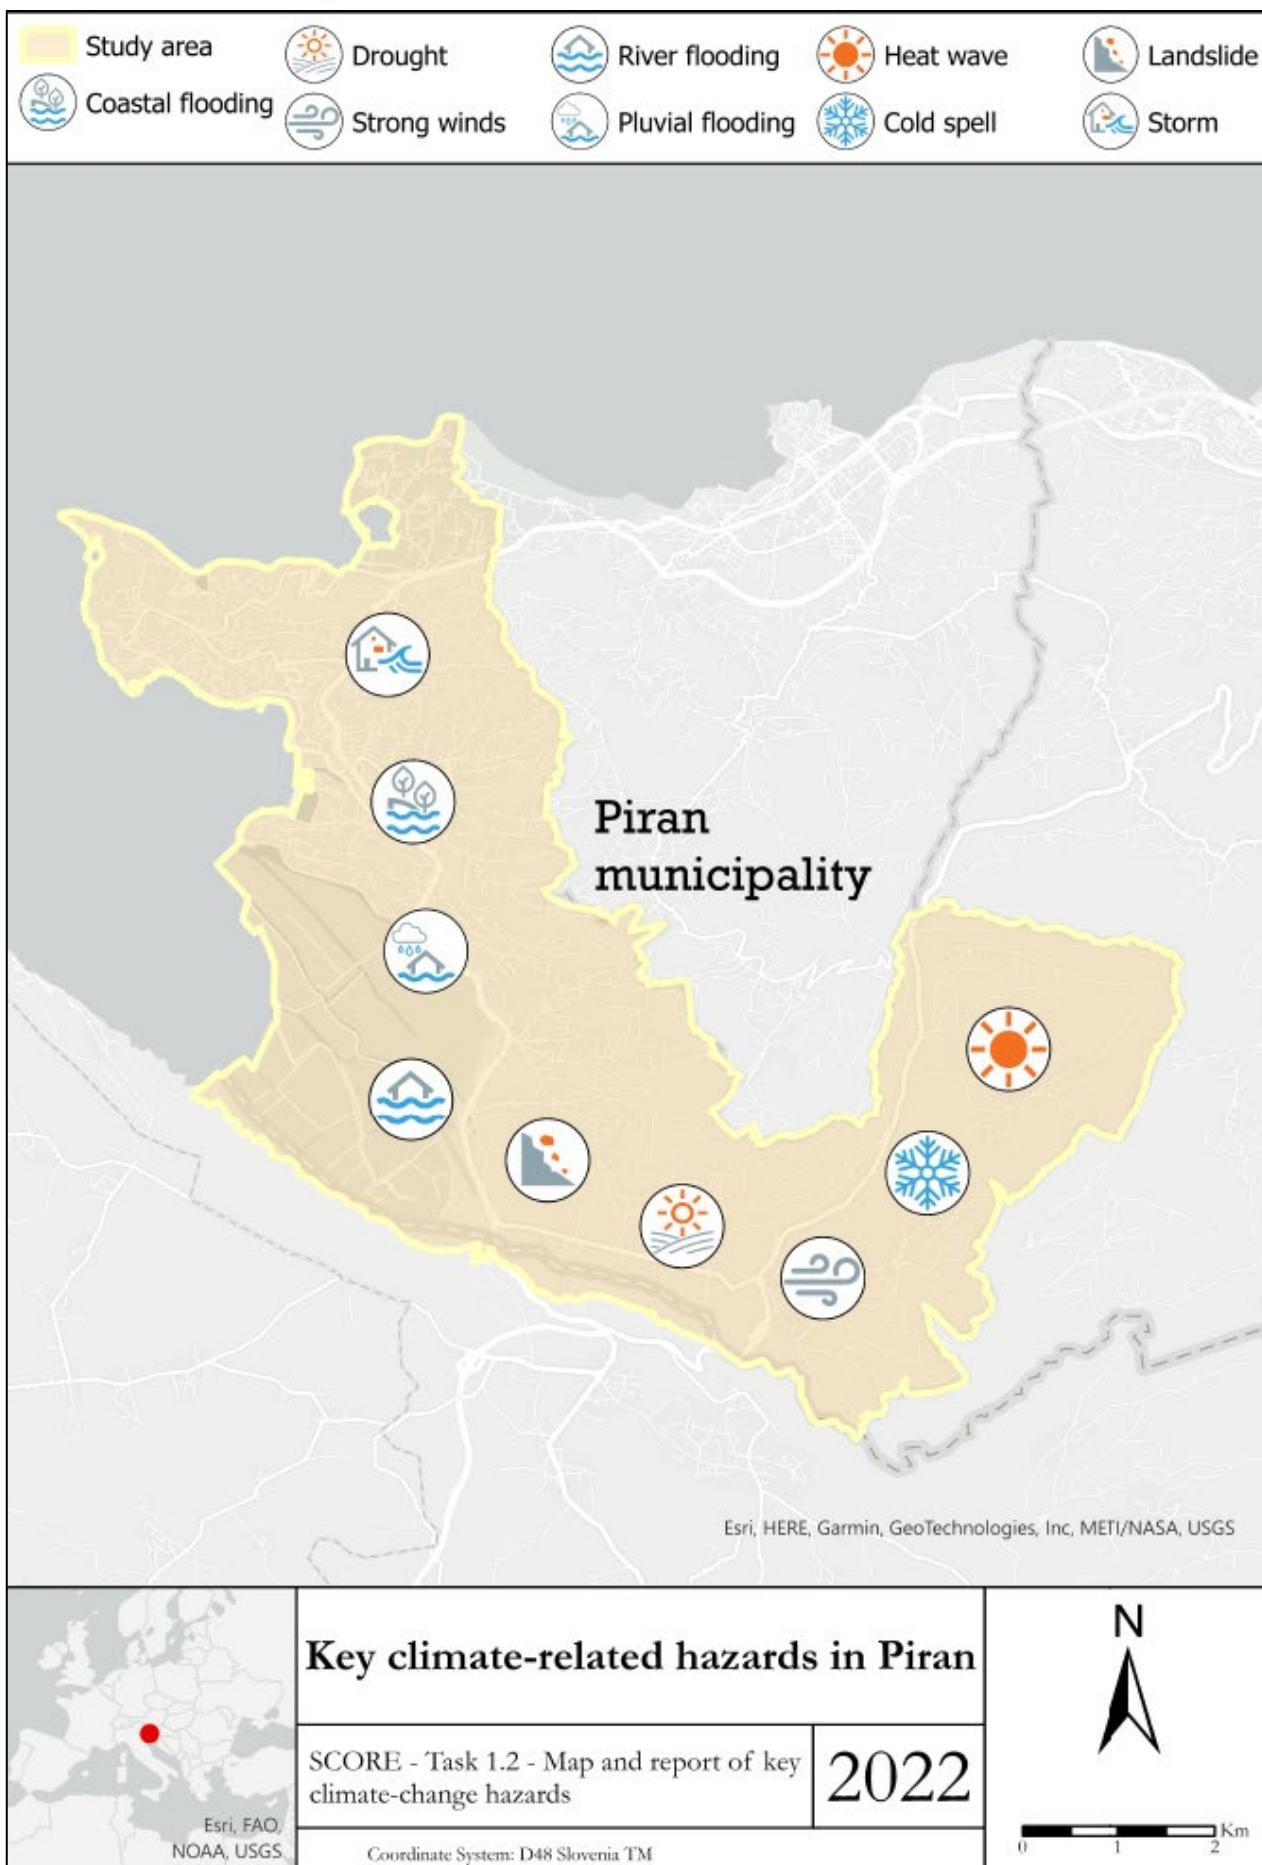
Figure 45: Schematic representation of key climate-related hazards in Piran CCLL.

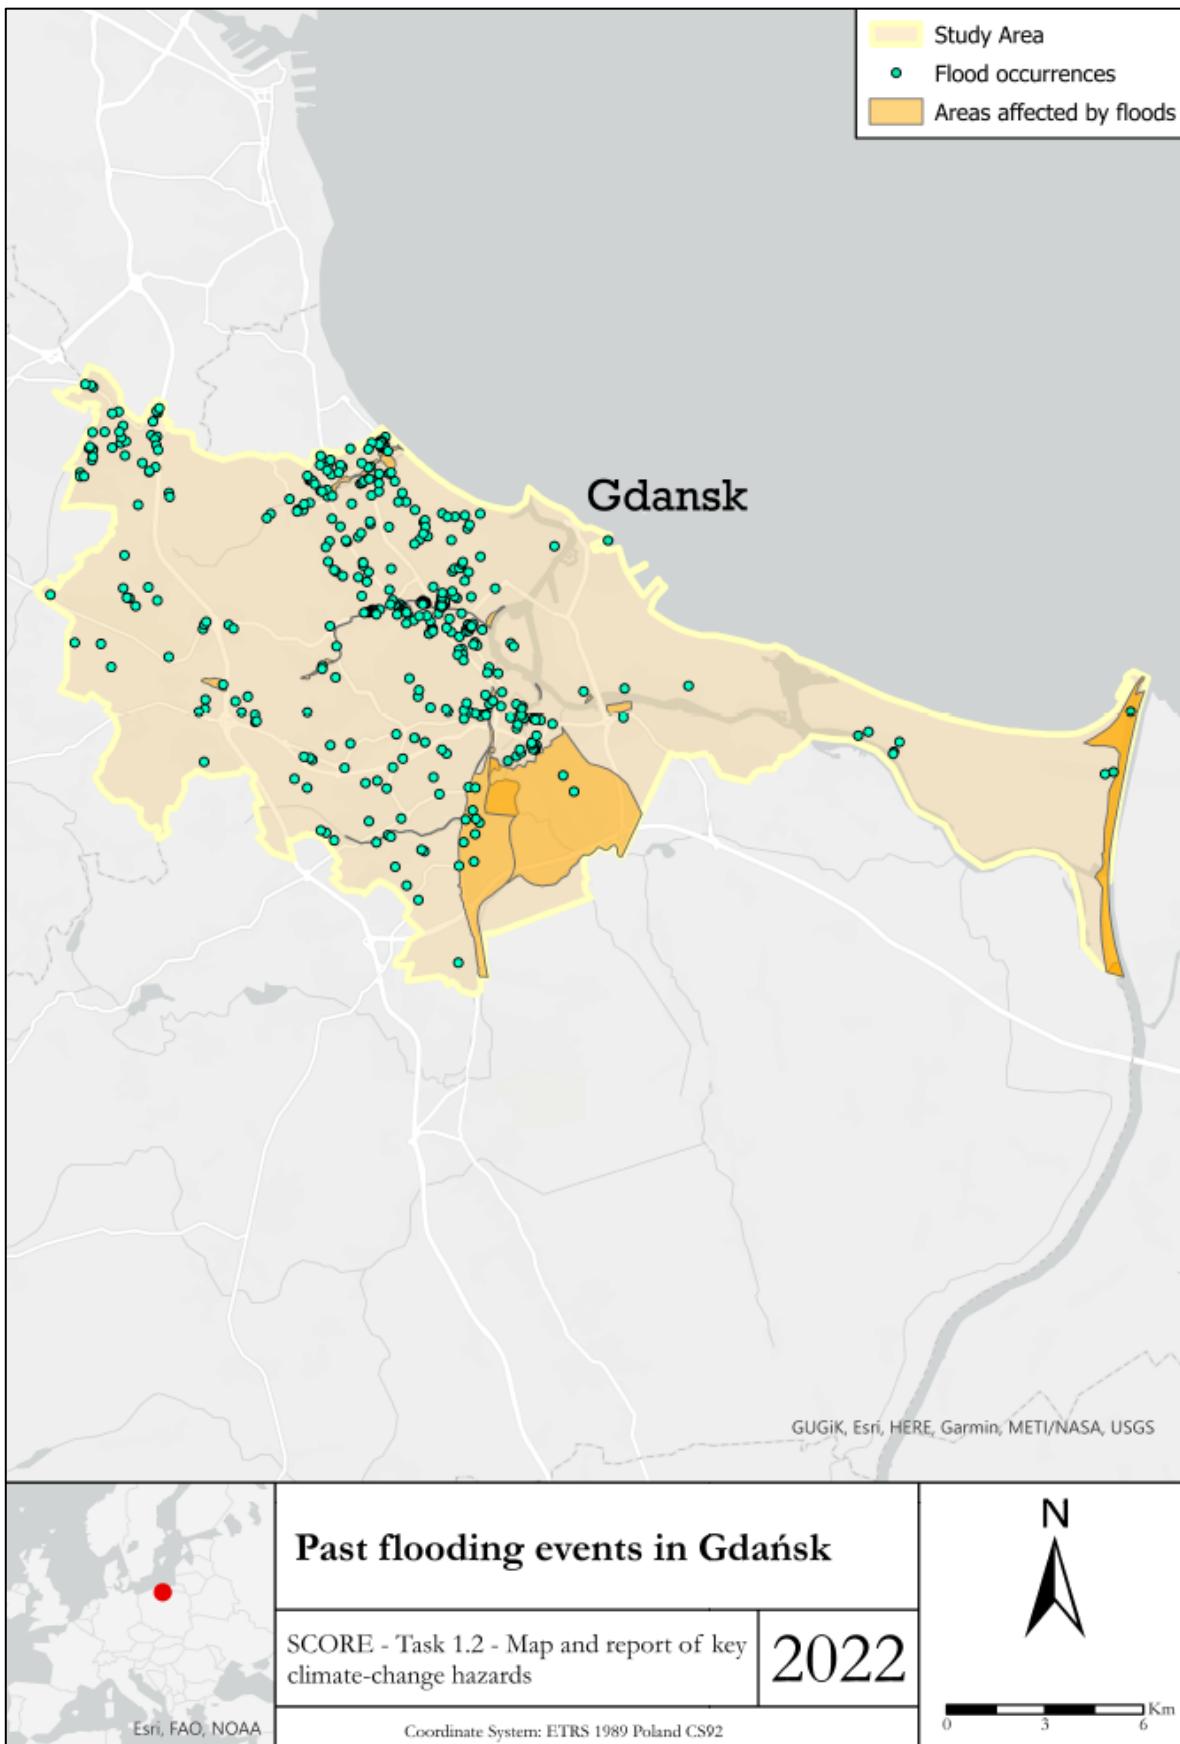
Figure 46: Map of the past flooding events recorded in Gdańsk CCLL.
