Application Problems of Anchor Dowels in Reinforced Concrete Shear Wall and Frame Connections

Musa H. Arslan

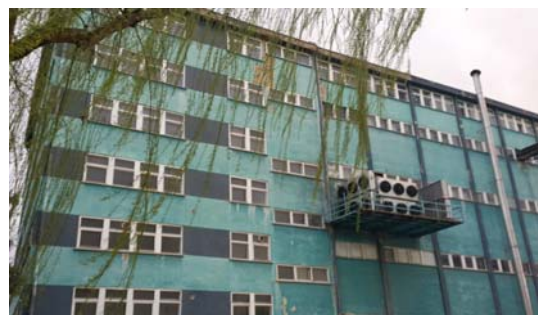
Fig. 9 Weak framed typical official building in Turkey

As for the tests carried out in another building given in Fig. 9, in Turkey with the same compression strength (average value of the compressive strength of concrete is 5.5 MPa), a brand "B" epoxy was used instead of the brand "A" one. The anchorage placement procedure is the same as the first example. As a result of the anchorage placing operation, it has found that the anchorages were able to hold the load to the desired capacity.

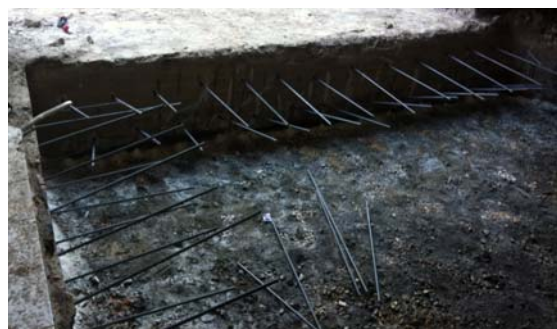
Fig. 7 A typical anchorage details in RC foundation connection

It is expected that, since the concrete strength of the structure is too low, some problems will occur related to the application of the anchorages and the anchorage performance mentioned in the project. The proposed anchorage details of shear wall-frame connection are given in Figs. 5 and 6. Also a typical anchorage application of a foundation is also given in Fig. 7.
