Open source integrated dataset of vegetation, waves, water depths, stability, controls/measures

Deliverable No: D.4.7

Grant Agreement number: 607131 / Project acronym: **FAST**
Project title: **Foreshore Assessment using Space Technology**
Funding Scheme: **Collaborative project** / Project start: **01-01-2014**
Project duration: **48 months** / Project coordination: **Deltares, Delft, the Netherlands**
Project website: **fast-space-project.eu** / DG Research - FP7 - SPACE - 2013

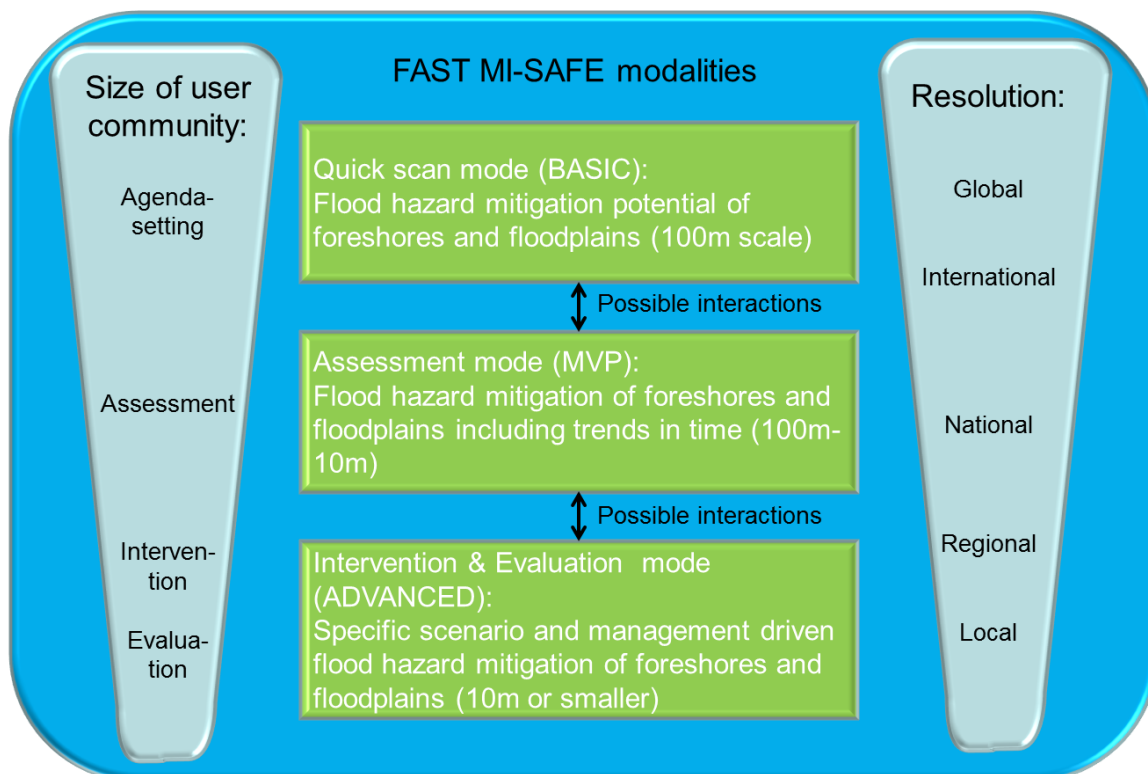
Figure 1 The FAST tool and the different version with their functionality (source De Vries et al., 2014: EU FAST Deliverable 5.10).

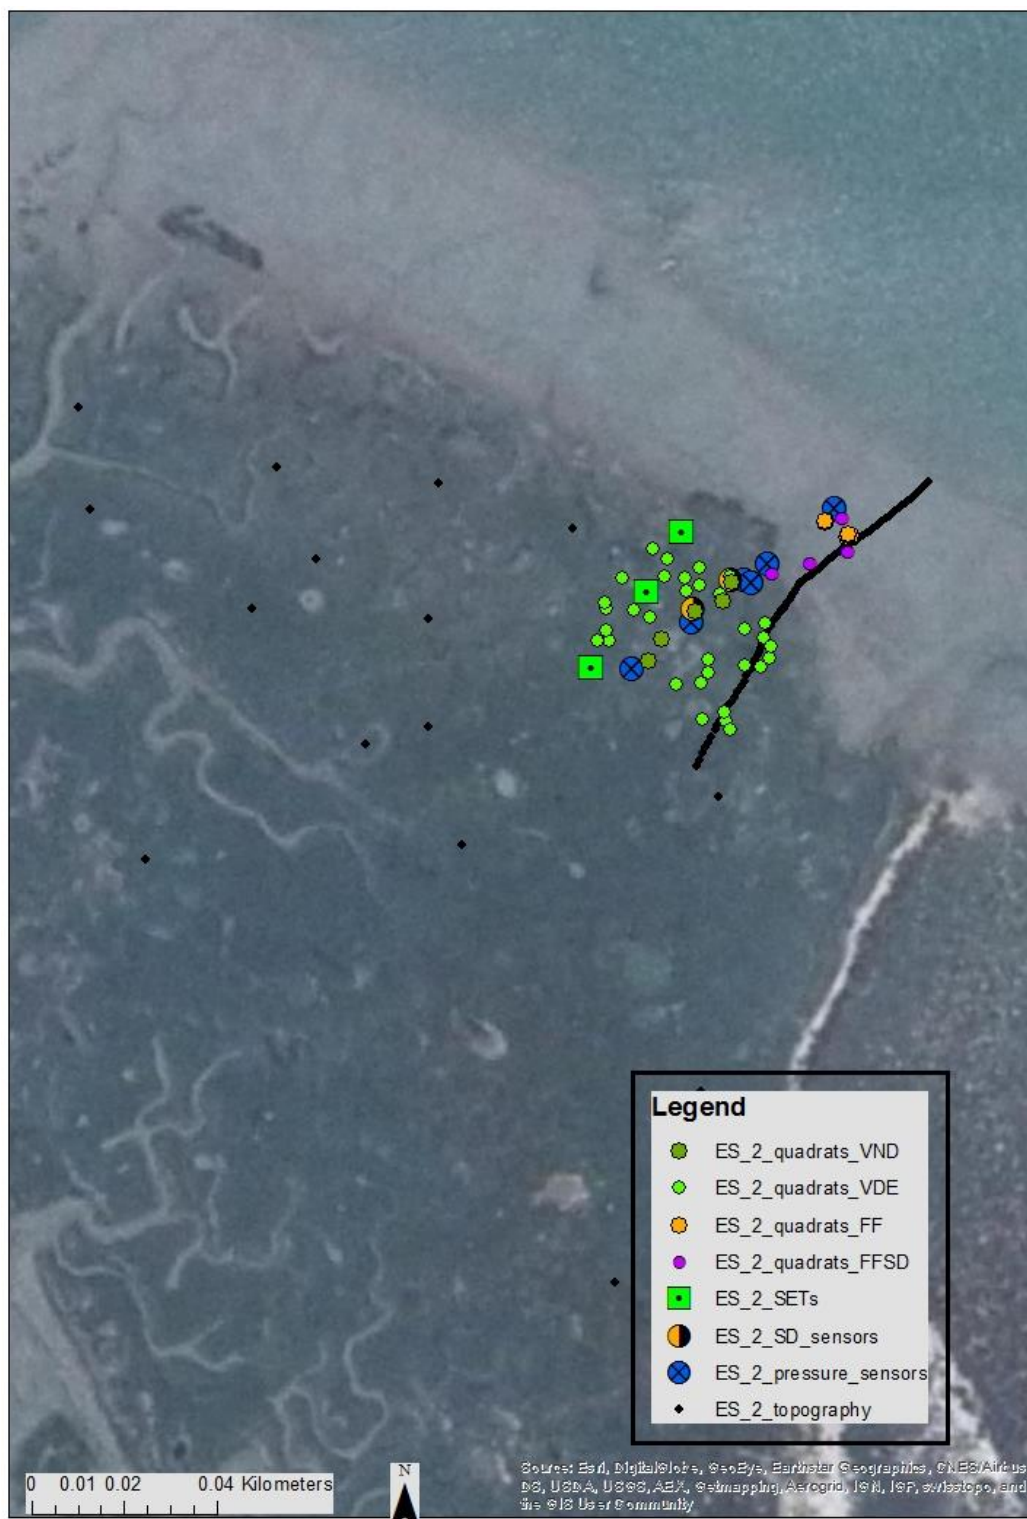
Figure 4 Locations of topographic surveys, monitoring equipment and sampling quadrats deployed at ES Y2 site

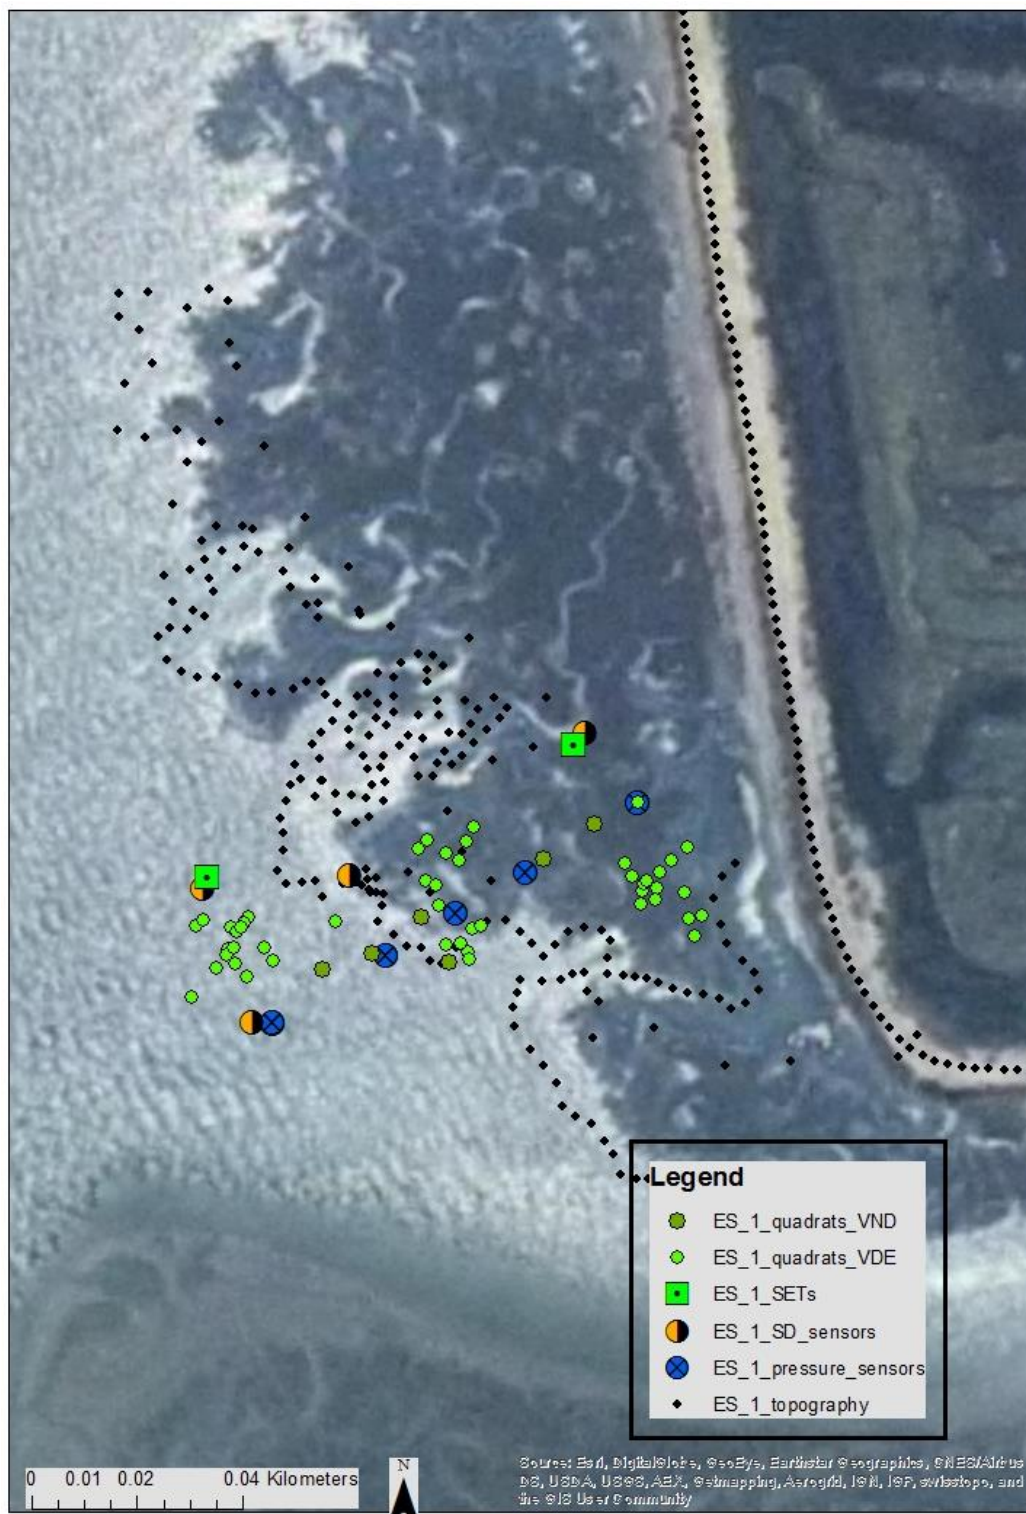
Figure 5 Locations of topographic surveys, monitoring equipment and sampling quadrats deployed at ES Y1 site

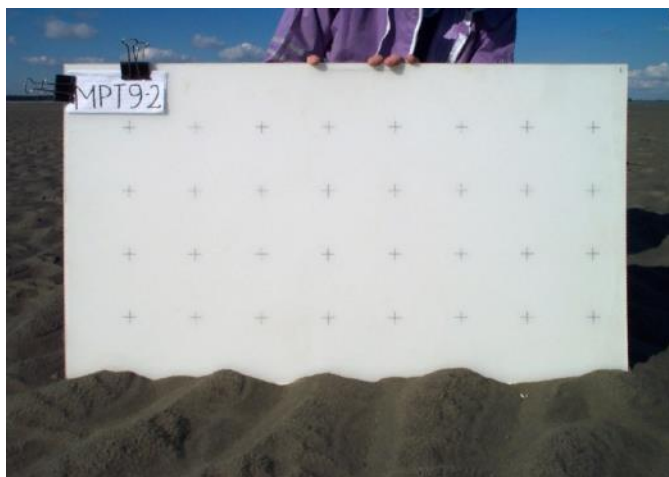
Figure 15 Example of a photograph with a properly clean (and thus white) roughness board.

On the unvegetated foreshore, surface roughness was measured by placing a ca 1 m by 0.5 m gridded board (with a grid spacing of ca 5 cm marked in pencil), as provided by NIOZ, horizontally into the ground and photographing the side-view (ideally with the same camera as used for the projected-area and top-down photographs above, set to the highest possible resolution) (see Figure 15). Three photographs were taken per quadrat per campaign with orientation and location being randomly selected. The board was inserted into the sediment so that the entire bottom edge was submerged, and the board was both level and vertical. Again, care was taken to avoid glare and shading effects that might complicate subsequent classification. In the next processing level, the photographs are to be scaled based on the grid marks, and information on the microtopographical profile will be extracted.

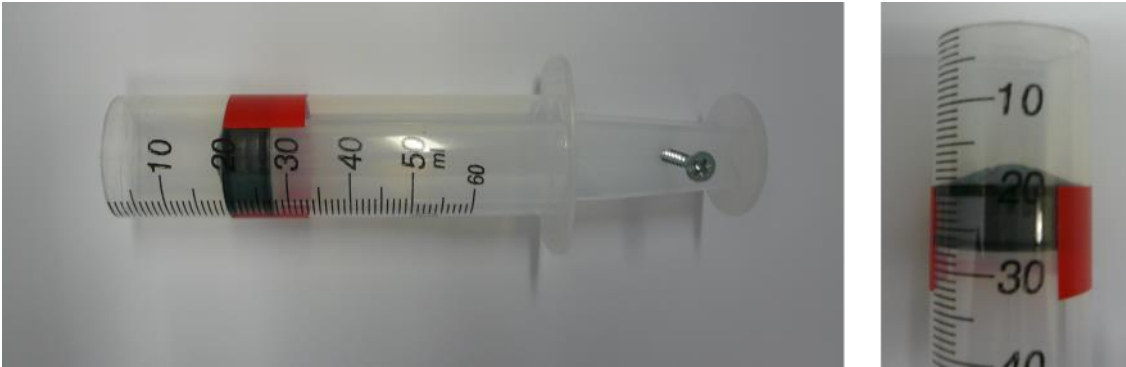
Figure 16 Sediment sampling with the big syringe, sides of the plunger should be level with top of the red tape to sample the right volume, as shown here.

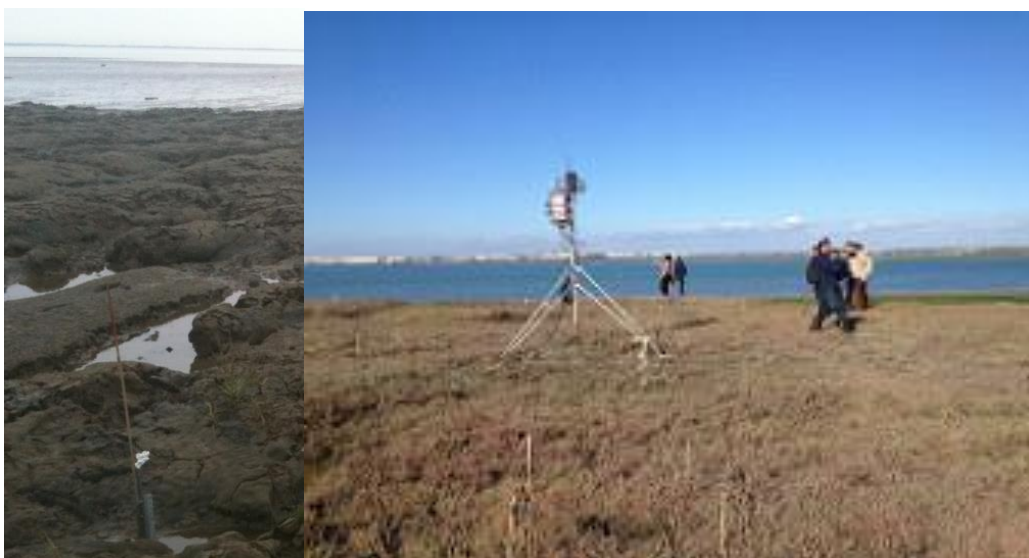
Figure 18 (left) Bed-mounted pressure sensor (see arrow) with buried cable connection to (right) telemetered data logging system at the Year 2 site in Cadiz Bay, ES.

Water level fluctuations were recorded using high frequency (4 Hz) dynamic water pressure measurements to resolve even small (2 Hz frequency) waves through the use of bed-mounted pressure sensors (see left of Figure 18). To allow for meteorologically induced variations in tidal high water level timing, the high-frequency wave recording was inundation-triggered and controlled by a data logging system (see Figure 18). For this purpose, water level averages were recorded at 5 minute intervals and, when the water level difference between successive water levels was less than a given threshold (indicating that levels are no longer rising), a high frequency wave record of 17 minute length was triggered. For each inundation event all five sensors recorded simultaneously. The Romanian field sites (Jurilovca (Razelm) and Hustria (Sinoe)) experienced continuous inundation, albeit with varying water levels, such that data acquisition at these sites varied from that at the UK, NL, and Spanish sites in that wave records were triggered every 8 hours (three times per day). Further at the Dutch sites, additional information on wave exposure of the foreshore to waves during the full tidal cycle was thought to be potentially important for tidal flat stability. To yield data on this exposure level, wave records were obtained for the full tidal cycle (i.e. high frequency pressure was recorded at the outermost sensor over a series of successive 17 minute-long intervals during inundation, ensuring that one 17-minute long wave record was obtained at high water as at all other sites, together with all sensors along the transect). Data was stored on data loggers and downloaded regularly by a mobile phone telemetry system (see antenna on top of the data logging station in Figure 18), with the exception of Spain, Cádiz Bay, where manual downloads were sufficient due to easy access and due to the manual deployment/recovery of the wave sensors before/after each deployment at the year 1 site. Pressure records acquired in this way were processed into wave spectra and summary wave statistics (L1) by the University of Cambridge, using tried and tested programming routines (Möller et al. 1996).
