3rd ICTG 2016

Evaluation of Granular Material Degradation in Repeated Load Triaxial Test

Caroline Lima, Carlos Correia e Silva, and Laura Motta

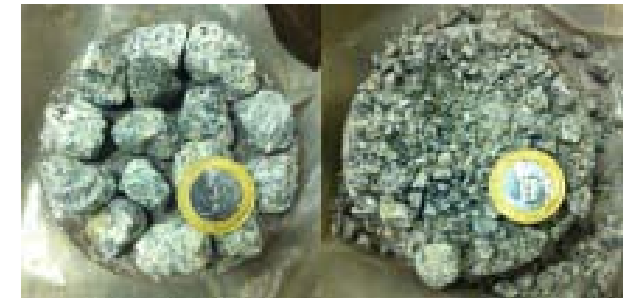
Los Angeles Abrasion (LA)

DNER-ME 035/98 Standard test method

- Evaluate the toughness, abrasion resistance and hardness of this aggregate

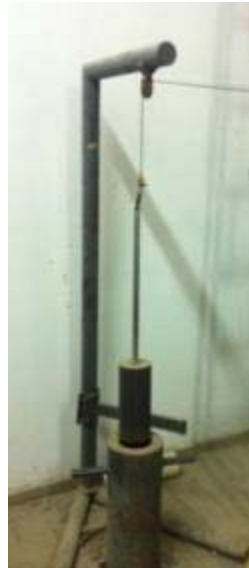
DNER ME 399/99 Standard test method

- Evaluate the loss, due to shock, of the stone material in Treton device.

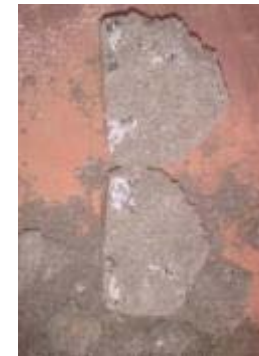
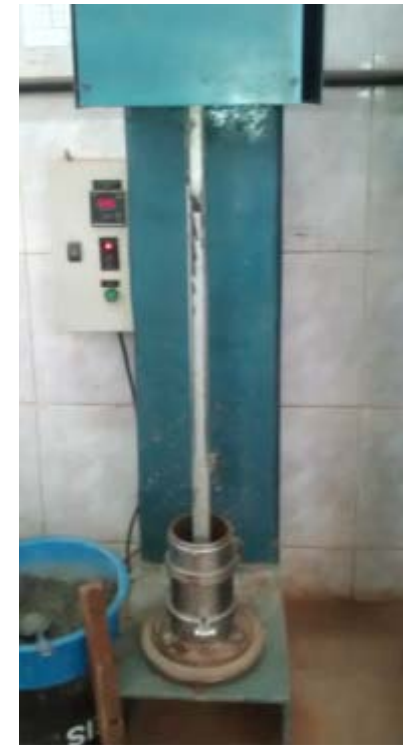
IDP – Índice de Degradação Proctor

The objective of this analysis in this research is to see where there were major breaks: in the compaction or in the repeat load triaxial test.

- new size distribution standard to adjust the quantity of available material,
- sample homogenization at optimum moisture content,
- modified Proctor energy,
- three samples molded in 10x20cm tripartite cylinder.

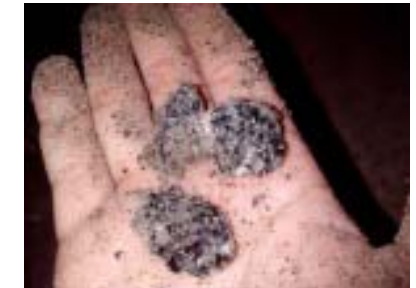
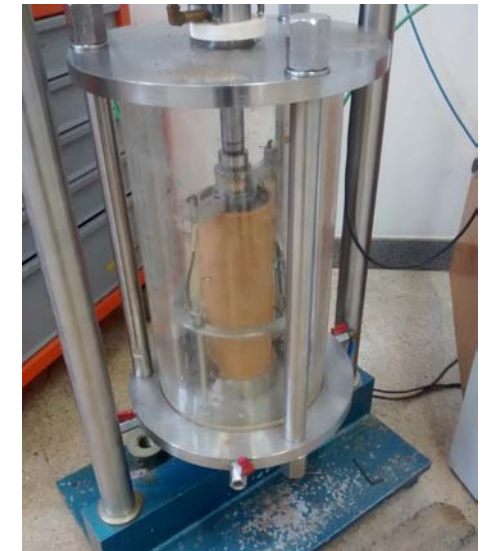
RLTDI – Repeated Load Triaxial Degradation Index

- nine dynamic tests (permanent deformation before resilient modulus),
- at least 150,000 cycles for permanent deformation test,
- one stress stage for sample at permanent deformation test,
- frequency of 1 or 2 Hz.

The degradation index after the RLT test is calculated the same way as an IDP. In this case, each RLTDI had to be calculated for nine samples.

All samples after the RLT tests were deranged and sieved as IDP procedure, and with these results it was possible to analyze the final particle size distribution to compare degradation
