SURVEY OF THE VILLAGE AND CARVED ROCKS OF ORONGO,
EASTER ISLAND, BY THE MANA EXPEDITION.¹

By MRS. SCORESBY ROUTLEDGE.

Plan of the Village
of
ORONGO
and of its
CARVED ROCKS

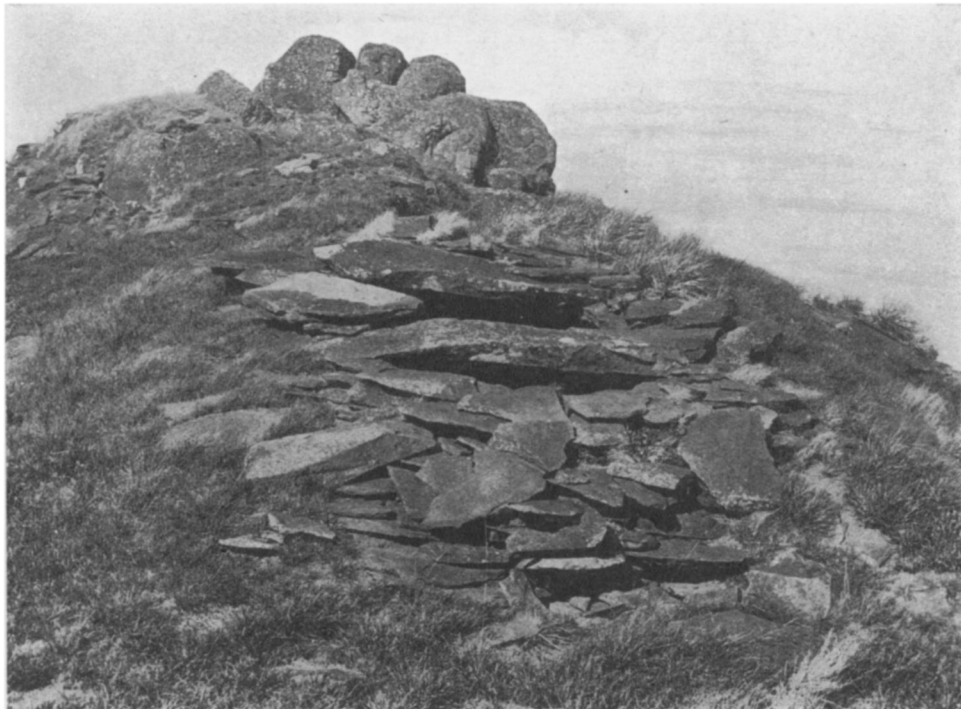
2. CAPSTONES OF HOUSES IN POSITION.

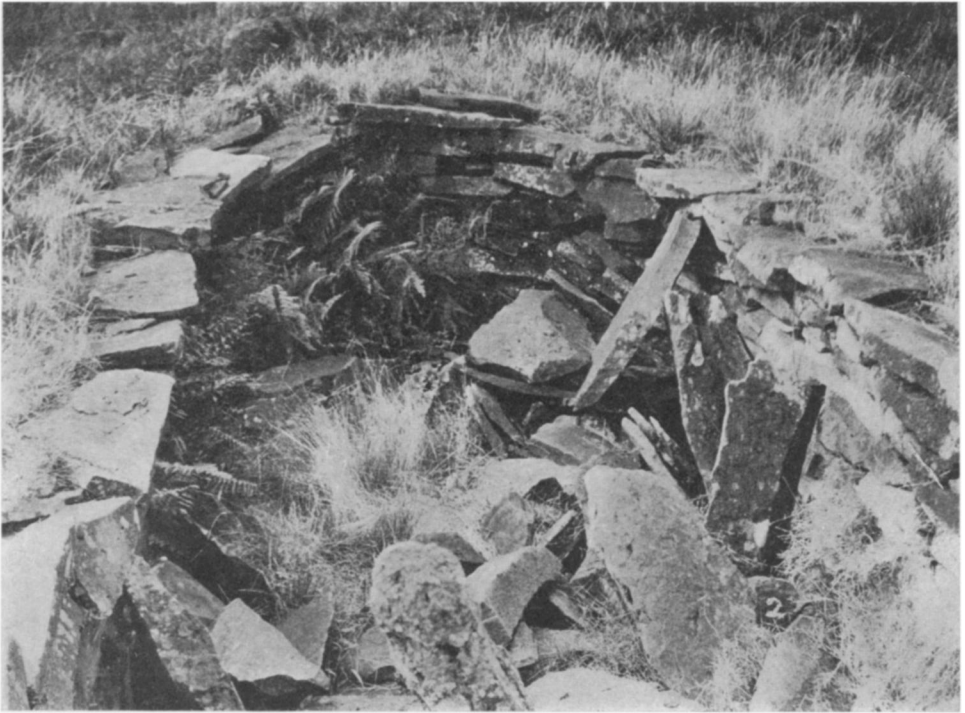
1. END OF A HOUSE UNROOFED. NO. 2.

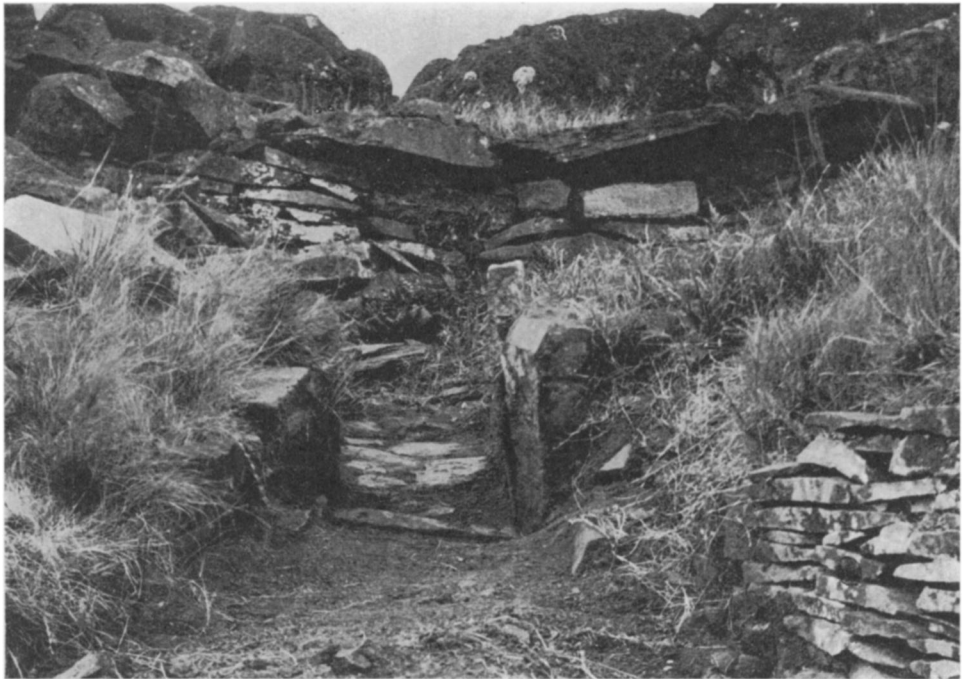
2. ENTRANCE PASSAGE UNROOFED. NO. 12.

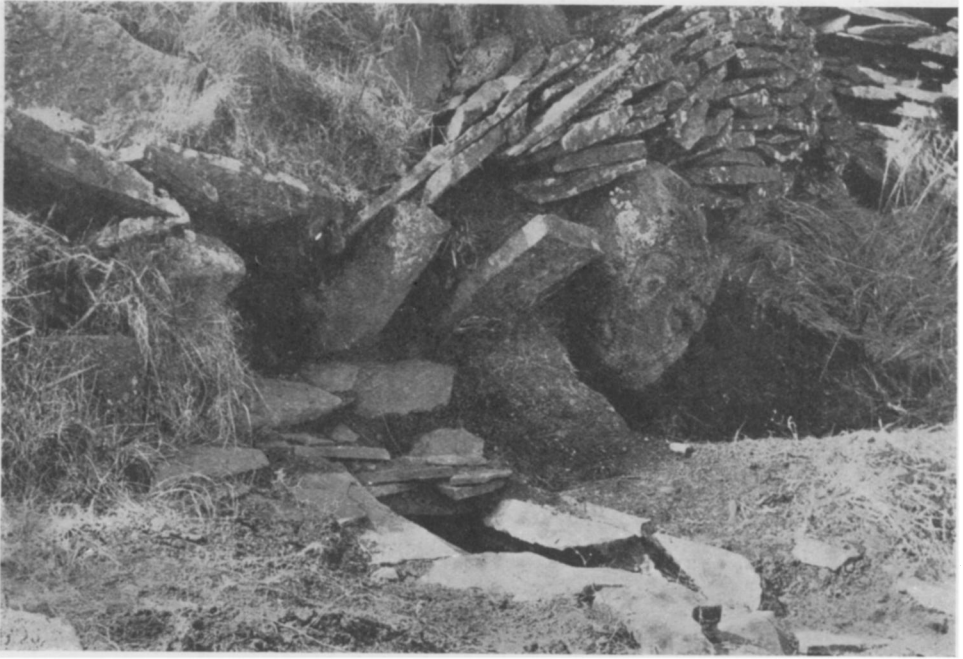
1. A BROKEN DOORWAY, SMALL PIT, AND CARVED STONE. NO. 7.

Chamber :—18' 10" × 6' 5" × 4' 2". Connecting hatch to No. 6, *q.v.* A small pit was found in the floor near the door, the only instance discovered of such a pit within a building ; two sides remained, length 2' 1" ; contained two sea boulders, bird bones and shells ; no sign of fire.

Decorations :—outside : a sculptured stone, partially buried, in exterior wall about 3' 0" from doorway, which was excavated and found to bear a roughly carved face, the eyes slanting from the nose upwards ; the ear is indeterminate but approaches the natural rather than the elongated type (Plate VII, Fig. 2). Inside : roof whitewashed in places : panel facing door has indications of square-rigged ship, black on white ground.

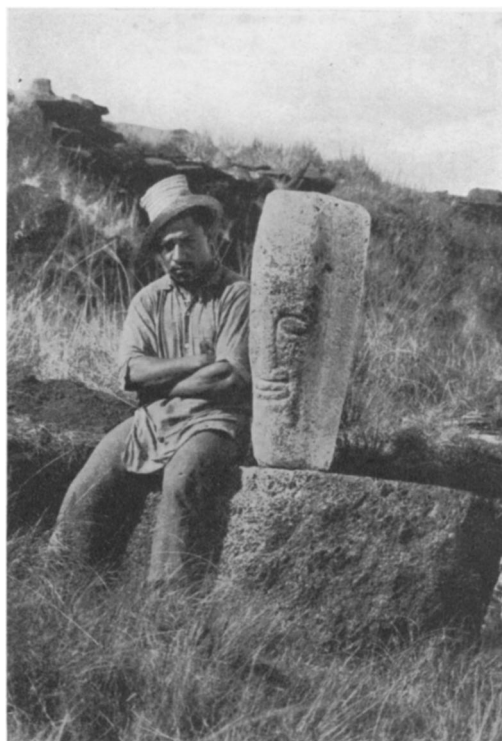
2. DOOR-POST, FORMERLY A FOUNDATION STONE, CARVED WITH FACE.
SURVEY OF VILLAGE AND CARVED ROCKS OF ORONGO.

Also near the line of stones, but on the crater side, were lying the two large stones wrought as foundations for a thatched house, which have been presumed to be the door-posts of No. 11, thrown aside when the house was destroyed. On one of these a face has been carved (Plate VIII, Fig. 2).

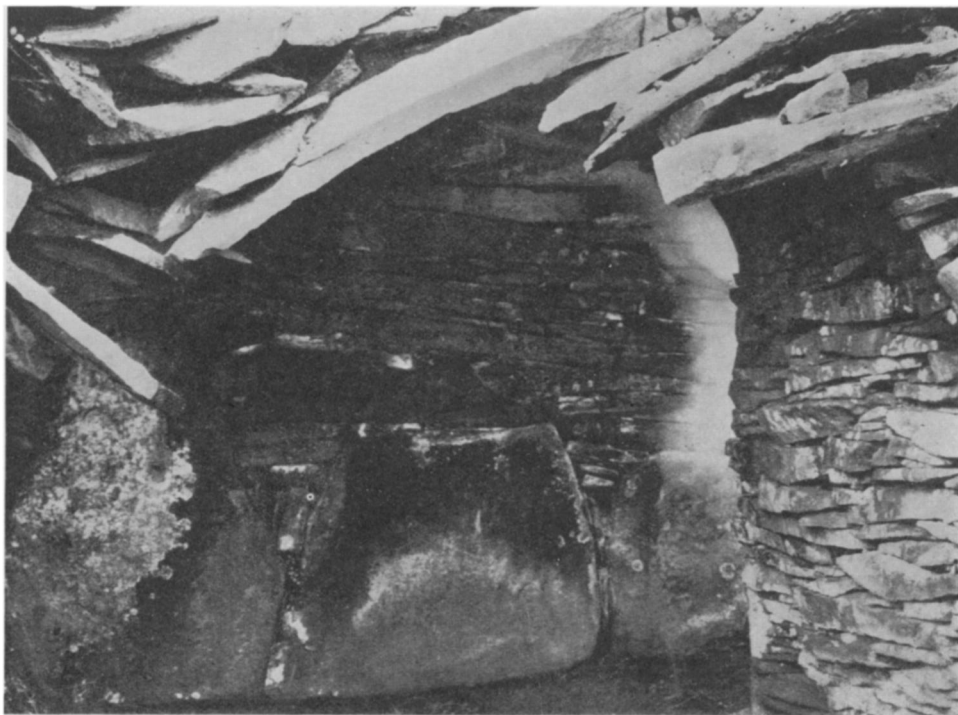
1. HOUSE NO. 11, WHICH CONTAINED THE STATUE.

No. 11 presents a form entirely different from that of any other house. It is a chamber with vertical walls and an almost flat roof. It has one square end, that at the north-west corner, and a rectangular recess at the north-east corner. One end of the roof and one end of the building, those on the south aspect, are entirely missing. The walls are laid bare some six to nine inches below the foundations.

The east side is formed as to its southern part by a straight wall, as to its northern part by a recess. The foundation consists of three blocks of stone, one of which blocks is hand-wrought. The floor has been excavated to the extent of 9" below the lower border of the blocks. On these three foundation blocks the wall is built by placing slabs horizontally. These laminae gradually extend inwards at the top of the wall so as to form the lower portion of the roof, which is finally completed by the super-position of large slabs measuring respectively in the clear inside 3' 5" × 3' 2", 3' 1" × 1' 3", and 3' 0" × 1' 2". The height of the east wall from the assumed old floor line to the spring of the arched roof is 3' 9". The length is 8' 5".

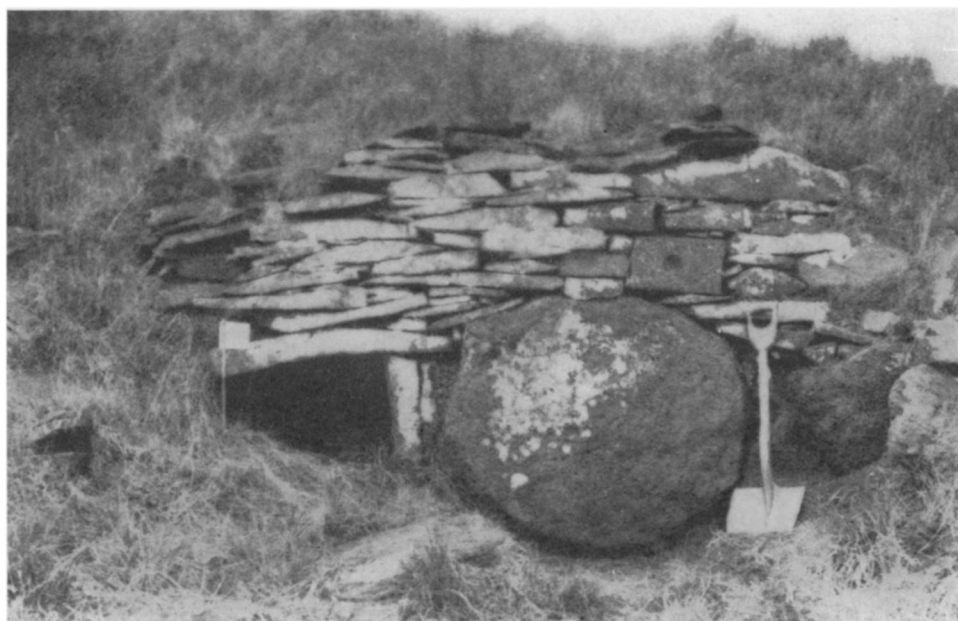
2. HOUSE NO. 18, WITH CIRCULAR STONE, PROBABLY A PEDESTAL.

Not less interesting than the old foundation stones is a circular stone, also of hard basalt, which is built into No. 18, and precisely resembles the bed plates of the images on the *ahu* (Plate X, Fig. 2). Its measurements are 3 feet 5 inches by 2 feet 10 inches, those of the base of the statue, 3 feet by 1 foot 6 inches. The probability seems great that the statue originally stood on it, in the open, in the same manner as the other statues in the island. The only difficulty lies in the contracted form of the base of the image which is not associated with the *ahu*, but with the buried statues. The image is said to have been, before its removal, embedded in the ground, which presumably accounts for the excavated condition in which we found the floor of No. 11. It seems not unlikely, however, that the figure would in any case be sunk when placed in or surrounded by the house, in order to lessen the necessary height of the building.
