Nonlinear air-coupled thermosonics for fatigue micro-damage detection and localisation

Artur Dyrwal, Michele Meo, Francesco Ciampa*

Materials and Structures Centre (MAST), Department of Mechanical Engineering, University of Bath, Claverton Down, BA2 7AY, Bath, UK

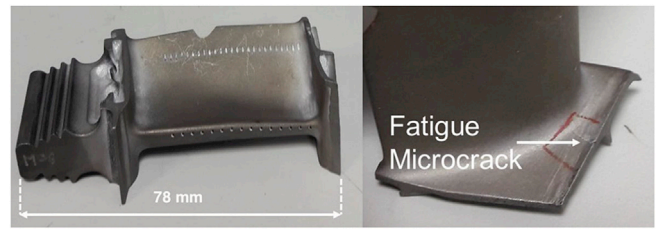
Fig. 1. Inconel aircraft engine turbine blade with a 1.4 mm fatigue micro-crack in its shroud.

Aircraft engine blades, typically made from titanium and nickel alloys, experience high-cycle fatigue loads due to mechanical vibrations and airflow dynamics in addition to high thermal stresses. Small indentation craters generated by foreign objects can become sites for fatigue micro-crack initiation, thus severely decreasing the lifetime of blades. A 78 mm Inconel aircraft engine turbine blade with a 1.4 mm fatigue micro-flaw in its shroud was selected for testing (Fig. 1). The experimental work included two major elements: nonlinear air coupled ultrasonic tests and thermosonics measurements.

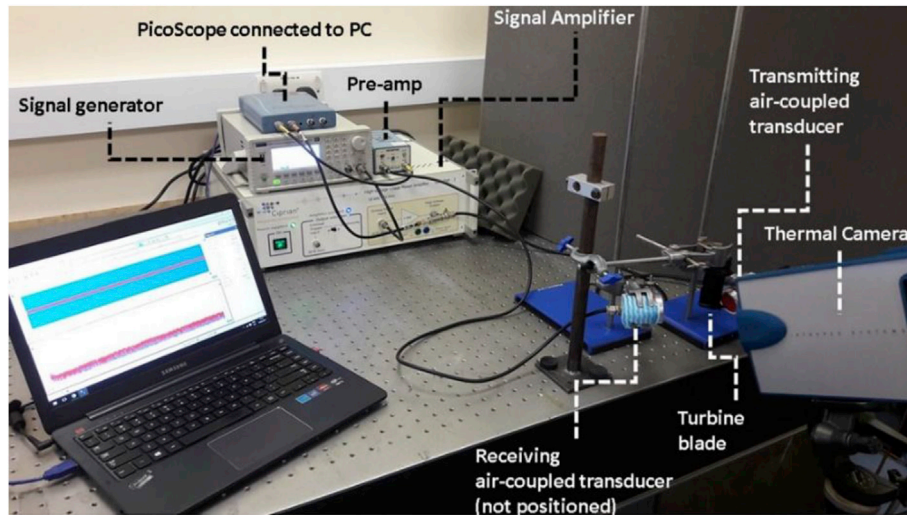
Fig. 2. Experimental set-up of the proposed NACT method.

For the nonlinear air-coupled ultrasonic testing, second harmonic was chosen as the nonlinear elastic feature indicating the presence of micro-cracks. A signal generator (TTi TG5011 Function Generator, 50 MHz) was used in conjunction with an amplifier (Ciprian US-TXP-3 High Voltage Power Amplifier) and a transmitting point-focused air-coupled transducer (Ultran ACT NCG50-D25-P76, bandwidth 30–70 kHz) with a central frequency of 50 kHz. The receiving ACT transducer was, instead, chosen with a central frequency of 100 kHz (ACT NCG100-D25-P76, bandwidth 50–150 kHz) in order to provide a higher second harmonic elastic response. The received signal was amplified using a pre-amp (Olympus Panametrics-NDT Ultrasonic Preamp 34 dB), which was fed into a digital oscilloscope (PicoScope 4424) connected to a personal computer. For the calibration of the air-coupled transmission, ultrasonic signals were also recorded using a contactless 2D laser Doppler vibrometry (LDV) system (Polytec PSV-A-420) with a stand-off distance of 507 mm. Signals received by the LDV system were sampled at 1 MHz with an acquisition window $\tau = 2.5$ ms and processed using MATLAB software. Thermography experiments for NACT involved the acquisition of thermal images using a mid-wavelength infrared camera (CEDIP Jade 3 MWIR 3–5 μ m, 320 x 250-pixel resolution, average NEDT of 30 mK) with a fixed frame rate of 25 Hz and 56 s recording time (equivalent to 1400 frames). It should be noted that the camera was positioned away from the ACT and was focussed exclusively on the damaged zone without having the ACT included in the video frame. This was to minimise the direct exposure of heat flow from the ACT transducer to the IR camera, which could negatively affect thermal measurements. Additionally, in order to provide a uniform thermal emissivity, the blade was painted black with spray paint. Fig. 2 illustrates the experimental set-up for both nonlinear ultrasonic and thermosonics tests.

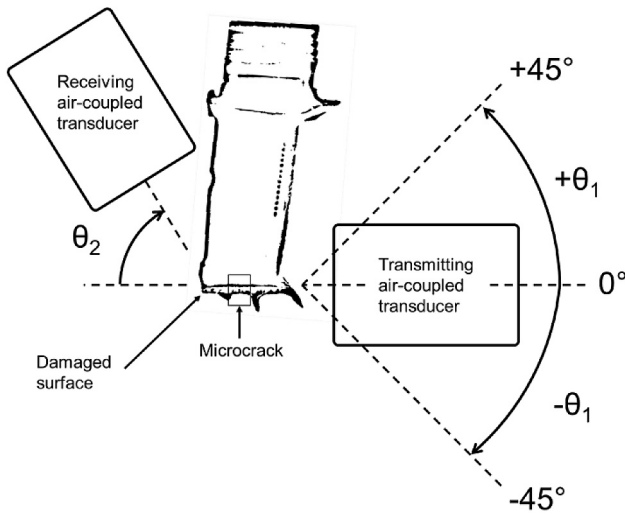
Fig. 3. Illustration of nonlinear air-coupled ultrasonic testing with slanted transmission set-up.

The implementation of nonlinear ACU testing required contactless transducers to be set at specific angles. A modified slanted transmission set-up of the air-coupled sensors was here used as it allowed minimising the impact of waves reflected from the blade surface on the received signal. In this set-up, the received signal will be mostly due to waves transmitted through the specimen and from the damaged location (see Fig. 3).

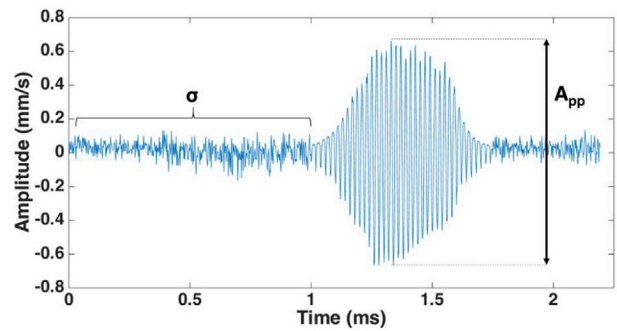
Fig. 4. Sine wave burst signal measured by the laser Doppler vibrometry (LDV) system. In this figure, A_{pp} is the peak-to-peak amplitude of the received signal and σ is the standard deviation of noise.

where A_{pp} is the peak-to-peak amplitude of the received signal and σ is the standard deviation of noise, was used to determine the optimal angle θ . For the ultrasonic signal transmission, a 15 cycles long sine wave burst $s(t) = A_0 H(t) \sin(2\pi f_0 t)$ enclosed in a Hanning window $H(t)$, with A_0 being the input amplitude and f_0 the input frequency was used (see Fig. 4).

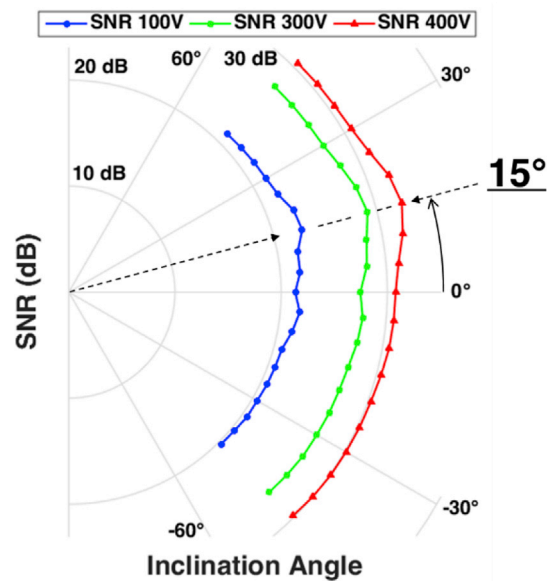
Fig. 5. Variation of SNR as function of the transmitter ACT inclination angle θ_1 for three input voltages A_0 (100 V, 300 V and 400 V) using the LDV system.

By setting the driving frequency $f_0 = 50$ kHz (i.e. the central frequency of the ACT), Fig. 5 shows the SNR variation for different transmitter inclination angles (with 5° increments) for three different input voltage amplitudes A_0 (i.e. 100 V, 300 V and 400 V).

As it can be seen in Fig. 5, SNR variations were more sensitive at lower input voltages, with the highest SNR achieved at $\theta_1 = 15 \pm 0.5$ degrees. This inclination angle θ_1 was selected for the nonlinear air-coupled ultrasonic experiments. With regard to the receiving ACT transducer, its position was set on the opposing side of the blade (see Fig. 3) at an angle $\theta_2 = 20 \pm 0.5$ degrees in order to minimise the impact of reflected ultrasonic waves between the sample and the air on the received signal. It should be noted that the difference of five degrees between θ_1 and θ_2 is likely due to the complex geometry of the blade. Moreover, in order to increase the accuracy of measurements and reduce the noise effects, the time-domain signals were averaged. By setting the excitation frequency $f_0 = 50$ kHz, the input voltage $A_0 = 400$ V and the inclination angles $\theta_1 = 15^\circ$ and $\theta_2 = 20^\circ$, non-contact ultrasonic experiments showed that for up to 50 averages the SNR rapidly increased and then converged toward a flat asymptote for higher values (i.e. ~ 33 dB at 130 averages, see Fig. 6).

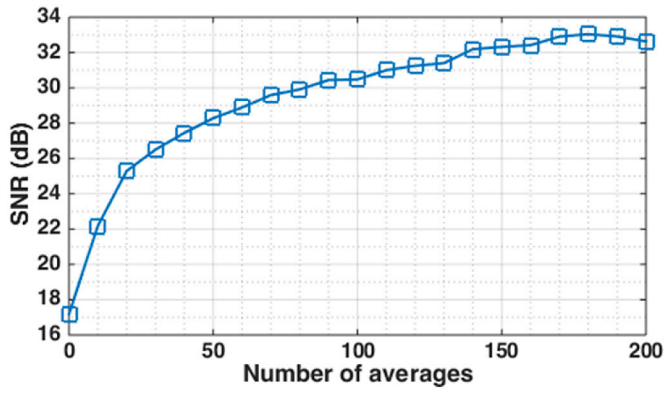
Fig. 6. Variation of SNR as function of time-domain signal averages at $f_0 = 50$ kHz, $A_0 = 400$ V and $\theta_1 = 15 \pm 0.5$ degrees.

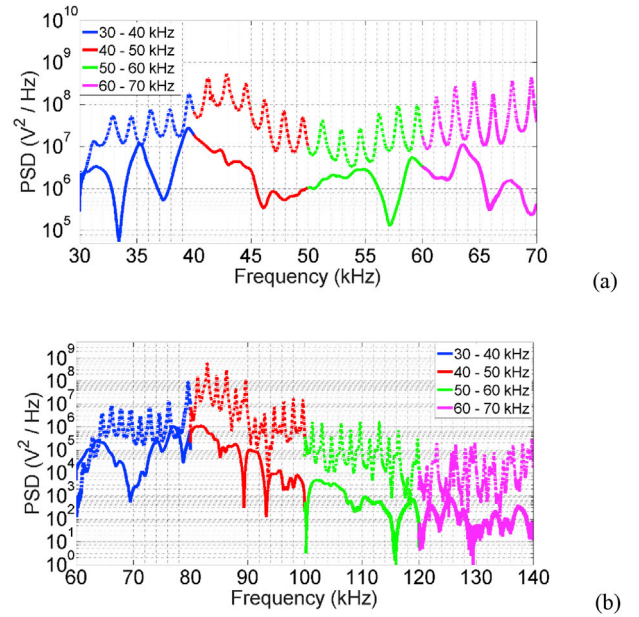
Fig. 7. Power spectral density (PSD) of both *material* (solid line) and *system* (dash-dot line) sweep responses in the fundamental (a) and second harmonic (b) regime. Both transmitter and receiver ACTs were used for the ultrasonic testing.

the theoretical existence of second harmonic peaks associated with the LDR effect (Eq. (3)), their experimental identification requires narrow-band ultrasonic frequency sweeps. It should be also noted that the high input voltages used with ACTs can generate second harmonics due to the acquisition system and not only to the damaged specimen. For this reason, air-coupled ultrasonic tests involved the estimation of the *specimen/material* response against the transducers one (here named as *system* response). The latter was defined as the response recorded by the receiving ACT when no specimen was present, i.e. with both ACTs located in a fixed position 100 mm opposite each other with an inclination angle θ of 0° . Hence, the driving frequency that showed a high second harmonic *material* response and a low second harmonic *system* one was considered as an LDR frequency candidate. Similarly to Fierro et al. [6], four narrowband sweep input signals ranging between 30 kHz and 70 kHz with a frequency span of 10 kHz at the input voltage of 400 V and a sweep duration time of 10 s each were generated. Time-domain signals were collected at 1 MHz sampling rate and a MATLAB code using a fast-Fourier transform (FFT) algorithm was used to compute power spectral density of recorded signals. The results for both the fundamental and second harmonic spectrum range are plotted in Fig. 7.

Different line colours were used to differentiate results for the four sweeps achieved at different frequency ranges. As it can be noticed in Fig. 7(b), the *material* second harmonic response (solid line) is much higher in the 60–100 kHz range. On the other hand, the *system* second harmonic response (dash-dot line) is generally higher in the 80–100 kHz range. This means that the second harmonic peaks in the 60–80 kHz range have a higher likelihood to be generated by the micro-crack rather than the acquisition system. Therefore, the driving frequency range of 30–40 kHz was selected for the identification of LDR frequencies. Fig. 8 shows the results for the frequency sweep in the 30–40 kHz range with both the *material* and the *system* responses. Two LDR frequency candidates were selected, i.e. 31.8 kHz (“circle” marker) and 38.5 kHz (“diamond” marker), as their second harmonics revealed a peak amplitude in the *material* response (blue solid line) and a minimum amplitude in the *system* one (red dash-dot line). It should be noted that even though the frequency $f_0 = 38.5$ kHz features a higher *material* second harmonic response than 31.8 kHz, also the *system* second order response is higher at this frequency. For this reason, it is difficult to establish at this stage of experiments which of these two fundamental frequencies is better for thermosonics testing. Therefore, both driving frequencies were used for the implementation of NACT. In addition, two other frequencies were selected for reference and comparison purposes. Particularly, $f_0 = 33.8$ kHz (“square” marker) featured a low fundamental and a second harmonic peak and $f_0 = 35.3$ kHz (“triangle” marker) had a large fundamental response, but a very low second harmonic material behaviour.

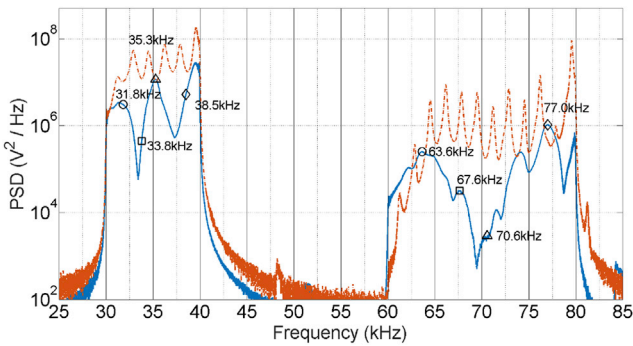
Fig. 8. Power spectral density of both *material* (blue solid line) and *system* (red dash-dot line) sweep responses for the frequency range of interest, 30–40 kHz. Four input frequencies were selected: 31.8 kHz (“circle” marker), 33.8 kHz (“square” marker), 35.3 kHz (“triangle” marker) and 38.5 kHz (“diamond” marker). Both transmitter and receiver ACTs were used for the ultrasonic testing. (For interpretation of the references to colour in this figure legend, the reader is referred to the Web version of this article.)

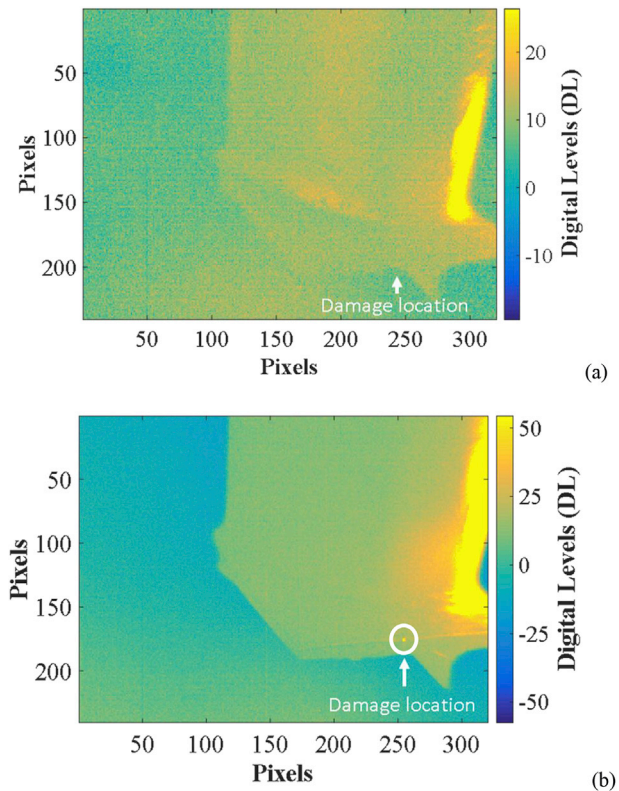
Fig. 9. NACT thermal amplitude results for continuous excitation frequency at 31.8 kHz with an input voltage of 200 V (a) and 400 V (b).

NACT testing was conducted with the thermal camera focussed on the damaged area of the blade and the ACU excitation being triggered with a short delay after starting the thermal image recording. The specimen was excited using a continuous sinusoidal signal at one of the frequencies selected in the previous Section. In accordance with the preliminary results achieved in Section 3.1, Fig. 9 depicts the thermal responses acquired by the IR camera at the excitation frequency $f_0 = 31.8$ kHz for two input voltages, 200 V (a) and 400 V (b). As expected, the micro-crack became visible only when 400 V was used, i.e. when sufficient acoustic energy was transmitted into the material in order to trigger the LDR effect and generate enough frictional heat. Thermal images were constructed using the data at the time $t = 56$ s and a background subtraction was carried out by selecting a number of pre-excitation frames P and then computing the average for every pixel across these pre-excitation frames. In this case, $P = 50$ frames (duration of 2 s) were used for the background subtraction.

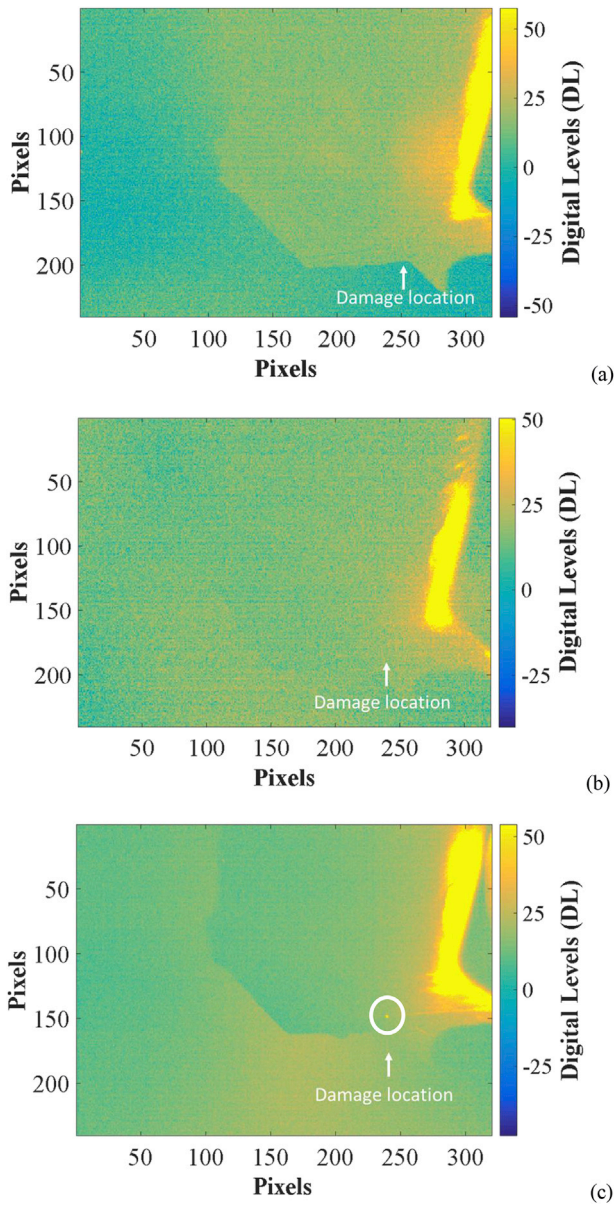
Fig. 10. NACT thermal amplitude results for continuous excitation frequency at 33.8 kHz (a), 35.3 kHz (b) and 38.5 kHz (c) with an input voltage of 400 V.

Fig. 10 shows the NACT thermal amplitude results for the remaining three frequencies previously selected at the input voltage of 400 V. The damage is only detected and localised for the other LDR frequency excited at $f_0 = 38.5$ kHz. Indeed, there is no conclusive thermal contrast between the micro-crack and its surroundings for driving frequencies at 33.8 kHz and 35.3 kHz.

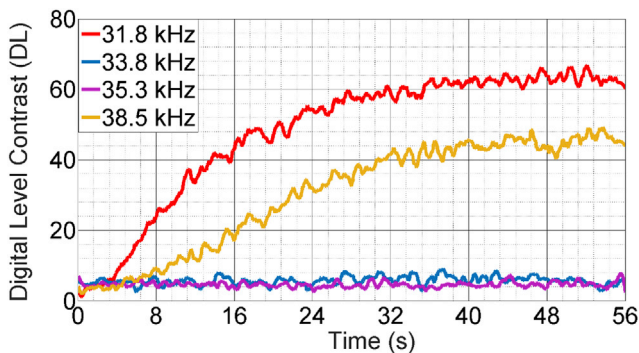
Fig. 11. Comparison of NACT thermal amplitude contrast variation for the four investigated driving frequencies, i.e. 31.8 kHz, 33.8 kHz, 35.3 kHz and 38.5 kHz.

Fig. 11 illustrates the comparison of apparent temperature contrast between the pixel at the damage location and the reference point for NACT tests using the four previously selected driving frequencies. The frequencies with a high second harmonic response (i.e. 31.8 kHz and 38.5 kHz) resulted in a visible DL contrast. On the contrary, the apparent temperature difference for the other two frequencies (i.e. 33.8 kHz and 35.3 kHz) was negligible.

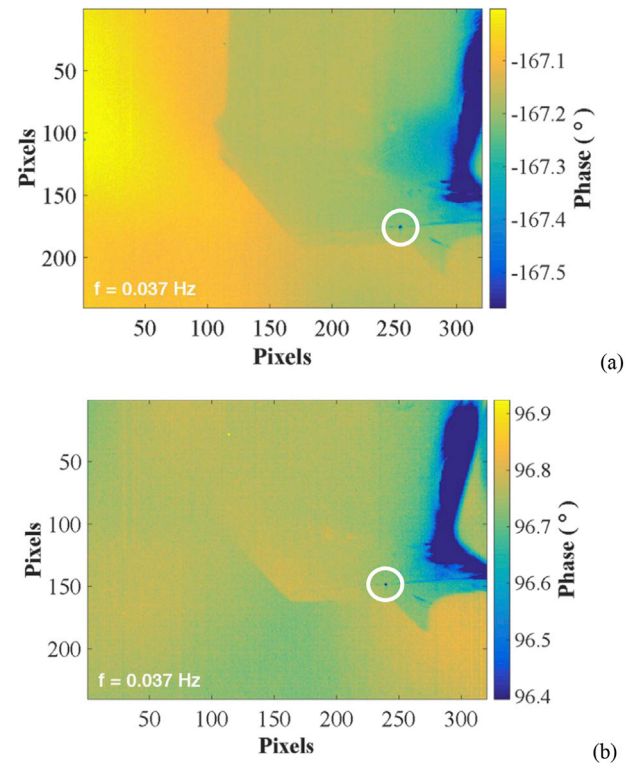
Fig. 12. NACT phase images obtained at the driving frequency $f_0 = 31.8$ kHz (a) and $f_0 = 38.5$ kHz (b).

are the real and imaginary parts of the FFT, $\hat{s}(f)$, of apparent temperature data. Hence, the phase image for every pixel at certain thermal frequencies was obtained as the arctangent of the ratio between the imaginary and the real part of the FFT [29]. Fig. 12 shows that for the case of sinusoidal excitation at $f_0 = 31.8$ kHz, the phase image revealed the presence of damage at the thermal frequency $f = 0.037$ Hz. The same thermal frequency was also used to retrieve the damage location at the ultrasonic driving frequency $f_0 = 38.5$ kHz.

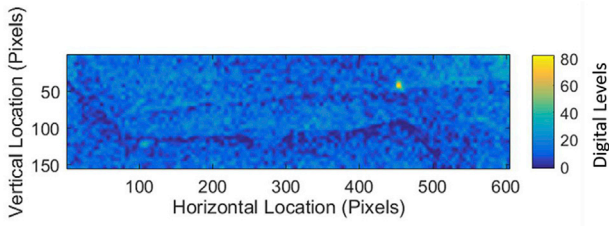
Fig. 13. Thermal amplitudes images of the fatigue micro-crack 5× enlarged and filtered using morphological opening and a Savitzky-Golay filter at the input frequency of 31.8 kHz.

The values for the $p(k)$ polynomial fitting coefficients were computed by using the signal data in a vector format and then constructing a matrix equation. For the thermal image processing, the algorithm simply operates by smoothing the data from subsequent columns of a 2D image matrix. It should also be noted that more advanced techniques could be used by deriving a two-dimensional Savitzky-Golay filter kernel [32] Fig. 13 shows the post-processed thermal image focusing on the damaged blade shroud area. In particular, it shows the filtered thermal plot enhanced by a combination of secondary background subtraction using morphological opening and the Savitzky-Golay filter at the input frequency of 31.8 kHz.

As it can be seen in Fig. 13, the secondary background subtraction via morphological opening with a smoothing filter enhanced detectability and localisation of the crack. Indeed, Fig. 14 illustrates thermal variations

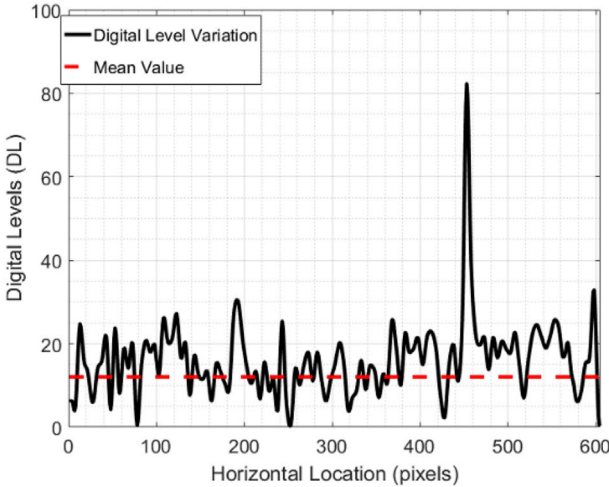
Fig. 14. Digital level variation versus mean value of digital levels across the horizontal line surrounding the micro-crack using morphological opening and smooth filtering.

across the horizontal line of the thermal amplitude image in Fig. 13 (black continuous line) using morphological opening and smoothing filter. From this Figure it can be seen that the maximum digital level is ~80 at the micro-crack location. The dashed red line in Fig. 14 is the mean value of digital levels (~10 digital levels), which reveals that the thermal contrast between the maximum digital level at damage location and the mean value is ~70 digital levels. Such a value is higher than the ~65 digital levels without morphological opening and filtering (see the maximum thermal amplitude contrast at 31.8 kHz in Fig. 11).

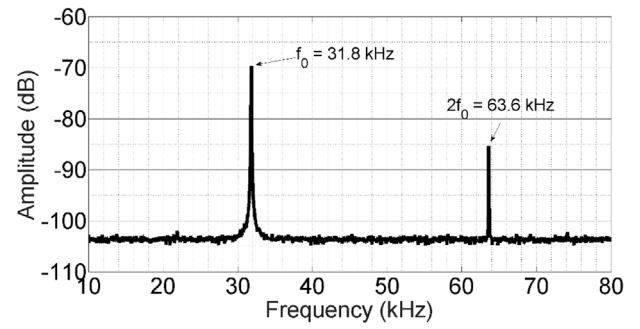
Fig. 15. Average LDV scan spectrum for continuous excitation using a driving frequency at 31.8 kHz and an input voltage at 400 V.

Following the same ACU set-up reported in Section 3.1, the 2D LDV scanning system was now used to validate the NACT imaging results and demonstrate that the thermal contrast between the micro-crack and its surroundings was the result of frictional heating generated exclusively at the LDR (micro-crack) location. The scanned region on the blade was an area around the damage of 2.0 mm × 8.4 mm using 175 scanning points in a 5 × 35 grid. Fig. 15 shows the generation of second harmonic $2f_0 = 63.6$ kHz from the measured average spectrum using the LDV scan at $f_0 = 31.8$ kHz and $A_0 = 400$ V.

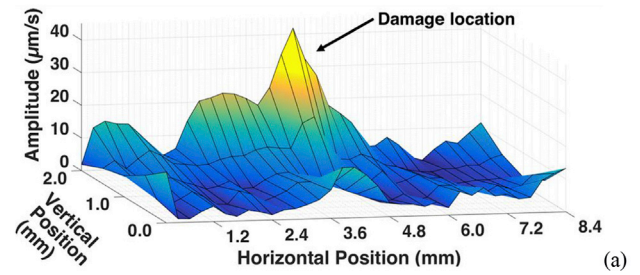
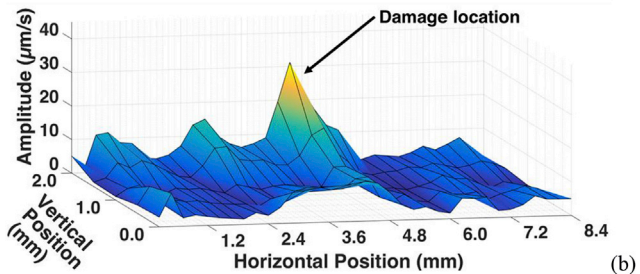
Fig. 16. Laser Doppler vibrometry second harmonic response for the input frequency of 31.8 kHz (a) and 38.5 kHz (b) at 400 V.

Fig. 16 depicts the second harmonic response from the LDV scan for the two LDR driving frequencies (31.8 kHz and 38.5 kHz). As a first consideration, both images show that the two driving frequencies (and their associated eigenmodes) are inherently connected to the spatial

location on the blade shroud surface as the peak of the vibrational amplitude (i.e. the velocity measured by the LDV system) occurs exactly at that particular location. This indicates that the excitation of the micro-damaged blade at those input frequencies resulted in maximum out-of-plane velocity at the crack interfaces. Secondly, the vibrational amplitude peak at the damage location is higher for 31.8 kHz than for 38.5 kHz. This result agrees with the NACT thermal plots in Fig. 11. It is also worth noting that the ultrasonic testing did not highlight this relation (see Fig. 8), as it had appeared that 38.5 kHz would be a better LDR frequency since it featured a higher second harmonic material response.

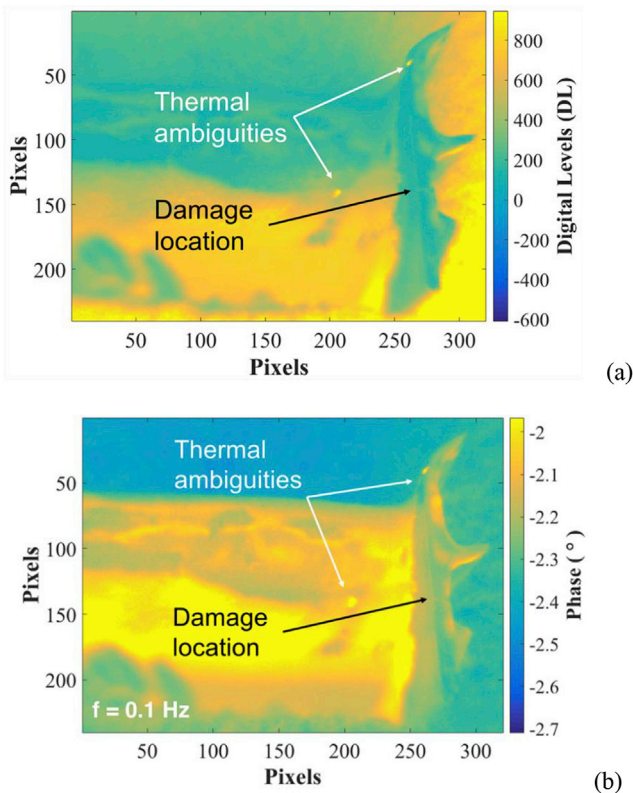
Fig. 17. Flash thermography (a) and pulsed phase thermography (b) thermal images of the damaged blade.

As a final element of this study, NACT was compared against standard flash thermography and pulsed phase thermography [33]. In order to accurately compare optically stimulated thermography and the proposed NACT technique, the test settings for optical thermographic methods were set to resemble those used in NACT. Particularly, thermal images of the damaged area were recorded over the period of 56 s with the flash being triggered shortly after the start of the recording (approximately 2 s delay). Both amplitude (at $t = 2.25$ s) and phase (at $f = 0.1$ Hz) images in Fig. 17 showed that optical thermography was not successful in retrieving the damage location and that thermal ambiguities were present in both apparent temperature and phase plots. These effects were likely to be due to surface imperfections caused by non-uniform heating and uneven black spray paint distribution.

Hence, thermal results in Fig. 17 revealed that flash thermography was not suitable for detecting micro-cracks in small specimens of complex geometry. Conversely, NACT successfully detected and localised fatigue micro-damage, so it can be considered as a valid alternative to traditional optical thermography for micro-flaws identification in geometrically complex structures such as engine turbine blades.
