IN SITU MOSAIC CONSERVATION: A CASE STUDY FROM KHIRBET YAJUZ, JORDAN

The methodology for the conservation of the mosaic floor of the byzantine bath in Khirbet Yajuz in Jordan is presented. The mosaic was discovered in 1998, and needed urgent protection measures. Both optical investigation and analytical examination of mosaic samples were carried out by stereo optical microscopy and XRD, and both revealed that the tessellatum (Mosaic surface) was subjected to intensive deterioration aspects such as deposited encrustation, salt efflorescence, cracking, surface pitting, discoloration and biological growth.

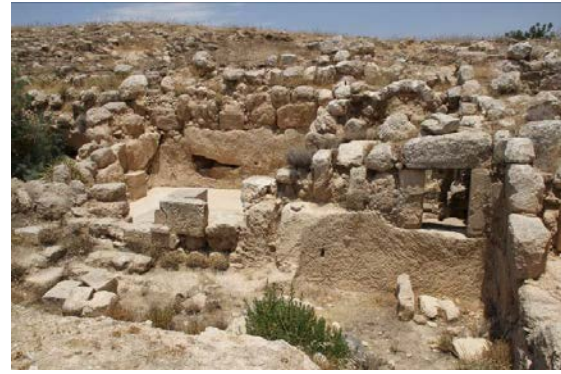
Figure 2 General View of the Byzantine Bath

The Byzantine Bath was discovered during the excavation work carried out in 1998 in the south-eastern area of the site (Fig. 2) (Suleiman, 1999).

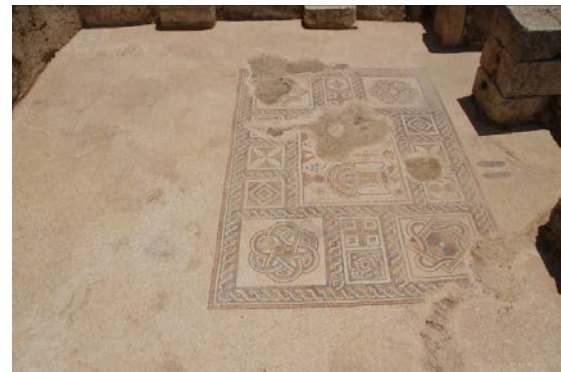
Figure 3 General View of the Mosaic Floor

The mosaic floor located at the middle room of the bath and is not particularly large, measuring approximately 4m.W x 5m.L. The room paved with mosaic floor of plain white tesserae. The southern side of the room and in front of the entrance is decorated with a rectangular polychrome mosaic.

The polychrome mosaic subdivided into squares and rectangular panels and surrounded by a braided guilloche. The panels contain a variety of geometric patterns. The middle of the mosaic has two amphora on a high pedestals with a vine pomegranate and grapes between them. Also, the area in front of the entrance of the room is decorated with a pair of sandals (Fig.3).

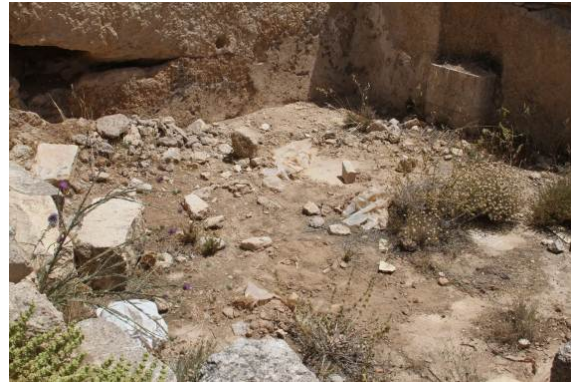
Figure 4 The mosaic before backfill removed

There were stones collapsed and grassy plants over the sand backfill. The plants were passed through the plastic layers and reached to the mosaic preparatory layers (Fig. 4).

The sand layer was removed manually and by brushing. The action has to be carried out with special attention to avoid disturbing the plastic layers, and then the plastic layers were removed only after they had been allowed to dry out gradually to prevent salt crystallization on the mosaic surface. Under the plastic sheets, plants and small roots were also existed (Fig. 4). There were removed by using hand tools during the removal of the plastic sheets.

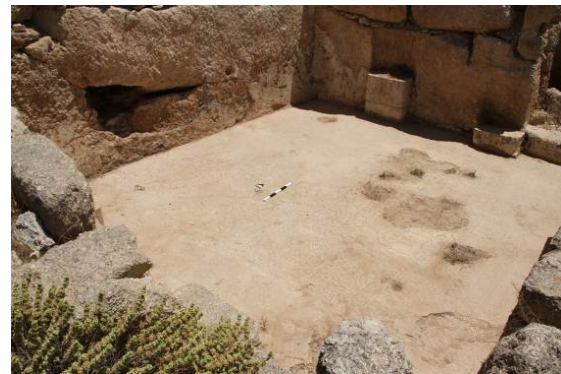
Figure 5 The mosaic after backfill removed

After brushing the soil, the mosaic showed a number of lacunae (Fig.5) and disintegrated tesserae (see below Fig.10). Several tesserae were detached from the bedding layer, which were under the risk of disintegration.

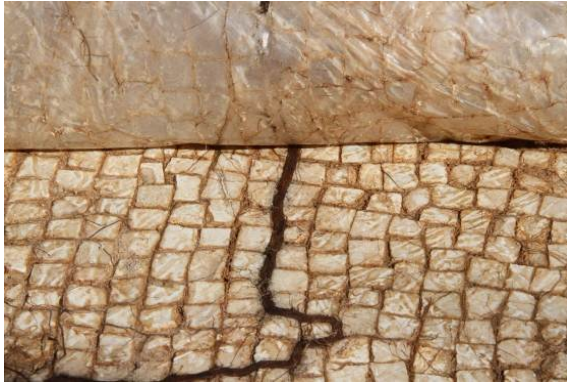
Figure 6 Plants have grown over tessellatum

The plants and roots under the plastic sheets were evident and caused significant mechanical damage on the tessellatum (Fig. 6). This means that the plastic sheets not work well against vegetation by preventing their growth. It is well known that the plastic sheet stop any liquid-water-vapor transport, then the water trapped under the plastic sheet will foster vegetation growth (GCI, 2011), as well as, the sand backfill was found inadequate to allow the ground water to evaporate completely. In addition, some dark colored residues caused by roots and plants and many spots of microorganisms were evident on the tessellatum (Fig. 7). However some of them were easily removable by hand tools, brushes and water, the others were needed a chemical cleaning.

The mosaic was reburied with the layer of sand about 50cm thick, and then the sand was treated with the herbicide Thymol (3% spray solution in water) and sprayed on the sand backfill in order to prevent plant intrusion and fungal growth (Fig.16).

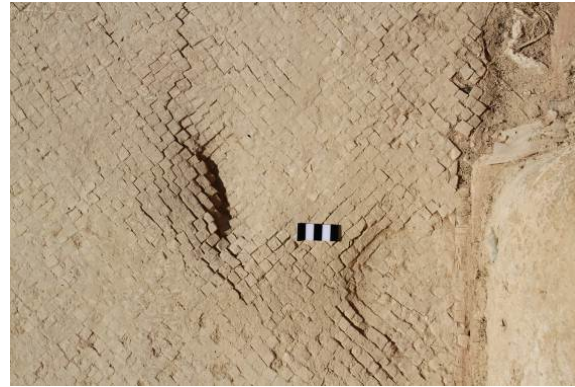
Figure 8 Depression of Tessellatum

Generally, the mosaic layers are still intact, but there is some of areas of the mosaic affected by different level of detachment between its layers, which required grout injections. Some depressions in different forms were presented in some areas of the mosaic floor, which may be due to the general weakness of the foundation layers or was result of loading or collapse of heavy objects over the mosaic floor (Fig.8). The mosaic also affected by different forms of bulges caused by plants growth (Fig.9).

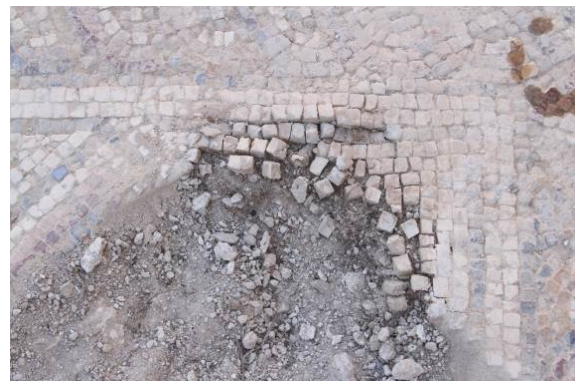
Figure 10 Disintegrated tesserae

The mosaic had also some fragmented and deteriorated tesserae, especially the black ones, because the structure of the black tesserae is weak and subject to mechanical alteration. Moreover, some deposits were found on the surface of the tesserae in the form of dirt, soil, and other hard deposits (Fig.11).

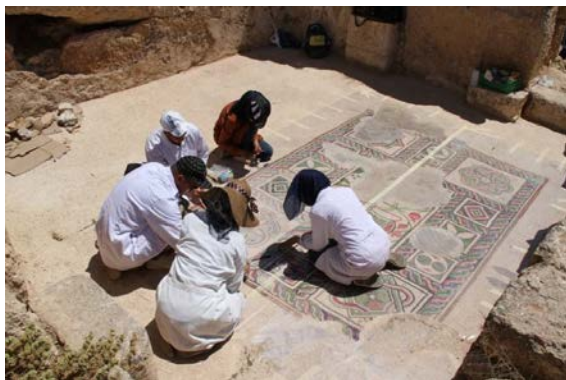
Figure 12 Documentation of the mosaic

Documentation was implemented in the form of drawings and photographs, in both traditional and digital formats. The mosaic was photographed using digital camera by placing measurement points at intervals of approximately 70cm.

These photos were then used as the basis for developing base map in Auto CAD. Also, all the mosaic was recorded in scale 1:1 on polyethylene sheets. These methods of documentation were used for documenting the state of conservation of the mosaic as well as the phases of mosaic interventions (Fig. 12). After all interventions on the mosaic, a general view of the mosaic was taken by using a digital camera.
