No. 1586.—“Portland Cement Concrete in Arches, and Portland Cement Mortar.” By CHARLES COLSON, Assoc. Inst. C.E.

EXPERIMENTS ON THE STRENGTH OF PORTLAND CEMENT CONCRETE ARCHES AND BEAMS. (Plate 11.)

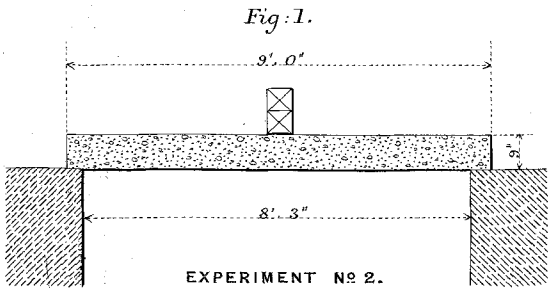
No. 2 experiment consisted of a concrete beam similar in all respects to No. 1 (Plate 11, Fig. 1), being made in fact from the same mass and deposited at the same time. In consequence, however, of No. 1 having failed on the removal of the supports at fourteen days, the supports were not removed in this case till twenty-one days after mixing. At this interval the beam stood perfectly sound, and remained unsupported for a further period of seven days, when it was tested, and broke under a central load of 5 cwt.

No. 1 experiment consisted simply of a beam of concrete, mixed in the proportions as before explained, 9 feet long, 1 foot 9 inches wide, and 9 inches deep; the distance between the supports was 8 feet 3 inches, with a bearing of $4\frac{1}{2}$ inches at each end. Fourteen days after mixing the supports were removed, when the beam suddenly gave way near the centre. The fracture showed that the concrete was perfectly sound, there being no vacuities whatever to cause a diminution of effective sectional area.

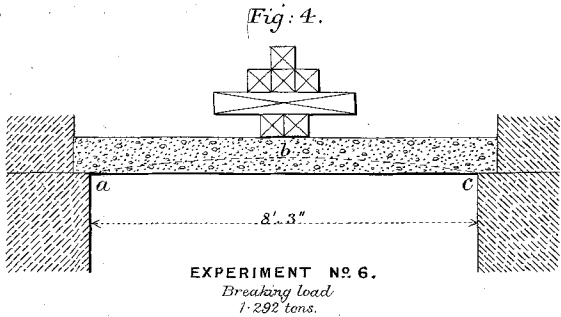
No. 3 experiment consisted of a portion of No. 1 beam (Fig. 1) 4 feet 6 inches long, placed on supports 3 feet 9 inches apart (Fig. 2). This beam supported a load of 7.50 cwt. for seven days, when the load was increased to 13.75 cwt., under which load the beam failed twenty-eight days after mixing.

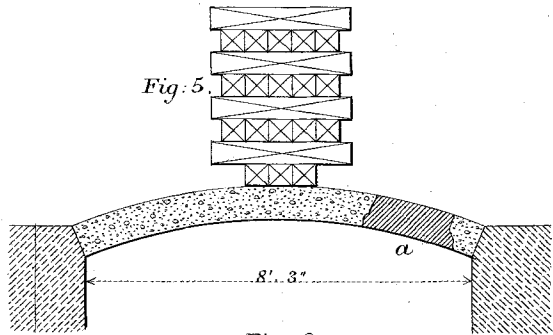
No. 4 (Fig. 3) consisted of a portion of No. 2 beam, 3 feet 9 inches clear of the supports, and tested immediately after No. 2, viz., at twenty-eight days after mixing. This beam failed under a load of 1.044 ton placed at the centre.

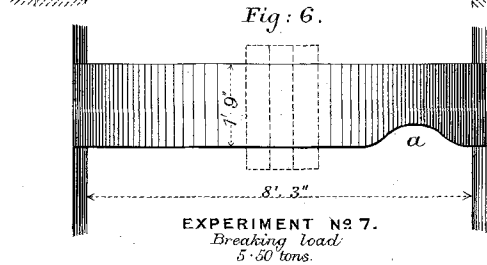
The foregoing experiments being upon beams resting simply on vertical supports, it was desired to know what increase of resistance to fracture would be derived from the ends of the beam being blocked in such a manner as to secure perfect rigidity. Sufficient concrete was therefore mixed in the proportions before described to form two beams. One, No. 5, was formed with the ends resting on piers, as in the case of the previous experiments (Fig. 1). The second, No. 6, was formed between two counterforts of the wall, in which bearings $4\frac{1}{2}$ inches deep had been cut (Fig. 4). After an interval of fourteen days the supports were removed, when No. 5 beam broke with its own weight in exactly the same way as No. 1. Having in view the first failure, additional precautions were taken in removing the supports, the folding wedges and bearers being all planed true in order to reduce the friction to a minimum. The circumstances attending the failure of these two beams being precisely the same lead to the conclusion that the strength of the concrete as used, at fourteen days' interval, was not sufficient to withstand the tensile strain at the centre due to its own weight. The supports were removed from No. 6 beam at the same time, no sign whatever of weakness being observed. After remaining unsupported for a further period of sixteen days the beam was tested by placing weights on the centre as before (Fig. 4). Under 0.25 ton a faint crack was observed at the centre through the whole width of the beam; with 0.635 ton it had increased as nearly as could be determined to half the depth, viz., $4\frac{1}{2}$ inches, and opened to about $\frac{1}{16}$ inch at the lower surface. The full extent of the fracture probably exceeded this, although not apparent on the surface. No perceptible upward extension of the fracture could however be detected after the imposition of the weight last referred to. The load at the centre was ultimately increased to 1.292 ton, when the beam broke. This experiment shows the necessity of guarding against the possibility of lateral movement, in the slightest degree, in the supporting girders of a floor; in this case by so doing the supporting power of the beam was materially increased. It also shows that the mass within the

dotted line *a b c* (Fig. 4) adds nothing to the strength of the beam when confined at the ends, as proved by the crack appearing so soon after the commencement of the loading.

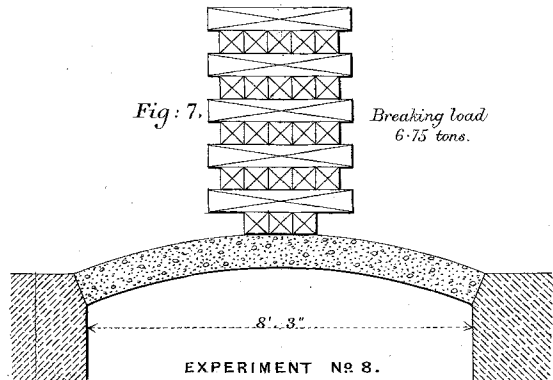
Experiments Nos. 7 and 8 were made to compare the gain in strength derived from a different disposition of the same bulk of concrete. The same proportions and dimensions were preserved, but the mass was deposited in the form of an arch with a rise of 9 inches at the centre (Fig. 5). The supports were removed from both arches at the expiration of sixteen days; there was, however, no necessity for their remaining supported for so long a time, as shown by subsequent experiments on arches of nearly double the span.

No. 7 (Figs. 5 and 6). Testing was commenced when the concrete was twenty-three days old. When loaded with 1.75 ton, a pig of iron, weighing 2.85 cwt., fell on one of the haunches, carrying away a portion, as shown in Figs. 5 and 6. The arch then stood for two days with a load of 3 tons on the centre. Under a load of 4.50 tons slight evidence of distress was observed at the crown, and with a load of 5.50 tons the arch failed by the complete crushing of the material at the centre.

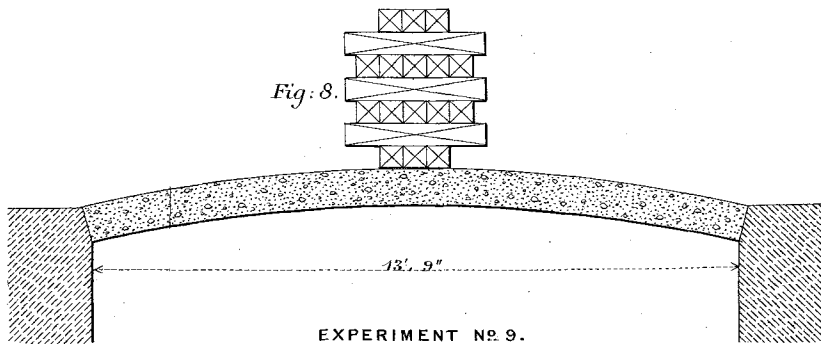
No. 8 (Fig. 7). The testing of this arch commenced at twenty-eight days after mixing the concrete. When loaded with 5 tons, the testing was suspended for three days; it was then resumed, and with a load of 6.75 tons the arch failed. The slight indications of distress observed in the previous experiment appeared in this case, only immediately before the fracture of the arch.

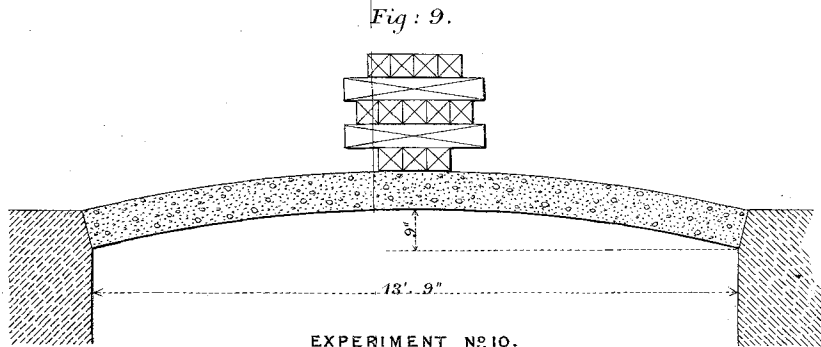
No. 9 (Fig. 8). In this experiment the arch was 13 feet 9 inches between the abutments, 1 foot 9 inches wide, and 9 inches thick at the crown, with a rise of 9 inches. Exactly the same proportions of shingle, sand, and cement were used as before described. The centering was removed at seven days from the date of mixing the concrete, and the arch was tested at twenty-one days. A gauge was fixed in order to ascertain the amount of deflection due to the imposed load, which consisted of pig-iron ballast applied at the centre of the arch. With a load of 4 tons slight signs of distress were observed at the crown, when the gauge registered a deflection of $\frac{1}{8}$ inch. With an additional load of $\frac{1}{2}$ ton, = 4.50 tons, the arch suddenly failed, with no greater indication of distress than was previously observed. The greatest deflection registered was $\frac{3}{16}$ inch.

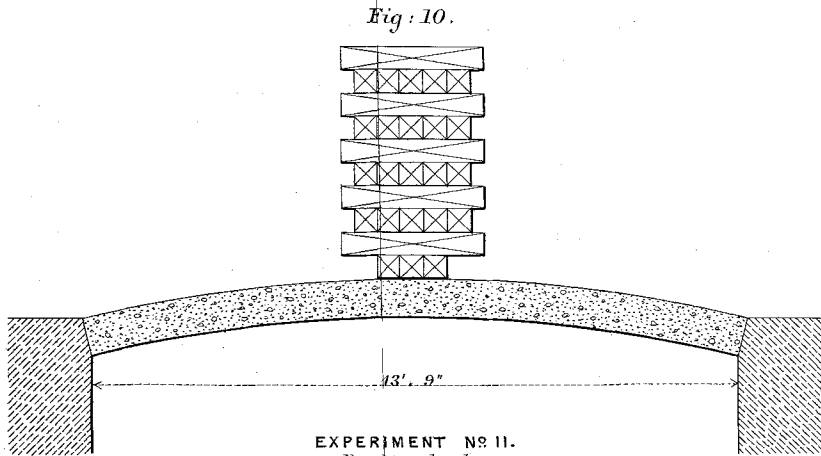
No. 10 (Fig. 9) consisted of an arch of the same span and dimensions, constructed and the centering removed on the same dates as No. 9, but tested after one month. With 3.14 tons at

the centre this arch failed, without even the slight warning observed in the previous experiments.

The concrete for the last two experiments was mixed in one mass as regards proportions of cement, sand, and shingle. No. 10 was, however, made much wetter than No. 9, to ascertain the effect of an excess of water upon the concrete. Judging from the results of these experiments the effect was to materially reduce the strength of the concrete. This was also found to be the case when concrete blocks were subjected to compression in the hydraulic press. These blocks, 6 inches \times 6 inches \times 6 inches, were composed of the same proportions of cement, sand, and shingle as used in the arches. An equal number was mixed with a maximum and minimum of water and tested when six months old. The same effect was also observed when broken bricks and broken Portland stone were used for the cement. The results of these experiments are shown in Table 6, Nos. 1, 2, and 3.

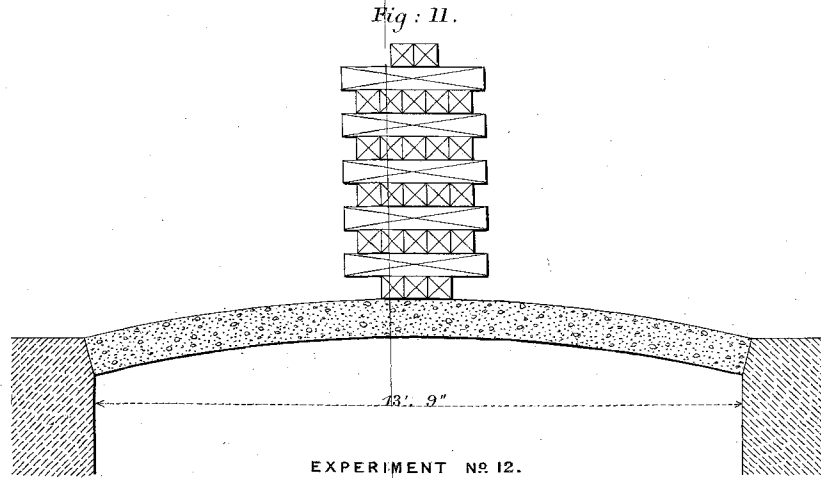
The concrete for Nos. 11 and 12 experiments was composed of broken bricks, mixed in the same proportions as used for the shingle arches, viz., 2 to 1 of broken brick and sand and 3 to 1 of sand and cement; before mixing, the broken material was well damped. The necessary bulk of concrete for both arches was mixed in one mass and deposited in position at the same time. The centerings were removed in both cases seven days after mixing, and the arches tested at twenty-eight days. In No. 11 experiment (Fig. 10), slight evidence of distress at the crown became apparent under a load of 6 tons on the centre, and with 6.77 tons the arch failed.

No. 12 (Fig. 11) was tested on the same day as No. 11 arch, and supported a load of 6.50 tons before any indication of distress was observed; the load was then gradually increased to 7.064 tons, under which the arch failed.

The superior strength of the arches in the last two experiments is evidently due to the more absorbent and angular character of the material. The appearance of the fractures in the two cases, *i.e.*, shingle and broken brick, showed a marked difference. In the first case, the strain destroyed the adhesive power existing between the shingle and the matrix; in no instance was a stone observed to be fractured, the casts being, as a rule, clearly defined in the cement. In the second case, the superior adhesive power existing between the broken brick and cement matrix was manifest; in but few instances had the cement left the surface of the brick, the general characteristic being that of complete disintegration of both brick and matrix.
