Ivan P. Kovalchuk¹, Mykytchyn O.I.², Andreychuk Yu.M.³, Ivanov E.A.³, Zhdanyuk B.S.⁴

Assesment of minor rivers flood-plain and stream-way complex condition (case study of the Berezhnytsya River, Dniestr basin)

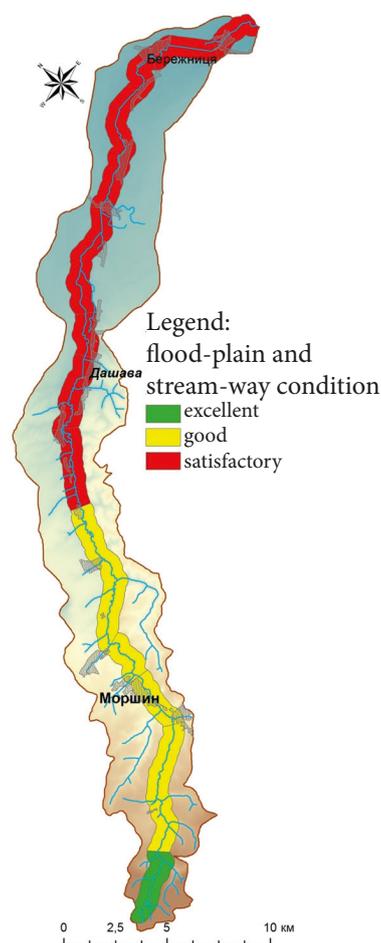
Figure 2. Flood-plain and stream-way complex condition within the Berezhnitsya river basin geosystem

According to the observations and assessment of twelve river segments there was a map chart showing the Berezhnitsya condition drawn

(Figure 2). The picture shows that only a segment close to the riverhead may be assessed as "excellent" since in this part the Berezhnitsya

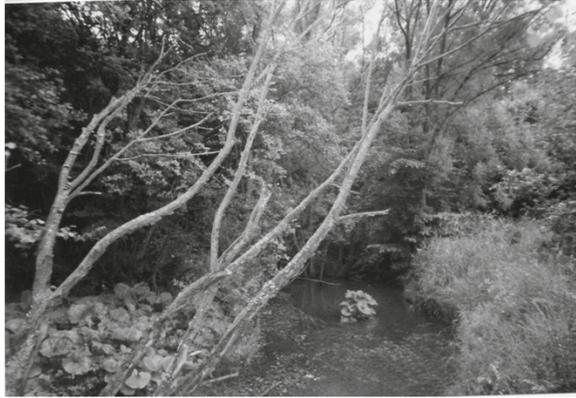
Figure 3. Aquatic and flood-plain vegetation at the first study segment along the Berezhnytsya river

sya is a true the Carpathian mountain torrent. Its stream-way is of natural character and possesses elements peculiar to mountain rivers, i.e. shallows and broads, meanders, slow flow parts are interchanged with fast flow ones, in the stream-way one may find bars and other natural stream-way formations. Water is clear and transparent up to the bottom (1 m depth), slightly muddy, has no smell and is tasteless. Large variety of aquatic vegetation (with no clear predominance of one species over the others) is present in the stream-way. Fish fauna is diverse; there are several favourite places of fishermen here. The banks are natural, undestroyed, the forest areas take over 50% of the flood-plain (Figure 3). Rest of the flood-plain is used as grasslands, there is no plough land here but there are small farming plots occupying a little flood-plain part. Protective bank-line zone is in a good condition. However, a product pipeline crosses the river stream-way in this area (Figure 4). In 2002 as a result of illegal oil uptake its great amount entered from a pipeline into the river. This led to an environmental disaster downstream and, consequently, small ponds contaminated by oil products remained on the flood-plain. The second study segment is located downstream (from the bridge at Bolekhiv-Tanyava highway to the highway bridge in the Morshyn city). Its condition was assessed as "good" but degradation processes have been developing here actively. The stream velocity along this segment becomes slower, water is characterized by less transparency, in the stream-way and along the bank-line individual unnatural objects and garbage dumps are observed.

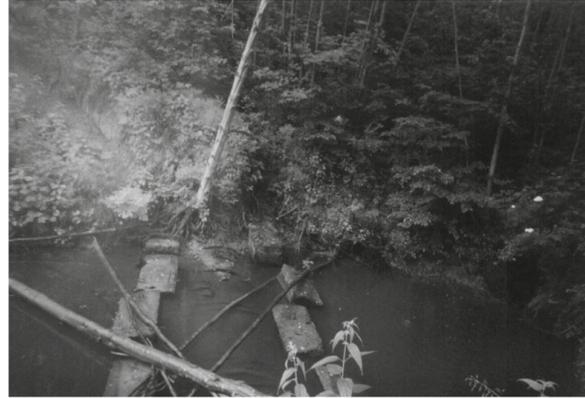
Figure 4. Product pipeline under the Berezhnytsya river stream-way

possibilities of getting water, contaminated with the toxic waste from toxic waste landfill “Shkiryanyk”, into the river and to ensure the oil pipelines crosses the stream-way under the due protection. It is also important to reduce the regulation of the runoff, because ponds are mainly lifeless and used for purposes other than intended ones. It is necessary to reduce the intensity of agricultural activity over the flood-plain lands.

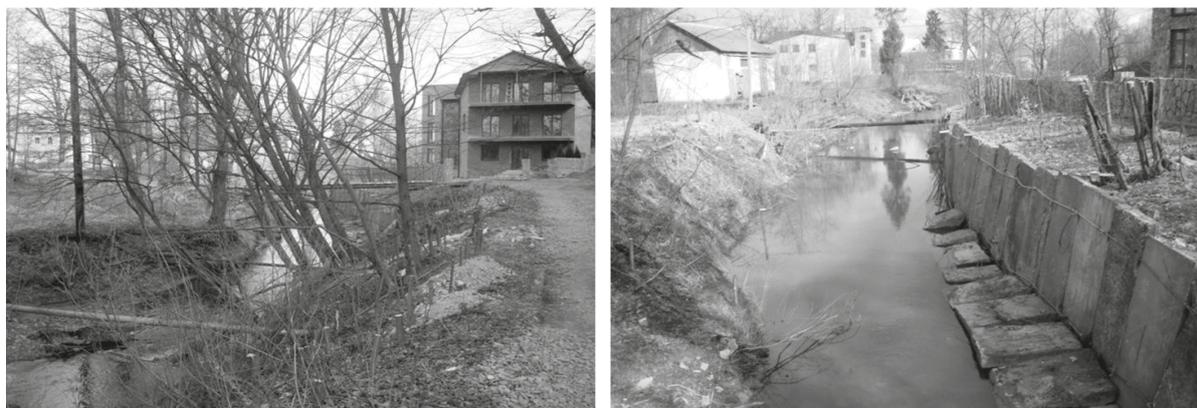
As compared to the first area, the variety of flora and fish fauna significantly decreases. The behaviour mode and limits being obligatory for water protective zones are not observed, urban territories dominate in the flood-plain, there are hayfields and motor roads here. The flood-plain is disturbed from both banks. Water intake for technical needs is also performed at this part of the river. The river needs public attention. In particular, it is necessary to clean the bank-line out of garbage. Within the limits of Morshyn city the river flow becomes slower, several natural stream-way and flood-plain formations were changed due to human activity (Figure 5). These facts make it impossible to decelerate the flood wave move. For this reason, during floods houses built in the region of flood-plain become drowned. Water is of swampy smell and muddy. Overgrown of channelled stream-way is noticeable as well. Fish fauna diversity has been decreasing. The banks are not destroyed, but there is scarce natural vegetation and it also degrades. Livestock systematically grazes at the flood-plain, the boundaries of bank-line protective zones within the city limits are violated.

Figure 5. Disturbance of limits of bank-line protective zone, Morshyn city

setting its limits; to fix eroded banks; to limit alluvium extracting from the bed and banks; to organize watering sites for animals; to better treat wastewater at municipal wastewater treatment plants located in Morshyn city and Dashava village, industrial effluents of Dashava production office of underground gas storage, Dashava composites plant, and Dashava plant management of construction materials through their renovation; to reduce

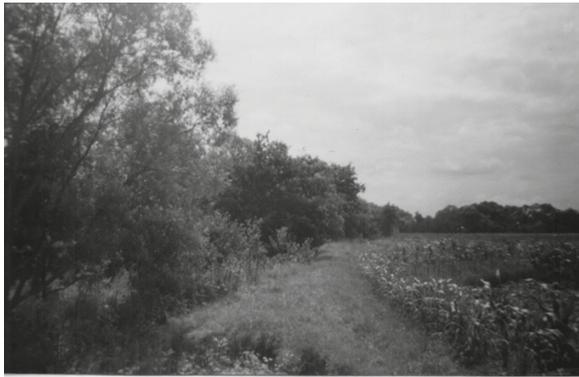
The worst condition of the Berezhnysya river was established within the Dashava urban settlement as the stream-way is partially canalized here and the bank-line protective zone regimen is not observed (Figure 6). Domestic garbage is found both within the protective zone and in the stream-way. Almost all flood-plain is built up or ploughed up. Natural biocenoses are disturbed, there is scarce fish in the river and aquatic vegetation is depressed. The manifestations of erosion processes are visible. Also, there are cases of untreated sewage discharge that enters the river bypassing wastewater treatment facilities. The river condition is assessed as “satisfactory” but for all that only one point parts it off from the “unsatisfactory” category. To cease the river destruction there is an urgent need to apply a wider range of short- and long-term measures aimed at stopping the degradation processes both in the stream-way and in the flood-plain.

Figure 6. Disturbance of bank-line protective zone limits, Dashava urban settlement

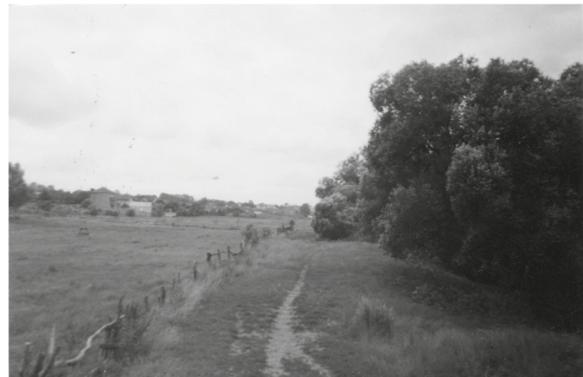
Figure 7. Degraded flood-plain vegetation, the Berezhytsya river (Yosypovychi village)

Next two segments are very similar to each other and for this reason we consider them as one. These segments stretch from Yosypovychi village to Berezhytsya village. Their condition is assessed as “satisfactory” because most of the flood-plain is covered with damaged or degraded agrobiocenoses, and the livestock permanently grazes here (Figure 7). The aquatic vegetation is very poor. The limits and regimen of bank-line protective zone is disturbed.
