1     **Acoustic Emission behavior of thermally damaged Self-Compacting**  
2                     **High Strength Fiber Reinforced Concrete**

32 This paper investigates the effect of high temperature on two different Self-Compacting (SC)  
33 cementitious composites. SC-High Strength (SCHSC) and Fiber-Reinforced Concrete (SCHSFRC)  
34 samples were tested in three-point bending after having been exposed to high temperature at 300 and  
35 600 °C. Besides the conventional force-displacement response, Acoustic Emission (AE) activity was  
36 monitored during the bending tests with the aim to investigate the possible correlation between the  
37 fracture behavior, the rate of AEs and the influence of high temperature exposure. The tests clearly  
38 pointed out the effects of heat exposure. More specifically, SCHSC specimens showed a significant  
39 decay in mechanical properties as a result of thermal treatment. Then, a lower degradation was  
40 observed for the SCHSFRC after heat exposure at 300°C, whereas the specimens exposed to 600 °C

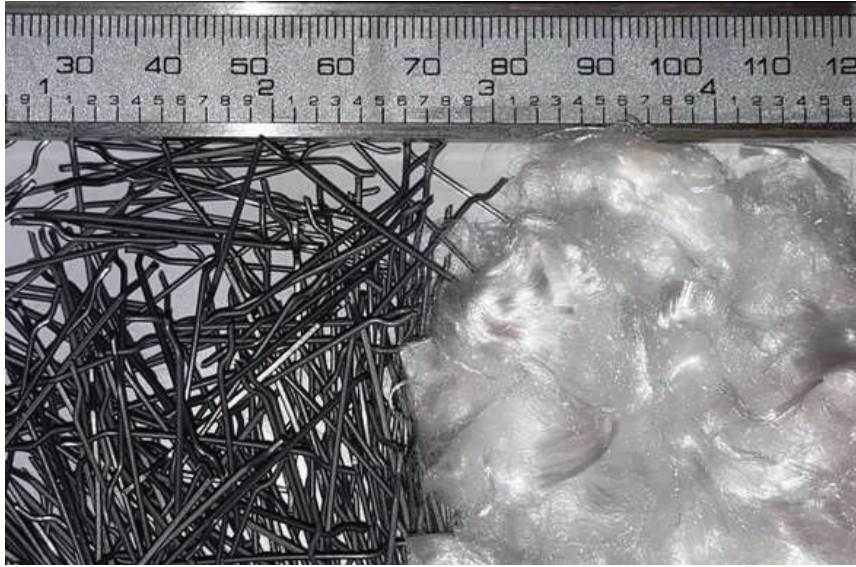
*Figure 1: Hooked-end steel macrofibers and polypropylene microfibers.*

158 According to their length, fibers for concrete are usually classified in micro and macrofibers.  
159 The former are used to reduce drying shrinkage and to prevent the spalling effect, while macrofibers  
160 increase the ductility and restrict the growth of macrocracks [57]. In this research, FibroMac 12  
161 monofilament polypropylene microfibers (0.1% in volume) and Wirand FS3N steel macrofibers  
162 (0.76% in volume) were used (*Figure 1*). Main technical data for both fibers are shown in Table 2.

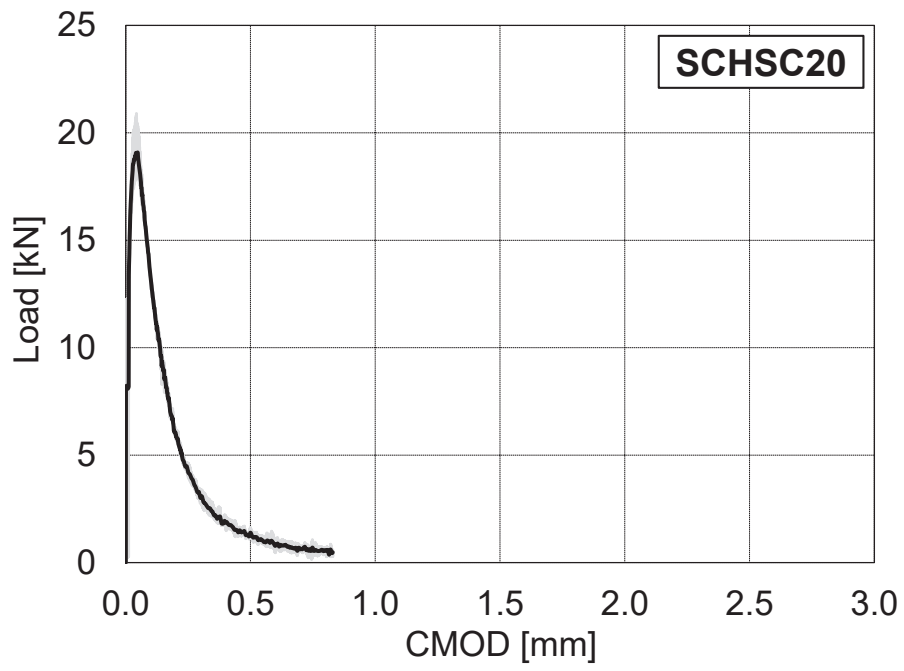
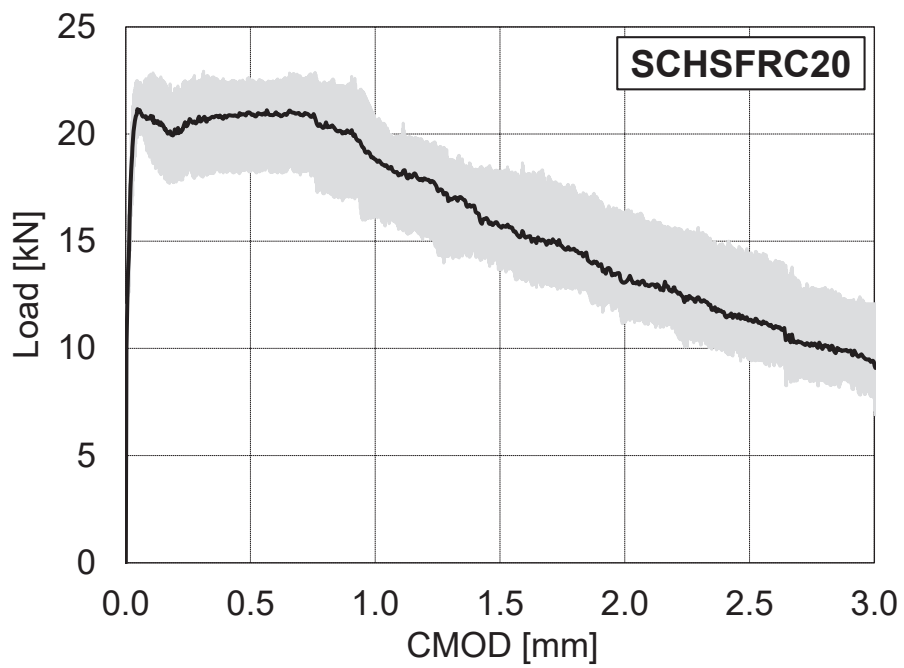
Figure 4: Load vs CMOD at reference temperature (20 °C): (a) SCHSC and (b) SCHSFRC.

225 Figures 4, 5 and 6 show the Load-CMOD behavior for the reference temperature and thermal  
226 treatments at 300 °C and 600 °C, respectively. In each graph, the black line represents the average  
227 response of the three tests, while the gray envelope area indicates the experimental scatter. The fibers  
228 random distribution and cracks induced by thermal conditioning are some of several factors, besides  
229 the natural heterogeneity of concrete behavior, which contribute with the dispersion of results.

230 As expected, the presence of fibers results in a much higher toughness of the SCHSFRC with  
231 respect to SCHSC (*Figure 4*). Conversely, the pre-peak branch and the cracking strength, which are  
232 mainly related to the matrix properties, were almost unaffected by the presence of fibers, as they  
233 mainly start working after the cementitious matrix cracking [59]. It is also observed that the maximum  
234 CMOD achieved was less than 1.5 mm for SCHSC20, contrarily in the case with fibers, the beams  
235 still had load bearing capacity even for 3.0 mm at the end of the test.

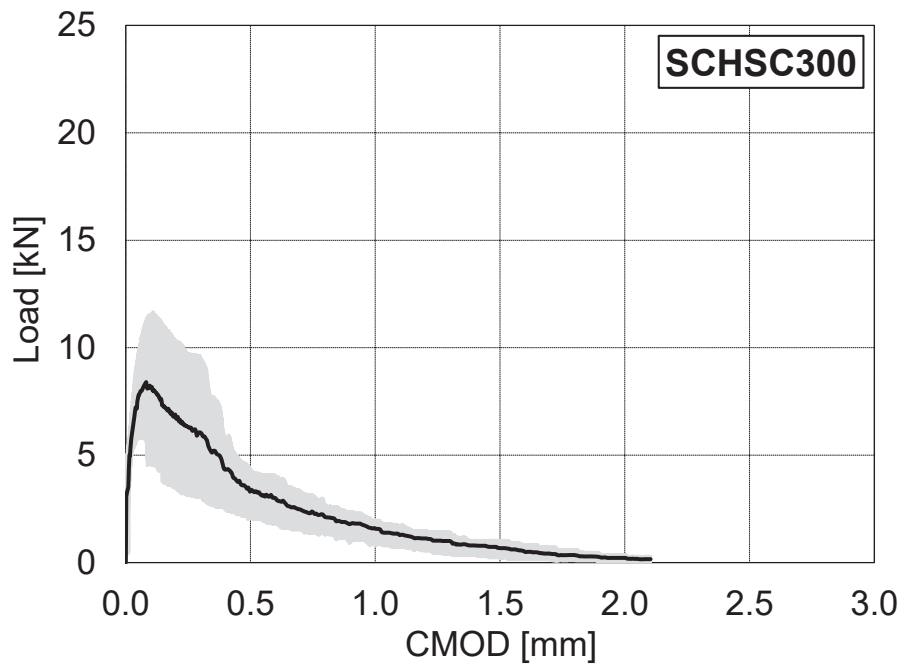
Figure 5: Residual Load vs CMOD curve after 300°C: (a) SCHSC and (b) SCHSFRC.

236 Peak load reduces for 300 °C maximum temperature treatment especially when plain concrete  
237 specimens (SCHSC300) were analyzed. Conversely, the bridging action of fibers is still effective, as  
238 specimens SCHSFRC300 exhibited a barely plastic response, though with a lower cracking strength  
239 due to the heat-induced degradation in the concrete matrix (*Figure 5*).

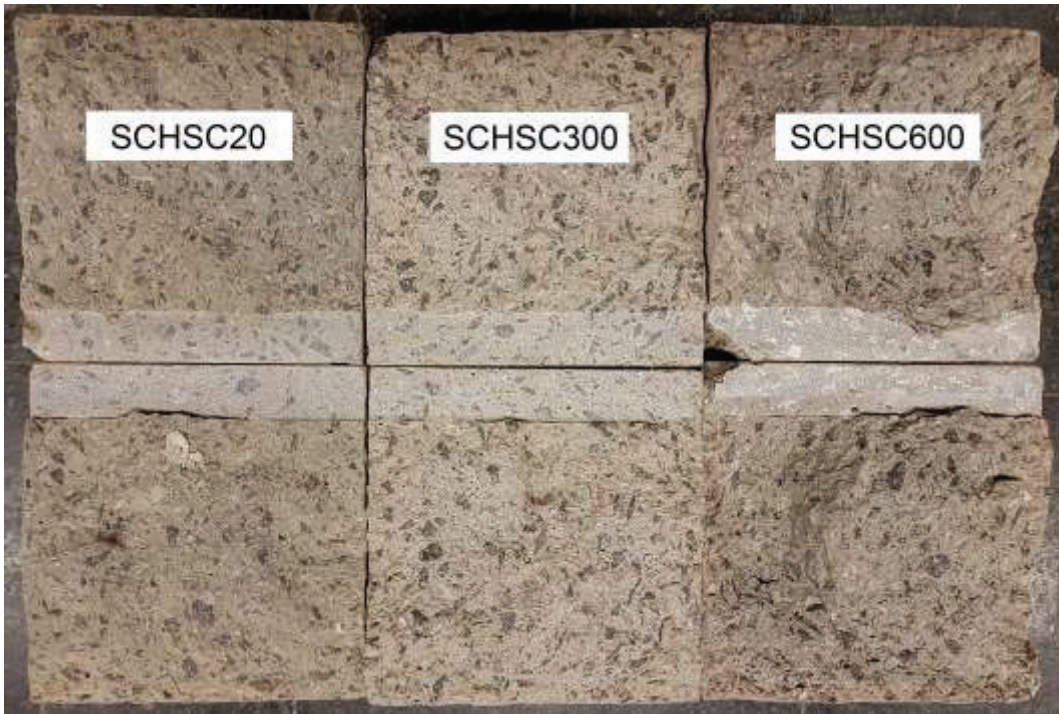
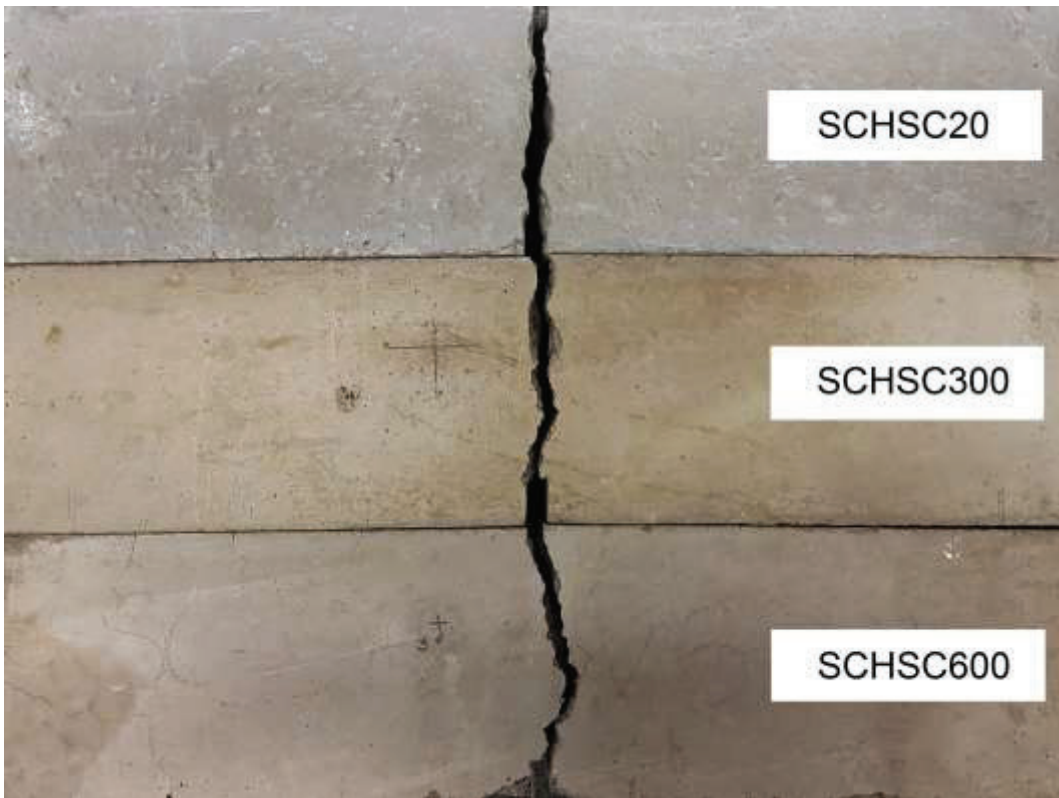
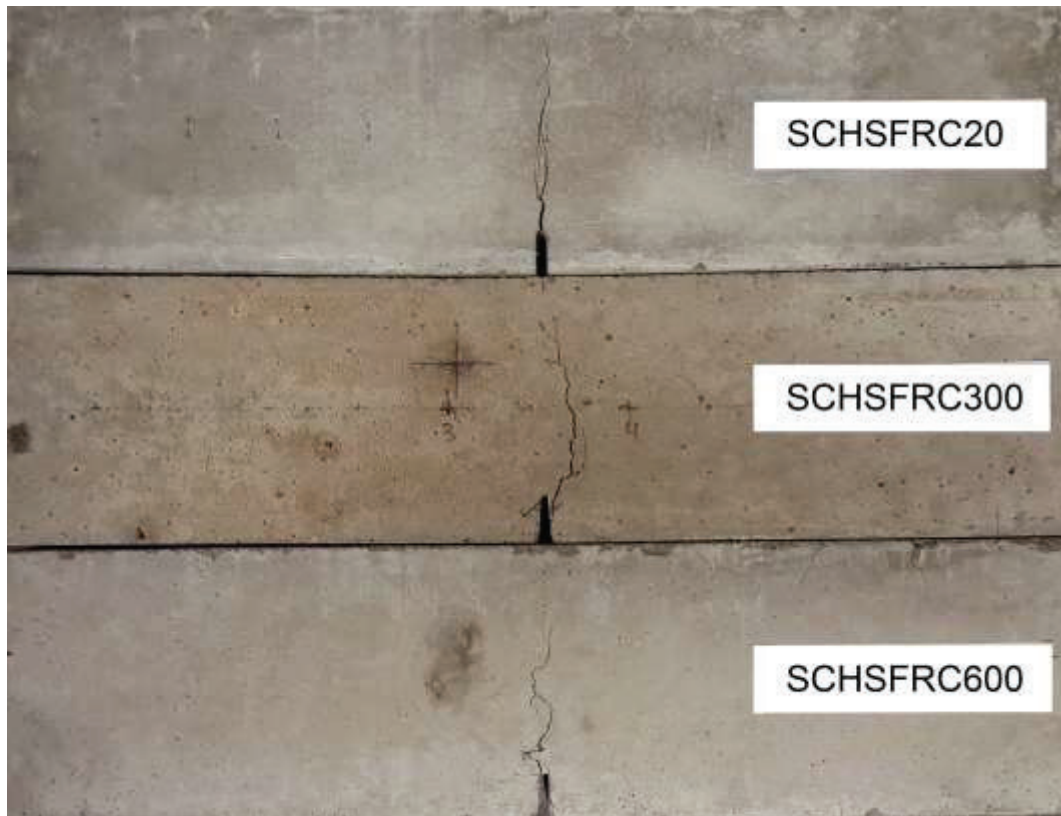
638 *Figure 8: (a) Fracture surface aspect of SCHSC, crack patterns of (b) SCHSC and (c) SCHSFRC.*

267 *Figure 8* shows photographs of the resulting failure faces and paths in three-point bending tests  
268 for SCHSC and SCFRHSC. Visual inspection of fracture surfaces of SCHSC specimens (*Figure 8a*)  
269 allowed distinguishing color changes related with maximum temperature of exposure. Granitic coarse  
270 aggregate shifted from dark bluish-grey at 20 °C and 300 °C to a lighter shade of grey, pink and white  
271 at 600 °C. Meanwhile, mortar phase color varied from normal grey to yellowish-grey at 300 °C and  
272 to darker grey at 600 °C with a remarkable increasing of porosity and friability. Another temperature

273 effects can also been detected on the fracture surfaces: at 20 °C and 300 °C the cracks fractured the  
274 aggregates while at 600 °C cracks go mainly through the interface between cement paste and  
275 aggregates, as it is usually occurring in non-thermally damaged NSC. From Figure 8b and 8c, it can  
276 be highlighted that the tortuosity of crack paths was increased with temperature for both SCHSC and  
277 SCHSFRC. Moreover, for SCHSFRC600 the matrix stiffness weakening and the fibers bridging  
278 action generated several path direction changes, ensuring structural integrity of the specimens.

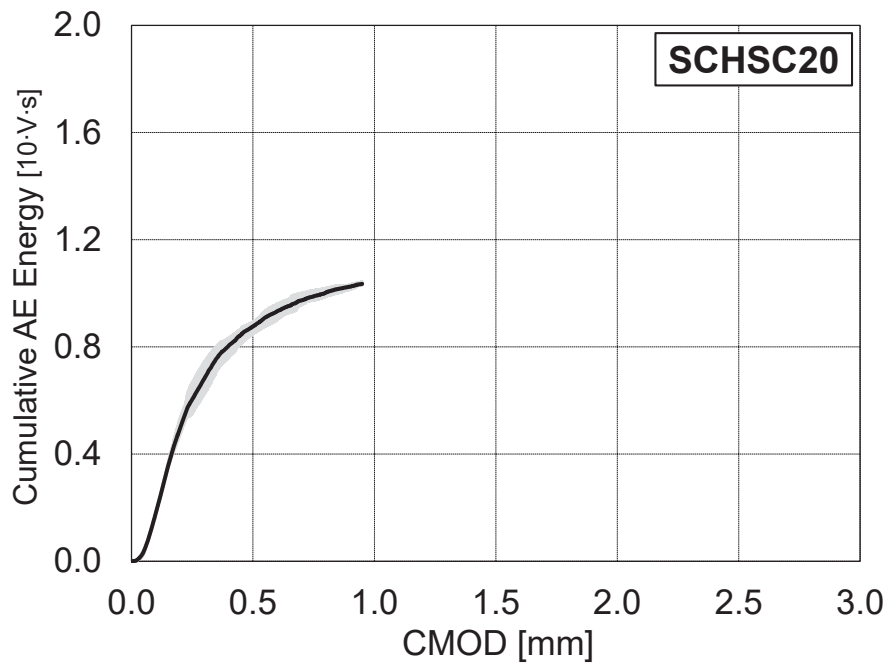
*SCHSC and (b) SCHSFRC.*

280 In the following “AE energy” refers to the Measured Area under the Rectified Signal Envelope  
281 (MARSE). The AE energy evolutions for the three thermal scenarios are shown in Figure 9, 10 and  
282 11. Again, the average response of three tests repetitions with their dispersion is presented, with the  
283 exception of SCHSC600 as was explained before. Similar tendencies were observed in the cumulative  
284 curves corresponding to different AE parameters such as Counts, Duration, Amplitude and Signal  
285 Strength when expressed in their relative values. The AE energy is often selected to represent the  
286 magnitude of source event rather than other AE parameters (e.g. hits) because it is a function of both  
287 duration and amplitude of the signal. Furthermore, it is also less sensitive on threshold setting and  
288 operating frequency [61]. For the sake of brevity, only the cumulative AE energy as representative

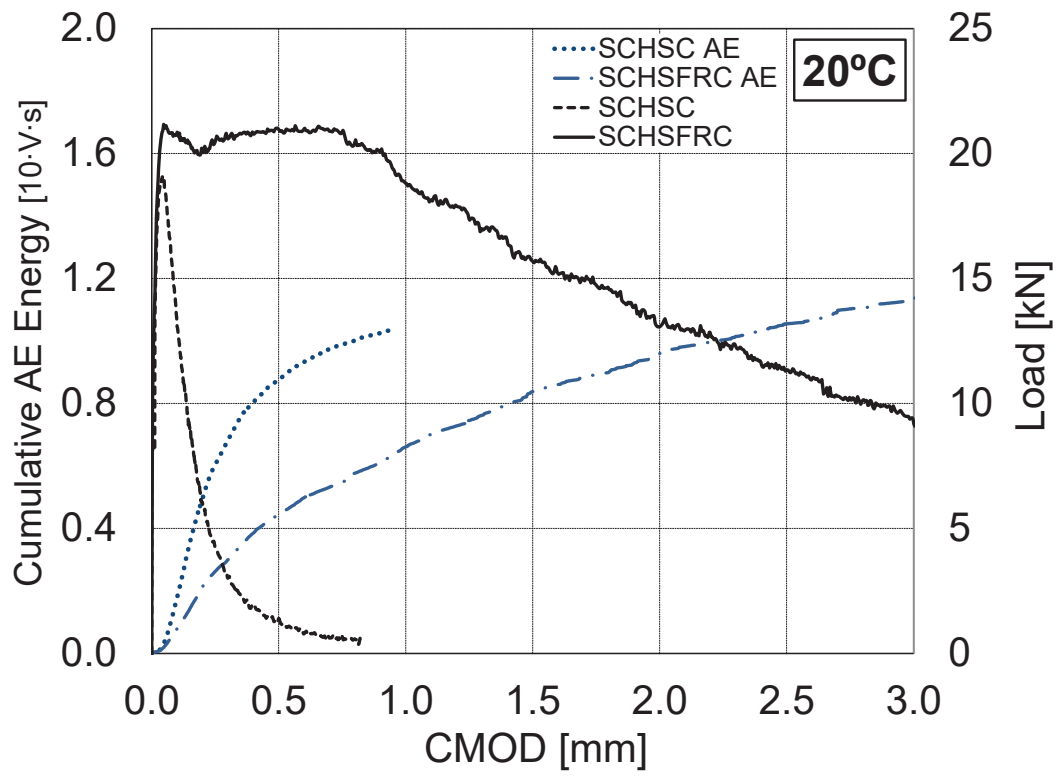
662 *Figure 12: Load and cumulative AE Energy vs CMOD behavior at reference temperature.*

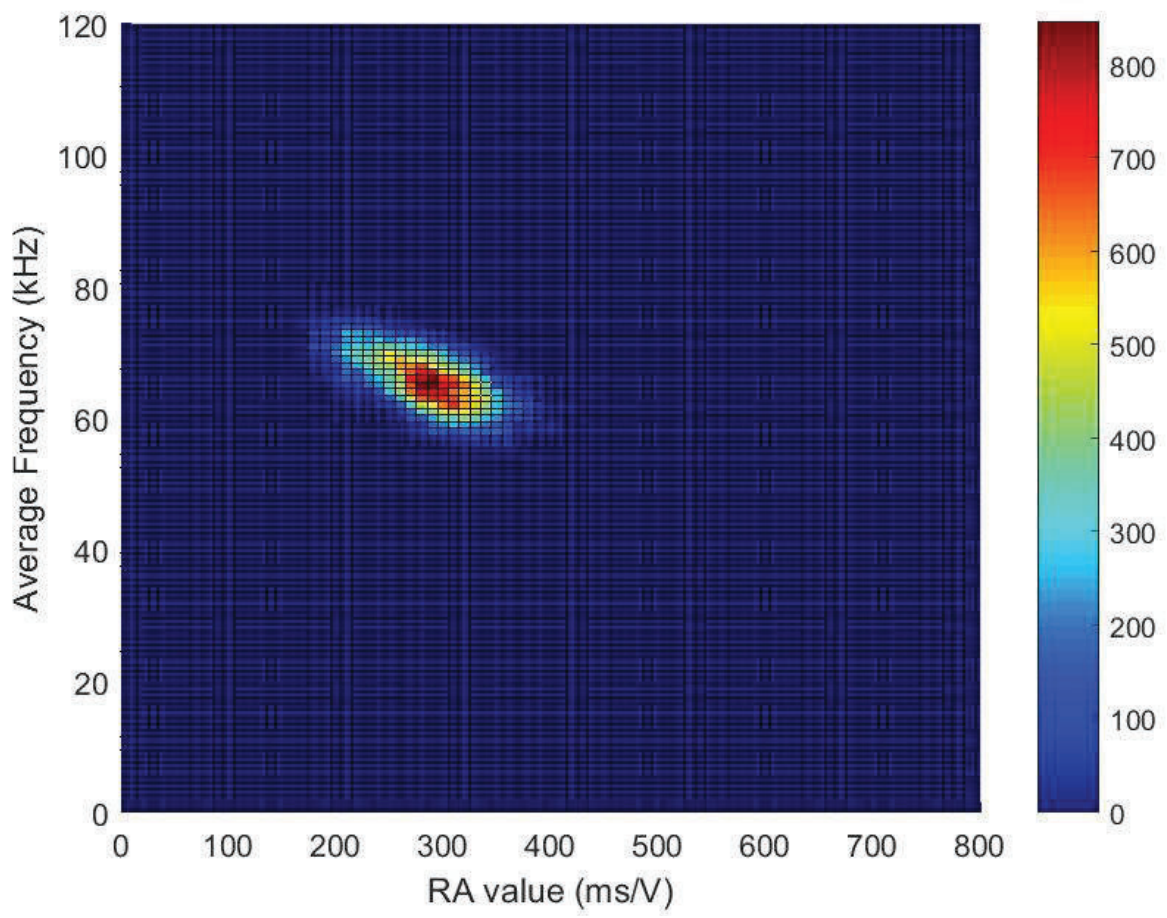
*SCHSFRC600.*

352 Figure 17 shows the histograms of RA value vs. average frequency of AE hits for all the  
353 analyzed concrete mix composition and temperature scenarios. The moving average of the RA value  
354 and the average frequency of 100 hits have been represented in order to smooth out scattering. The  
355 adopted criterion for a moving average of 100 hits was chosen as result of a previous sensitive study  
356 on AE data analysis. Trial examples performed with 25, 50, 75, 100, 150 and 200 hits were done. It  
357 was found that the plotted data become smooth and stable from 100 hits. This is also in accordance  
358 with RILEM TC 212-ACD [64] that recommends the adoption of more than 50 hits.

359 The plots distribution indicates that as the temperature grows up, the AE events decrease in  
360 frequency and increase in RA. This can be visualized by the progressive displacement of the AE  
361 cluster to the right and down corner in the figures. The tendency is evidenced both in SCHSC and  
362 SCHSFRC, and clearly point out that as concrete thermal degradation is more severe, the cracking  
363 behavior shifts to more mixed fracture modes. This is consistent with the observed increasingly  
364 tortuous fracture morphology.

365 Moreover, if the effect of the incorporation of fibers is analyzed, an increase of the RA value  
366 and the AF (although slightly in this case) is observed. This indicates that the fibers tend to modify  
367 the cracking modes activating the mixed modes as well. This was also supported by the fracture  
368 pattern aforementioned. Finally, Figure 18 illustrates this behavior representing the peak frequency  
369 distribution of AF and RA value.
