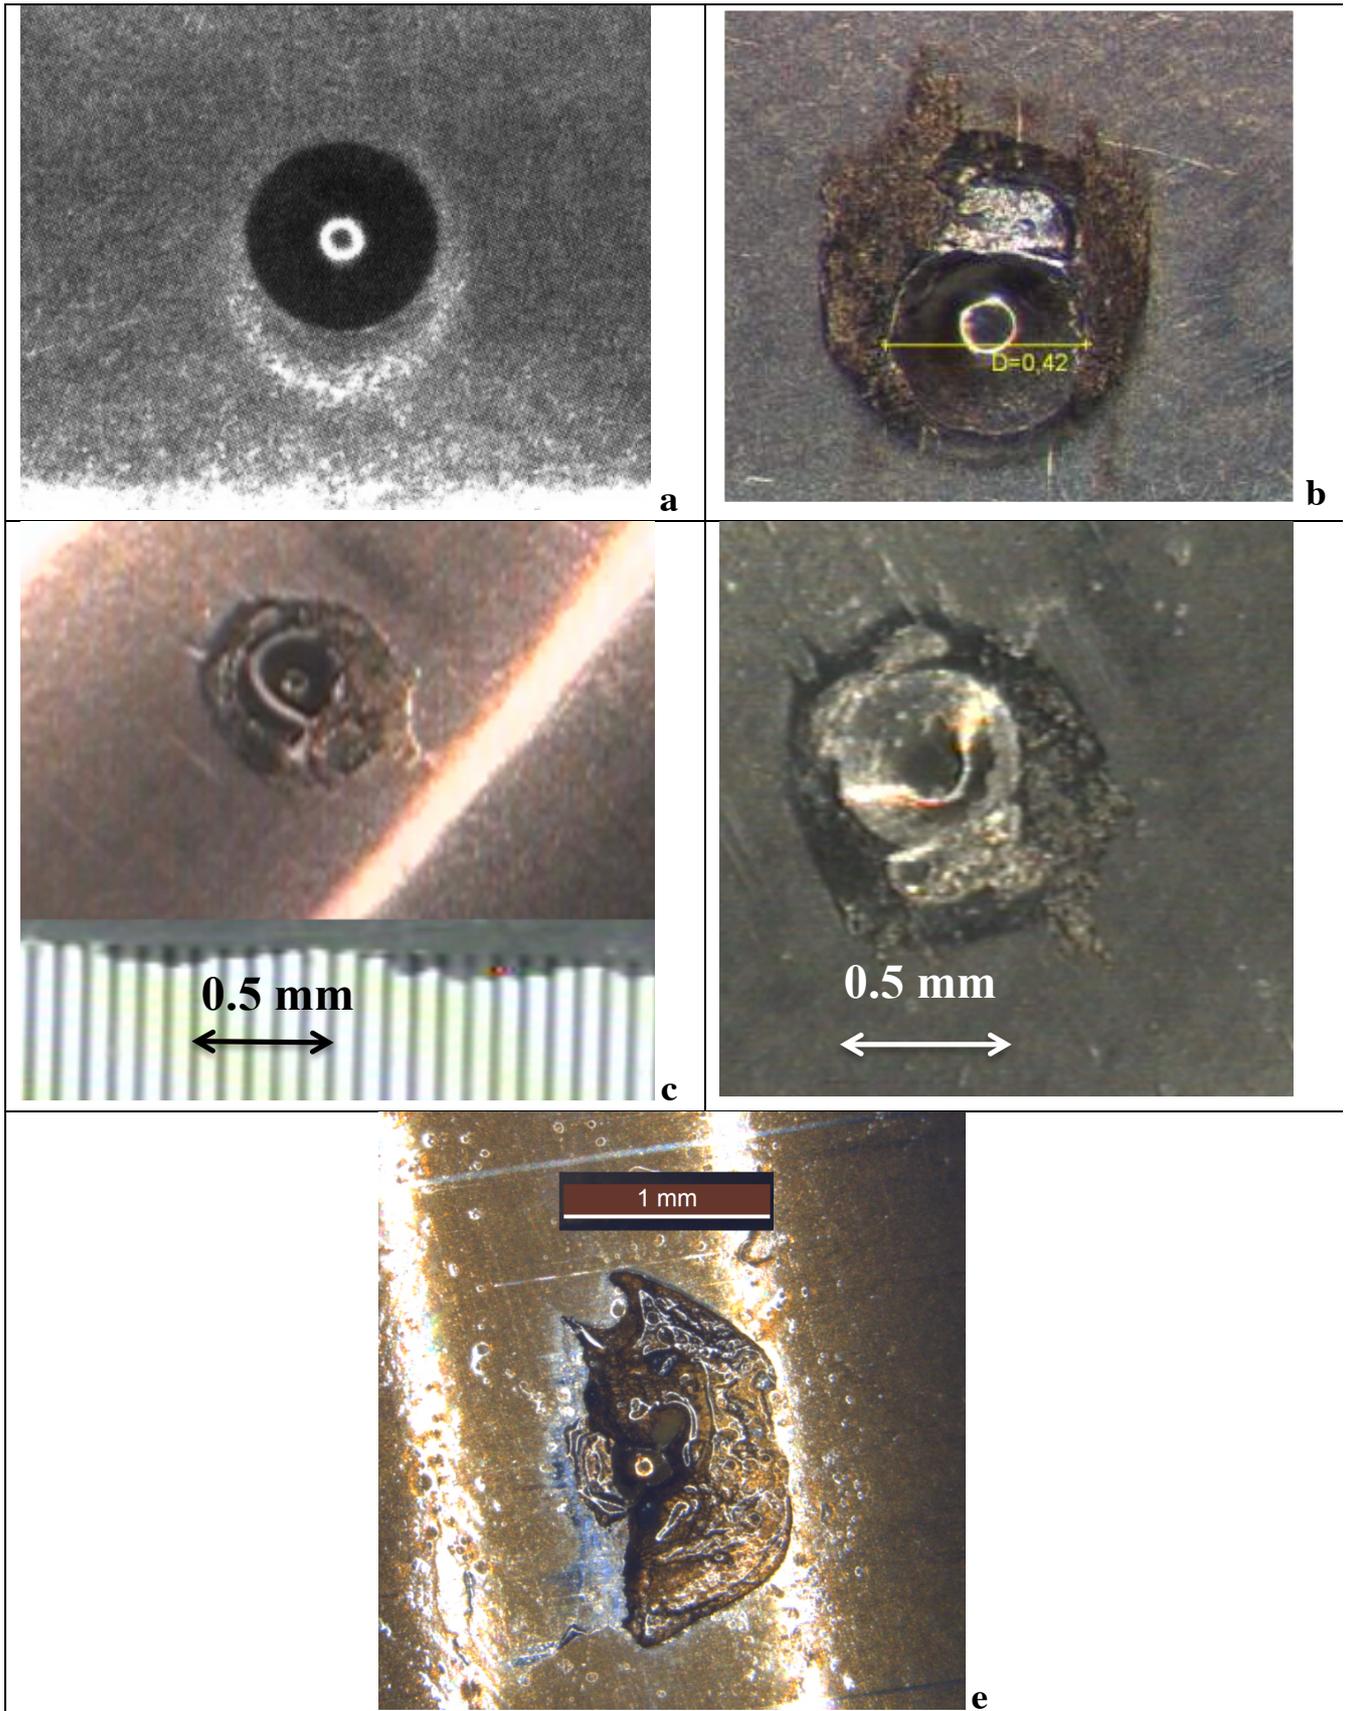
Figure 3: the progression of the indentation of bearing 4A; a) initial defect; b) after 19 hours at various load and speed conditions; c) after 70 hours ; d) after 124 hours; e) after 332 hours – c), d) and e) at 300 rpm and 1800 N
