Eur. Phys. J. Plus (2018) 133: 526

Hypercolorimetric Multispectral Imaging (HMI) system for cultural heritage diagnostics: an innovative study for copper painting examination

Keywords: Hypercolorimetric Multispectral Imaging, HMI, copper paintings, restoration, image processing

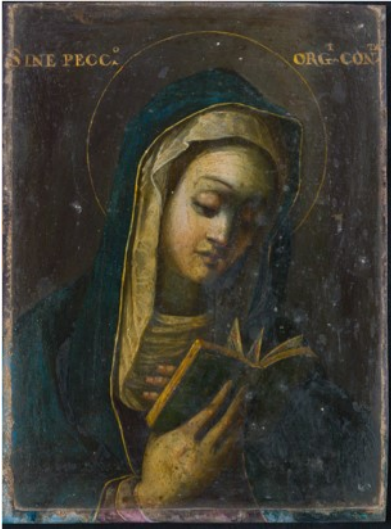
Figure 1 - Virgin of the Immaculate Conception (painting A) before cleaning, oil painting on copper plate (14.5 x 19.5 cm). Photo supplied by the restorers.

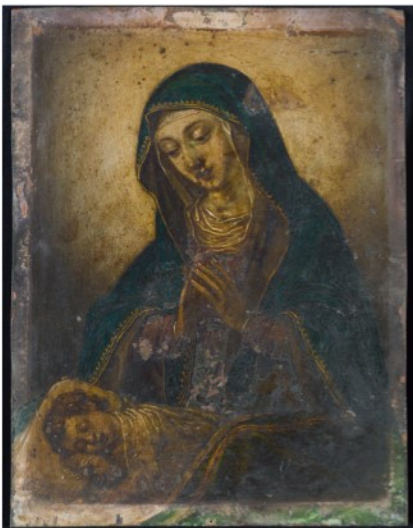
Figure 2 - Praying Virgin with Sleeping Child (painting B) before cleaning, oil painting on copper plate (15.3 x 20 cm). Photo supplied by the restorers.

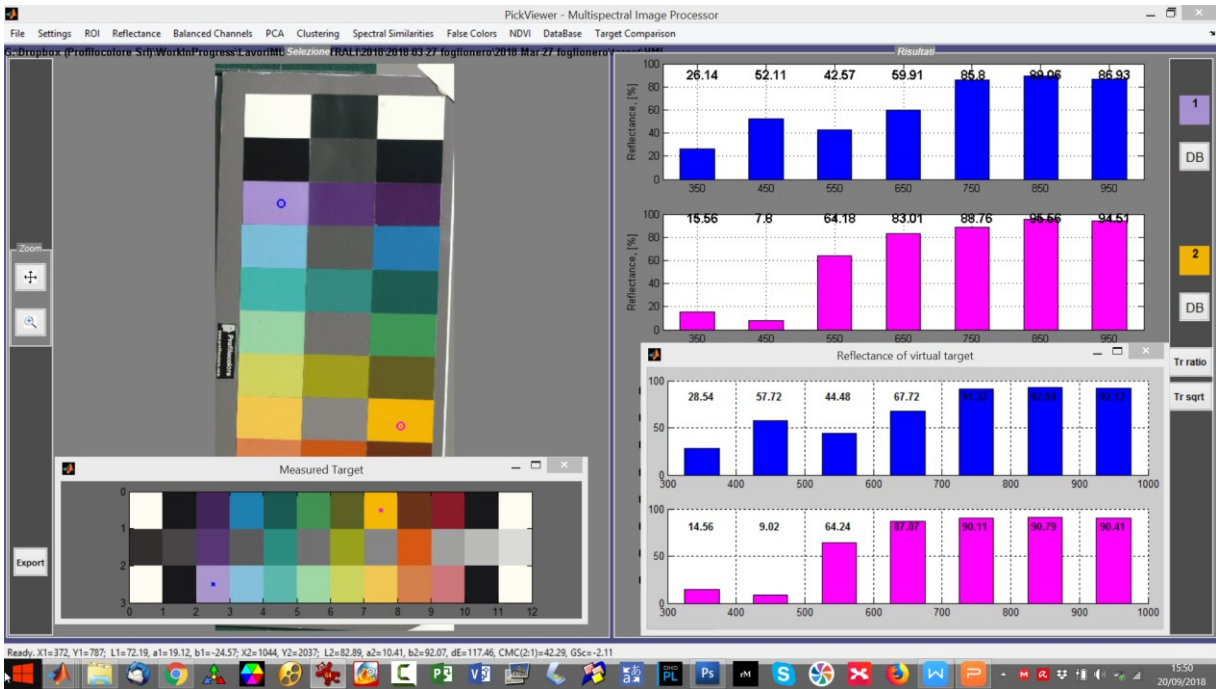
Figure 3 - Radiometric precision: comparison between laboratory dark room spectro-radiometer measurements and calibrated camera multispectral image of the reference colour-checker.

Considering the high resolution and radiometric precision (see Fig. 3) of the HMI imaging technique and the small dimensions of the copper painting, these acquisitions and damage mappings are extremely precious to study the state of conservation of the painting during the restoration intervention, allowing to clearly distinguish original and restoration materials, alteration products and deformations in the metal support.

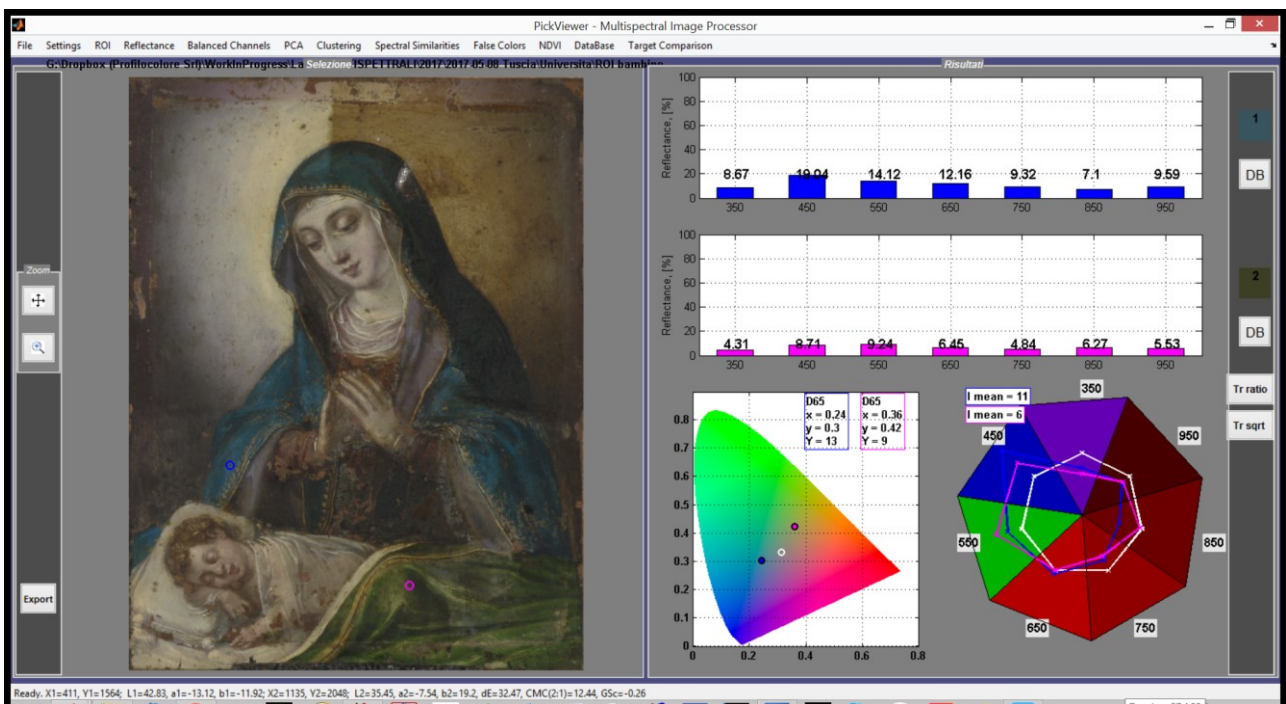
Figure 4 – Graphic user interface of PickViewer® Multispectral Image Processor

- integration of any other imaging data (fluorescence, X-ray, thermal etc.)
- multichannel images viewer, pan, zoom
- any pixel colorimetry and spectral reflectance read-out
- mapping by: colour, spectra, arbitrary channels
- principal components analysis
- neural network based clustering
- colour and spectral signature database
- two ways mapping by database entry
- any channel to RGB false colours visualization
- channels math, indexes and normalised contrast
- calibration and colour-checker test

The graphic user interface of the software is shown in Fig. 4.

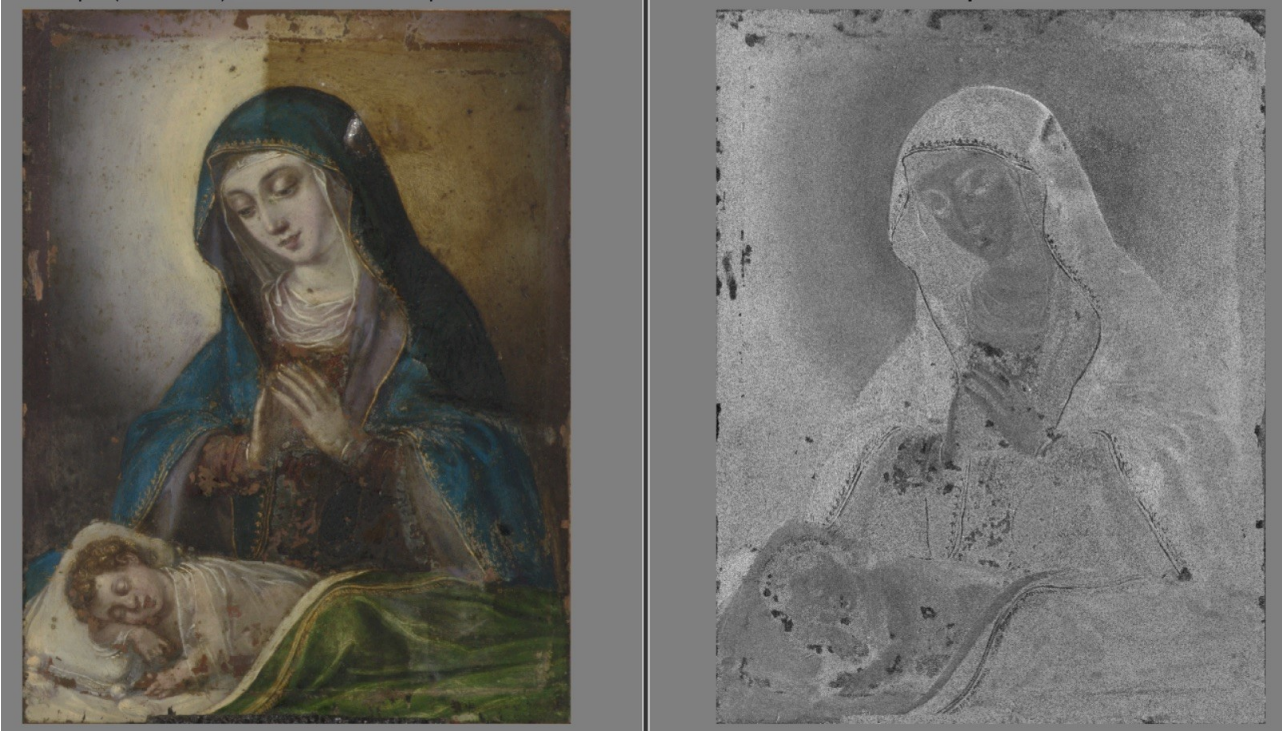
Figure 5 - Painting B: result of spectral similarity and edge detection tools applied to VIS image for highlighting lacks of pictorial materials.

The potentiality of the technique can be seen in Fig. 5 where visible image during cleaning and the result of image processing (spectral similarity and edge detection) of it is shown, immediately highlighting some losses of pictorial materials.

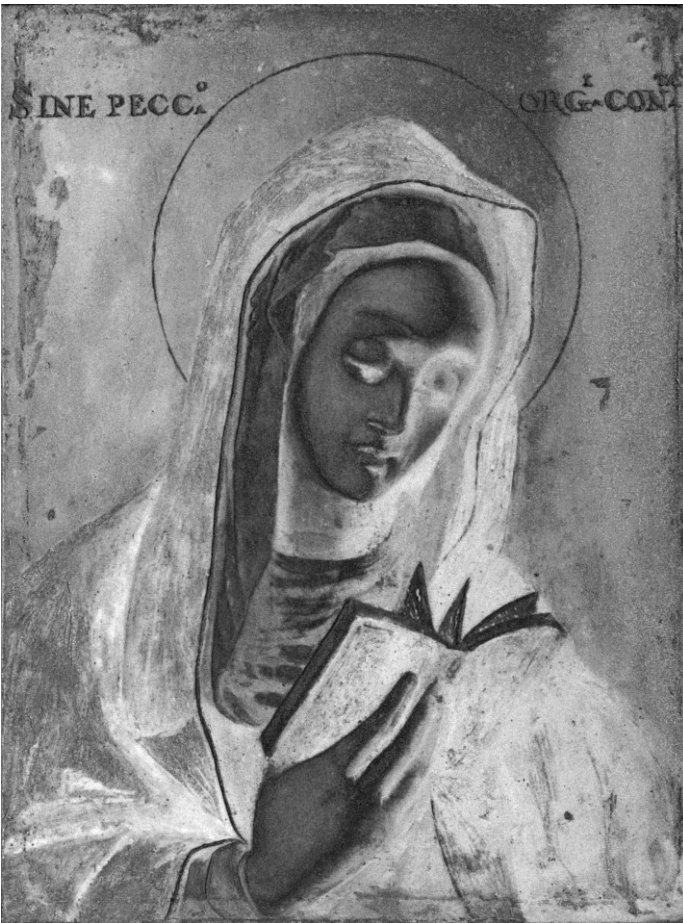
Figure 6 - Painting A: result of combining the UV and the induced-fluorescence images. Punctual discontinuities in the pictorial layer are highlighted.

In painting A, contrast enhancement operations performed on the combined UV reflectance and the induced-fluorescence images (Fig. 6) have highlighted all the punctual discontinuities in the painted layer which are mostly concentrated along the edges of the small copper board, where the original frame was still before restoration procedures began.

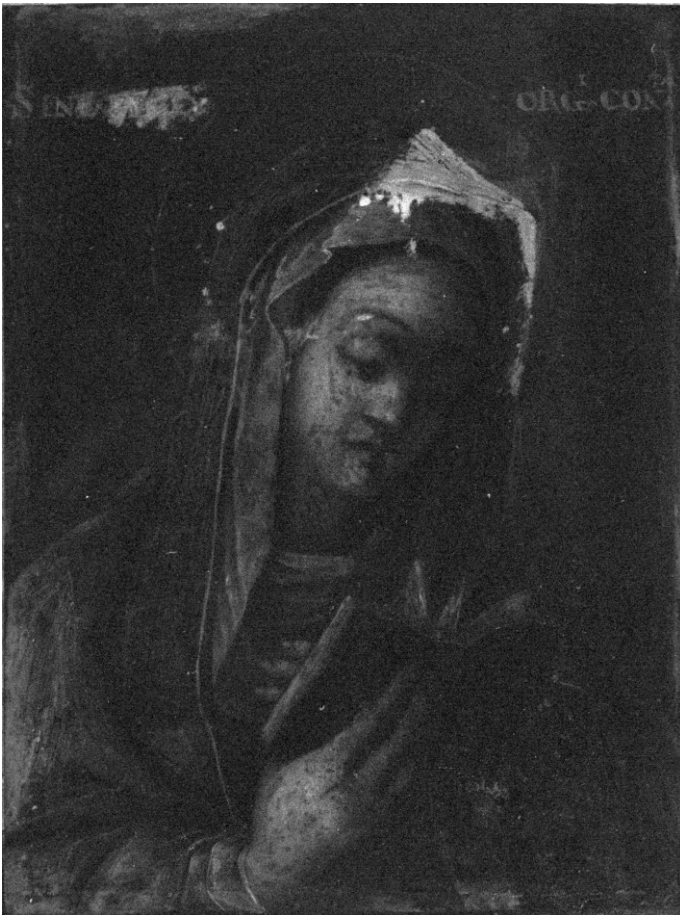
Figure 7 - Painting A: result of second PC from PCA applied on UV-induced fluorescence image and colorimetric blue component of VIS image.

Other contrast enhancement algorithms were applied on the second principal component from PCA performed on the UV-induced fluorescence image combined with the colorimetric blue component

of VIS image (normalized difference:  $[A-B]/[A+B]$ ). This elaboration allowed to clearly distinguish areas where the altered varnish was completely removed, from areas still covered by residuals of the varnish (Fig. 7). The still uncleaned areas are well visible on the upper part of the Virgin veil and on some letters in the left upper corner of the painting, appearing lighter in respect to the rest of the digital elaborated image (Fig. 7). The comparison of spectral profiles between the two areas (uncleaned and cleaned) highlights the differences (see Fig. 8).

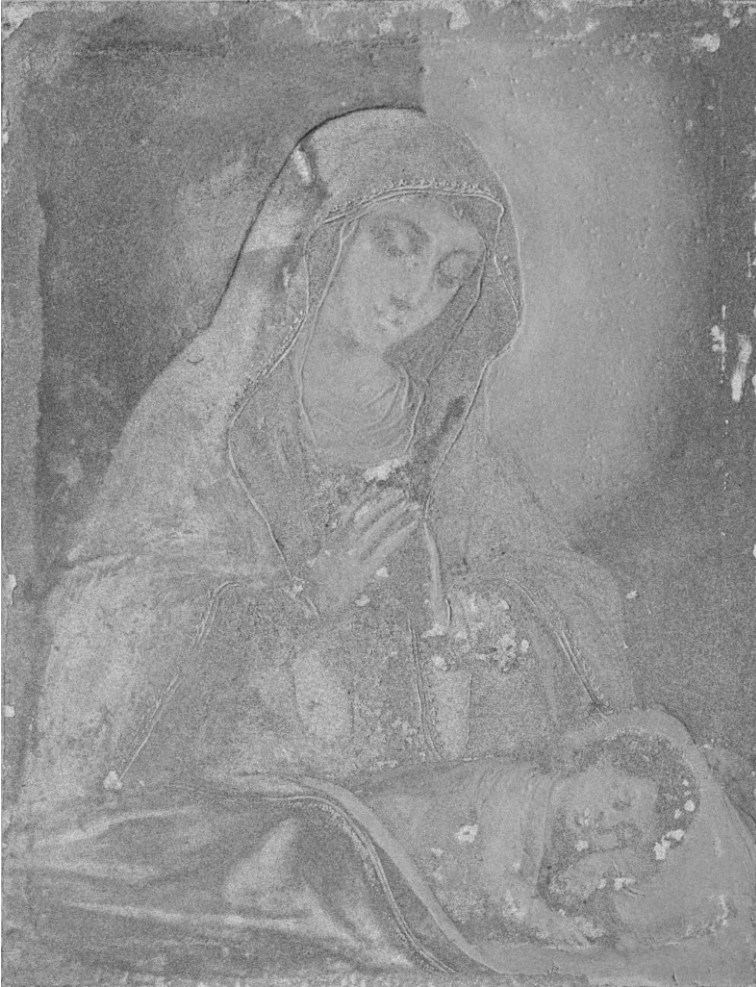
Figure 9 - Painting B: result of PCA applied on the induced-fluorescence image processed with IR2 (centered at 850 nm) image and the radiometric blue component of the VIS image.

In the HMI investigation of painting B, principal components from PCA run on the induced-fluorescence image were processed with IR2 image (i.e. the band centered at 850 nm) and the radiometric blue component of the VIS image in order to highlight detachment spots and small mechanical hollows in the metallic foil (Fig. 9). These are especially visible in the left part of the painting background (which at the moment of the multispectral acquisition had been cleaned from the overlaid altered varnish) and in correspondence of the foil's borders originally covered by the ancient frame (Fig. 9).

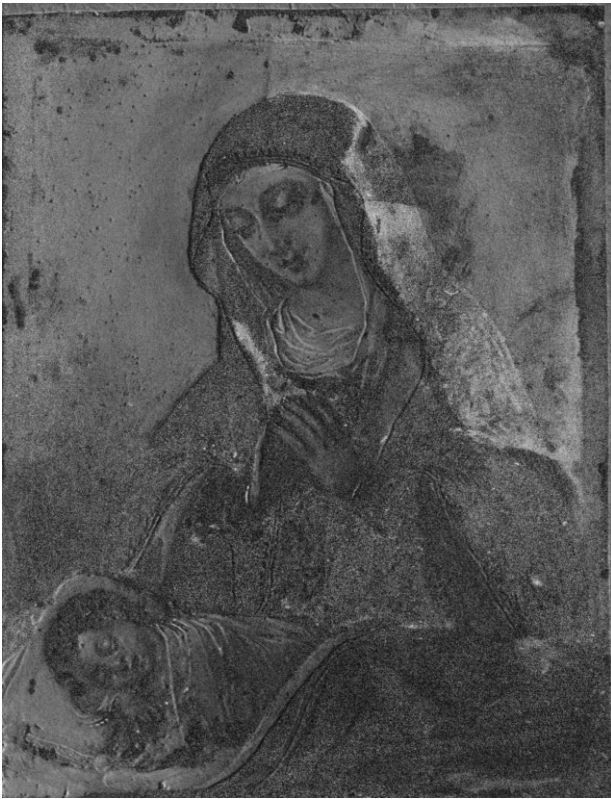
Figure 10 – Painting B: image resulting from contrast enhancement, processing the first three PCs applied on UV-induced fluorescence and the RGB image in the UV spectral band.

A further contrast enhancement operation, processing the first three components of PCA performed on the UV-induced fluorescence and the RGB image in the UV band, permitted to better investigate the right part of the copper painting, highlighting an alteration (probably in the ground layer or in the metallic support) on the top right part of Virgin's veil (Fig. 10).

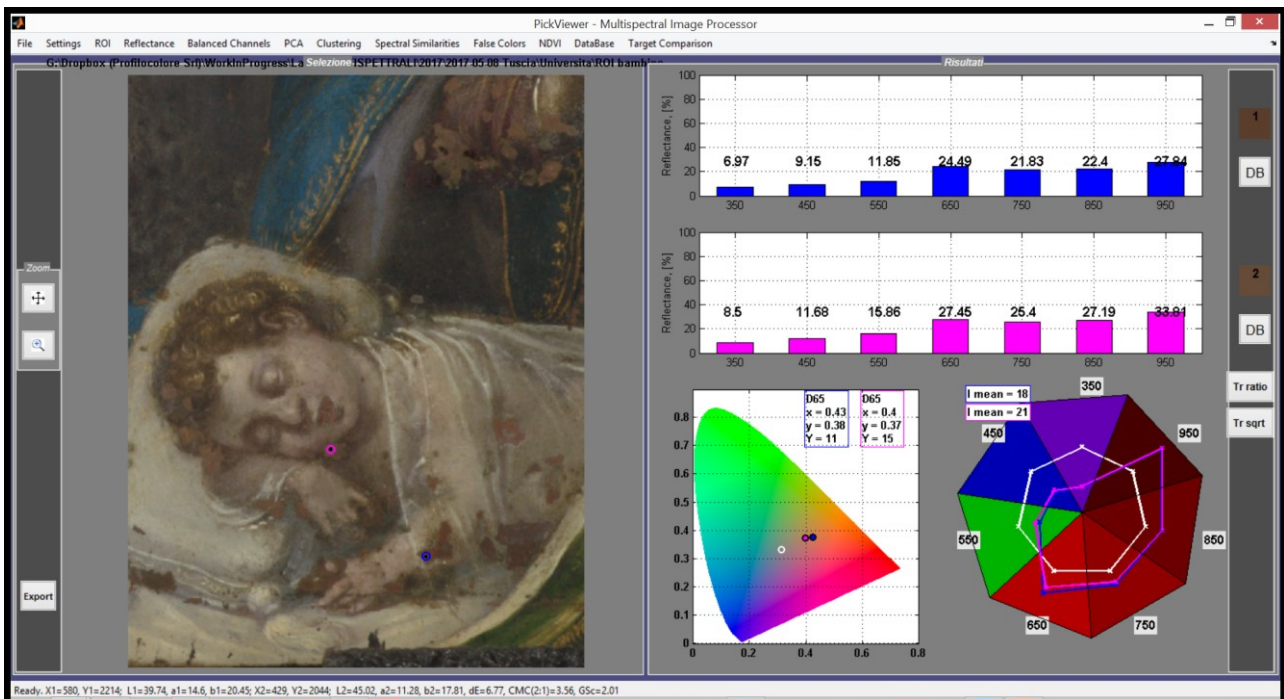
Figure 11 – Painting B: spectral profiles of two areas where the copper support is visible due to the loss of the painting layer.

Thank to the possibility to have a highly reliable spectral reflectance for each pixel of the image, after identifying a little area where the painting layer is missing, pixels of spectral similarity within a given threshold were identified on the whole painting (Fig. 11). Edge detection output on the resulting map has been extracted and over imposed to the original VIS image, allowing to highlight all the areas where the original pictorial material was missing, included the ones not clearly discernible by naked eye, because of the adjoining painting spots presenting the same colour (Fig. 12).
