Walkability and Pedestrian Settings in Dhanmondi R/A, Dhaka City: Approach of Sidewalk Condition Index (SCI) and Perception

ABSTRACT

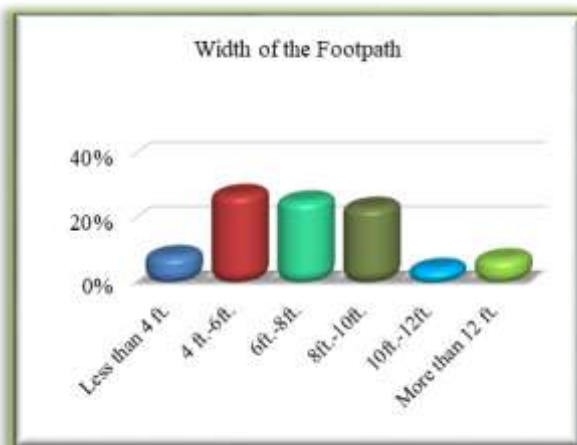
Fig.2:-Width of footpath

Wider footpaths increase the ease of walking as they accommodate more people. The Indian Road Congress recommends footpaths on both sides of the road with a minimum width of 1.5 meters (5 feet). Some road segments had footpath of Less than 4 ft. (9%). It is very short in terms of road function, road capacity and pedestrian volume of the study area. Most of the roads had footpath of 4ft.-6ft. (28%) (Figure 2). Some roads had footpath of 6ft.-8ft. (26%). The percentage of road segment having footpath of 8ft.-10ft. is 24%. Only a few roads had footpath of 10ft.-12ft. (5%). However, the primary roads, such as Mirpur Road, Satmasjid Road and Dhanmondi-27 (Old) had footpath more than 12 ft. wide. Their percentage is 8%.

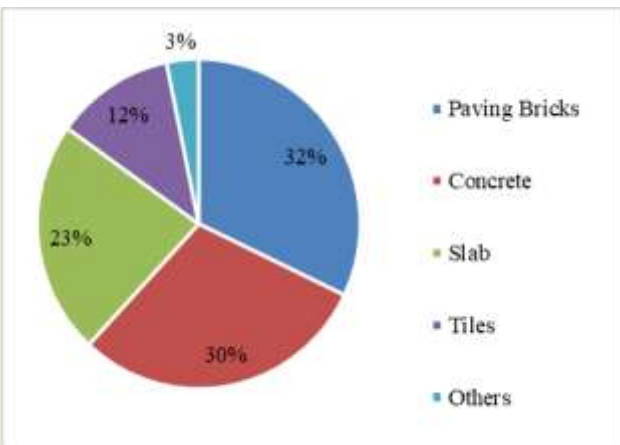
Fig.3:-Type of materials used

The Figure 3 shows the percentage of materials used in constructing the footpaths of the study area. The most common material is Paving Brick which amounts for about 32%. The second highest used material is Concrete which is used in 30% footpaths. Slab is used in 23% footpaths whereas Tiles is used in only

12% footpaths. However, Bitumen-which is another widely used material in construction of footpath all over the world, was not used at all. And, the most important part, Dirt/Sand was not used at all in the study area which is cost effective. Though the use of Dirt/Sand is not desired, it is widely used in our country. Other

materials constitute 3% of the flock.

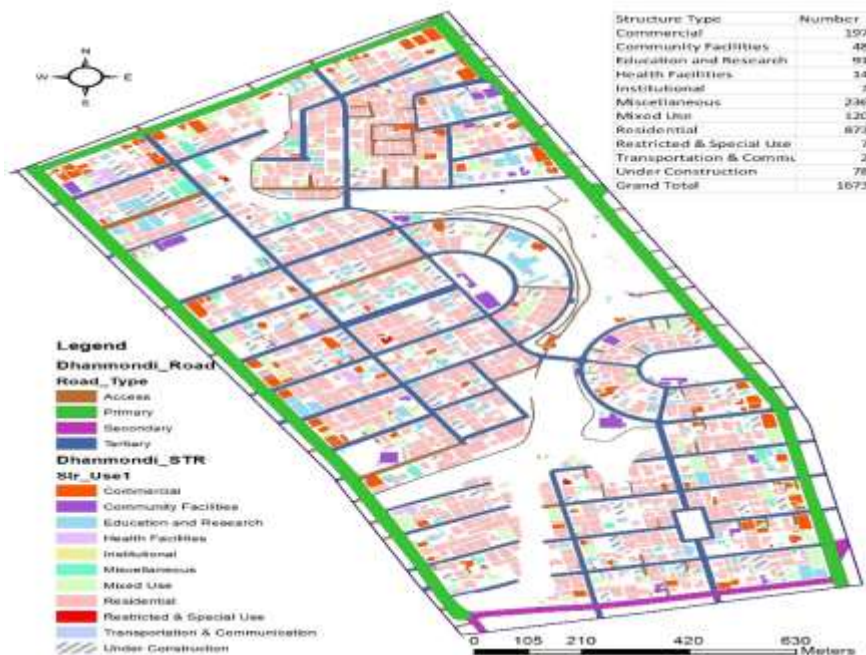
Fig.7:-Map of Structures and Roads

From Figure 7 it is seen that almost all of the commercial, educational and health facilities are situated along both side of the Satmosjid road and Mirpur road and this two road are also the primary road of the

study area. There are two sided pedestrian way of these two road and the pedestrian volume is also very high in these two roads comparative than other road in Dhanmondi residential area.

From the Figure 7 it is seen that most of the commercial, educational and other major used building are besides the two major road and these are the Satmosjid road and the Mirpur road. But from Figure 9 it is seen that the parking facilities are absent along the both side of the two major

roads. As a result the on street parking are seen there besides the major roads as the consequences the pedestrian way is occupied in a congested situation and these problems make different problems to the pedestrian.

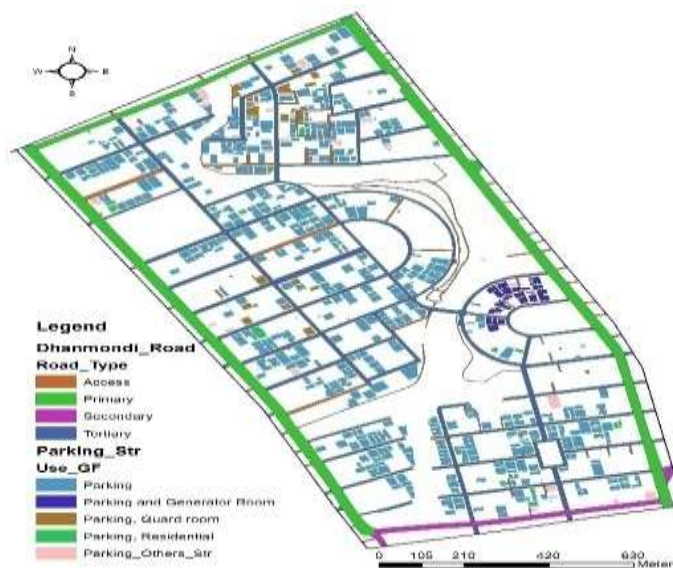
Fig.9:-Map of Parking Facilities Structures

The studies observed parking of vehicles, whether legally or illegally, have in every streets of the study area. Legal parking refers to parking in specified areas and places which do not affect the mobility of pedestrians and other vehicles. Illegal parking refers to vehicles parked on footpaths, in specified no parking areas and on the side of the road blocking the traffic. Seventy-five road segments had cars/microbus parked illegally. Total of 1673 structures only 591 structures have

(35.33%) the self-parking facilities in the study area. Among them only parking has 482 structures (81.56%), 5.92% (35 structures out of 591) have the parking and guard room both. The 35.33% structures have the self-parking facilities and it is not enough as the demand basis need and Almost all of them are residential parking facilities. The parking in the roadside or adjacent to the pedestrian way make the trouble to the freeway of the pedestrian sidewalk.

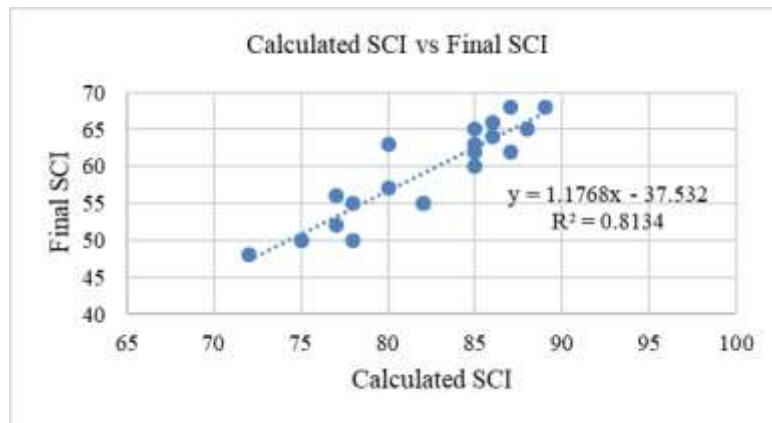
Fig.17:-Calculated SCI vs. Final SCI

So the final Sidewalk Condition Index (SCI) is the arithmetic mean of Calculated SCI. For Adjusting the Calculated SCI this following Linear Equation should be used: Adjusted SCI = 1.1768 X Calculated SCI – 37.532. This linear equation is developed from the Calculated SCI and Final SCI

The Adjusted SCI= 1.1768 X Calculated SCI – 37.532. This Regression SCI will be termed as “The Side walk condition Index (SCI)” for that particular road.
