EARTHQUAKE-INDUCED COLLAPSE OF STEEL  
MOMENT RESISTING FRAMES WITH CONVENTIONAL  
AND HIGH PERFORMANCE STEEL COLUMNS

A thesis submitted to McGill University in partial fulfillment of the requirements  
of the degree of Doctor of Philosophy

# CHAPTER 5: Experimental Studies on the Collapse Behaviour of Steel Columns in Moment Resisting Frames

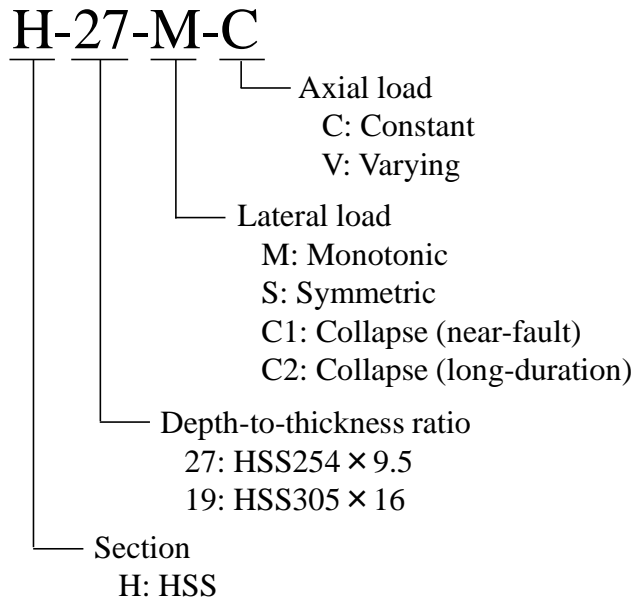
Figure 5.1 Specimen designation

(a) HSS columns

(b) wide flange columns

The testing matrix includes 21 cantilever ASTM A992 Grade 50 (i.e., nominal yield stress,  $f_y=345\text{MPa}$ ) wide flange and ASTM A500 grade B (i.e., nominal yield stress,  $f_y=315\text{MPa}$ ) steel HSS columns. The selected column sizes cover a representative range of local slenderness and shear span-to-depth ratios typically used in the North American and Japanese construction practice. All the columns are subjected to combined axial load coupled with lateral drift demands. The test matrix is summarized in Tables 5.1 and 5.2 for HSS and wide flange steel columns, respectively. These tables also include the nominal yield stress of the columns, their local slenderness ratios and the employed lateral and axial loading protocols. Referring to Figure 5.1 a 4- and 5-index specimen designation is used for HSS and wide flange specimens, respectively. For instance, “W-6-34-M-C” indicates that a W-shape steel column is tested with a  $b_f/2t_f$  and  $h/t_w$  ratios equal to 6 and 34, respectively; the specimen is tested under monotonic lateral loading (i.e., “M”) that is coupled with constant (i.e., “C”) axial load (see Figure 5.1b).

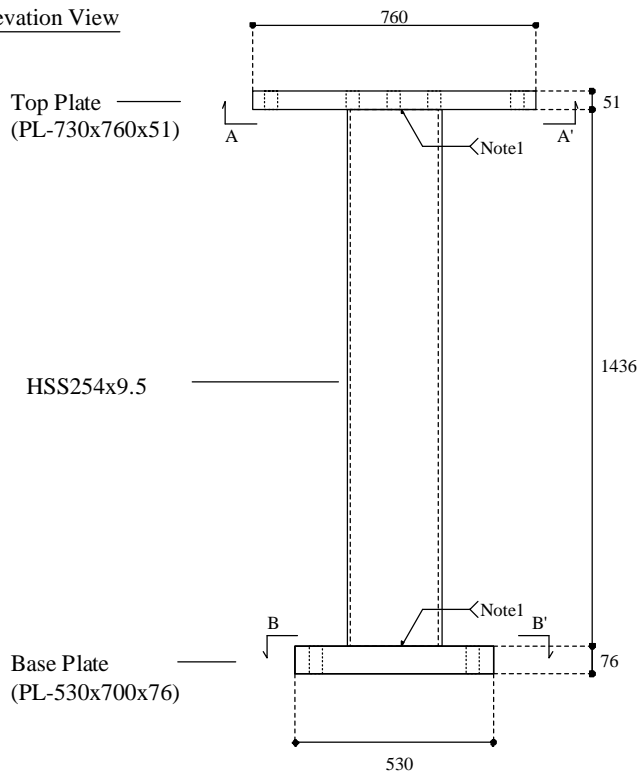
Figure 5.2 Specimen drawings of HSS columns

Note1 - HSS wall plate to base/top plate groove welding detail

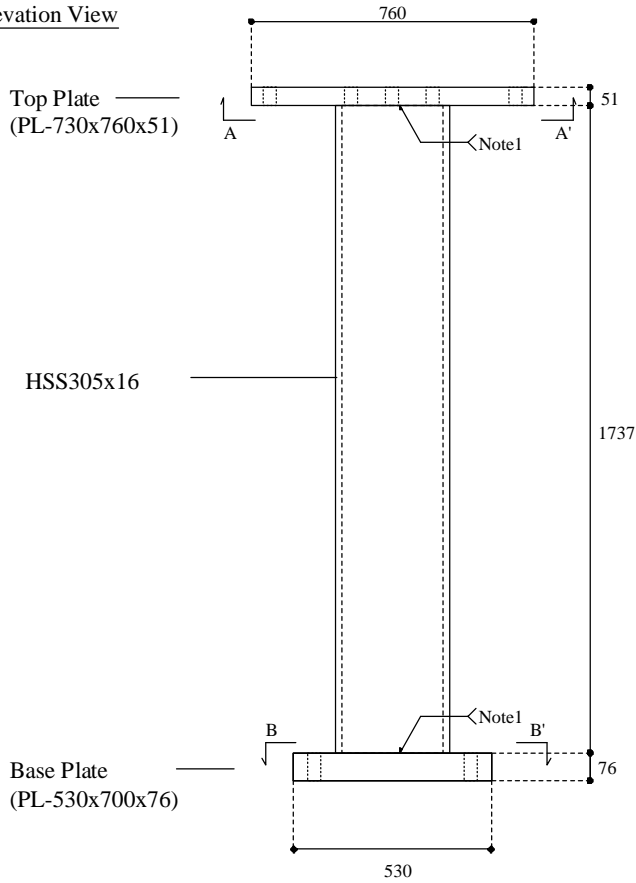
Figure 5.2 Specimen drawings of HSS columns (continued)

Note1 - HSS wall plate to base/top plate groove welding detail

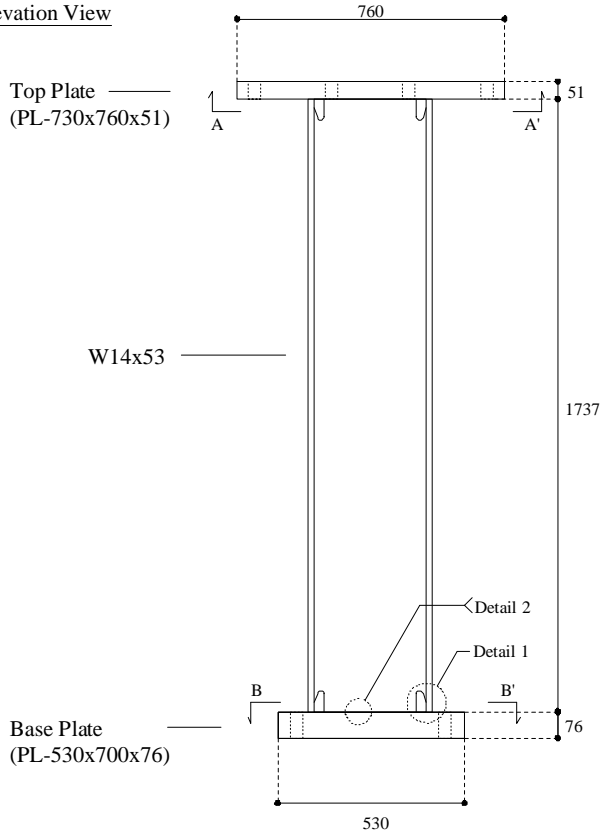
Figure 5.3 Specimen drawings of wide flange columns

Detail 1 - Flange weld access hole and groove weld detail

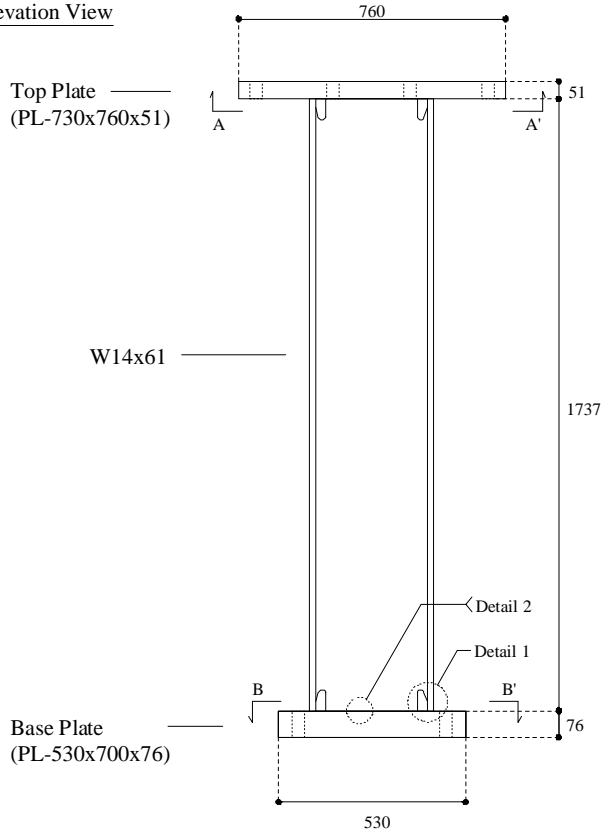
Figure 5.3 Specimen drawings of wide flange columns (continued)

Detail 1 - Flange weld access hole and groove weld detail

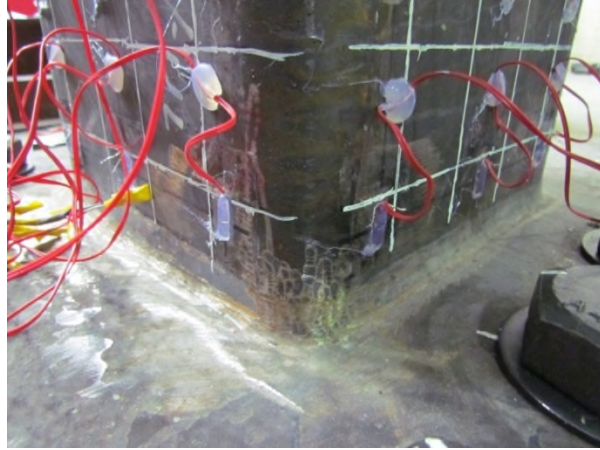
(a) HSS-to-base plate welding (H-27-C1-V)

Figure 5.4 Examples of welds and web access holes

D1.1/D1.1M:2010 (AWS 2010). Figure 5.4 shows examples of fabricated welds and weld access holes of the H-27-C1-V and W-6-34-S-C specimens. Weld surfaces were grounded so that possible weld notches were removed. The W14×61 (W-8-34 series), W14×82 (W-6-25 series) and HSS305×16 (H-19 series) specimens were sand blasted prior to fabrication. Tables 5.3 and 5.4 summarize the corresponding measured dimensions for each specimen. Note that the HSS specimens are made of cold-formed hollow sections with a single side seam welding. The seam weld was oriented on the web of specimens H-27-M-C, H-27-C1-C, H-19-S-C, H-19-C1-C and H-19-C1-V; the seam weld was oriented at the flange of specimens H-27-S-C, H-27-C1-V, H-27-C2-C and H-27-C2-V.

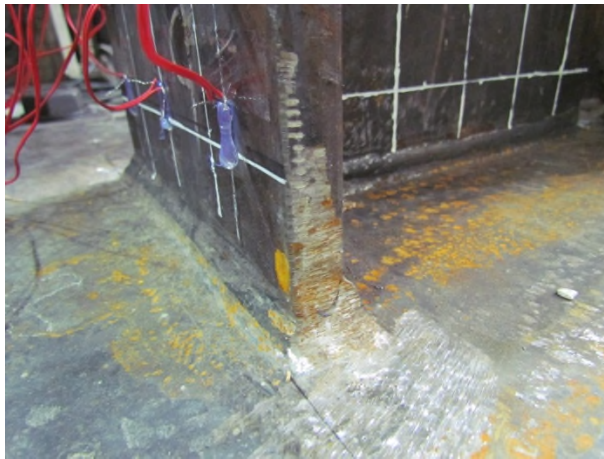
(b) Flange-to-base plate welding (W-8-34-S-C)

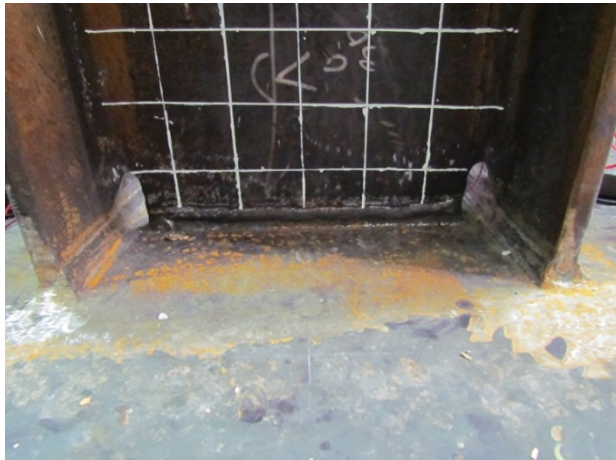
(c) Web-to-base plate welding and weld access holes (W-8-34-S-C)

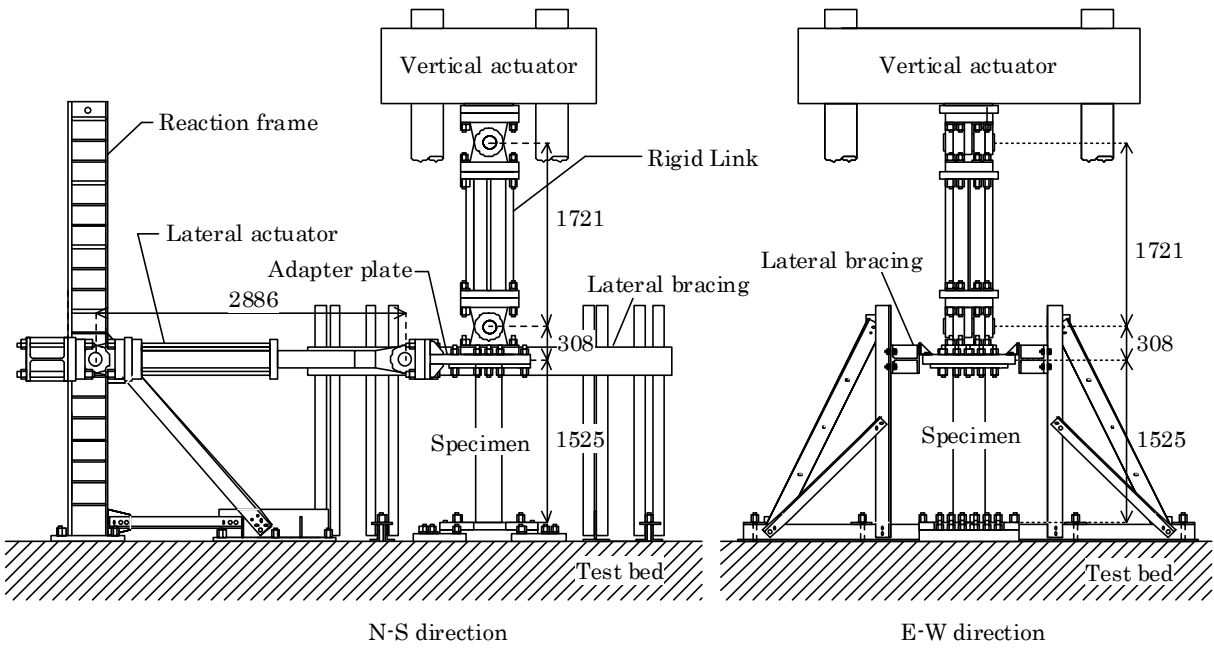
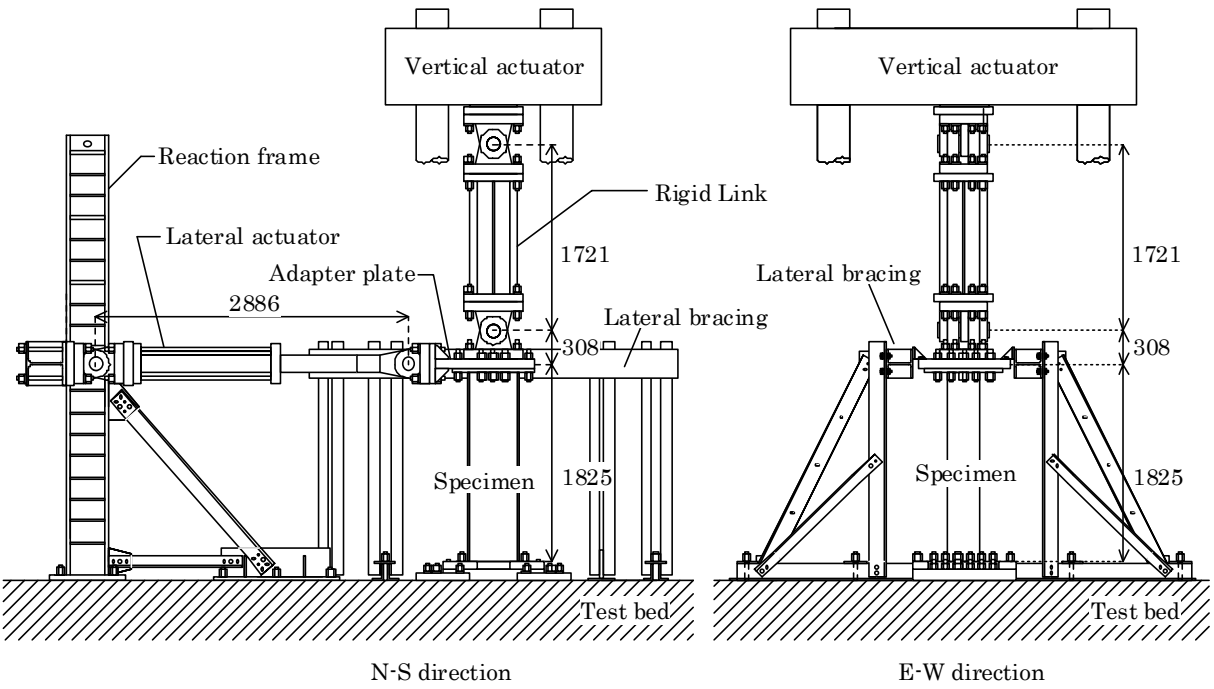
Figure 5.5 Elevation view of test setup

(a) H-27 series specimens

(b) other than H-27 series specimens

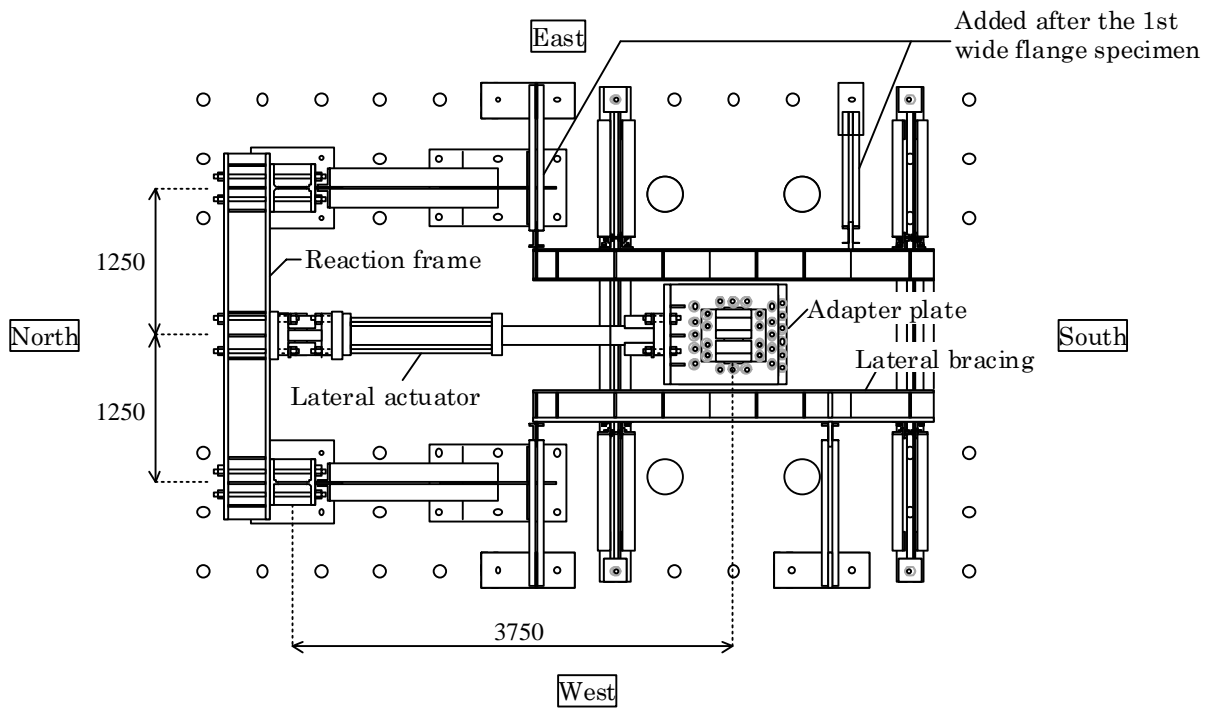
Figure 5.6 Plan view of test setup

A test specimen is laterally braced at its loading height to restrain any out-of-plane movement. A set of slider plates is used for this purpose as shown in Figure 5.13. This allows for a column specimen to slide against two longitudinal wide-flange beams (noted as lateral braces) located on each side of the loading plate adaptor. To minimize friction between the two sliding surfaces a thick lubricant is used. After the first test (i.e., W-6-34-M-C) it was found that the out-of-plane deflection of the lateral bracing system was fairly large thus, the lateral support system was reinforced with a set of four additional braces (see Figures 5.6 and 5.14).

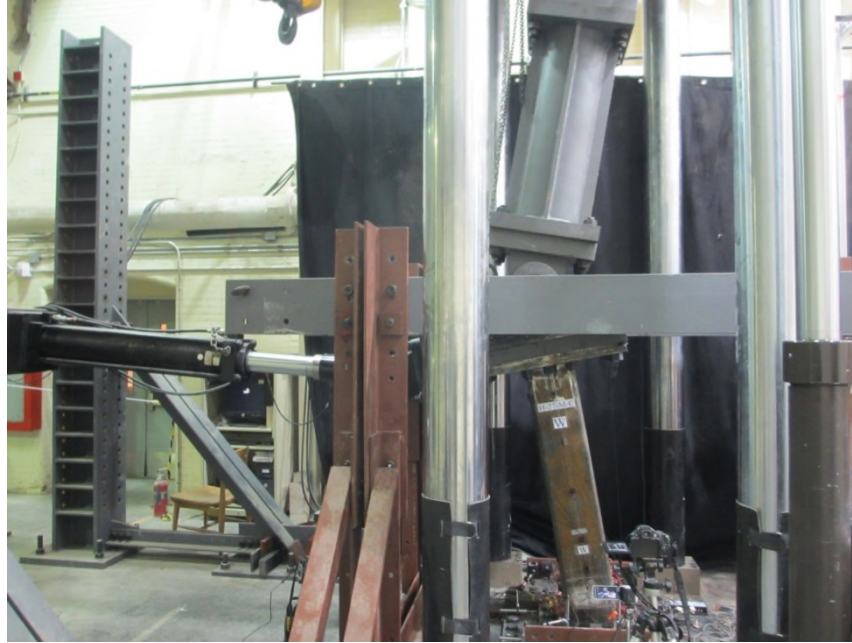
Figure 5.11 Deformed configuration of test setup

Referring to Figure 5.9, a vertical actuator of 11,000kN is utilized to apply the constant or varying axial load on the steel column specimens. This actuator has a 300 mm displacement stroke. The axial load is applied to a steel column specimen through an axially rigid link that is designed for -4,000kN in compression and 2,000kN in tension. The top end of the axially rigid link is connected to a structural pin attached to the vertical actuator. The other end of the rigid link is also connected to a nominally identical structural pin, which is connected to a steel column specimen at the other end. The location of this pin represents the inflection point of a first story column when it behaves elastically during cyclic loading. The structural pins are shown in Figure 5.10. They were designed for -4,000kN compressive and 2,000kN tensile axial load. The two pins allow for the lateral displacement of a test specimen up to about 20% lateral drift ratio without transferring any moments at the top of the vertical loading system. Figure 5.11 shows a column nearly at 20% lateral drift ratio. Because the vertical load is applied on a steel column with load control, in case that a steel column loses its axial load carrying capacity (i.e., column fully squashes) then the actuator control is automatically switched to displacement control.

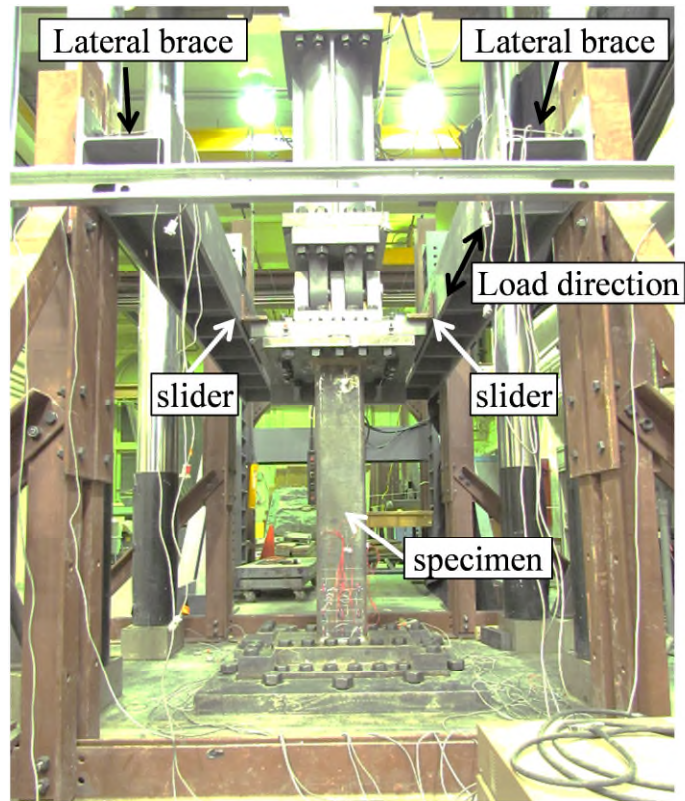
Figure 5.13 Detailed view of lateral bracing system

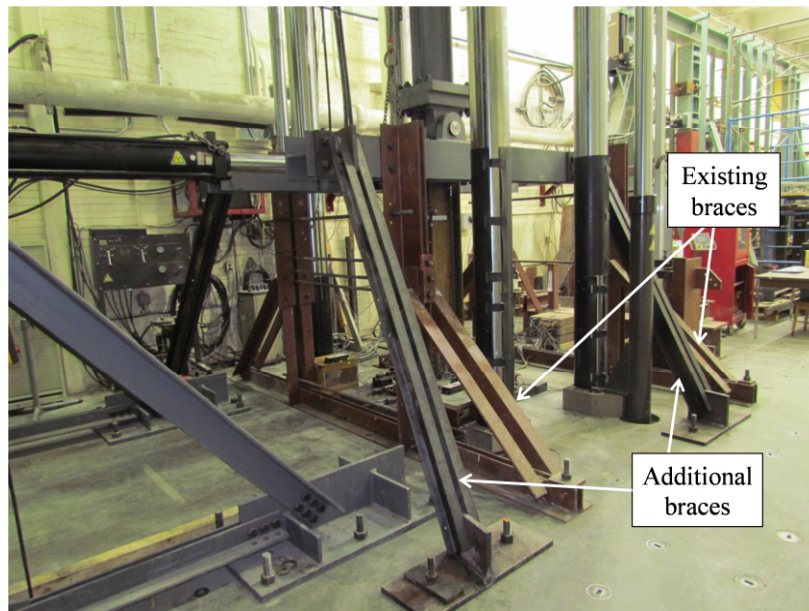
Figure 5.14 Reinforcement of existing lateral bracing system

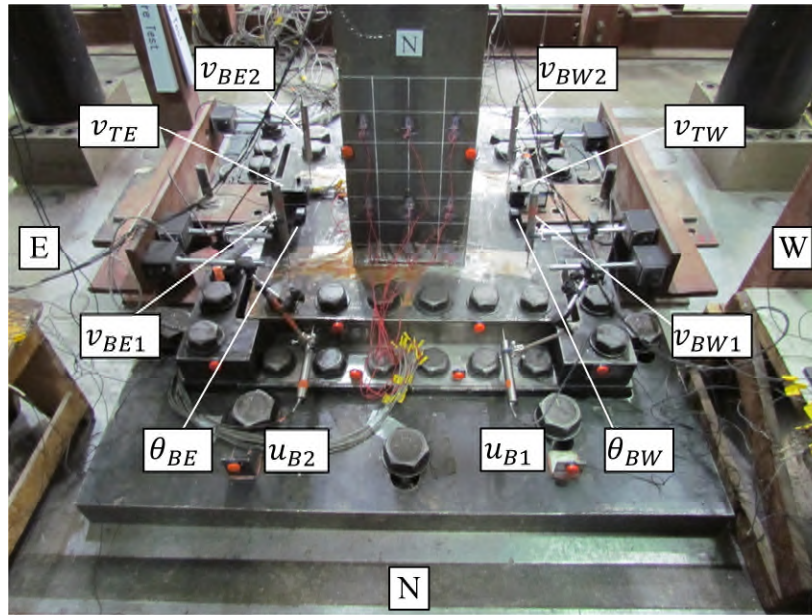
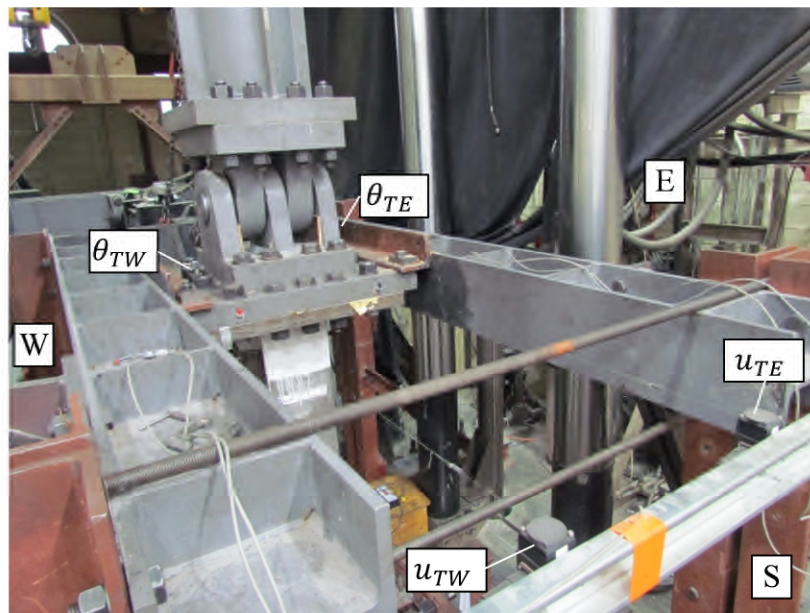
Figure 5.18 Photos of instrumentation setup

(a) LVDTs, inclinometers, string potentiometers on the base plate

(b) LVDTs, inclinometers, string potentiometers on the top plate

Base plate rotation is also measured with two inclinometers ( $\theta_{BW}$  and  $\theta_{BE}$ ) as shown in Figures 5.16 to 5.18 that are placed in line with the vertical LVDTs. These measurements are used as a backup in case that the primary measurements from the LVDTs won't work during a test. The base plate rotation,  $\theta_{b1}$ , can be deduced based on the LDVT measurements from Equation 5.2. If the inclinometers are employed for the same purpose, the base plate rotation (noted as,  $\theta_{b2}$ ) can be deduced from Equation 5.3,

From Figures 5.16 to 5.18, two additional LVDTs (noted as  $u_{B1}$  and  $u_{B2}$ ) are positioned on the side of the base plate in plane with the lateral displacement loading in order to monitor potential base plate slip during a test. The base plate slip can be deduced from Equation 5.4,

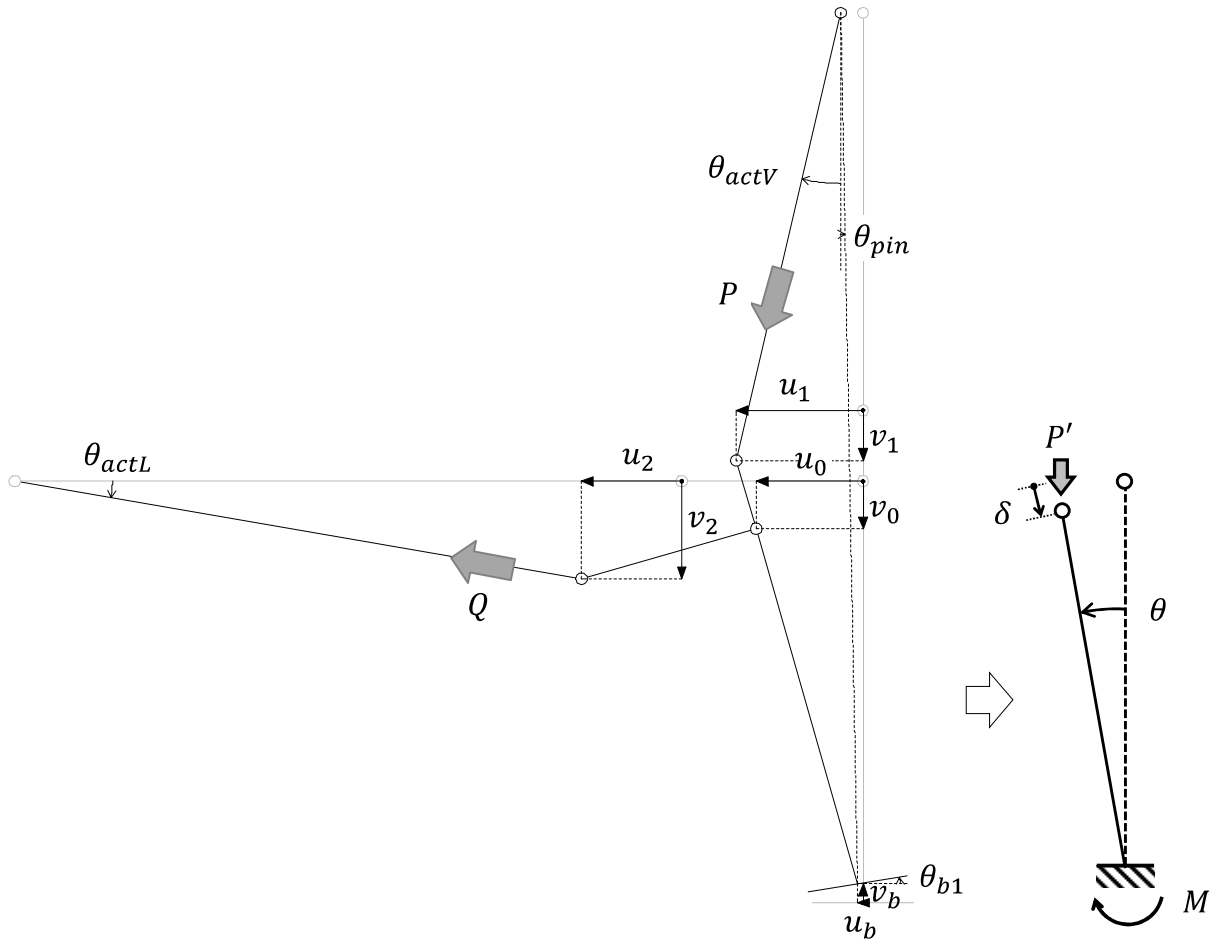
Figure 5.19 Considered deformation mode of the specimen including definitions of the positive rotation

In order to be able to compute the top plate lateral and vertical displacements (noted as  $u_0$  and  $v_0$ ) at the centerline of the adaptor plate as shown in Figure 5.19 with respect to the global coordinate system, the following set of equations should be used,

In order to deduce the position of the center of the bottom pin in terms of vertical and lateral displacements with respect to the global coordinate system (noted as  $u_2$  and  $v_2$ , respectively), Equations 5.13 and 5.14 should be used, respectively. This point infers to the position of the column inflection point,

vertical displacements of this point are noted as  $u_2$  and  $v_2$ , respectively as shown in Figure 5.19.

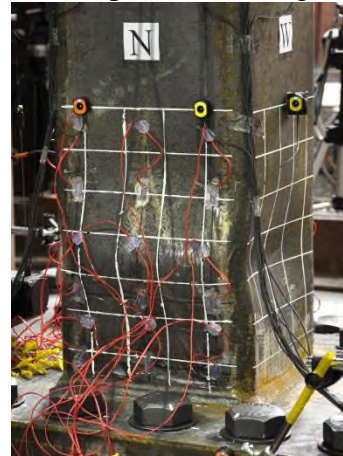
(f) H-27-C2-V  
(after phase 1 loading)

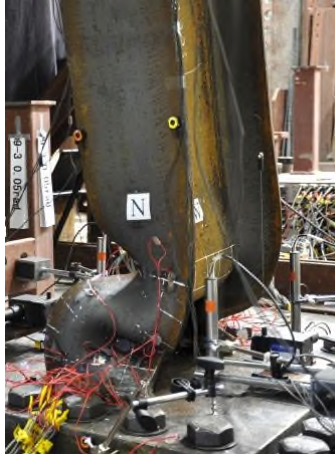
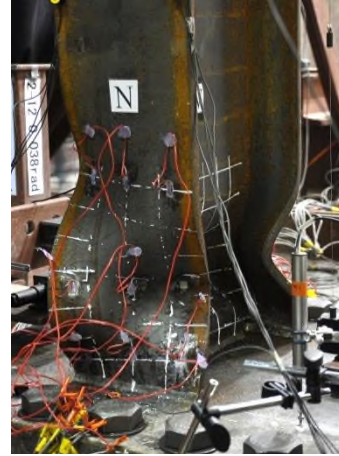
(b) W-6-34-S-C  
( $\theta_{max}=5$  rads)

(c) W-6-34-C1-C  
(after phase 2 loading)

Figure 5.33 Deformed shape of wide flange specimens

Figure 5.33 shows the observed deformed shapes of the tested wide flange specimens. Table 5.14 summarizes the observed failure modes and locations of local buckling of the wide flange specimens. Local buckling near the base of the wide flange steel columns typically included two types. The first one initially formed at a location close to the column base plate; the second one typically developed above the first buckling wave. Although the corresponding  $L/r_y$  ratios were well below 50 in all cases, the second buckling mode triggered lateral torsional buckling in most cases. This sequential buckling mode formation was observed in most of the wide flange specimens as summarized in Table 5.14. From the same table, the observed buckling lengths of the first and second buckling wave were equal to  $0.6D$  to  $1.0D$ , respectively. The locations of the buckling center ranged from  $0.4D$  to  $0.7D$  for the first buckling wave and from  $0.9D$  to  $1.2D$  for the second one from the base plate's top surface, respectively. The location and the corresponding buckling length did not change regardless of the employed lateral loading protocol and the specimen section profile. Interestingly, in the case of W-6-34-C2-V and W-8-34-C1-V columns where a varied axial load was coupled with the lateral loading protocol, the second

buckling mode did not develop. This is because the first buckling wave did not grow much. In the case of W-6-25-S-C, the first buckling wave occurred at a higher location compared to the rest of the columns with the same cross section. The test observations suggest that once the buckling center location is at a higher position with respect to the column base, this triggers the torsional deflection of a wide flange column while it displaces laterally. Referring to Figures 5.33c and 5.33d, local buckling deformation of W-6-34-C1-C under constant compressive axial load after phase 2 loading (i.e. achieved rotation was 0.084 rads) is much more substantial compared to the W-6-34-C1-V specimen under varying axial load. Referring to Figures 5.33c and 5.33e, W-6-34-C2-C (long-duration collapse protocol) developed more local buckling damage than that of W-6-34-C1-C (near-fault collapse protocol).

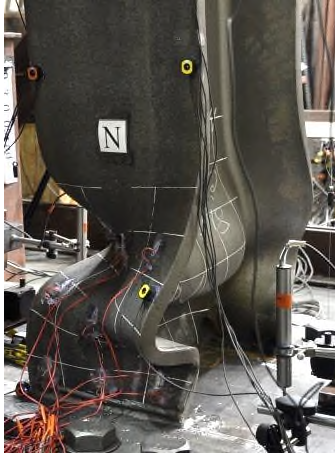
(g) W-6-25-S-C  
( $\theta_{max}=0.05$  rads)

Figure 5.33 Deformed shape of the tested wide flange specimens (continued)

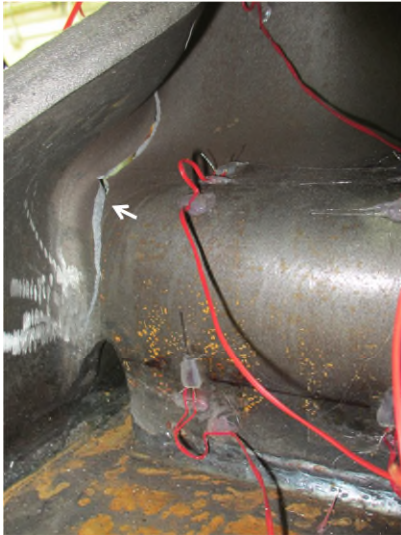
(a) k-area  
(W-8-34-S-C)

Figure 5.34 Typical fracture modes of wide flange specimens

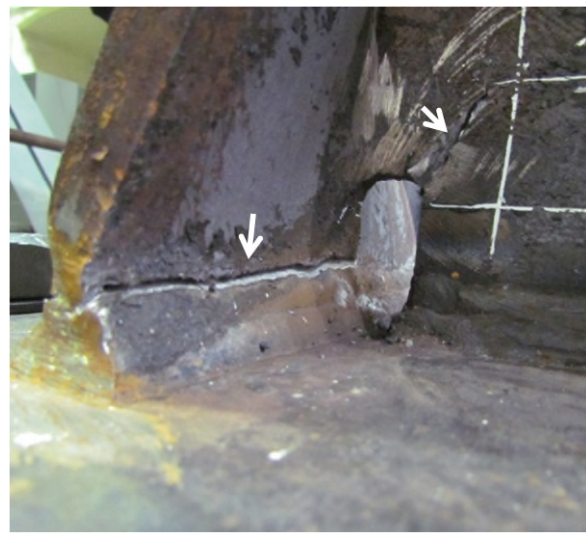
(b) flange weld toe and weld access hole  
(W-6-34-C2-V)

Figure 5.34 shows photos of typical fracture modes observed in the wide flange specimens. Referring to Figure 5.34a, wide flange columns subjected to a constant compressive axial load (typically interior columns in moment resisting frames) is likely to experience fracture in the k-area. This is attributed to the substantial growth of local buckling around the steel column web due to severe axial shortening. Referring to Figure 5.34b, stockier wide flange columns subjected to varying axial load may experience fracture in the flange welding toe and the web access hole if the AISC design provisions are not strictly followed. This is attributed to the high strain demand at the column base due to the delay of the local buckling formation.

Table 5.15 summarizes the achieved loading phase and associated maximum rotation of the specimens. From this table, except for specimens H-27-C1-V, H-27-C2-V, W-6-34-C1-V, W-6-25-C1-C and W-6-25-C1-V, the rest completely lost flexural strength and/or fractured as shown

in Figure 5.34. All specimens were tested to the stage where the bending moment degraded by at least 50% with respect to the peak moment. The general consensus is that end columns behaved better than interior columns that experienced a constant compressive axial load and were subjected to the same lateral loading history.

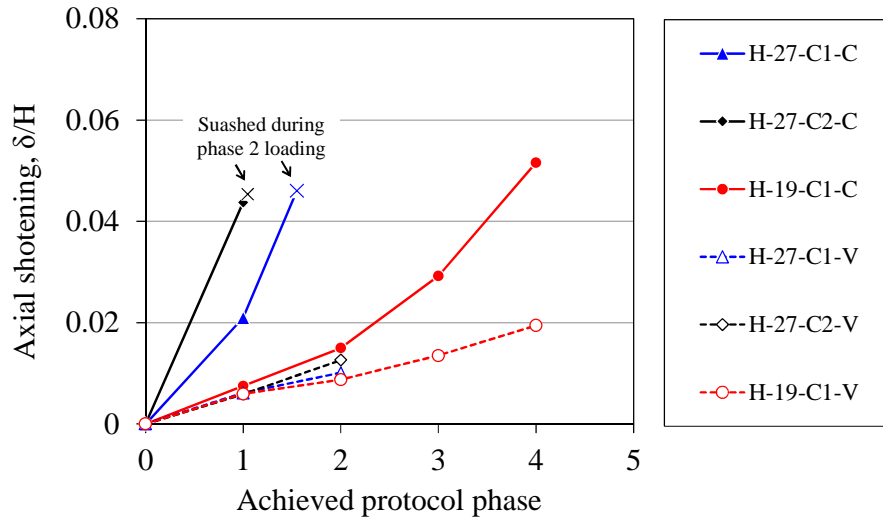
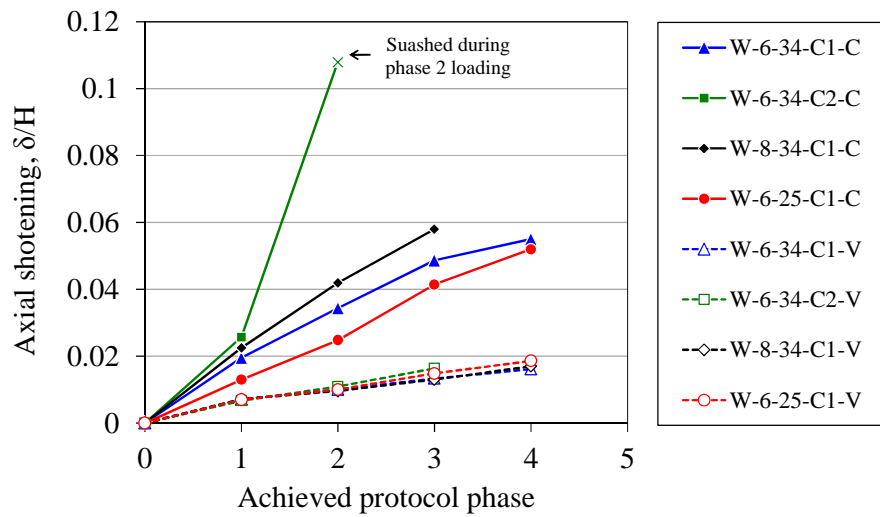
Figure 5.38 Achieved axial shortening after every collapse-consistent loading protocol phase

(a) HSS specimens

(b) wide flange specimens

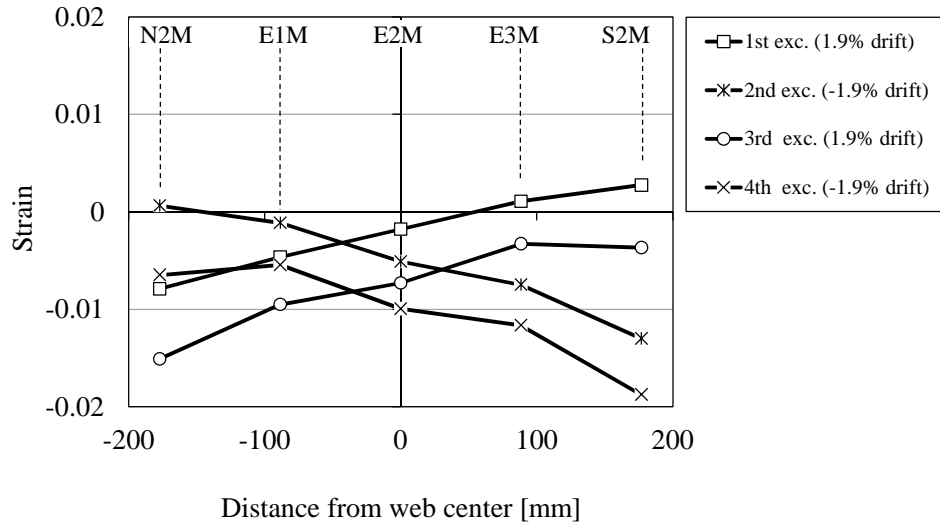
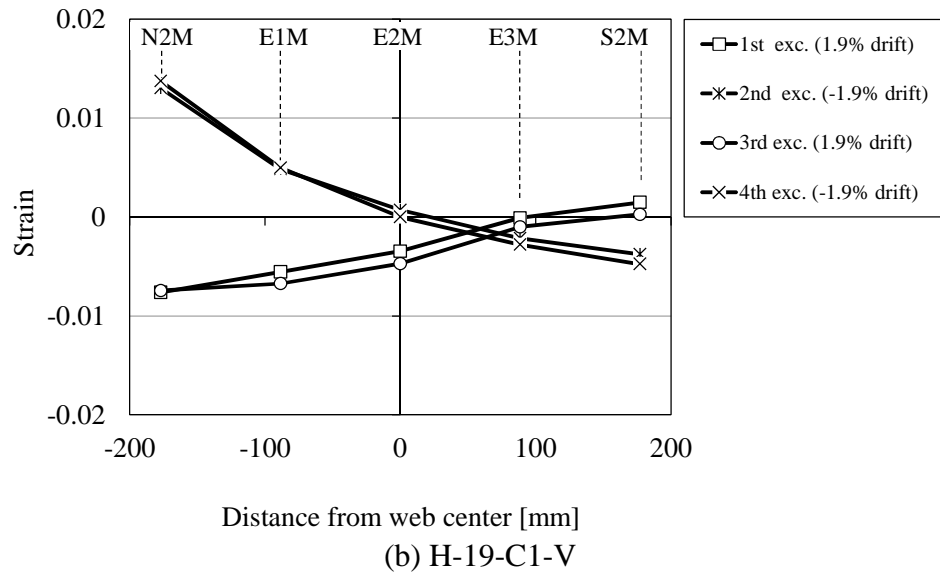
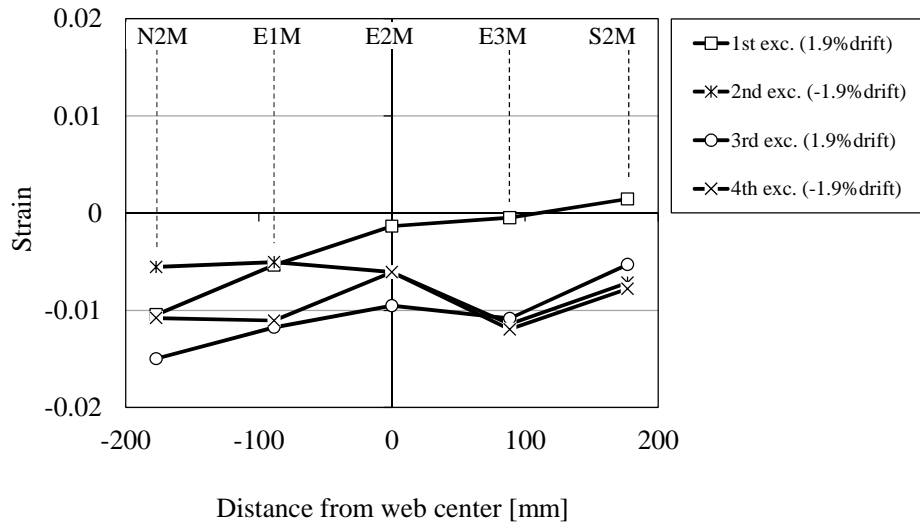
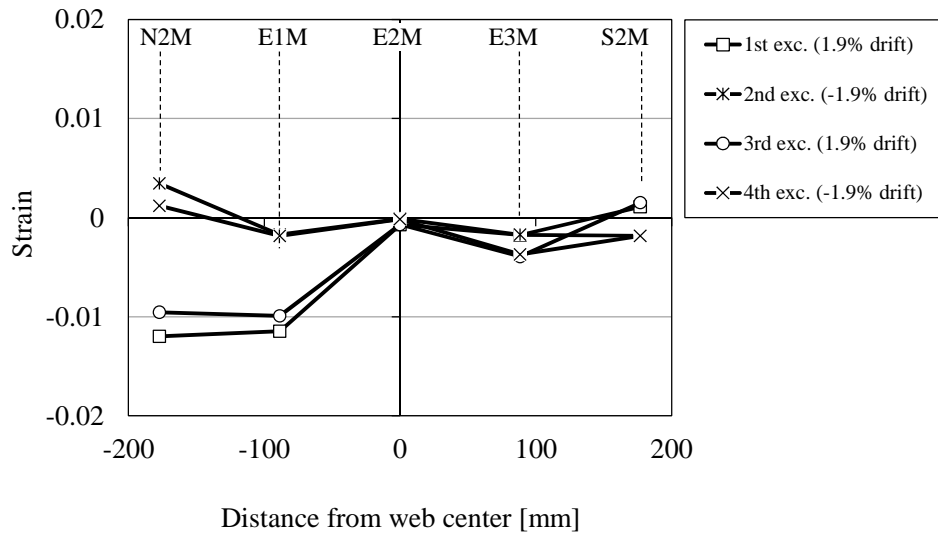
Figure 5.40 Strain distribution along latitudinal direction at  $0.5D$  height from base plate  
(continued)

Figure 5.40 Strain distribution along latitudinal direction at  $0.5 D$  height from base plate

(c) W-6-25-C1-C

(d) W-6-25-C1-V

- From the recorded strain distribution along the latitudinal direction of a column, a neutral axis shifting is observed. In particular, the neutral axis shifted both on north and south flange sides under constant axial load demands. On the other hand, the neutral axis of a cross section under varying axial load stayed only near the south flange of the steel column. This is the primary reason for the fundamental differences between the moment- and axial shortening-rotation relations of interior and end columns within the same steel MRF story.

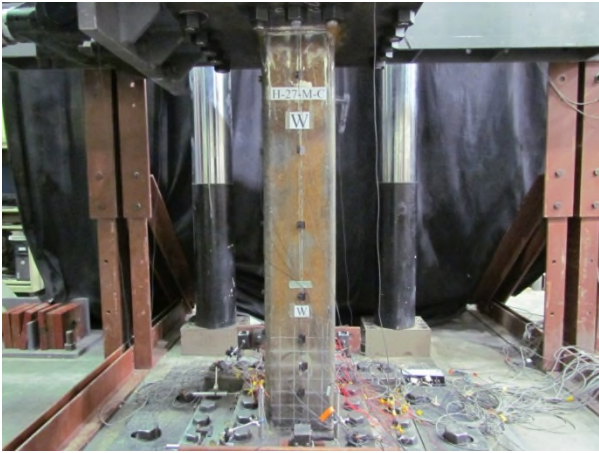
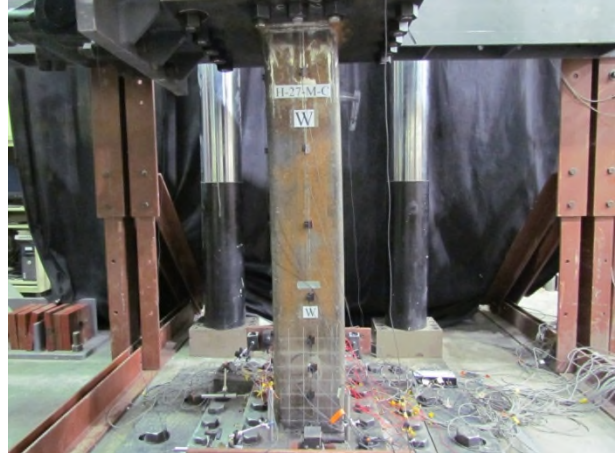
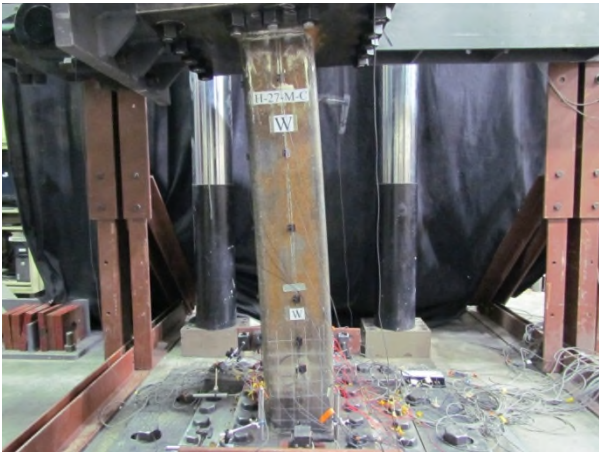
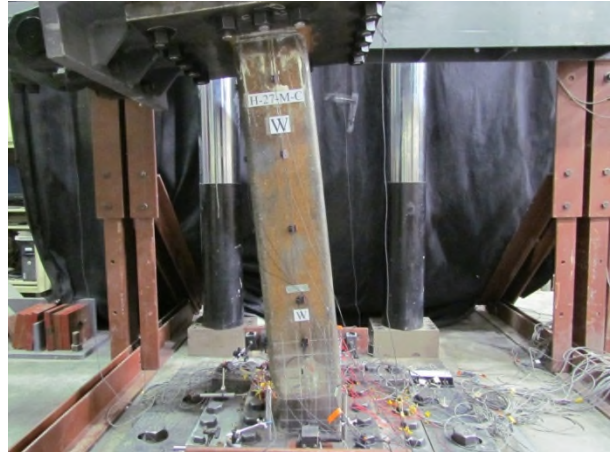
(a) before test

(b) 2% drift

(c) 6% drift

(d) 6% drift

Figure A.2 H-27-M-C: Overall deformed configuration (West view)

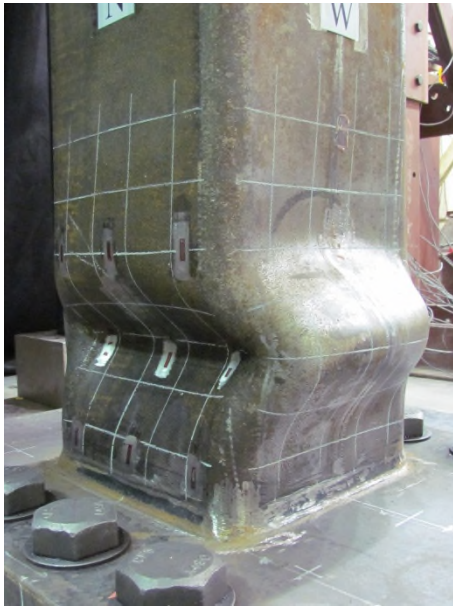
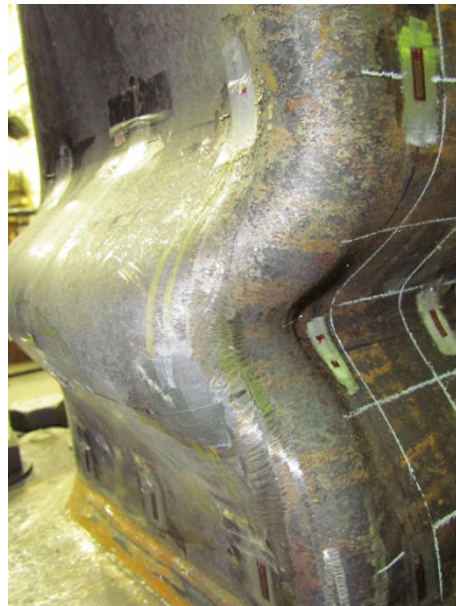
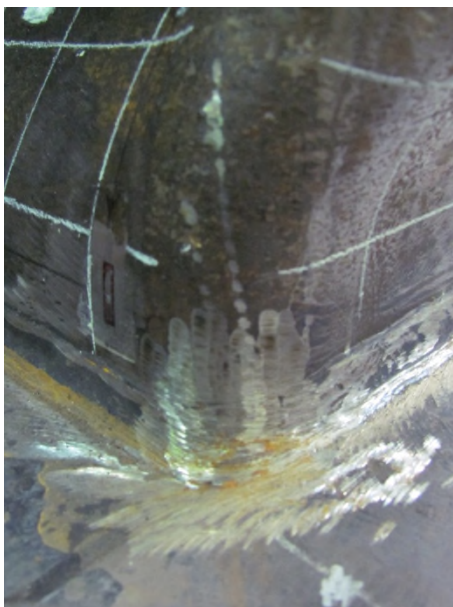
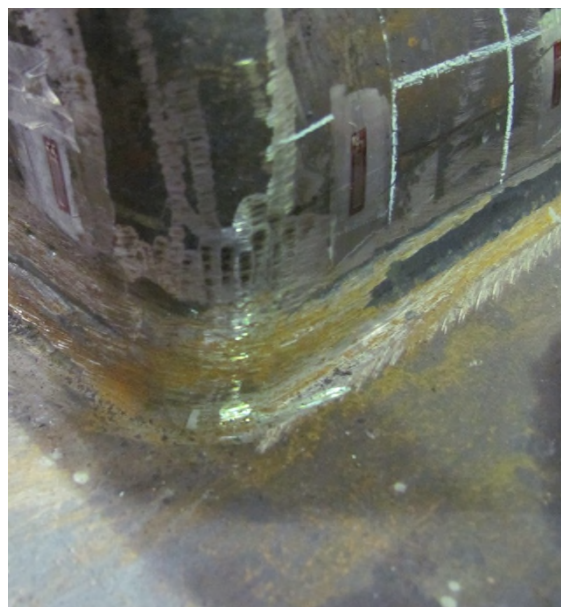
(a) North west view

(b) North east view

(c) Welding on north west corner

(d) Welding at north east corner

Figure A.3 H-27-M-C: Post-test specimen observation

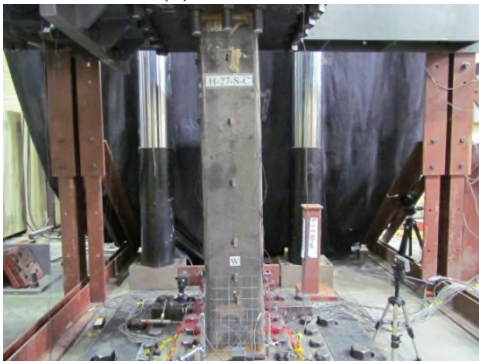
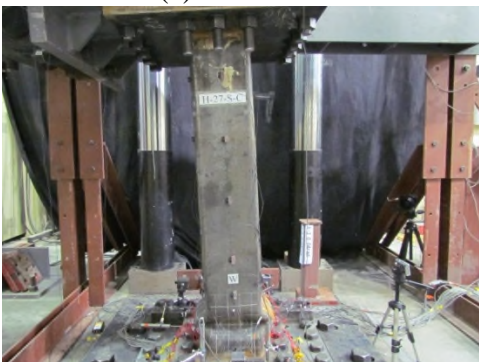
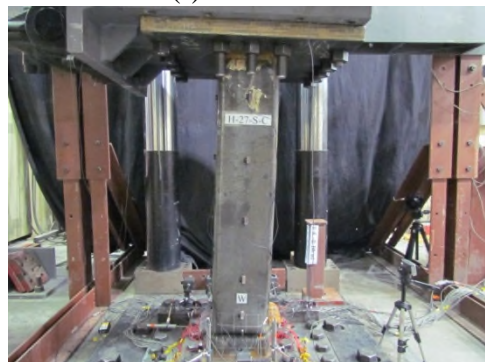
(c) +2% drift

(g) +4% drift

(h) -4% drift (squashed)

Figure A.5 H-27-S-C specimen: Overall deformed configuration (west view)

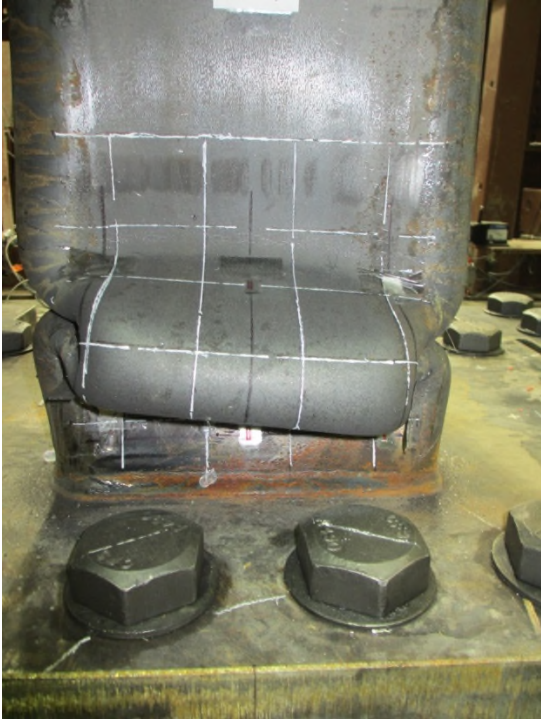
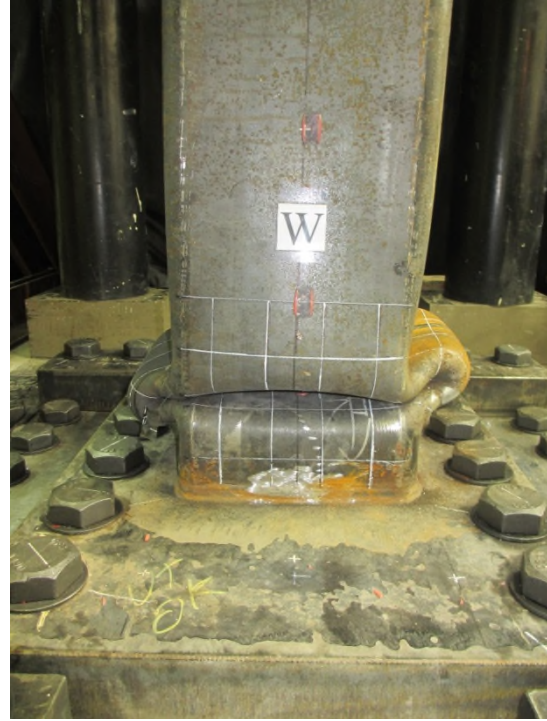
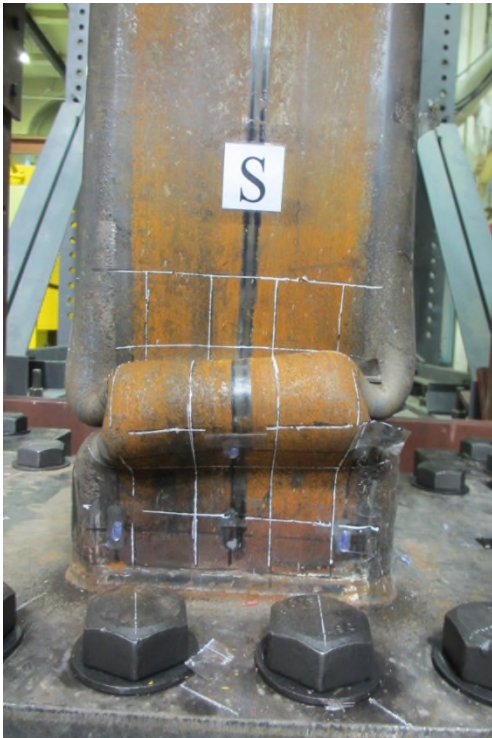
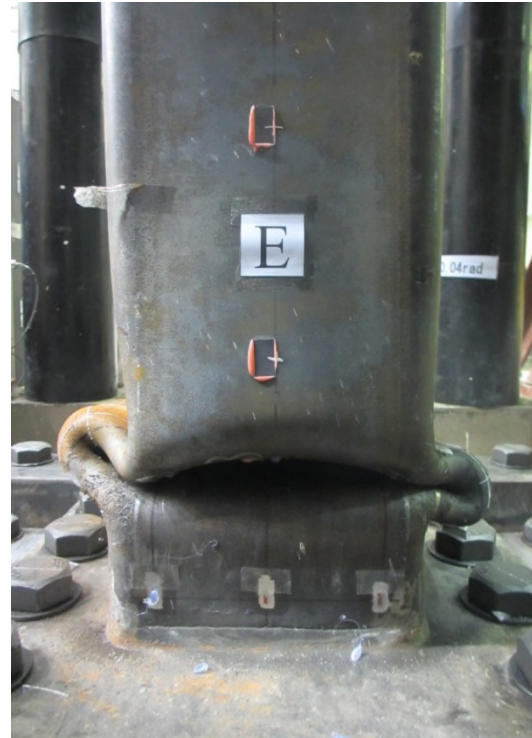
(a) North view

(b) West view

(c) South view

(d) East view

Figure A.6 H-27-S-C specimen: Post-test specimen observation

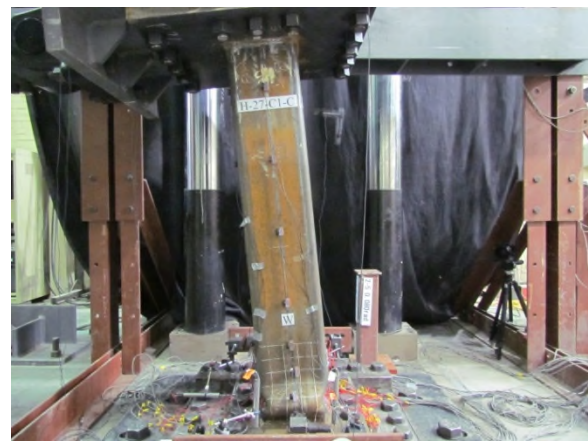
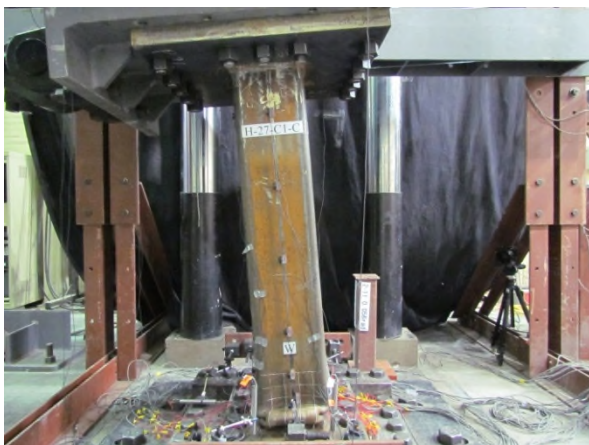
(d) 5<sup>th</sup> excursion in phase 2 (8% drift)

(e) 11<sup>th</sup> excursion in phase 2 (squashed)

Figure A.8 H-27-C1-C: Overall deformed configuration (West view)
