EARTHQUAKE-INDUCED COLLAPSE OF STEEL  
MOMENT RESISTING FRAMES WITH CONVENTIONAL  
AND HIGH PERFORMANCE STEEL COLUMNS

A thesis submitted to McGill University in partial fulfillment of the requirements  
of the degree of Doctor of Philosophy

# CHAPTER 5: Experimental Studies on the Collapse Behaviour of Steel Columns in Moment Resisting Frames

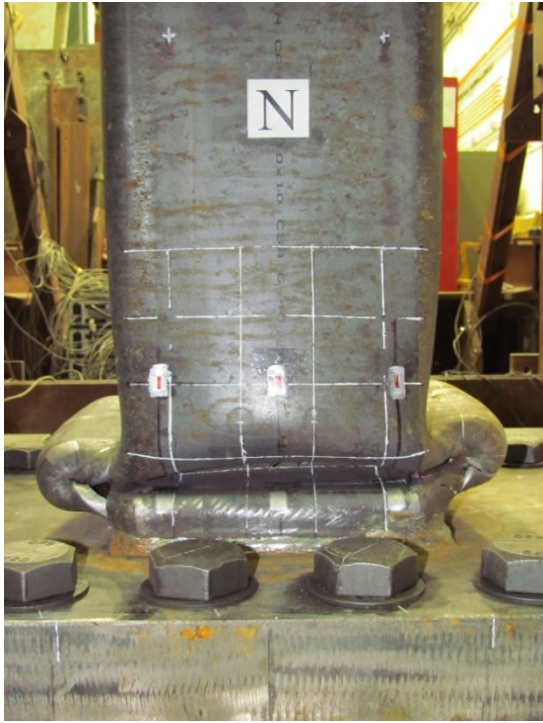
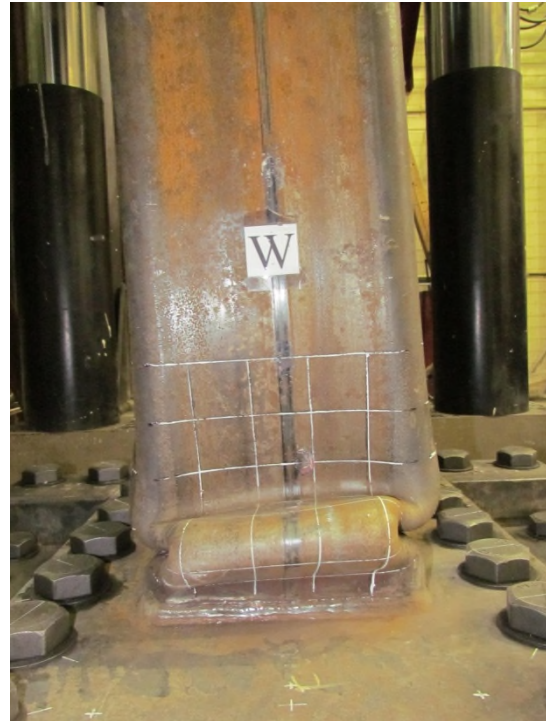
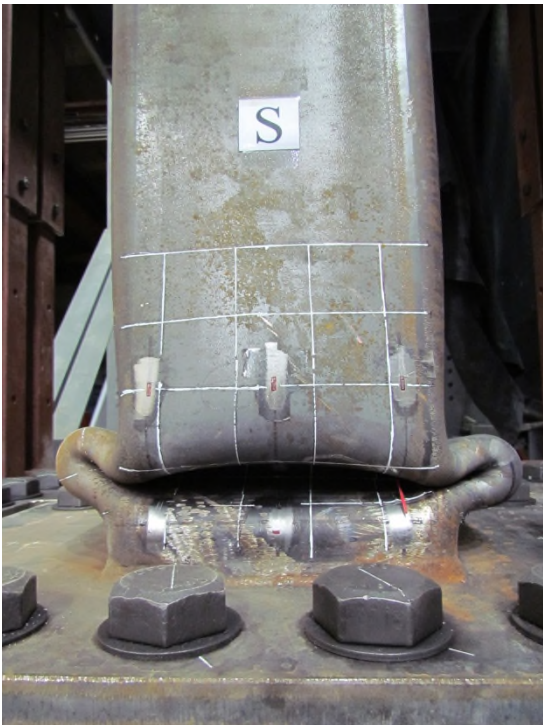
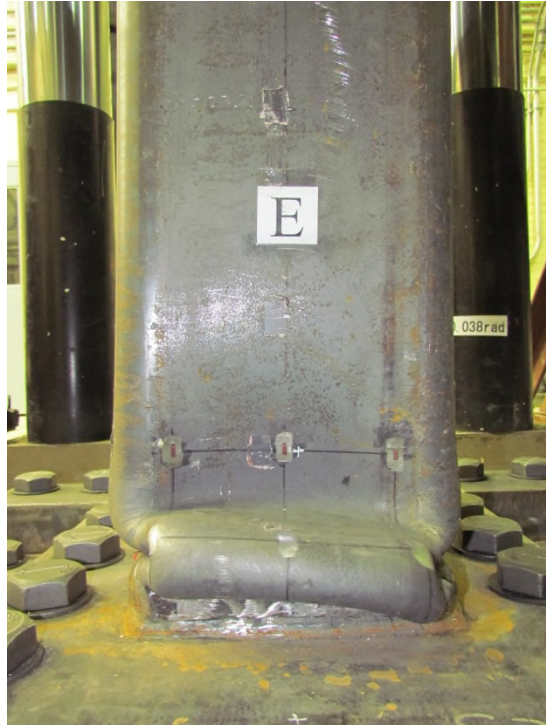
(a) North view

(b) West view

(c) South view

(d) East view

Figure A.9 H-27-C1-C: Post-test specimen observation

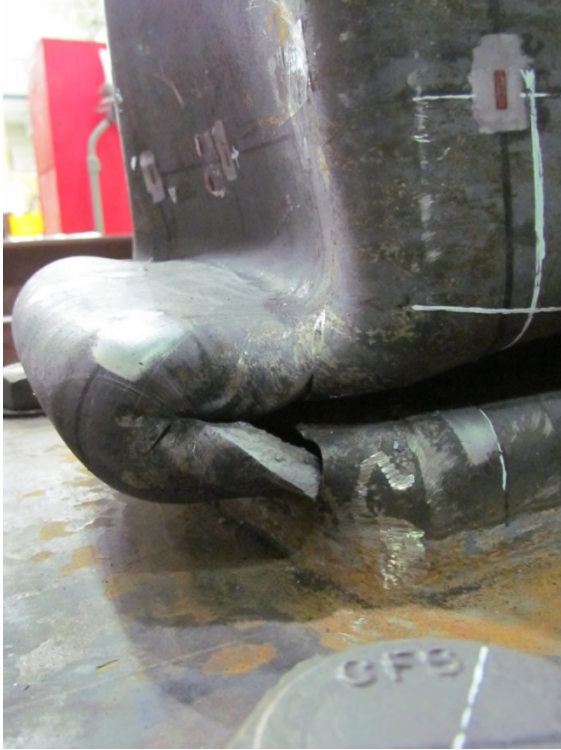
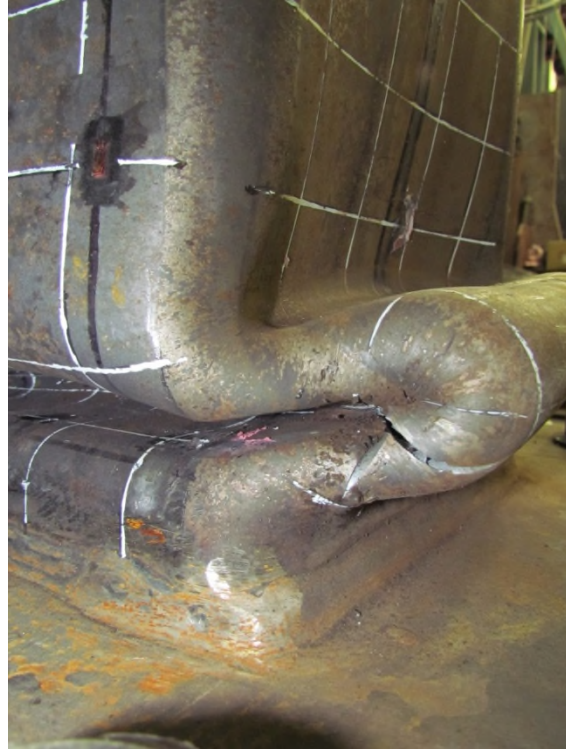
Figure A.9 H-27-C1-C: Post-test specimen observation (continued)

(e) North east corner fracture

(f) North west corner fracture

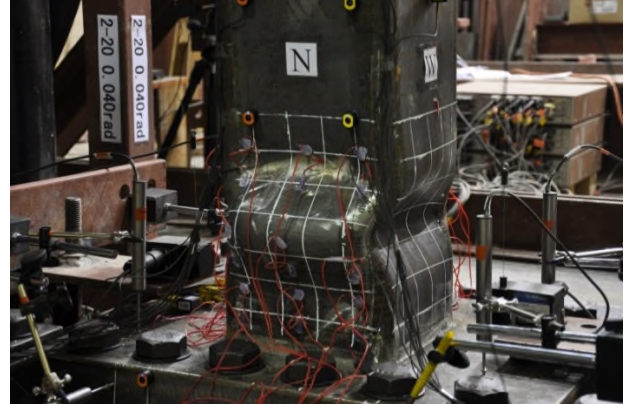
(f) End of phase 2 (4% drift)

Figure A.10 H-27-C1-V: Flange local buckling (North West view)

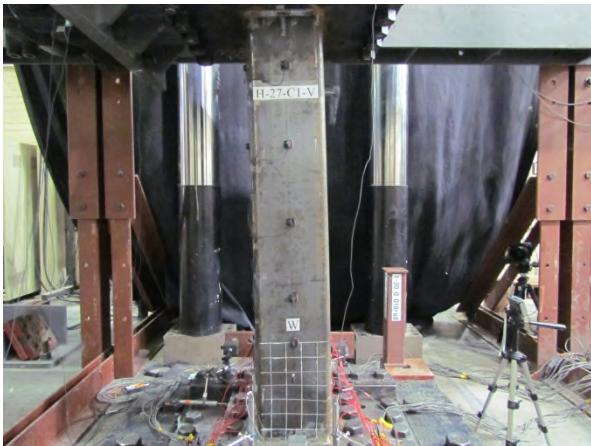
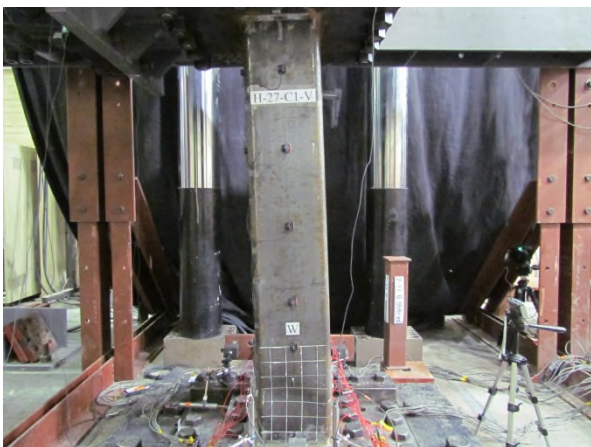
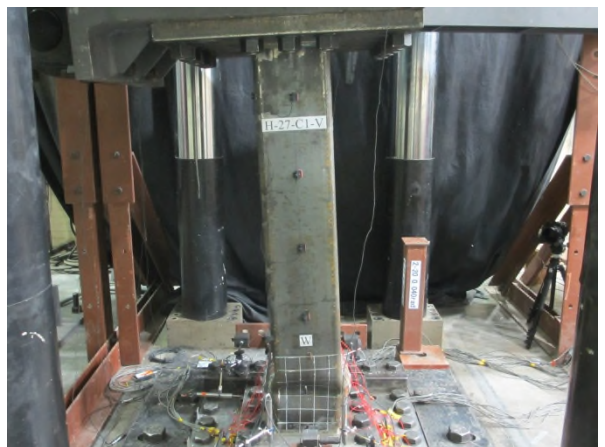
(c) End of phase 1 (1.8% drift)

(e) 11<sup>th</sup> excursion in phase 2 (5.6% drift)

(f) End of phase 2 (4% drift)

Figure A.11 H-27-C1-V: Overall deformed configuration (West view)

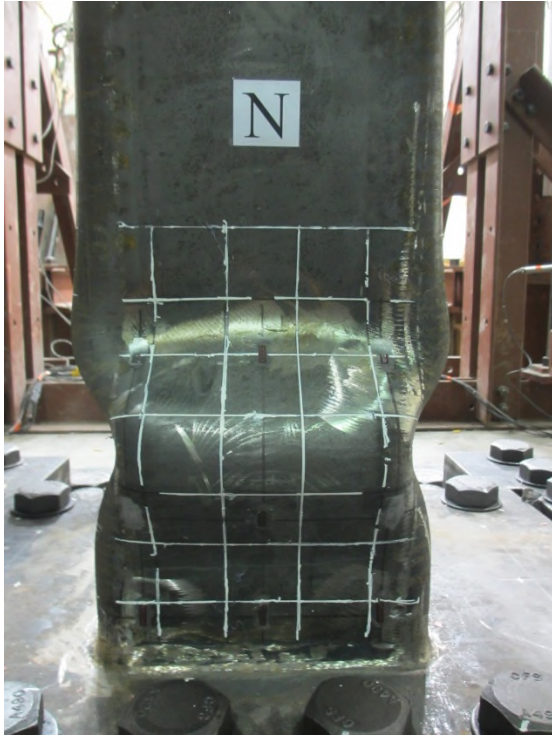
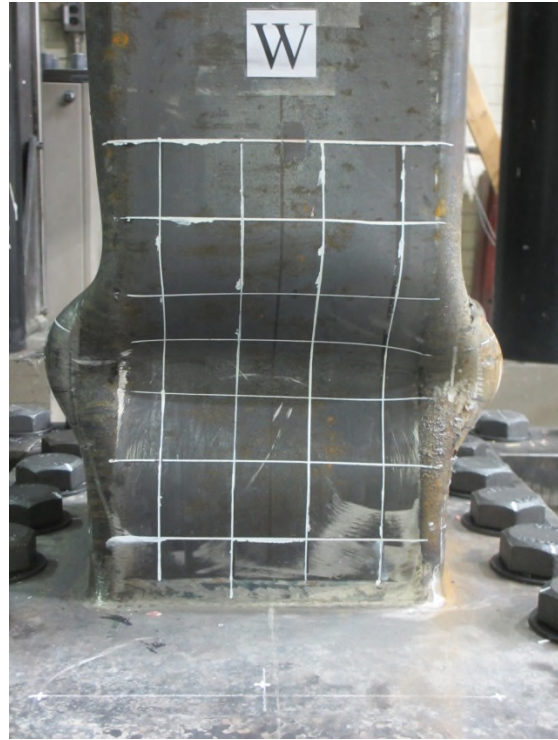
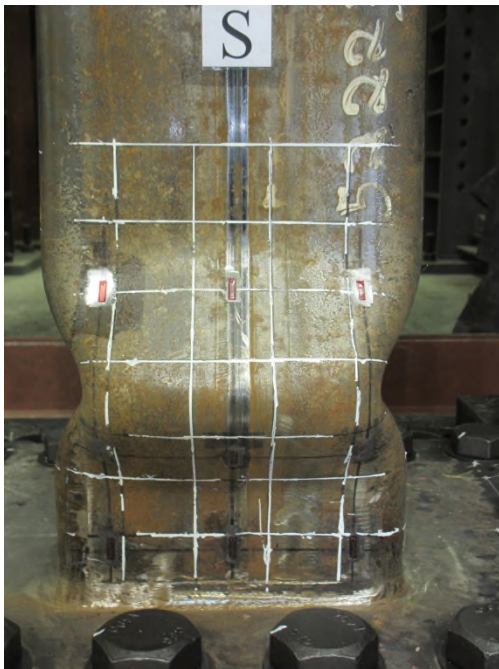
(a) North view

(b) West view

(c) South view

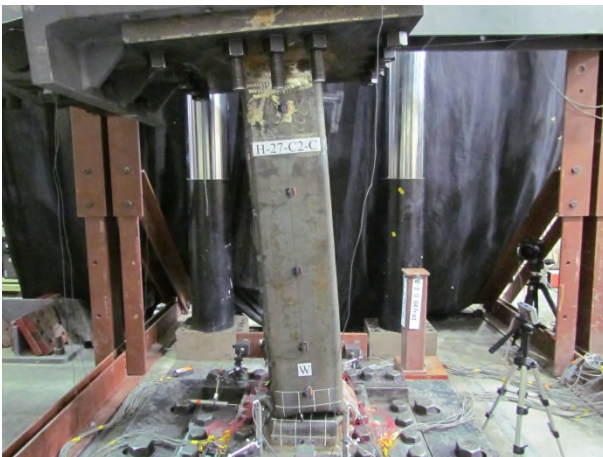
(e) 2<sup>nd</sup> excursion in phase 2 (squashed)

Figure A.14 H-27-C2-C: Overall deformed configuration (West view)

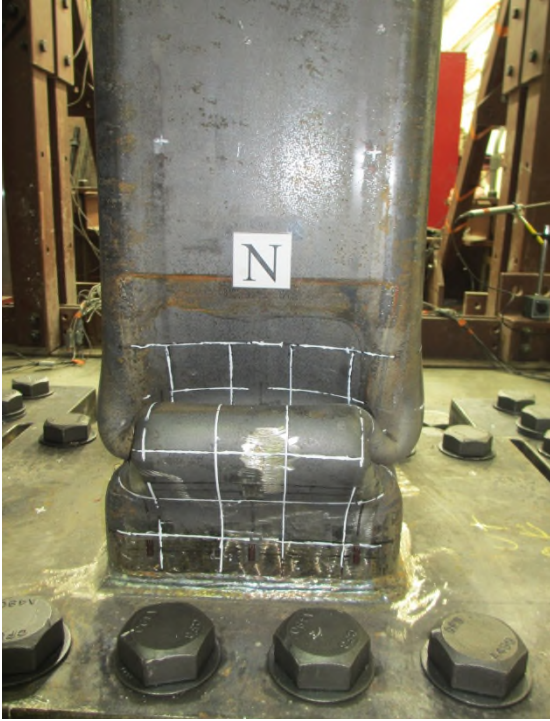
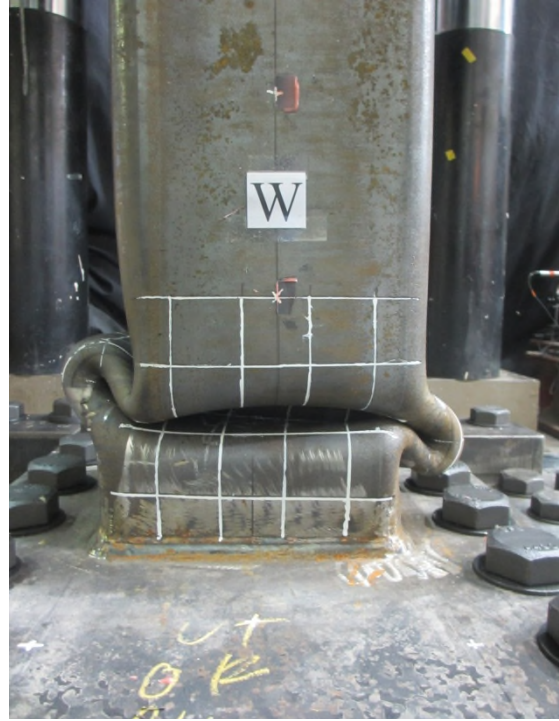
(a) North view

(b) West view

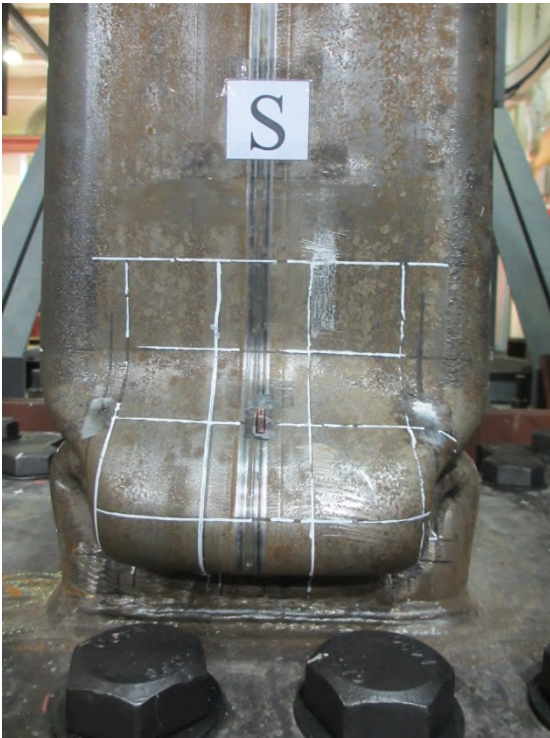
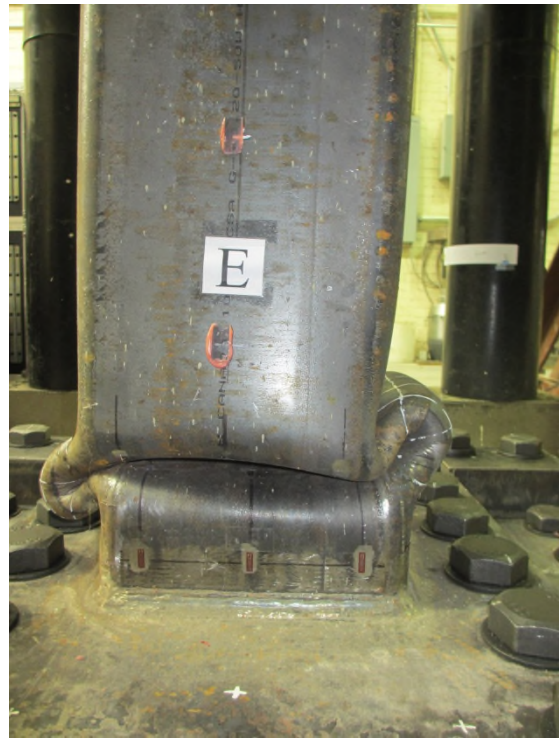
Figure A.15 H-27-C2-C: Post-test specimen observation

(c) South view

(d) East view

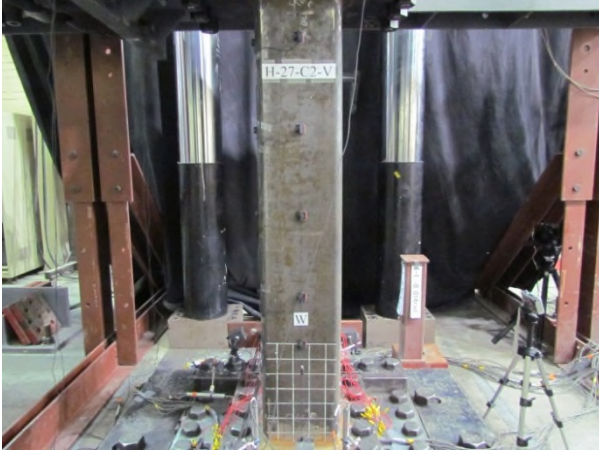
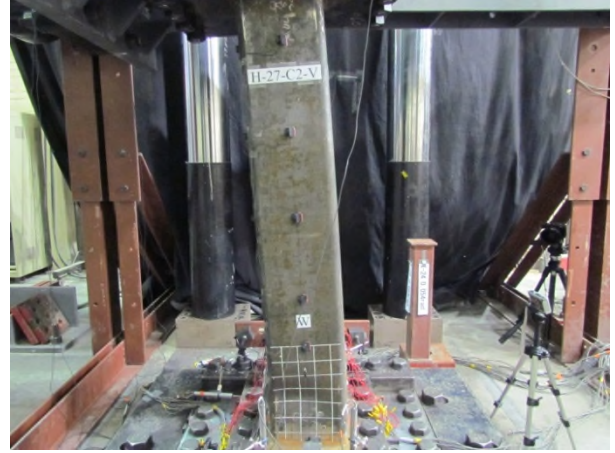
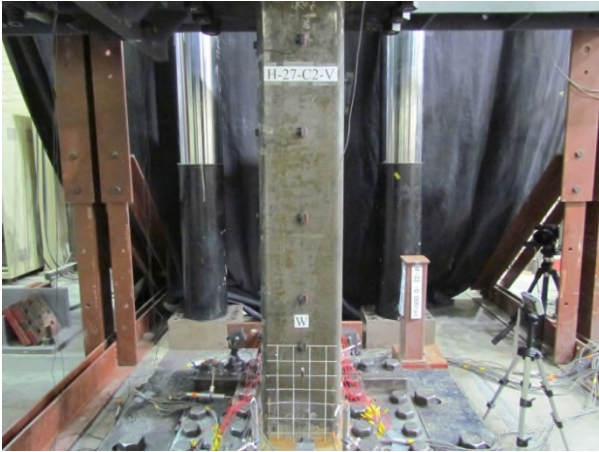
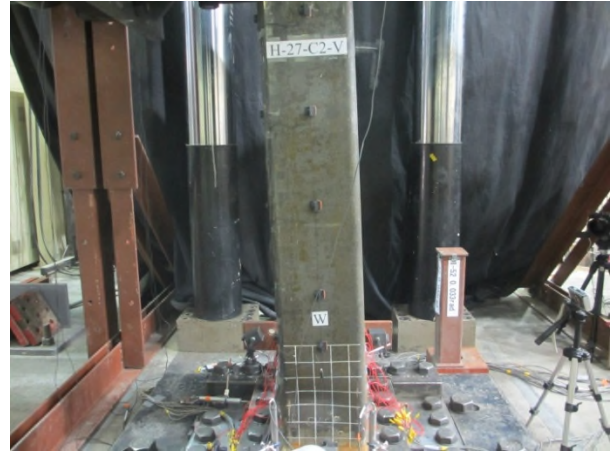
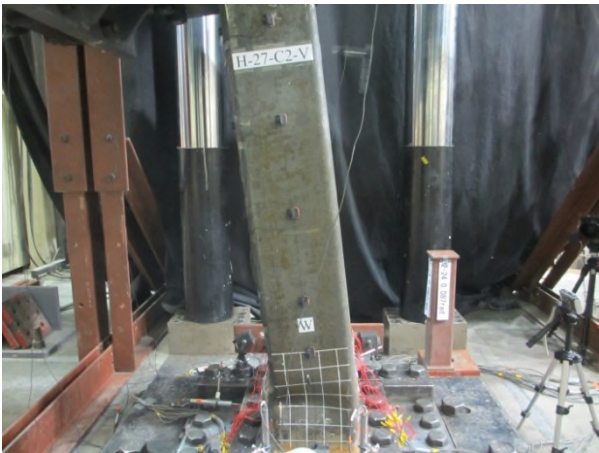
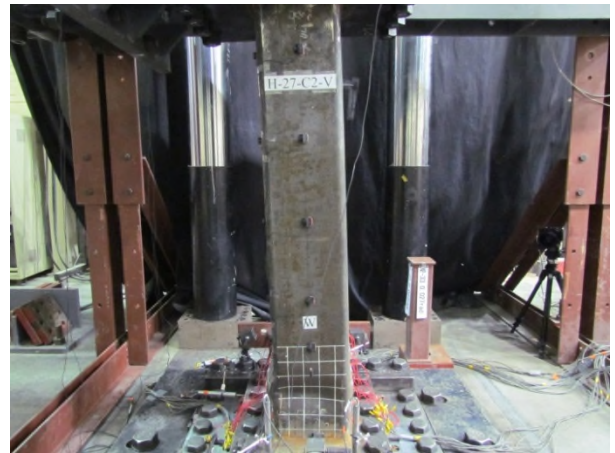
Figure A.17 H-27-C2-V: Overall deformed configuration (West view)

(a) Before test

(b) 24<sup>th</sup> excursion in phase 1 (5.4% drift)

(c) 33<sup>rd</sup> excursion in phase 1 (-0.6% drift)

(d) End of phase 1 (3.3% drift)

(e) 24<sup>th</sup> excursion in phase 2 (8.7% drift)

(f) 33<sup>rd</sup> excursion in phase 2 (2.7% drift)

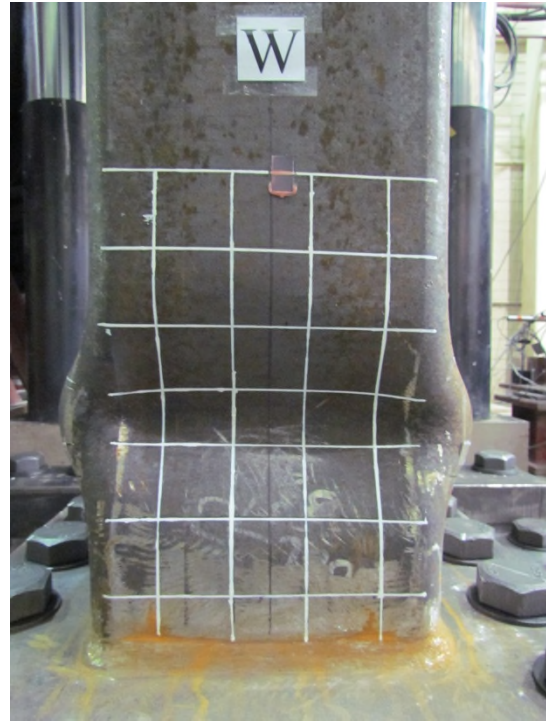
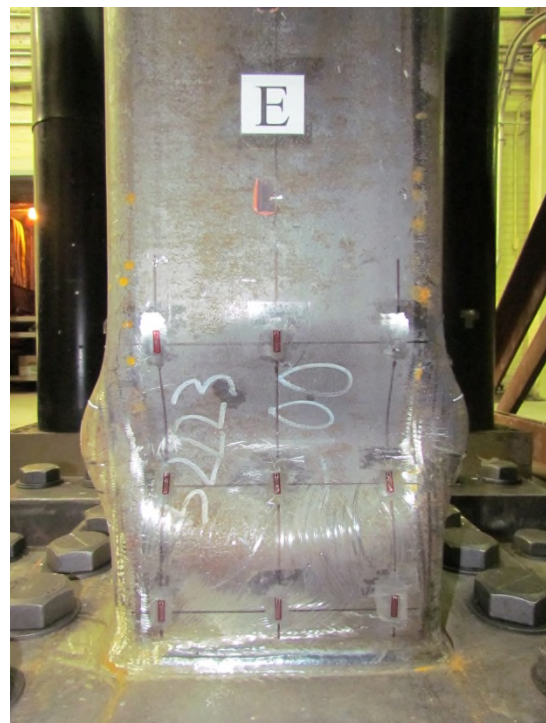
Figure A.18 H-27-C2-V: Post-test specimen observation

(b) West view

(d) East view

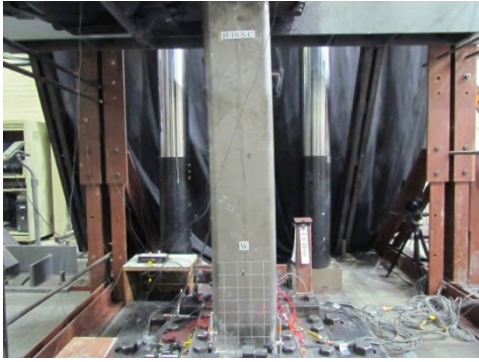
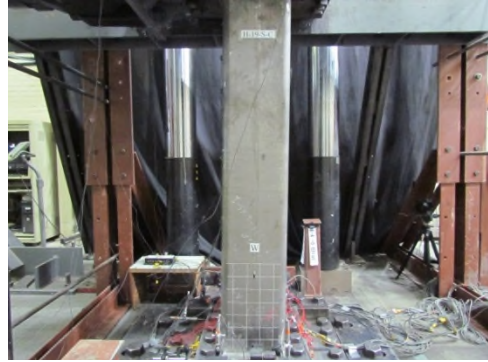
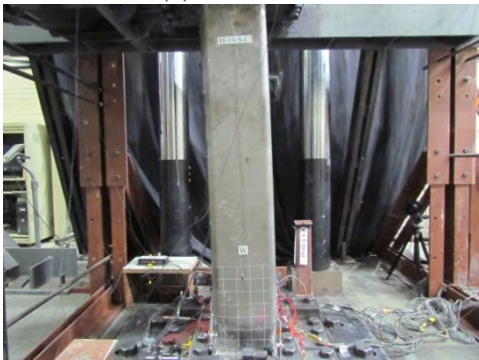
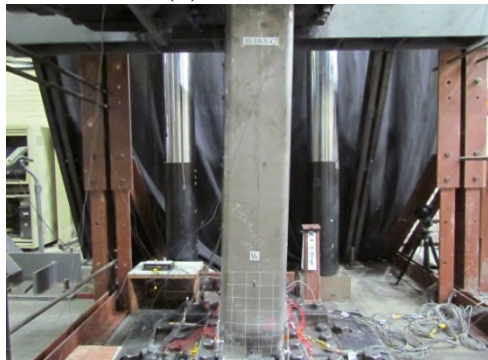
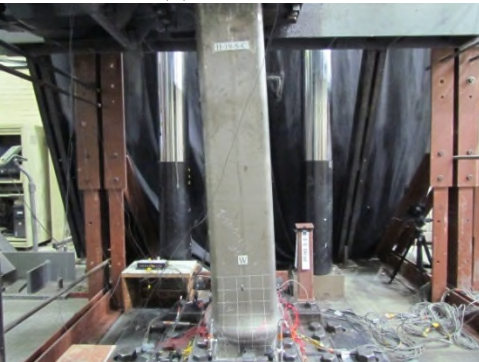
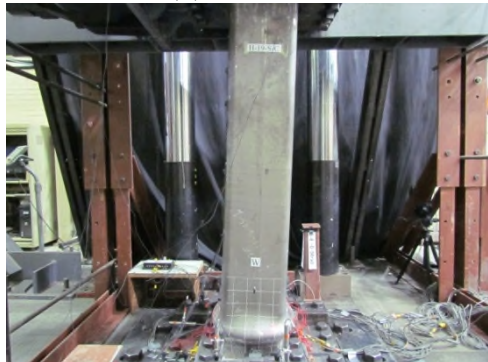
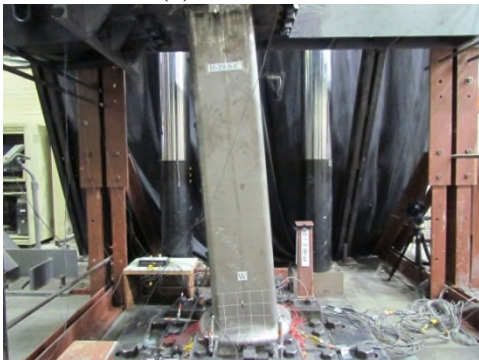
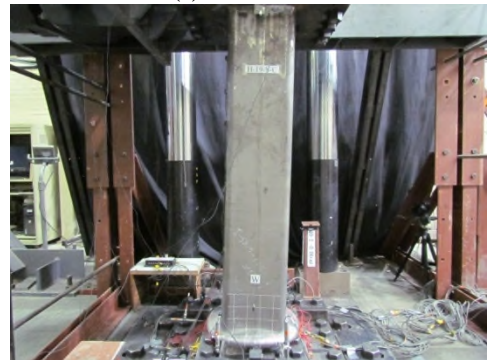
Figure A.20 H-19-S-C: Overall deformed configuration (West view)

(a) +2% drift

(b) +2% drift

(c) +3% drift

(d) -3% drift

(e) +4% drift

(f) -4% drift

(g) +6% drift

(h) -6% drift

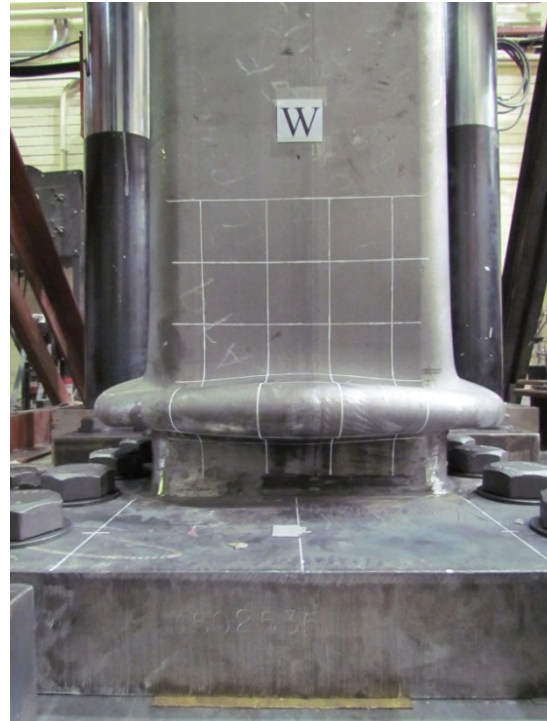
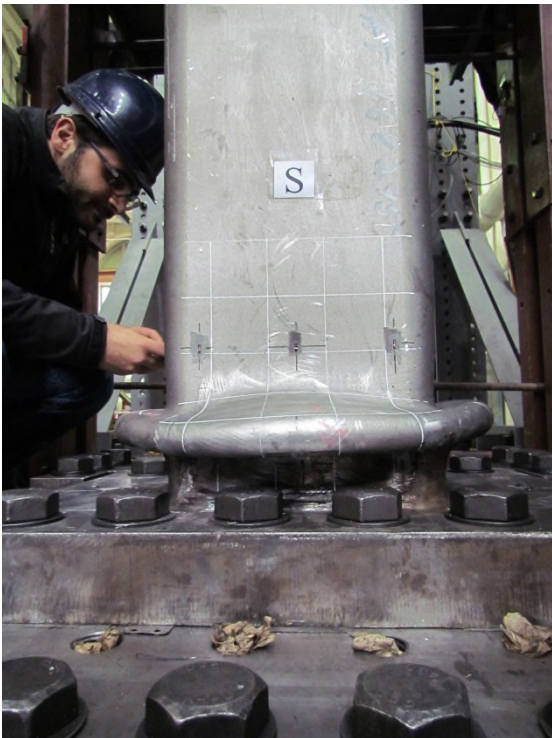
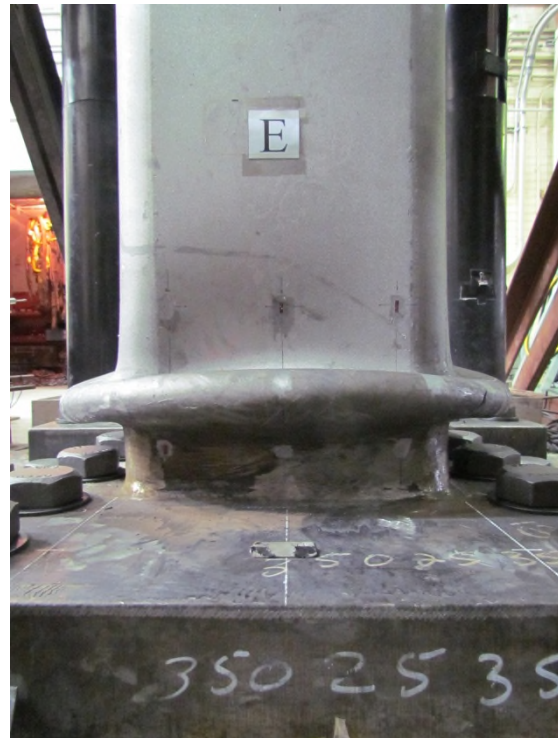
Figure A.21 H-19-S-C: Post-test specimen observation

(b) West view

(c) South view

(d) East view

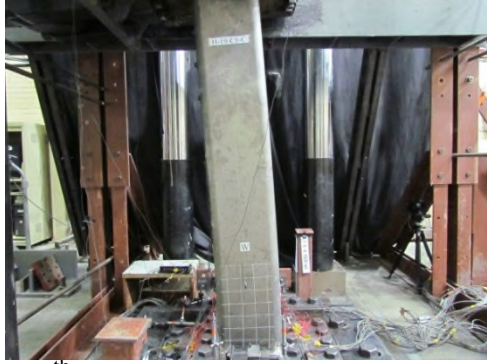
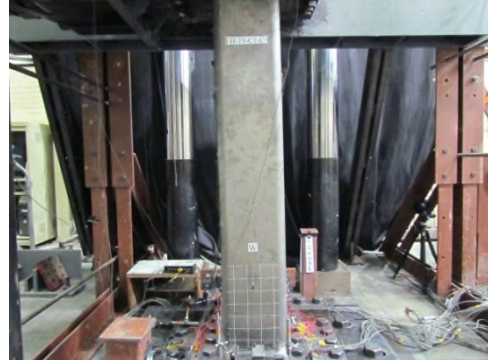
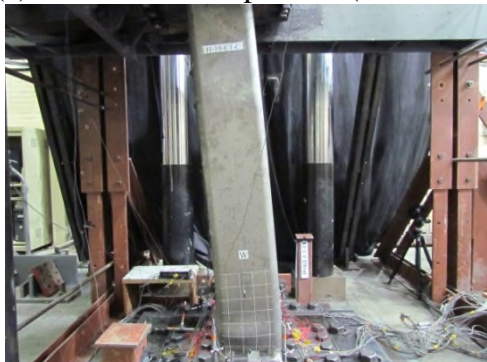
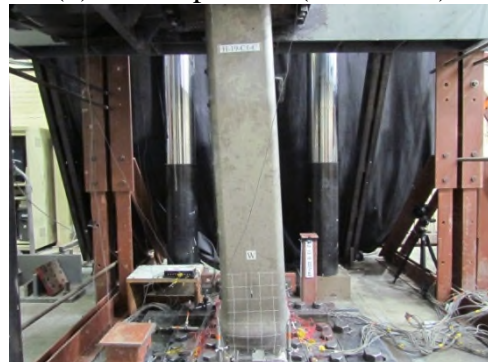
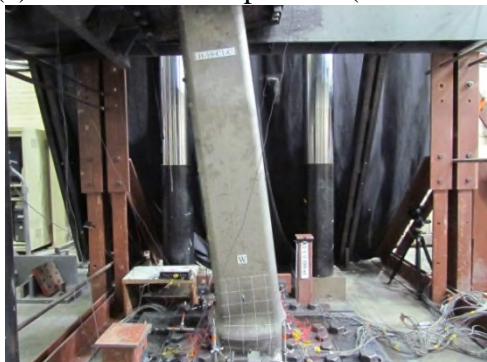
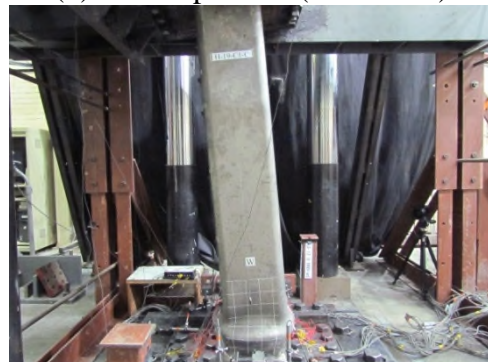
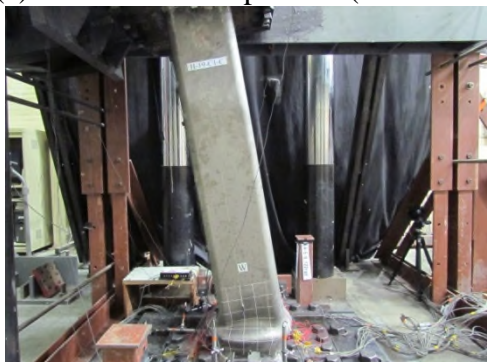
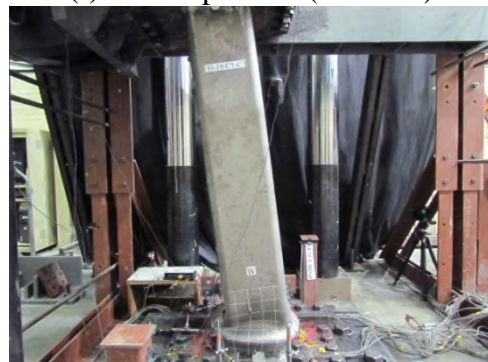
Figure A.23 H-19-C1-C: Overall deformed configuration (West view)

(a) 5<sup>th</sup> excursion in phase 1 (5.9% drift)

(b) End of phase 1 (1.4% drift)

(c) 5<sup>th</sup> excursion in phase 2 (7.6% drift)

(d) End of phase 2 (3.7% drift)

(e) 5<sup>th</sup> excursion in phase 3 (9.9% drift)

(f) End of phase 3 (6% drift)

(g) 5<sup>th</sup> excursion in phase 4 (12.2% drift)

(h) End of phase 4 (8.3% drift)

During Phase 3 loading, the steel column deteriorated in flexural to about 40% of its capping strength at a drift amplitude close to 10% rads. The associated axial shortening of the column was in the range of 2.5% of its length. This can be seen in Figures A.22e and A.23e that show the progression of local buckling at the base of the column at this drift amplitude. Note that after this point, column axial shortening increased fairly fast to about 3% of the column length due to the remaining small inelastic cycles of Phase 3 loading. During Phase 4 loading, once the steel column experienced a 12.2% target drift amplitude (i.e., peak drift of Phase 4 loading) its flexural strength degraded close to zero and the associated axial shortening was in the range of 4% of the steel column length. After this the applied axial load was reduced from 30% to 25% due to equipment limitation and the capping moment after this excursion slightly increased due to the relaxation of the second order moment. Column axial shortening accumulated to about 5.1% of the initial length of the specimen. Figures A.22h and A.23h illustrate the progression of

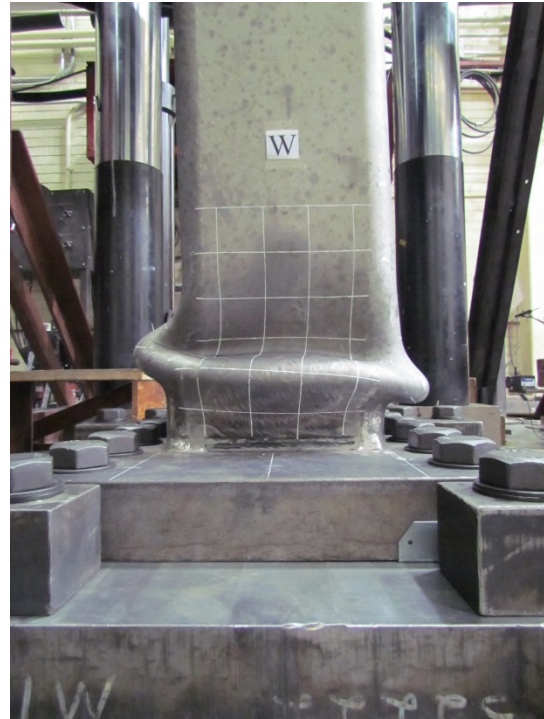
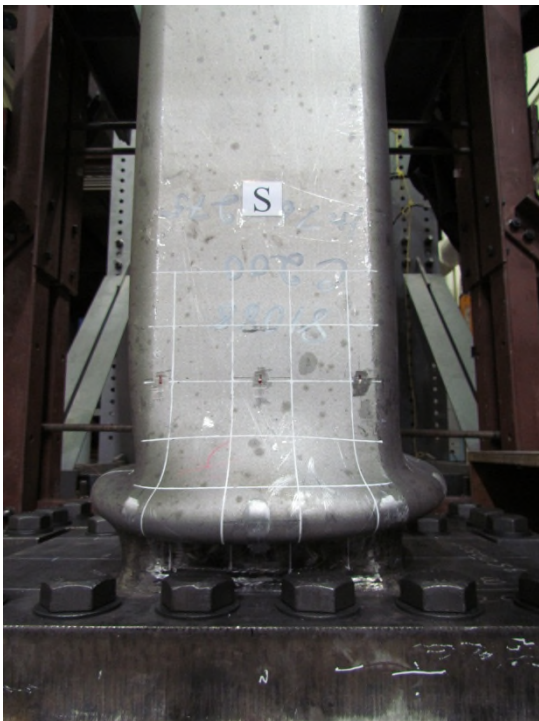
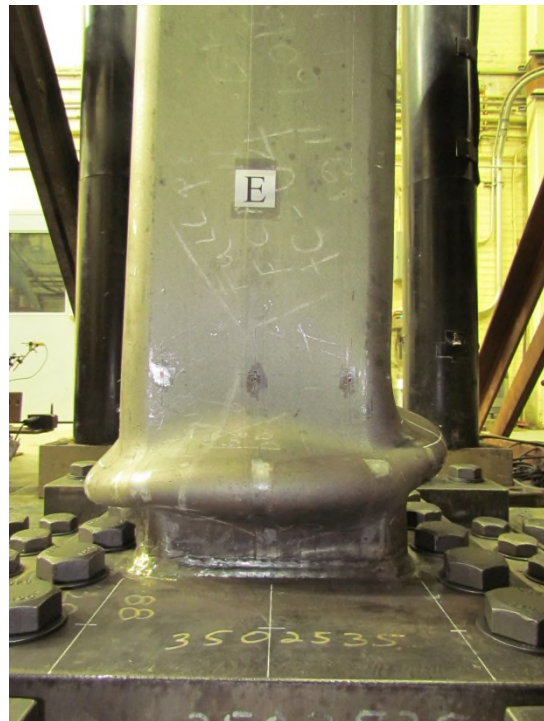
Figure A.24 H-19-C1-C: Post-test specimen observation

(b) West view

(c) South view

(d) East view

local buckling at the base location of the column after the end of the test. Fracture and torsional deflection was not observed during this test, as shown in Figure A.24.

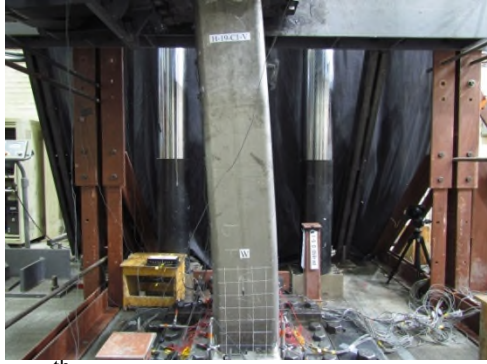
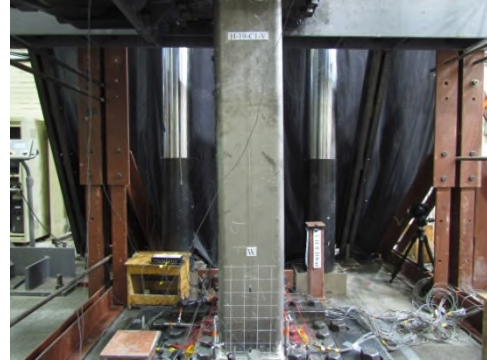
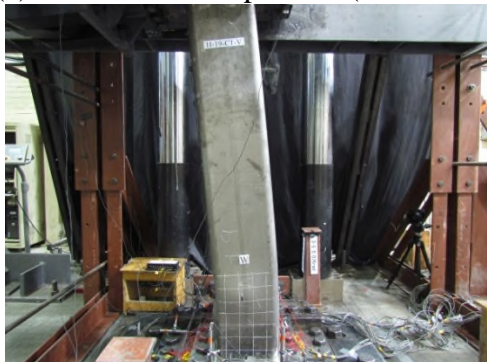
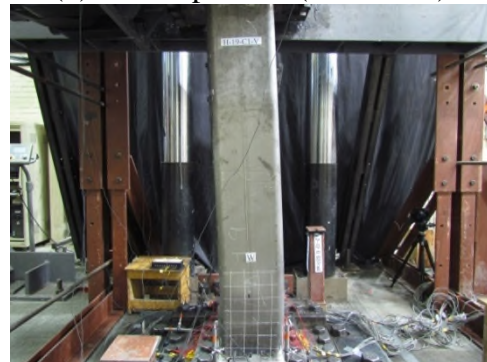
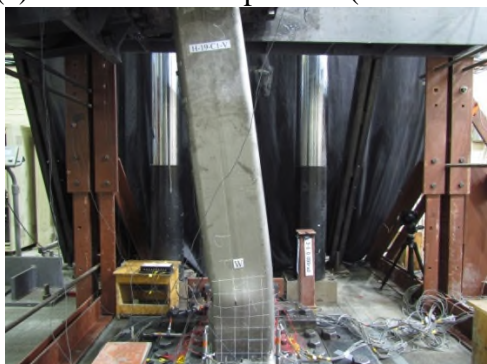
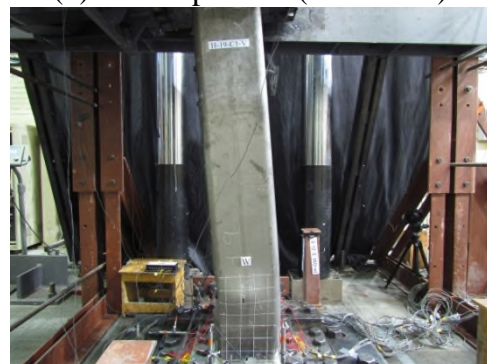
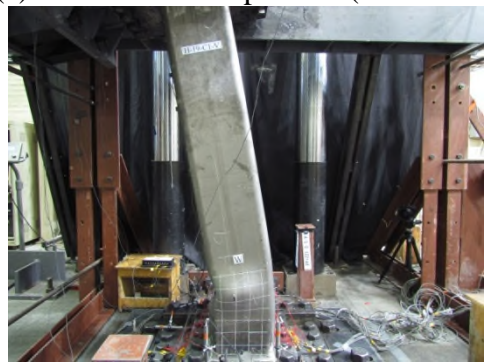
Figure A.26 H-19-C1-V: Overall deformed configuration (West view)

(a) 5<sup>th</sup> excursion in phase 1 (5.9% drift)

(b) End of phase 1 (1.4% drift)

(c) 5<sup>th</sup> excursion in phase 2 (7.6% drift)

(d) End of phase 2 (3.7% drift)

(e) 5<sup>th</sup> excursion in phase 3 (9.9% drift)

(f) End of phase 3 (6% drift)

(g) 5<sup>th</sup> excursion in phase 4 (12.2% drift)

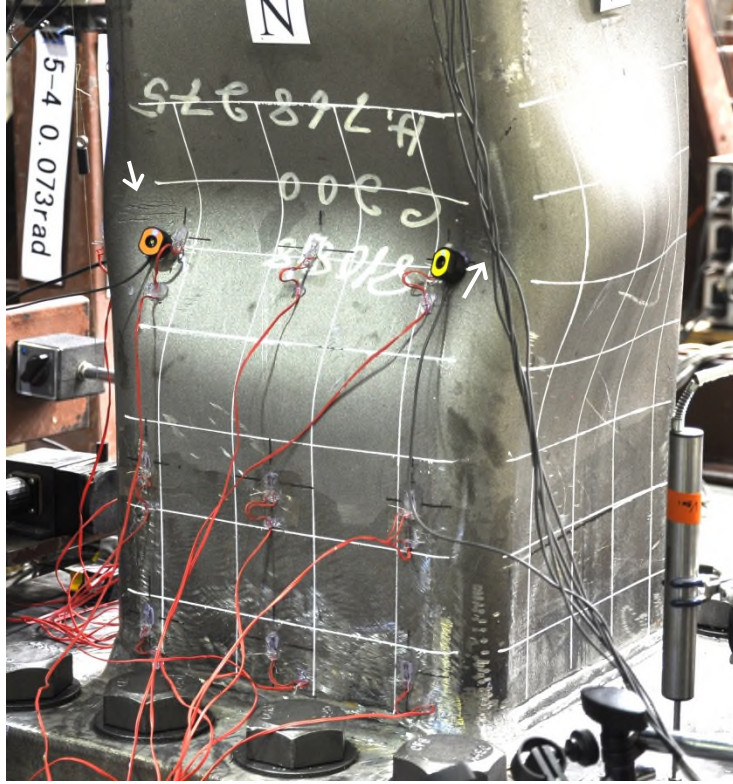
Figure A.27 H-19-C1-V: Post-test specimen observation (North West view)

Fracture did not occur in any of the tested HSS columns. Ductile tearing was only observed at the corner portion of the H-19-C1-V specimen near the end of the test. No observed cracks were evident at the welding toe of all the HSS columns even for very compact cross-sections.

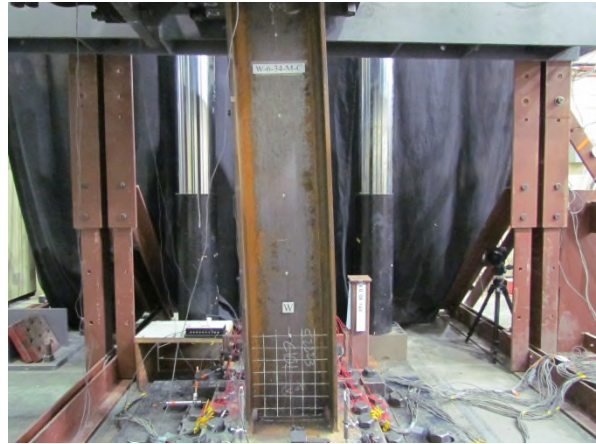
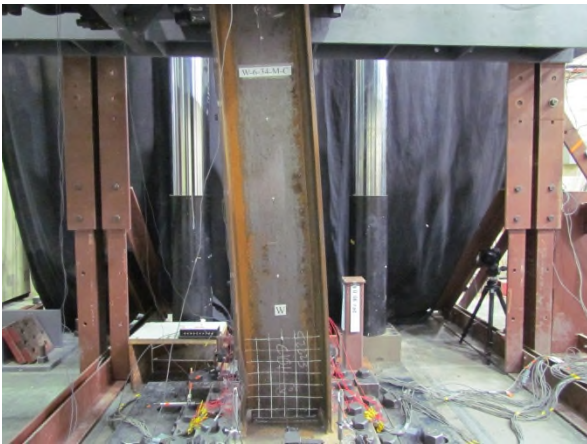
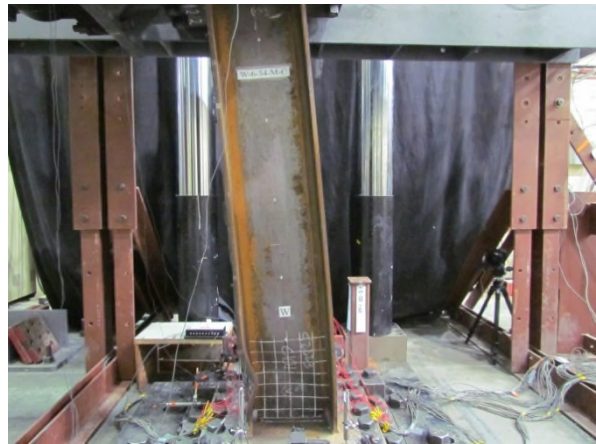
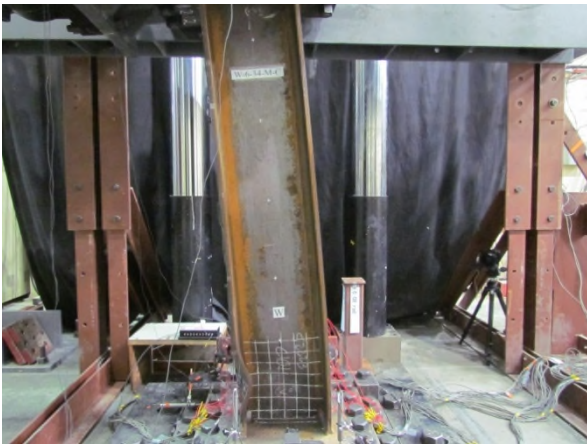
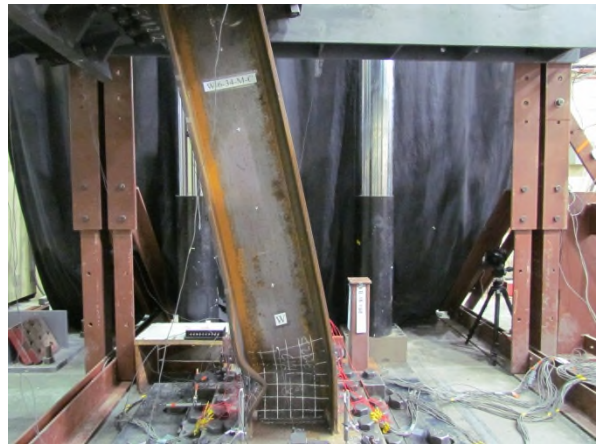
Figure A.29 W-6-34-M-C: Overall deformed configuration (West view)

(a) 2% drift

(b) 4% drift

(c) 6% drift

(d) 8% drift

(e) 10% drift

(f) 16% drift

Figures A.28 and A.29 show global and local snapshots of W-6-34-M-C specimen that shows the progression of local buckling during testing, respectively. Figure A.30 shows photos of the post-test observation of the same specimen. The specimen W-6-34-M-C was tested under monotonic lateral loading protocol with constant axial load of  $-0.3P_y$  (-1134kN). In this testing the flexural strength of the column deteriorated at about 4% rads. The north flange and web buckled at 4% drift and the moment capped at this point (see Figures A.28b and A.29b). The buckling mode of the flange had a half wavelength of  $1.0D$ ; the buckling center was located at a height of  $0.6D$  from the top surface of the base plate of the specimen. This can be clearly seen from Figures A.28c that shows the progression of local buckling of the column at 6% rad. Once the column was pushed laterally to 10% drift, a second wave buckling began to develop as shown in Figures A.28e. The buckling length of the second wave was equal to  $1.0D$  and the buckling center was at a height of  $1.2D$  from the top surface of the base plate. After this stage, the secondary buckling

was more dominant than the first one and that triggered lateral torsional buckling. This can be seen by a simple comparison between Figures A.28e and A.28f. From these figures, the primary buckling closer to the base did not develop much between 10% and 16% drift ratios. At 16% drift, the moment deteriorated close to 15% of its capping moment. Axial contraction was 2.4% of the column length at the same drift ratio. South flange did not buckle during the test. Fracture was not observed in this test, as shown in Figure A.30 that illustrates post-test observations after the completion of the test.

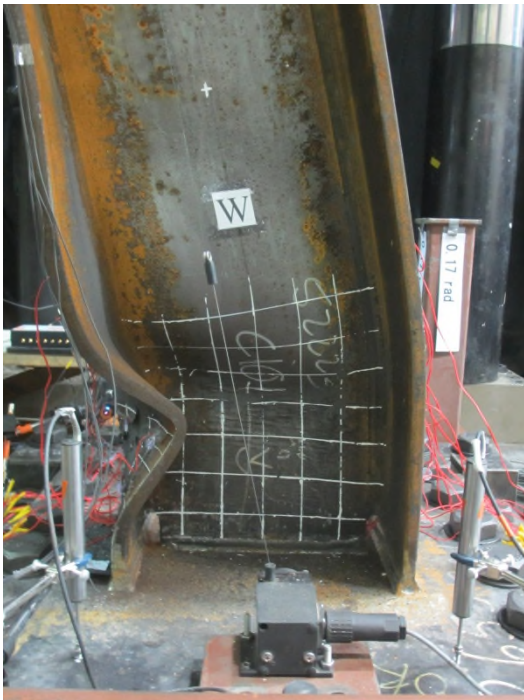
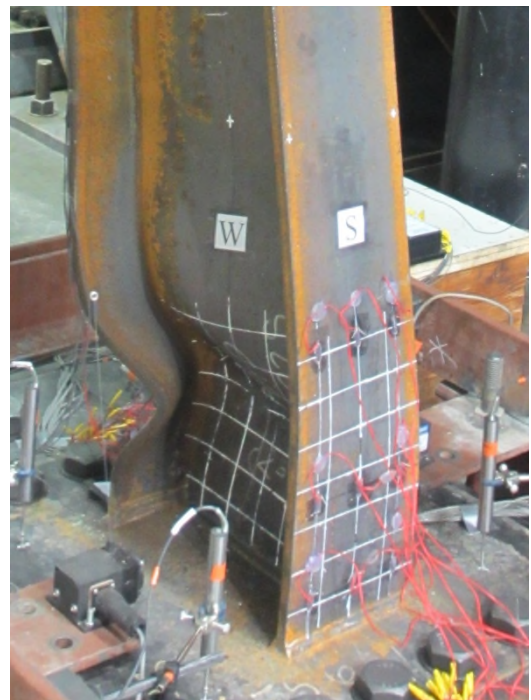
Figure A.30 W-6-34-M-C: Post-test specimen observation

(b) North East view

(c) West view

(d) South West view

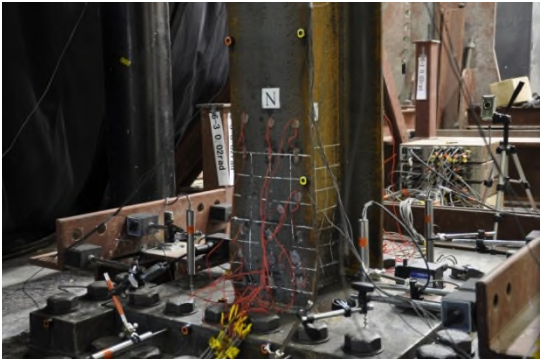
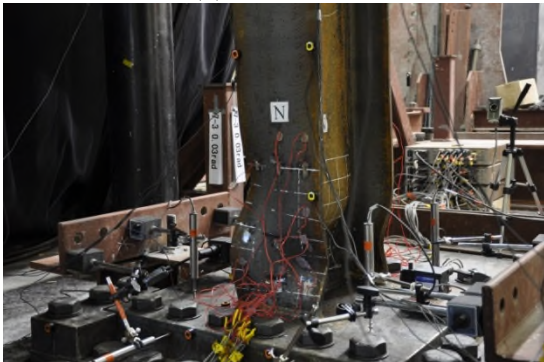
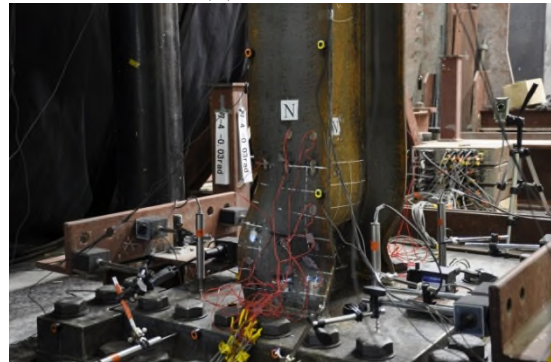
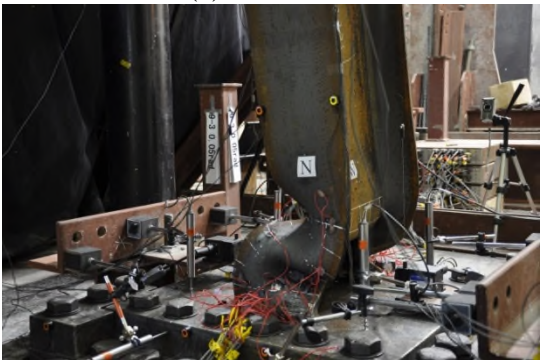
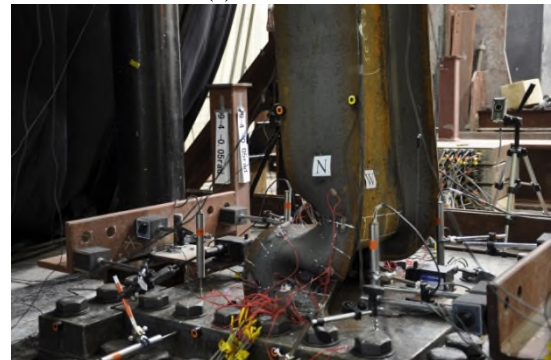
Figure A.31 W-6-34-S-C: Flange local buckling (North West view)

(b) -1% drift

(d) -2% drift

(e) +3% drift

(f) -3% drift

(g) +5% drift

(h) -5% drift

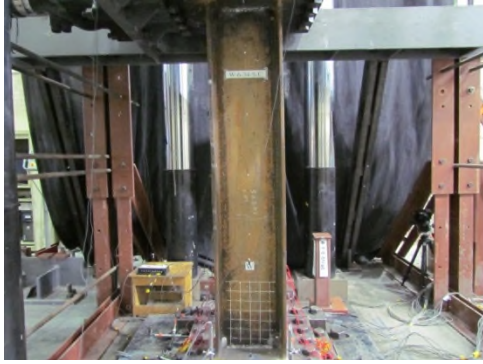
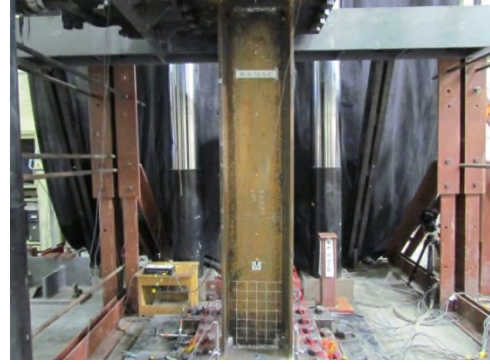
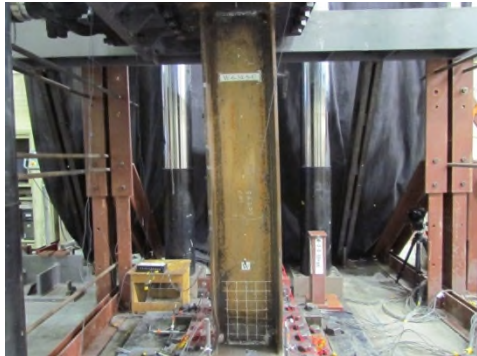
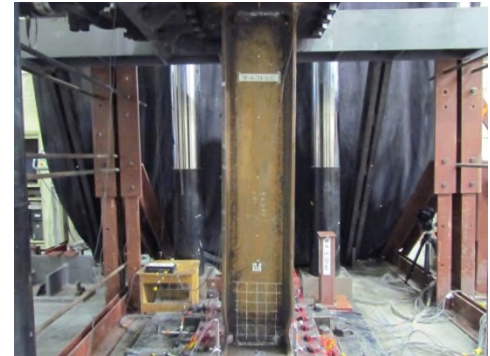
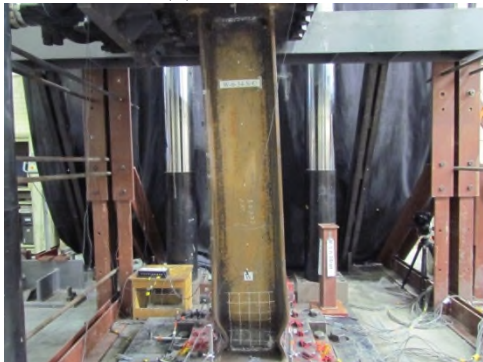
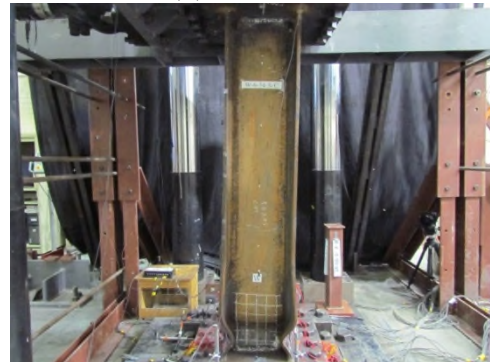
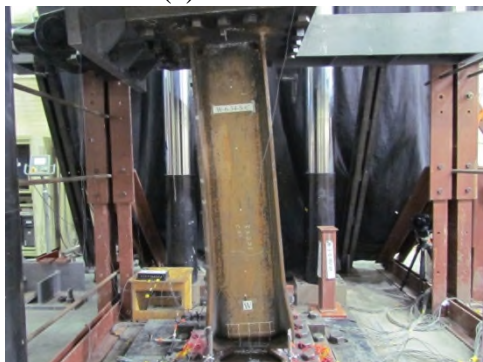
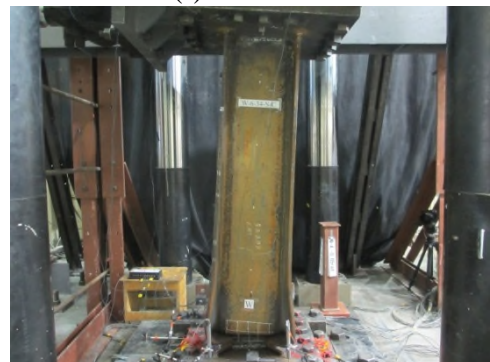
Figure A.32 W-6-34-S-C: Overall deformed configuration (West view)

(a) +1% drift

(b) -1% drift

(c) +2% drift

(d) -2% drift

(e) +3% drift

(f) -3% drift

(g) +5% drift

(h) -5% drift
