EARTHQUAKE-INDUCED COLLAPSE OF STEEL  
MOMENT RESISTING FRAMES WITH CONVENTIONAL  
AND HIGH PERFORMANCE STEEL COLUMNS

A thesis submitted to McGill University in partial fulfillment of the requirements  
of the degree of Doctor of Philosophy

# CHAPTER 5: Experimental Studies on the Collapse Behaviour of Steel Columns in Moment Resisting Frames

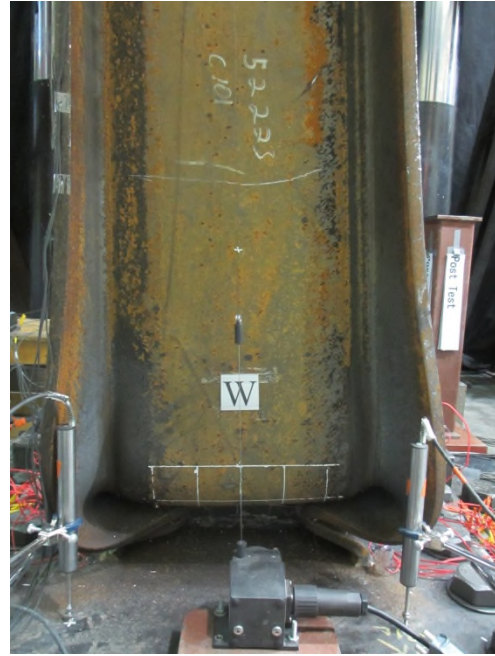
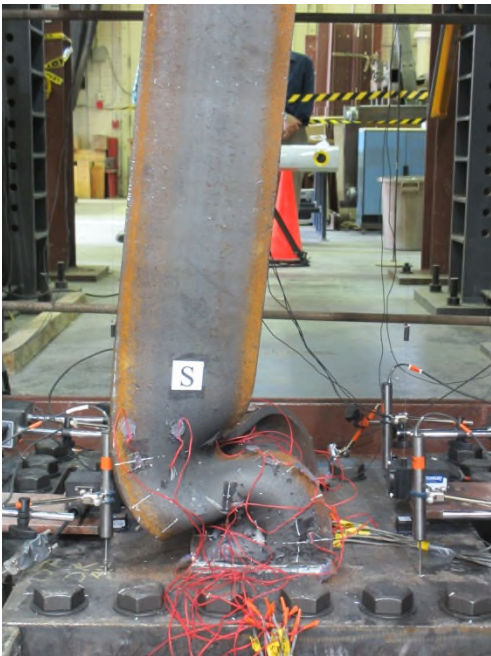
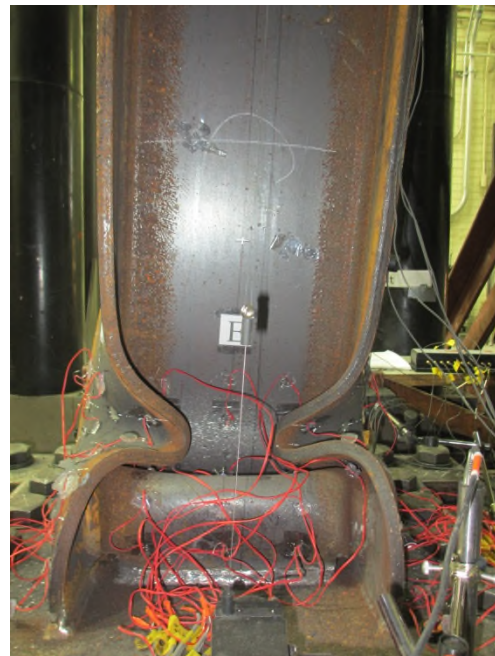
Figure A.33 W-6-34-S-C: Post-test specimen observation

(a) North view

(b) West view

(c) South view

(d) East view

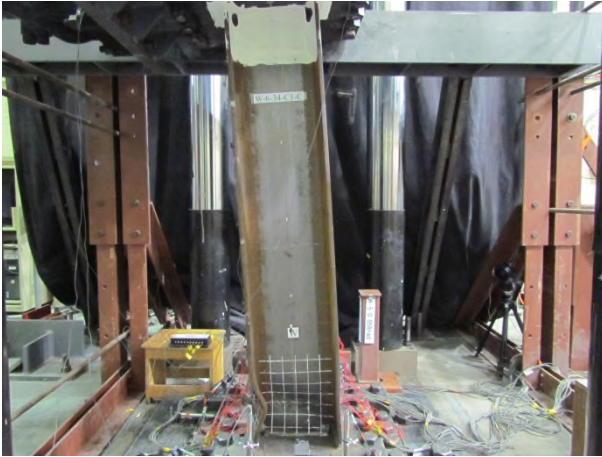
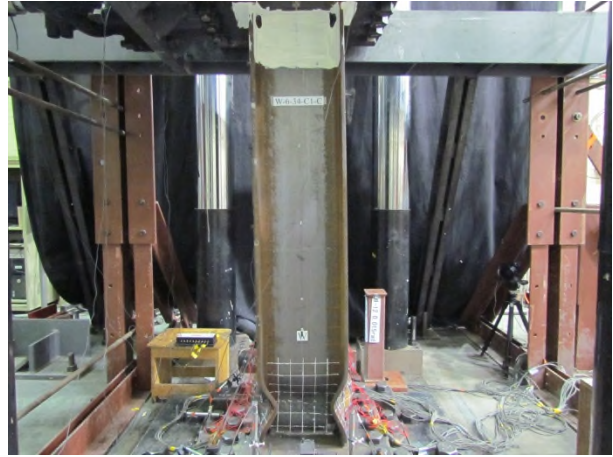
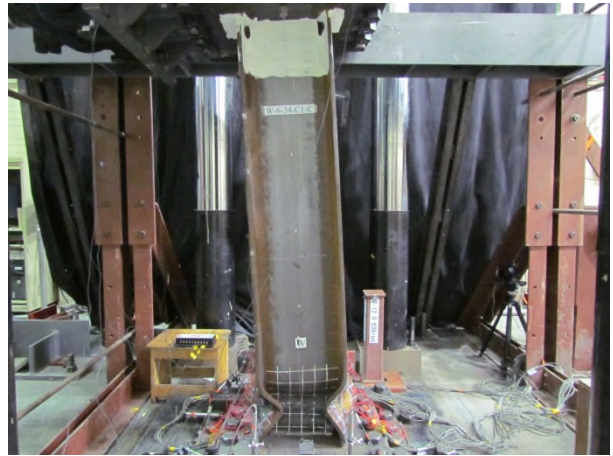
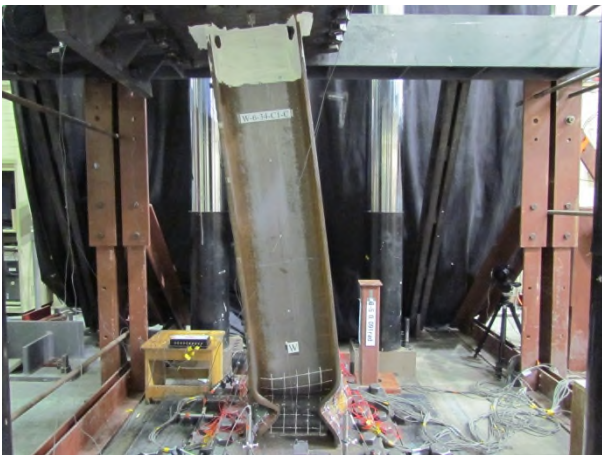
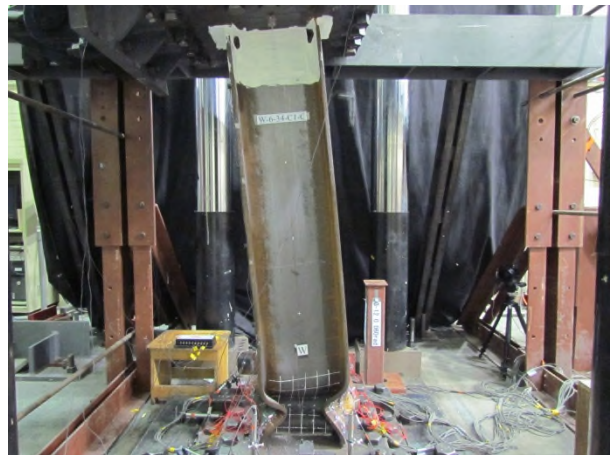
Figure A.35 W-6-34-C1-C: Overall deformed configuration (West view)

(a) 5<sup>th</sup> excursion in phase 1 (5.8% drift)

(b) End of phase 1 (1.5% drift)

(d) End of phase 2 (3.8% drift)

(e) 5<sup>th</sup> excursion in phase 3 (9.1% drift)

(f) End of phase 3 (6% drift)

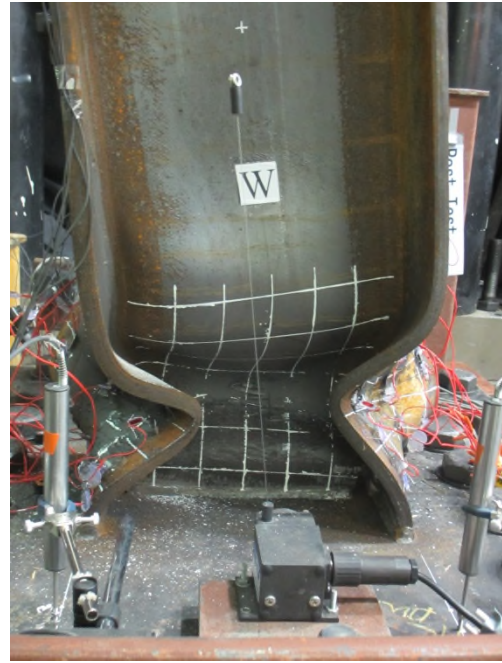
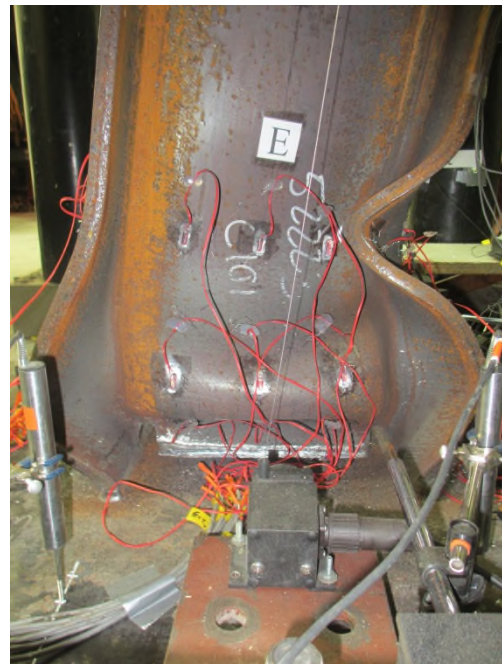
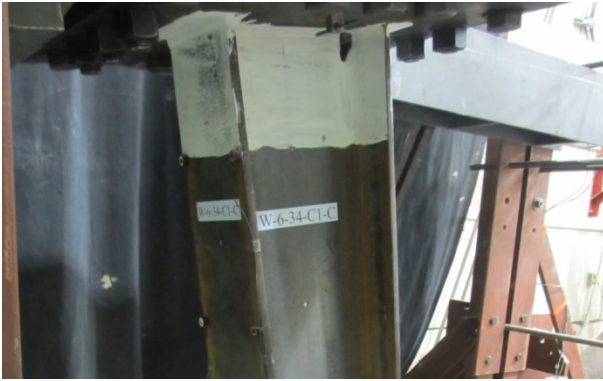
Figure A.36 W-6-34-C1-C: Post-test specimen observation

(b) West view

(d) East view

(e) Top end of north west flange

deteriorated close to zero. At this stage, axial shortening was in the range of 5.5%. Despite the fact that the inelastic cumulative damage to the column was substantial, fracture due to low-cycle fatigue was not observed during this test, as shown in Figures A.36a to A.36d that shows the specimen from all sides at the end of the test. Due to lateral torsional buckling, the top end of the north flange of the steel column yielded as shown in Figures A.36e to A.36f.

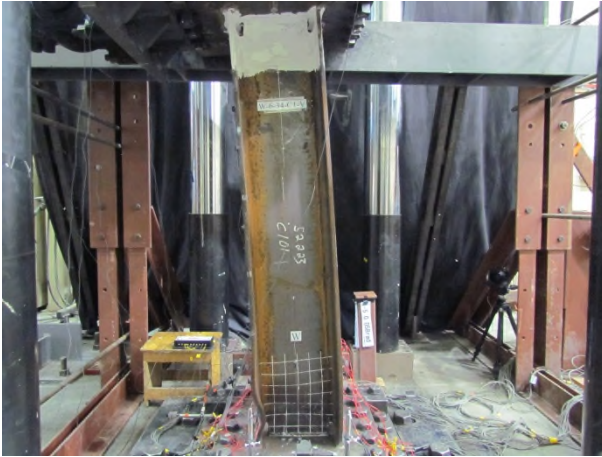
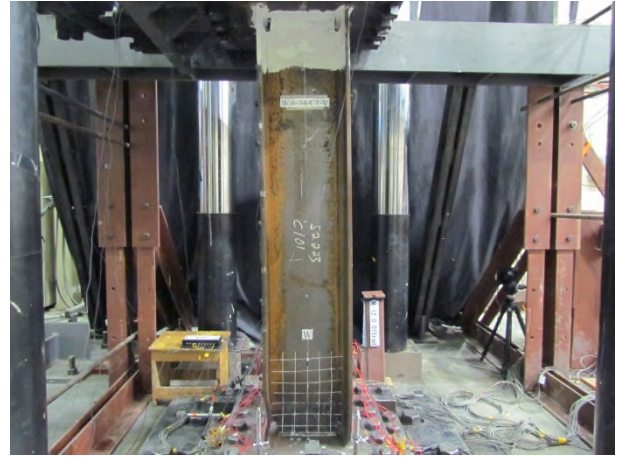
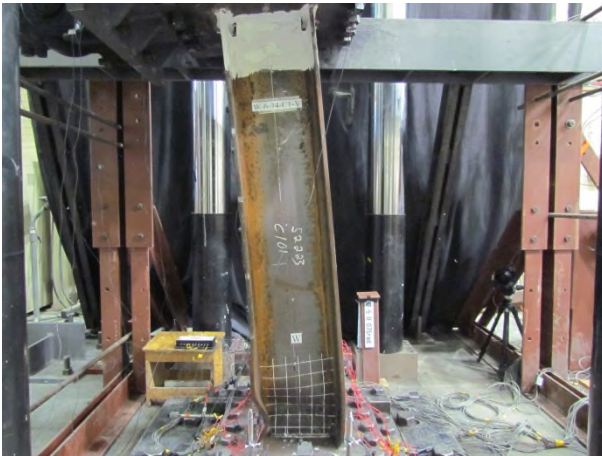
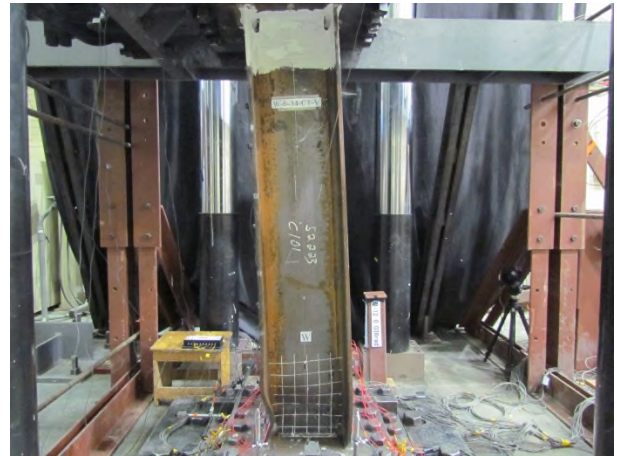
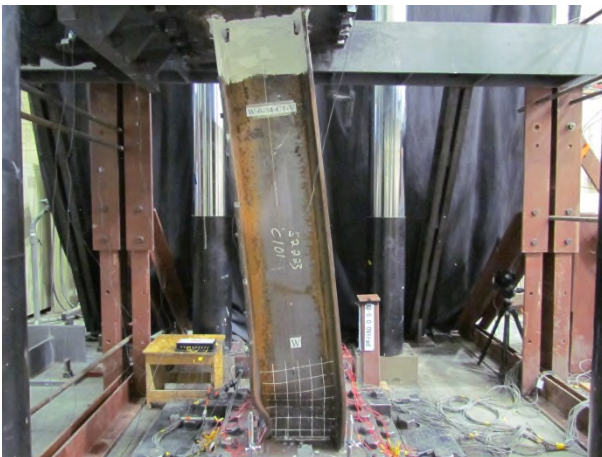
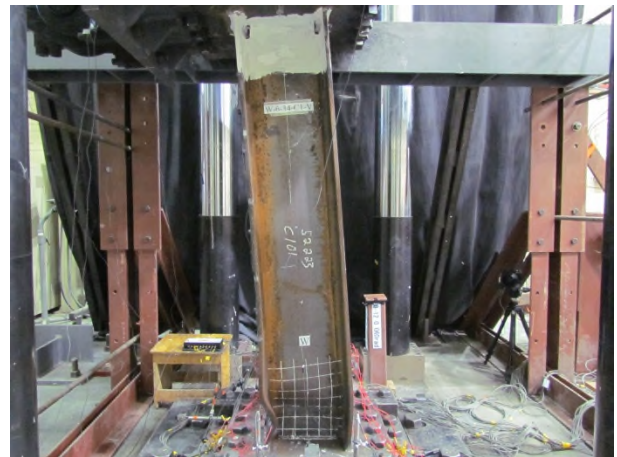
Figure A.38 W-6-34-C1-V: Overall deformed configuration (West view)

(a) 5<sup>th</sup> excursion in phase 1 (5.8% drift)

(b) End of phase 1 (1.5% drift)

(c) 5<sup>th</sup> excursion in phase 2 (7.5% drift)

(d) End of phase 2 (3.8% drift)

(e) 5<sup>th</sup> excursion in phase 3 (9.1% drift)

(f) End of phase 3 (6% drift)

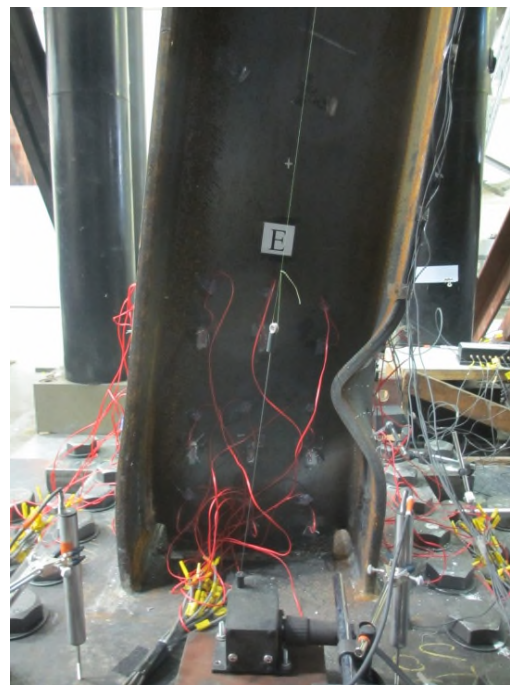
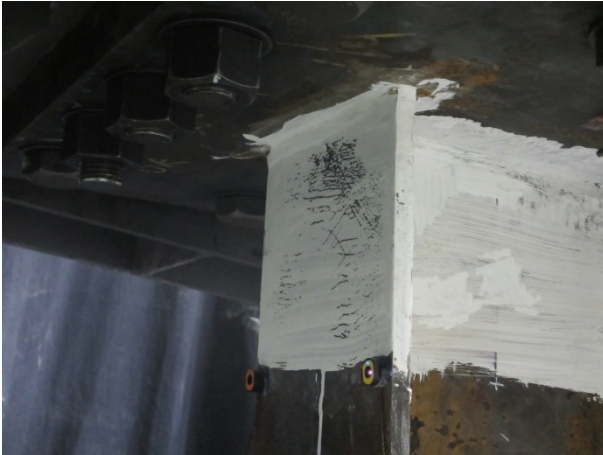
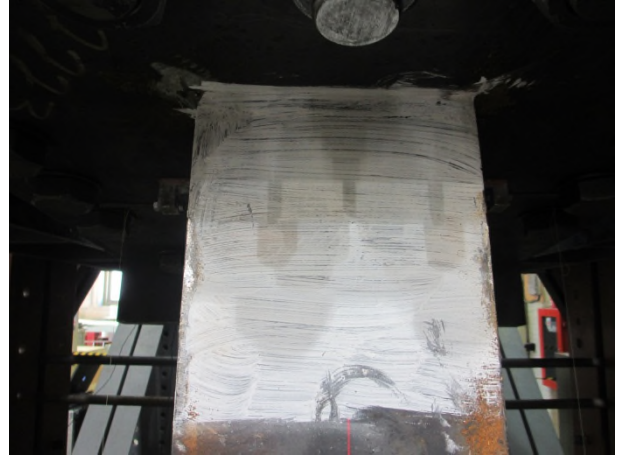
Figure A.39 W-6-34-C1-V: Post-test specimen observation

(d) East view

(e) Top end of north west flange

(f) Top end of south flange

protocol, as shown in Figure A.39c. The stretching of the buckling wave of the north flange is the reason why the column moment did not deteriorate in the negative loading; instead, it kept increasing with the increase of the lateral drift. After the 5th excursion of Phase 4 loading (i.e., 12% drift), the moment degraded to about 30% of the capping moment. The column axial shortening progressed linearly with respect to the column chord rotation. The axial shortening at the end of the first three loading phases was equal to 0.4%, 0.9% and 1.2% of the column length, respectively. Note that fracture due to low cycle fatigue was not observed during this test, as shown from Figures A.39a to A.39d. Due the lateral torsional buckling that occurred during the test, the top end of the north flange of the steel column yielded as it can be seen in Figure A.39e.

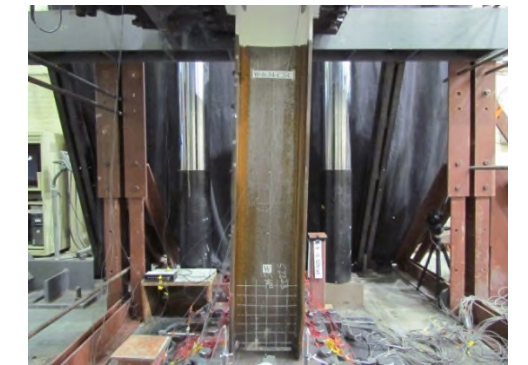
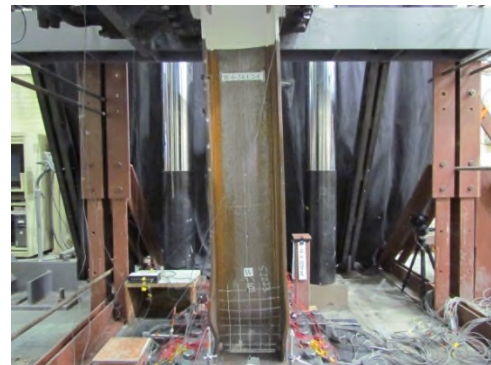
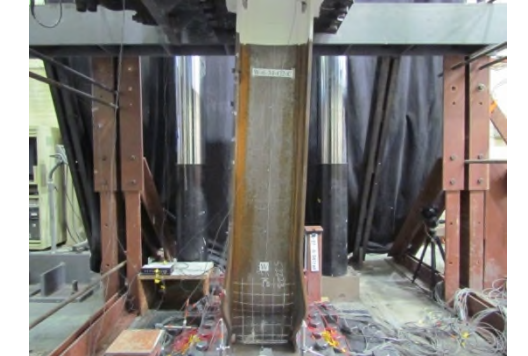
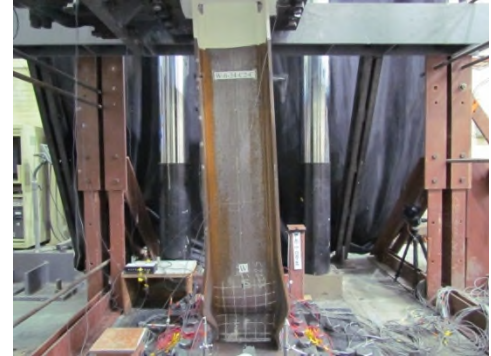
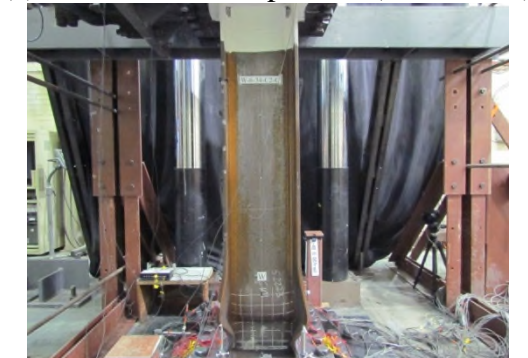
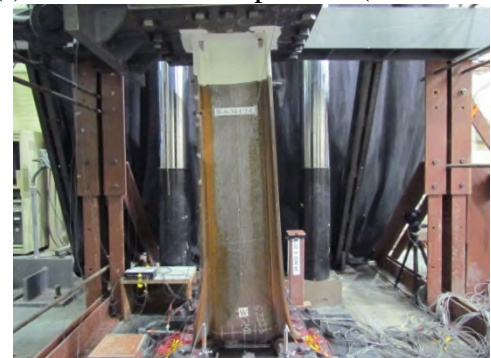
Figure A.41 W-6-34-C2-C: Overall deformed configuration (West view)

(a) 9<sup>th</sup> excursion in phase 1 (-2.9% drift)

(b) 18<sup>th</sup> excursion in phase 1 (2.8% drift)

(c) 27<sup>th</sup> excursion in phase 1 (-4.1% drift)

(d) 40<sup>th</sup> excursion in phase 1 (3.8% drift)

(e) End of phase 1 (0.7% drift)

(h) 32<sup>th</sup> excursion in phase 2 (squashed)

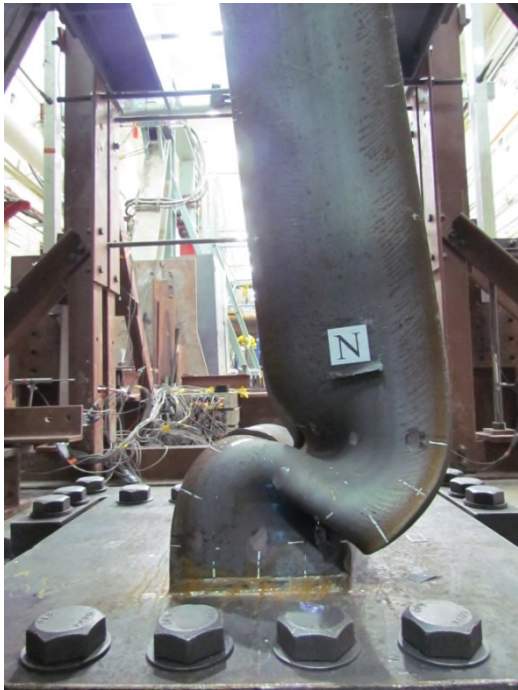
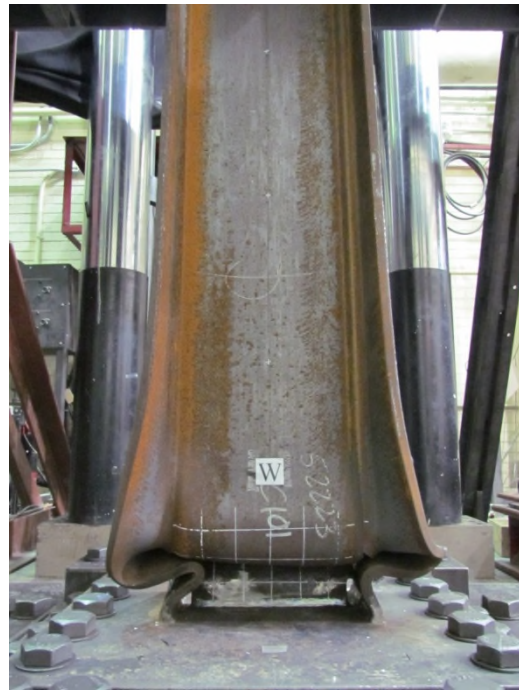
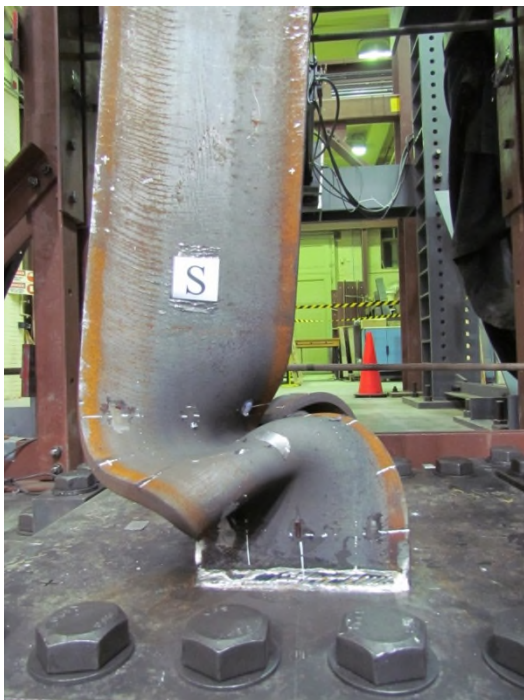
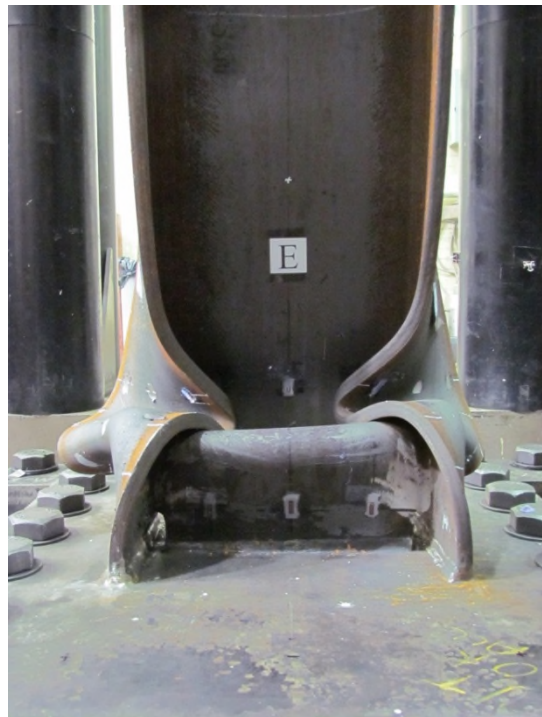
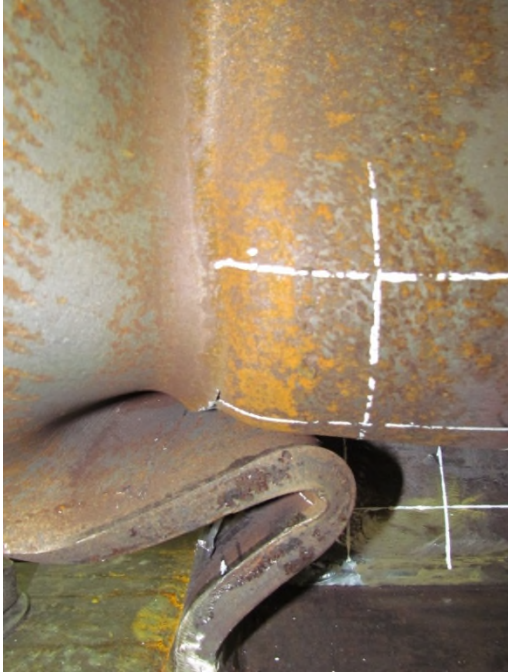
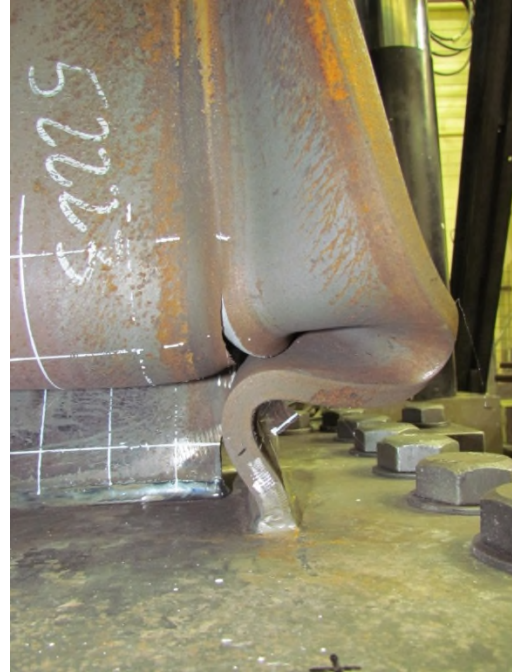
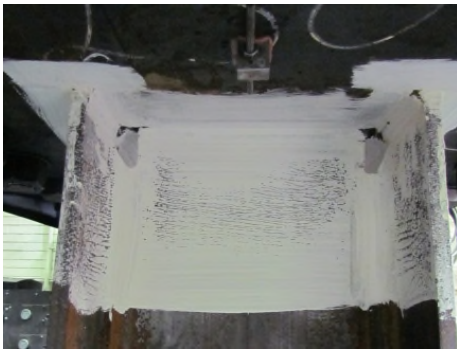
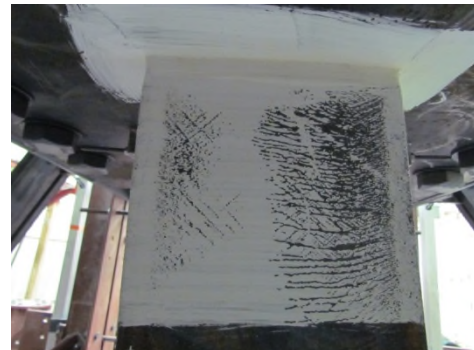
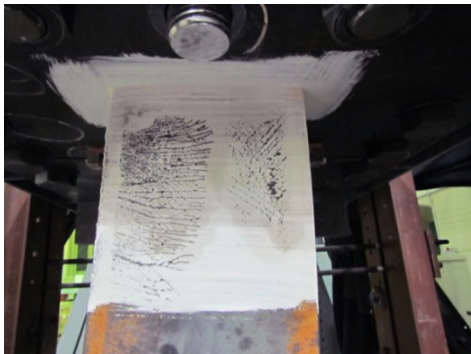
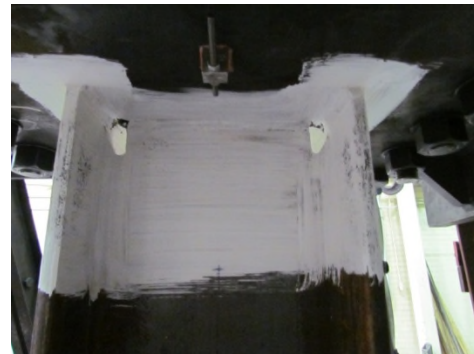
Figure A.42 W-6-34-C2-C: Post-test specimen observation (continued)

(a) North view

(b) West view

(c) South view

(d) East view

(e) North west flange

(f) South west flange

(g) Top end of west web

(h) Top end of north flange

(i) Top end of south flange

(j) Top end of east web

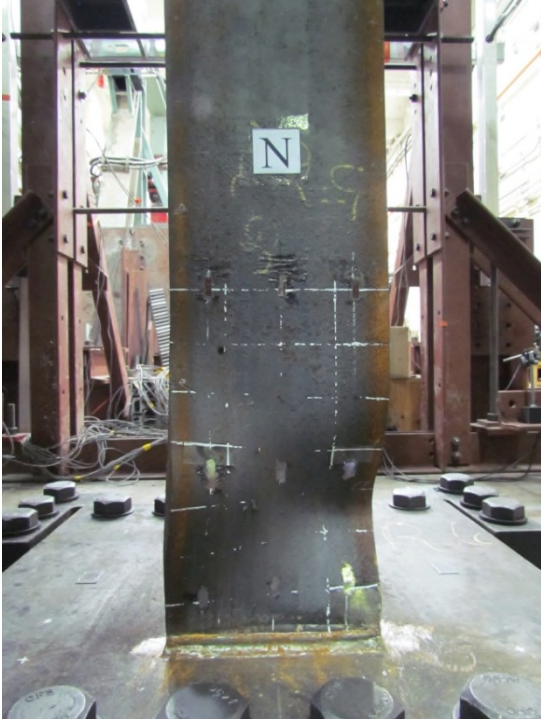
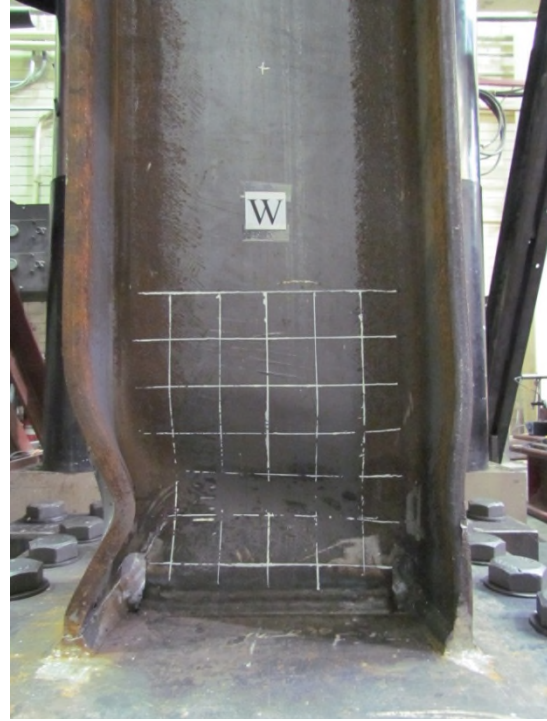
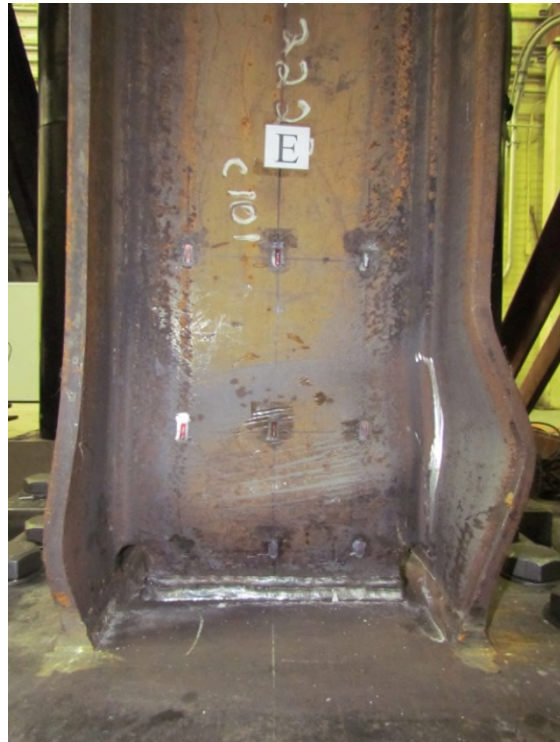
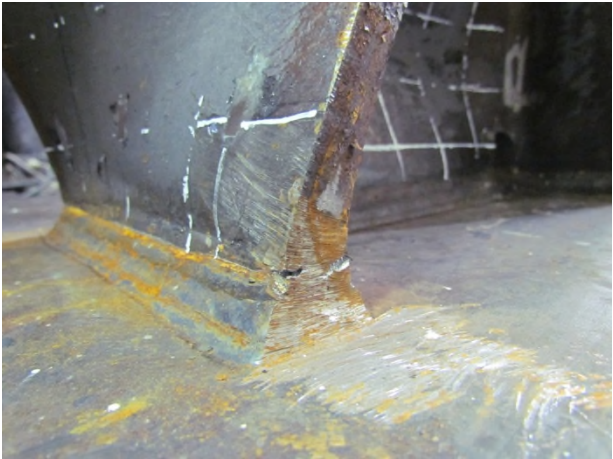
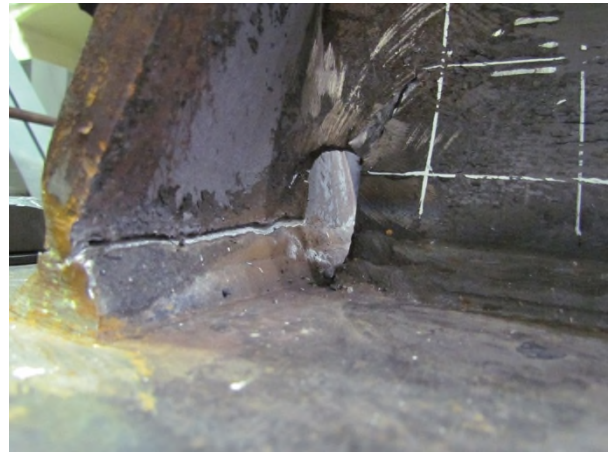
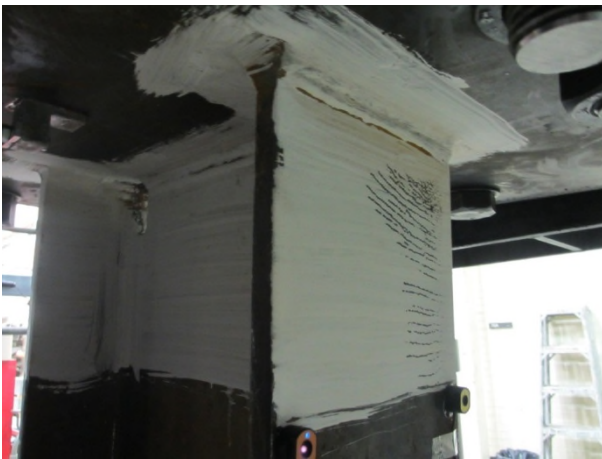
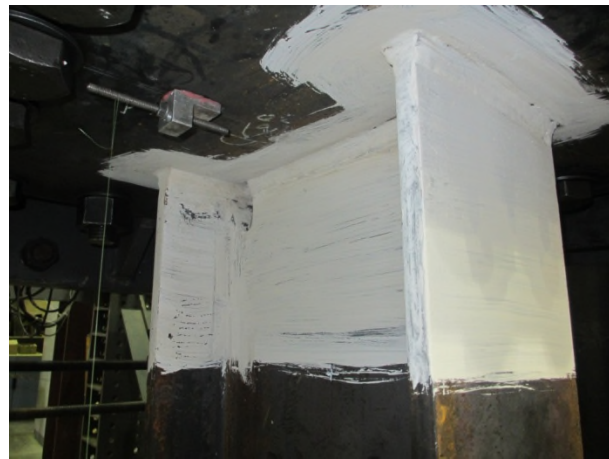
Figure A.45 W-6-34-C2-V: Post-test specimen observation (continued)

(a) North view

(b) West view

(d) East view

(e) Tip of north west flange

(f) North west flange and weld access hole

(g) Top end of north east flange

(h) Top end of south west flange

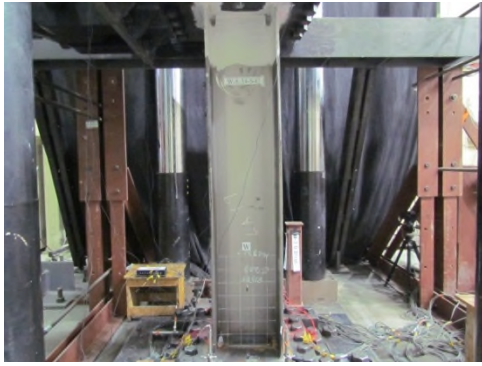
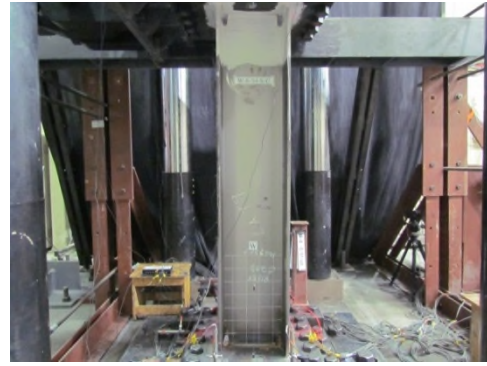
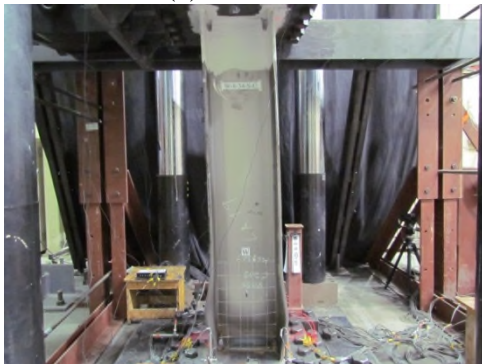
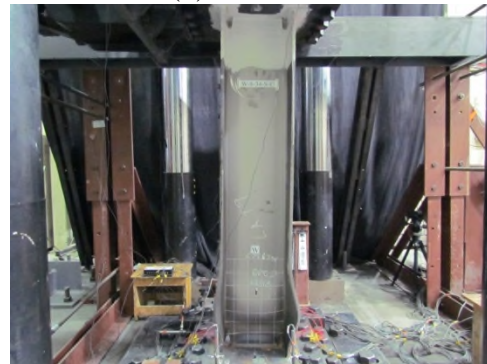
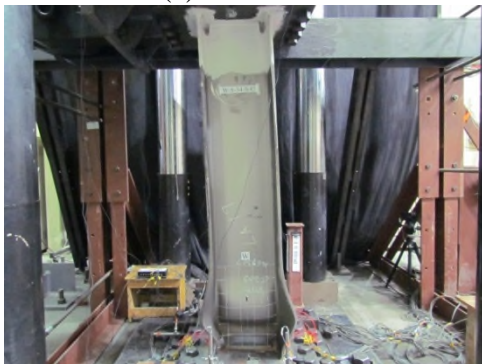
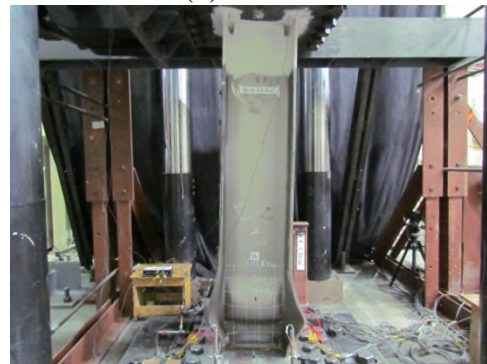
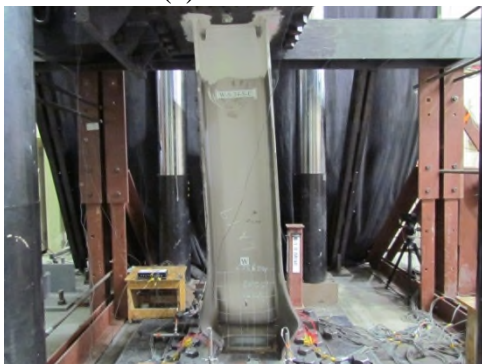
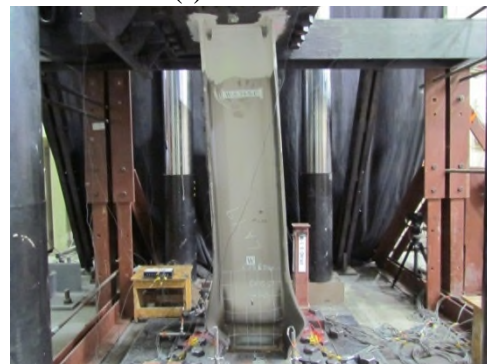
Figure A.47 W-8-34-S-C: Overall deformed configuration (West view)

(a) +1% drift

(b) -1% drift

(c) +2% drift

(d) -2% drift

(e) +3% drift

(f) -3% drift

(g) +4% drift

(h) -4% drift

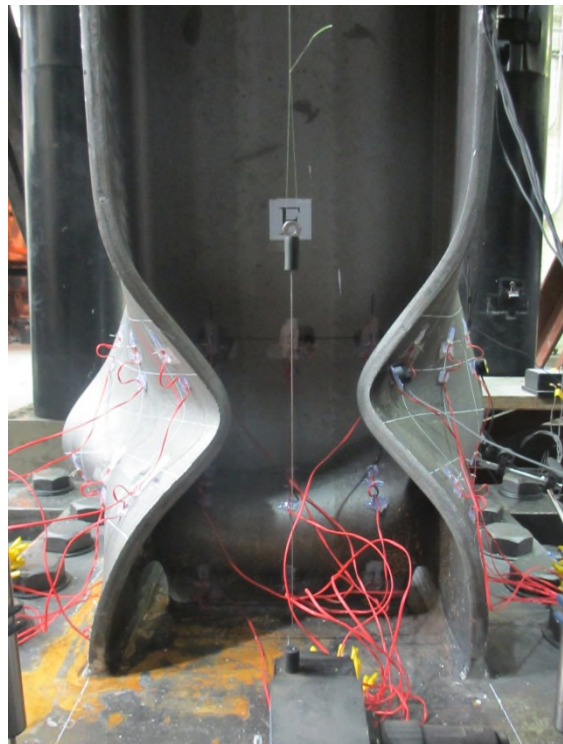
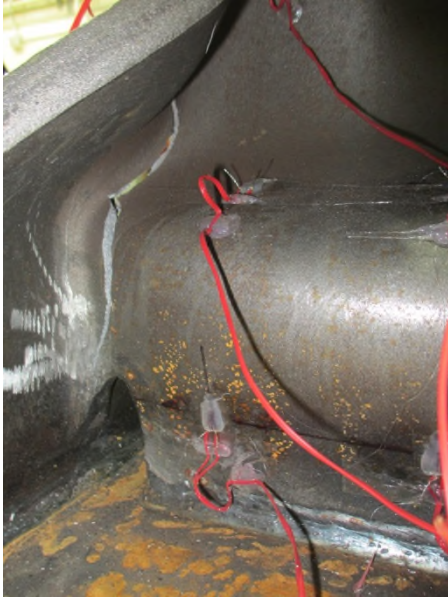
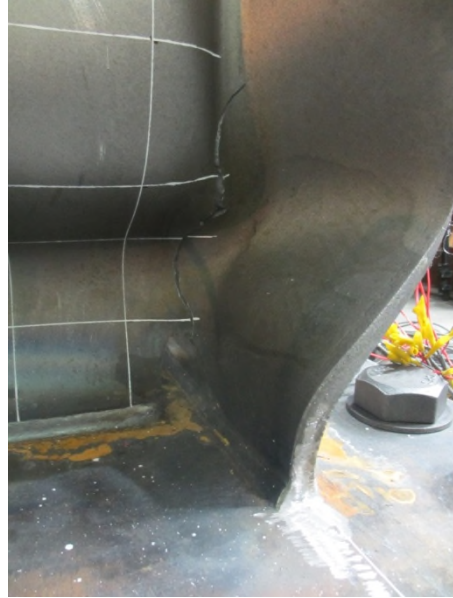
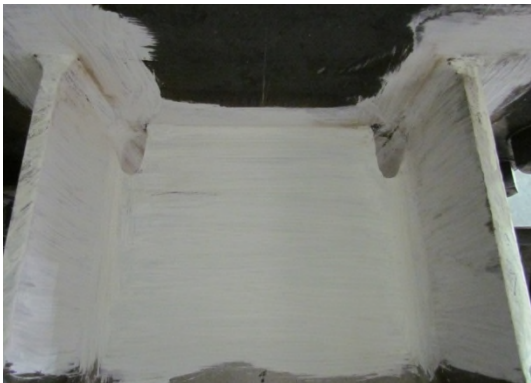
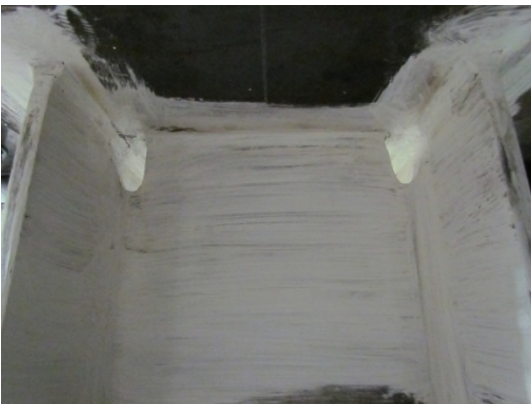
Figure A.48 W-8-34-S-C: Post-test specimen observation

(d) East view

(e) South side K-area (West view)

(f) South side K-area (East view)

(g) Top end of west web

(i) Top end of east web

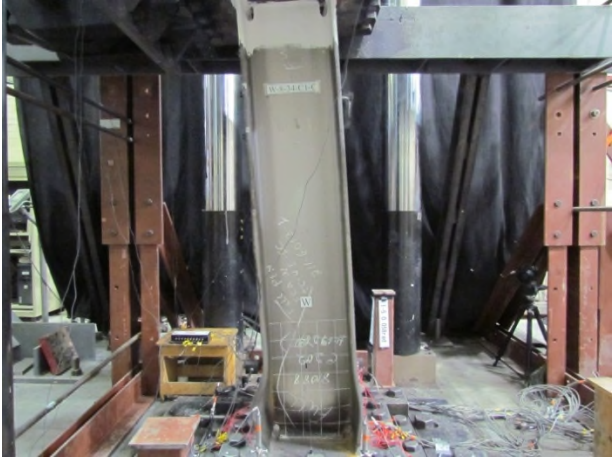
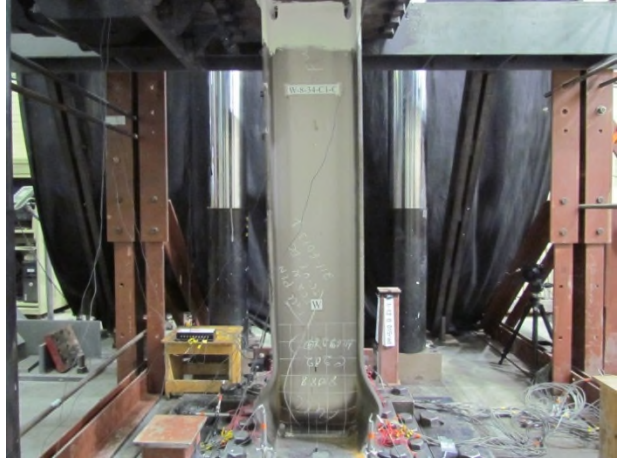
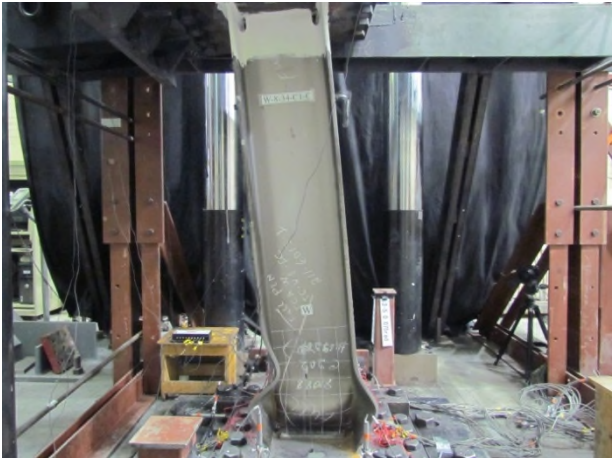
(a) 5<sup>th</sup> excursion in phase 1 (5.8% drift)

(b) End of phase 1 (1.5% drift)

(c) 5<sup>th</sup> excursion in phase 2 (7.5% drift)

Figures A.49 and A.50 show global and local snapshots of W-8-34-C1-C specimen that shows the progression of local buckling during testing, respectively. Figure A.51 shows photos of the post-test observation of the same specimen. The specimen W-8-34-C1-C was tested under a collapse-consistent lateral loading protocol that represented a near-fault ground motion coupled with a constant compressive axial load equal to  $-0.3P_y$  ( $-1317\text{kN}$ ). This protocol was repeated three times incrementally till the specimen failed. In this test local buckling occurred on both the north and south flange of the steel column during the 2nd and 3rd loading excursion of Phase 1 loading, which represents 1.9% and -1.9% drift ratio, respectively. The buckling mode had a half

wavelength of  $1.0D$  and the buckling center was located at a height equal to  $0.5D$  from the top surface of the column base plate. From Figure A.49, local buckling in both flanges of the steel column kept growing with the progression of lateral loading. After the 5th excursion of Phase 2 loading (i.e., lateral drift of 7.6% rads), the steel column started twisting due to lateral torsional buckling that was triggered by a second wave buckling (see Figure A.49c); however, the torsional deflection was not as large as the one observed in W-8-34-S-C specimen that was tested under a symmetric lateral loading protocol. Because a buckling wave was developed in both the north and south flange of the steel column, axial shortening was accumulated such that it reached 2.5% and 4.3% at the end of Phase 1 and 2 loading, respectively. This can also be seen by Figures A.49b and A.49d. At the end of the 5th excursion of the Phase 3 loading, the flexural strength of the column was almost zero. After this excursion, a brittle fracture occurred at the k-area of the south flange as shown in Figures A.51e and A.51f. At this point, the flexural strength of the steel column dropped rapidly. Fracture initiated due to the substantial out-of-plane distortion of web and flange, as shown in Figures A.51a to A.51d. The column torsional deflection initiated during Phase 2 loading and progressed during Phase 3 loading. At the time of fracture, the column axial shortening was 5.8% of its total length. The top end flanges did not yield, as shown in Figures A.51g to A.51j. The white wash came off from the top north flange of the column due to the energy release from the k-area fracture (Figure A.51h).

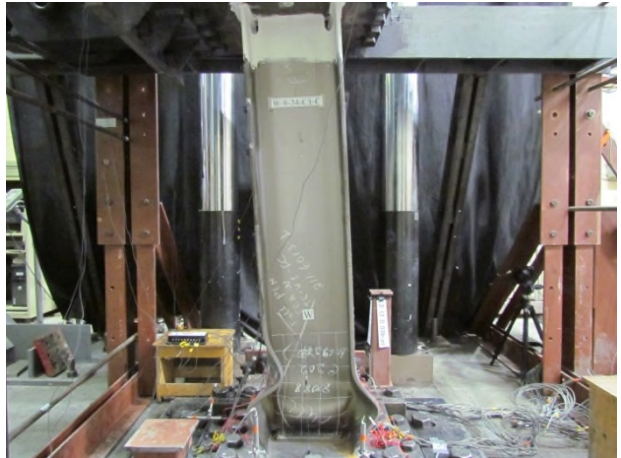
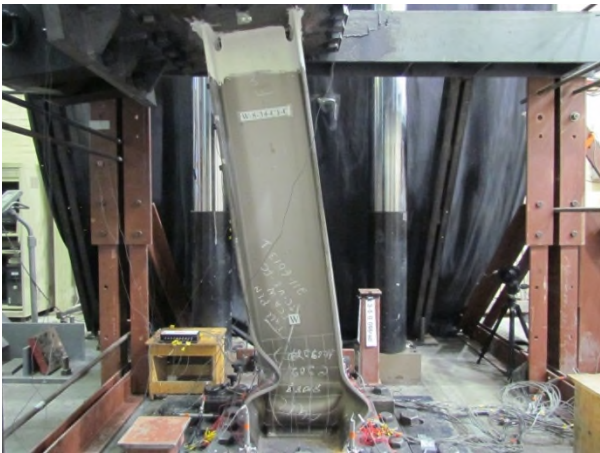
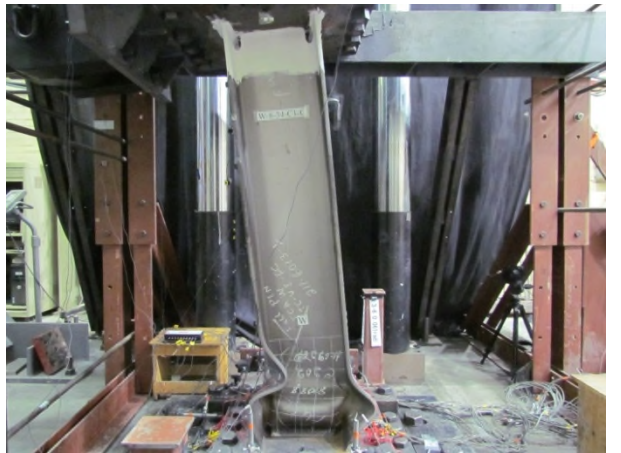
Figure A.50 W-8-34-C1-C: Overall deformed configuration (West view)

(d) End of phase 2 (3.9% drift)

(e) 5<sup>th</sup> excursion in phase 3 (9.8% drift)

(f) End of test (fractured)

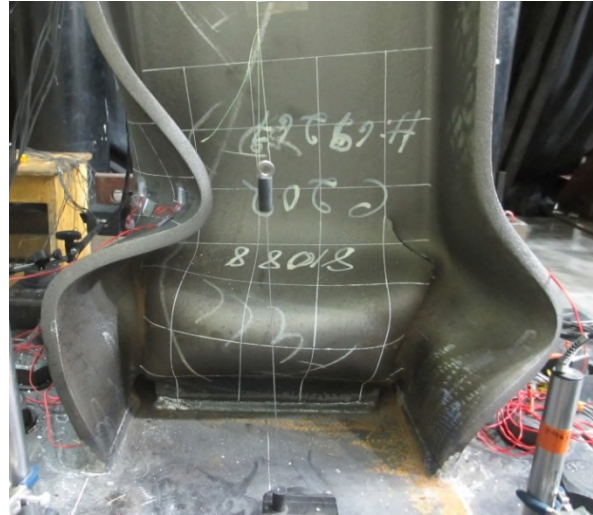
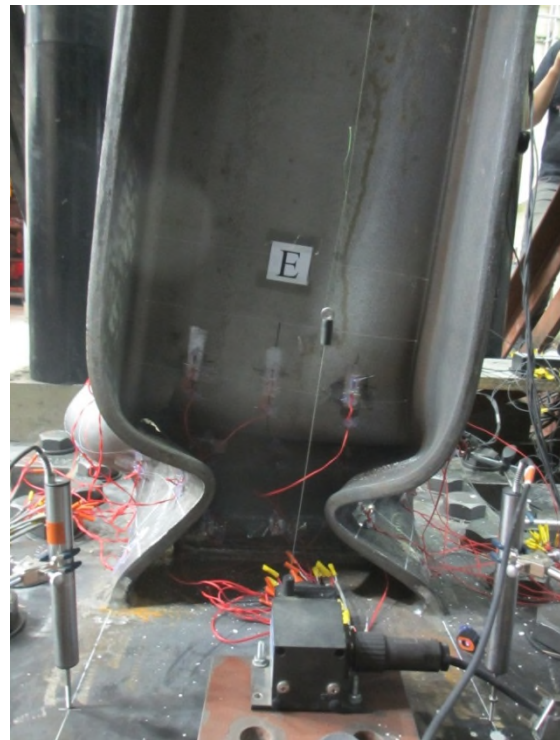
Figure A.51 W-8-34-C1-C: Post-test specimen observation

(b) West view

(d) East view

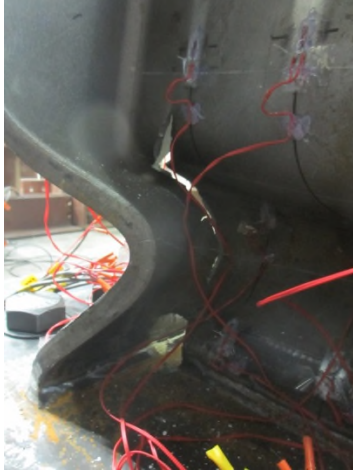
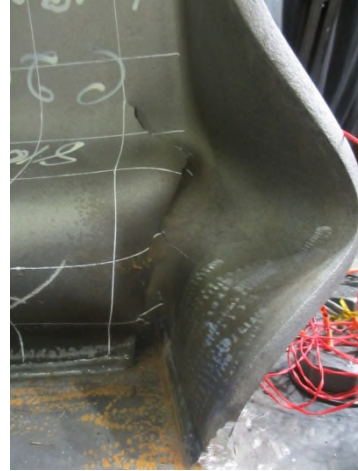
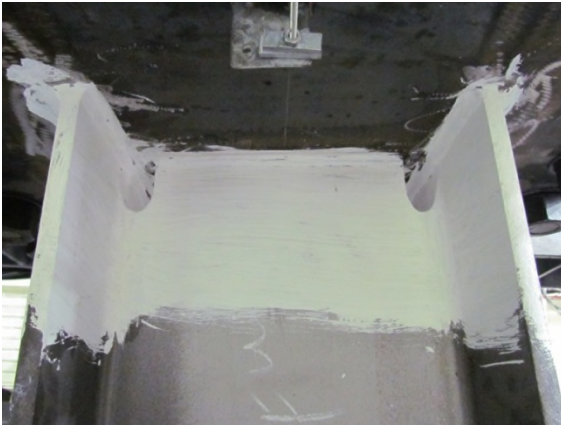
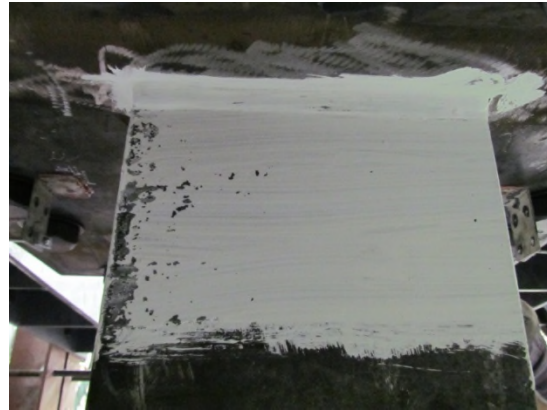
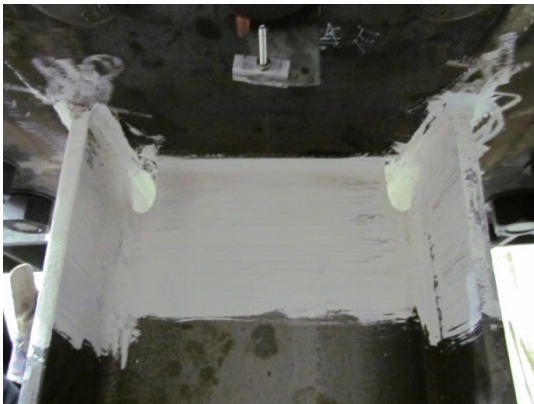
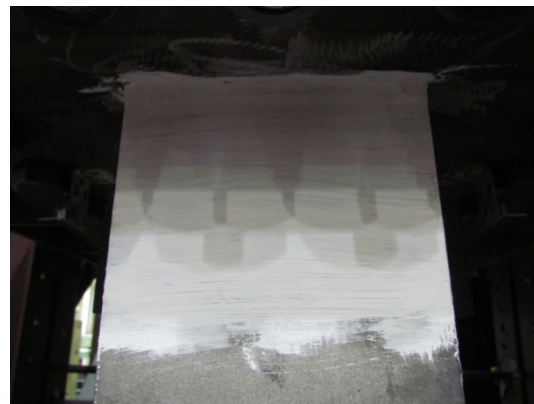
Figure A.51 W-8-34-C1-C: Post-test specimen observation (continued)

(e) South side K-area (East view)

(f) South side K-area (West view)

(g) Top end of west web

(h) Top end of north flange  
(White wash dropped due to the impact of brittle fracture.)

(i) Top end of east web

(j) Top end of south flange

performance. During the 2nd excursion of the Phase 4 loading, the south flange of the steel column slightly buckled and the negative moment capped. During the 7th excursion of the same loading phase, a fracture noise occurred again, and the other crack was observed as shown in Figure A.54e (noted as “B”). The first crack propagated extensively as well as the second crack appeared, the test was ended. Column axial shortening was approximately linear with respect to the rotation. The top end flanges did not yield, as shown in Figures A.54f and A.51g.

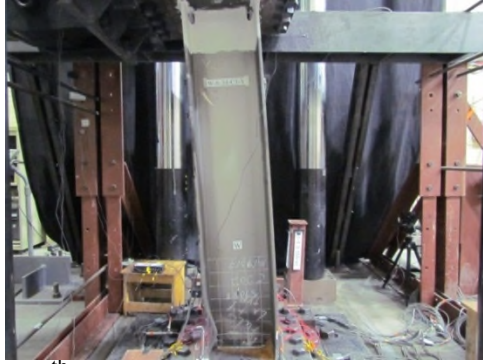
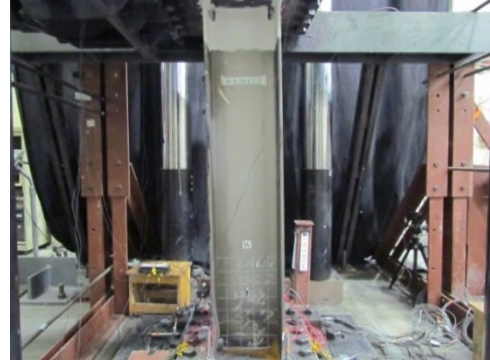
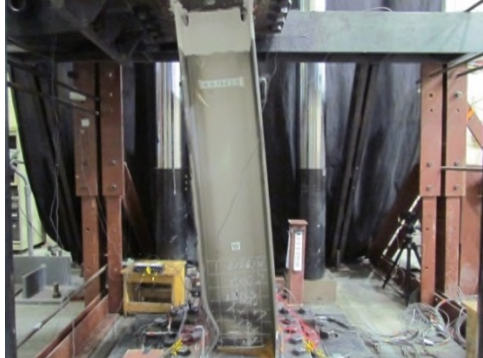
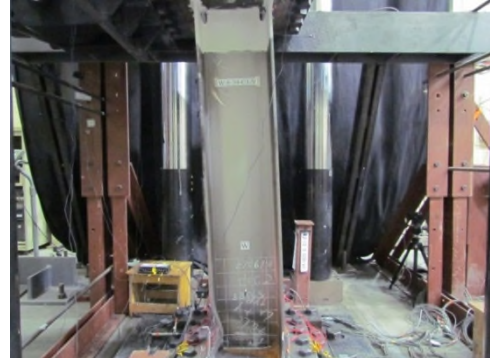
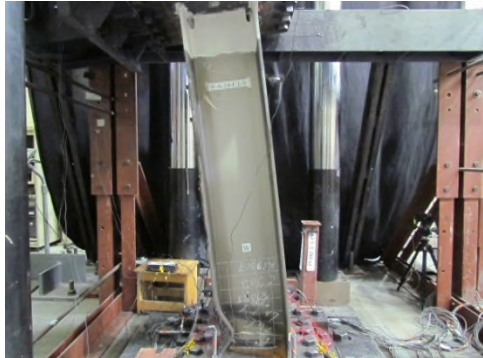
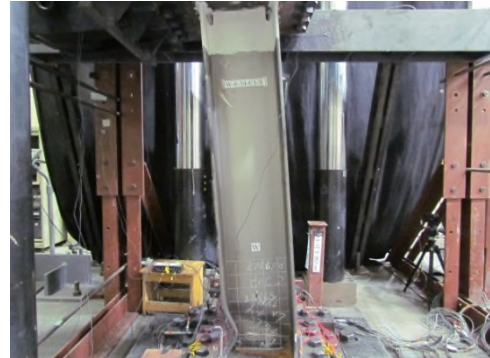
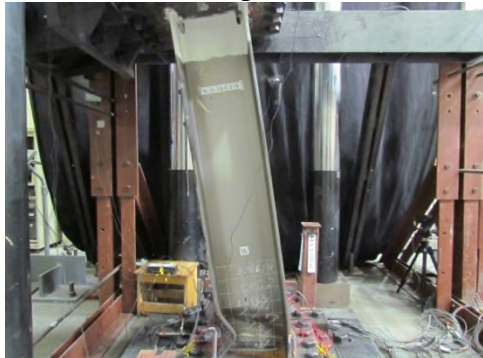
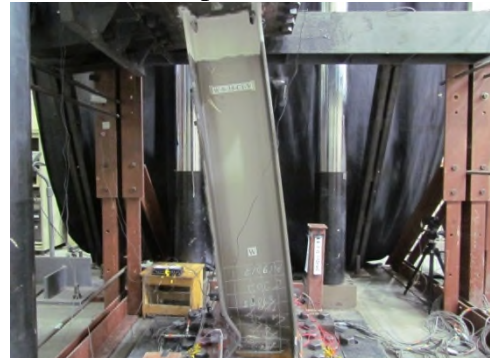
Figure A.53 W-8-34-C1-V: Overall deformed configuration (West view)

(a) 5<sup>th</sup> excursion in phase 1 (5.8% drift)

(b) End of phase 1 (1.5% drift)

(c) 5<sup>th</sup> excursion in phase 2 (7.5% drift)

(d) End of phase 2 (3.9% drift)

(e) 5<sup>th</sup> excursion in phase 3 (9.8% drift)

(f) End of phase 3 (6% drift)

(g) 5<sup>th</sup> excursion in phase 4 (12.2% drift)

(h) End of test (fractured)

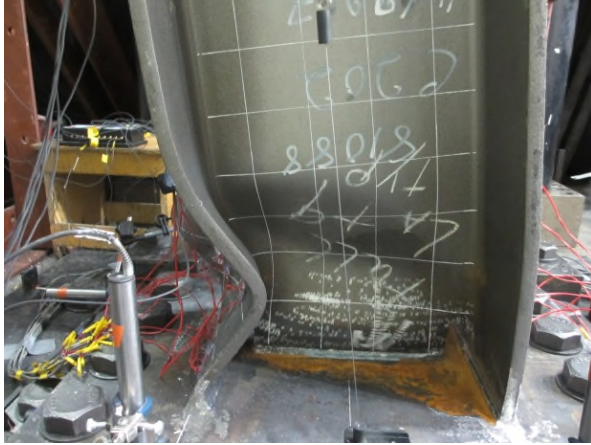
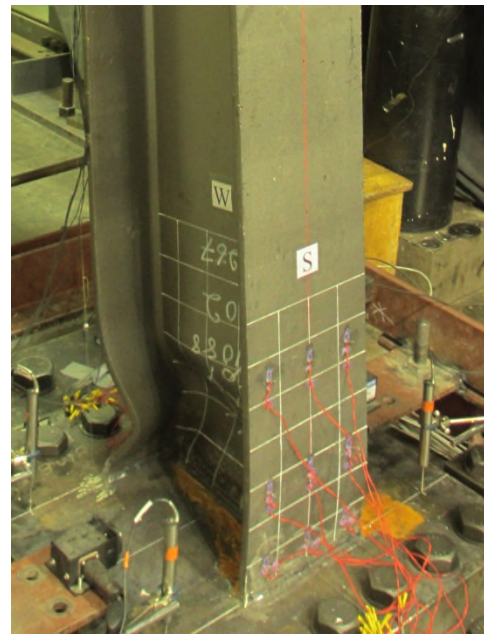
Figure A.54 W-8-34-C1-V: Post-test specimen observation

(a) West view

(d) South West view
