EARTHQUAKE-INDUCED COLLAPSE OF STEEL  
MOMENT RESISTING FRAMES WITH CONVENTIONAL  
AND HIGH PERFORMANCE STEEL COLUMNS

A thesis submitted to McGill University in partial fulfillment of the requirements  
of the degree of Doctor of Philosophy

# CHAPTER 5: Experimental Studies on the Collapse Behaviour of Steel Columns in Moment Resisting Frames

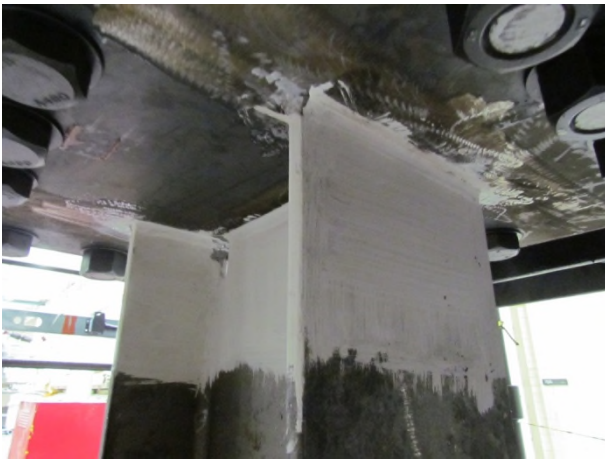
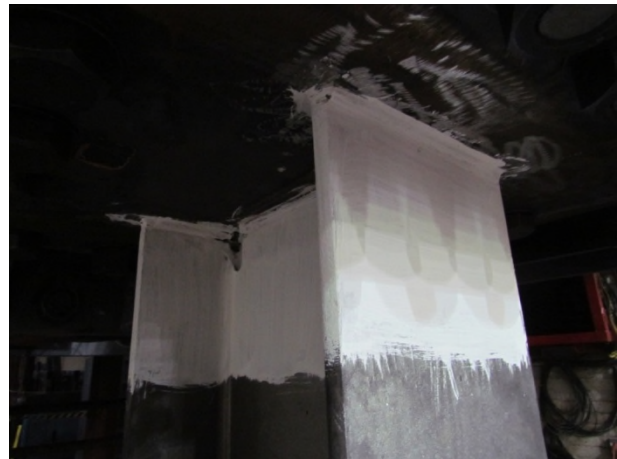
Figure A.54 W-8-34-C1-V: Post-test specimen observation (continued)

(f) Top end of north east flange

(g) Top end of south east flange

performance. During the 2nd excursion of the Phase 4 loading, the south flange of the steel column slightly buckled and the negative moment capped. During the 7th excursion of the same loading phase, a fracture noise occurred again, and the other crack was observed as shown in Figure A.54e (noted as “B”). The first crack propagated extensively as well as the second crack appeared, the test was ended. Column axial shortening was approximately linear with respect to the rotation. The top end flanges did not yield, as shown in Figures A.54f and A.51g.

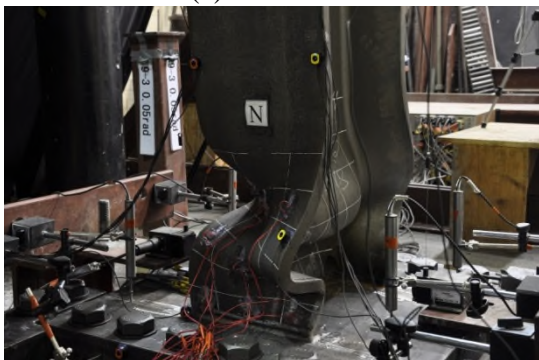
Figure A.55 W-6-25-S-C: Flange local buckling (North West view)

(g) +5% drift

Figures A.55 and A.56 show global and local snapshots of W-6-25-S-C specimen that shows the progression of local buckling during testing, respectively. Figure A.57 shows photos of the post-test observation of the same specimen. The specimen W-6-25-S-C was tested under a symmetric cyclic loading protocol coupled with a constant compressive axial load equal to  $-0.3 P_y$  (-1741kN). Both the north and south flange slightly buckled during the 1.5% drift amplitude; however, the flexural strength of the column started deteriorating cyclically during the 3% drift amplitude of the symmetric loading protocol. The buckling mode shown in Figure A.55 had a half wavelength equal to  $0.9D$  and the buckling center was located at a height equal to  $0.7D$  from the top surface of the column base. The buckling wave progressed with the increasing amplitude of inelastic cycles of the same protocol and a torsional mode appeared at the 4% drift amplitude. During the 3rd excursion of the 5% drift amplitude, a fracture noise occurred. In the 4th excursion, a tearing at the k-area of the south side was observed, as shown in Figure A.57e. The tearing propagated along the longitudinal direction of the k-area of the same specimen. For this reason, the test ended. The steel column flexural strength degraded about 20% of its capping moment up to this point. At this lateral drift, the corresponding column axial shortening was

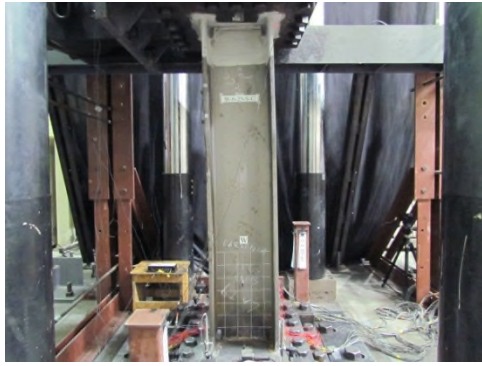
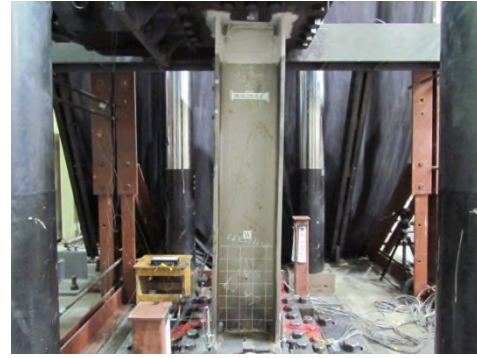
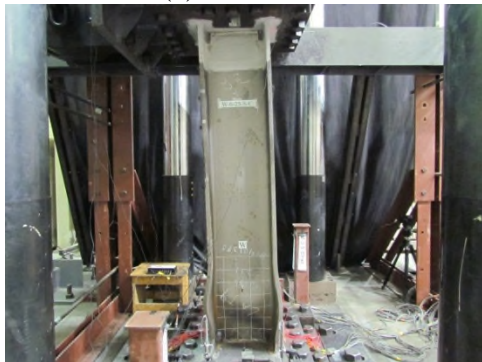
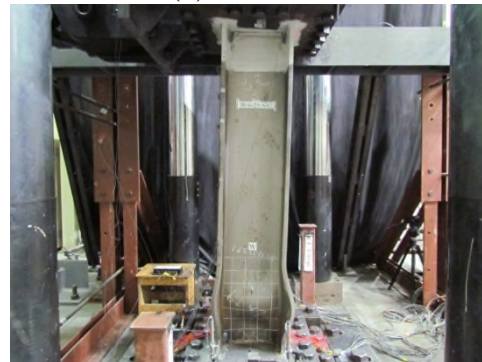
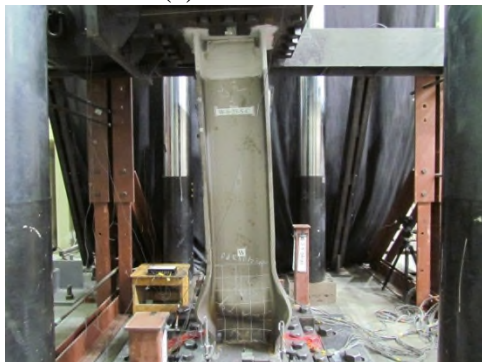
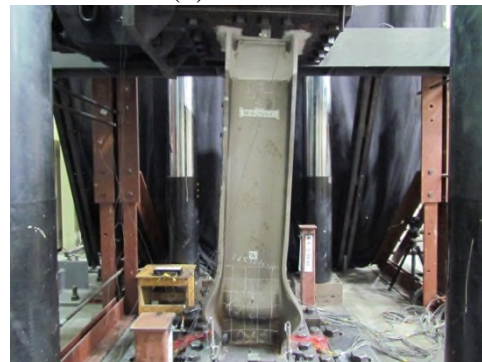
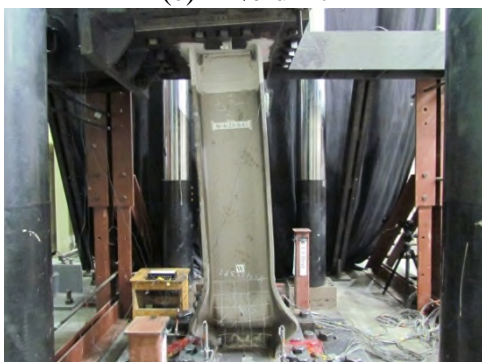
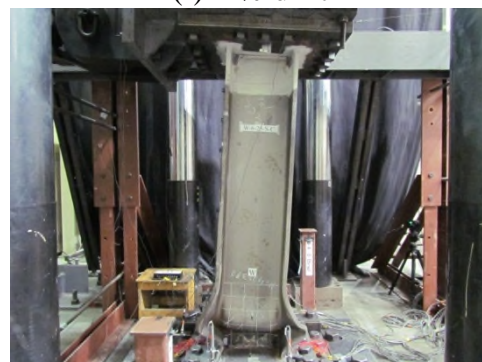
Figure A.56 W-6-25-S-C: Overall deformed configuration (West view)

(a) +2% drift

(b) -2% drift

(c) +3% drift

(d) -3% drift

(e) +4% drift

(f) -4% drift

(g) +5% drift

(h) -5% drift

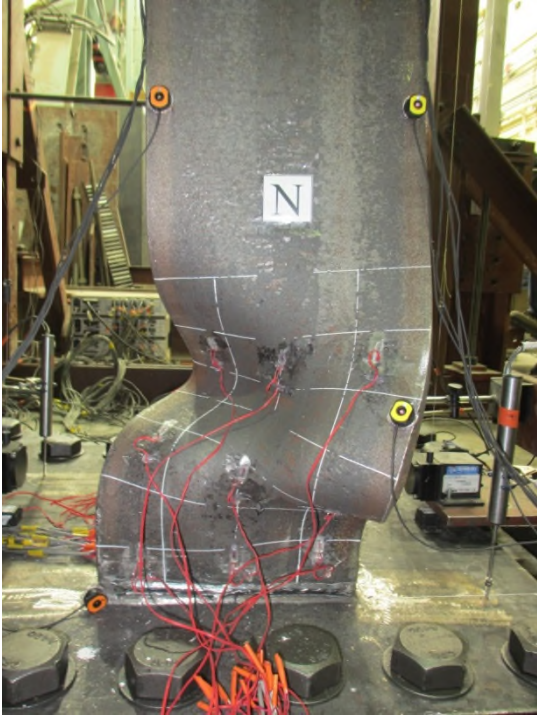
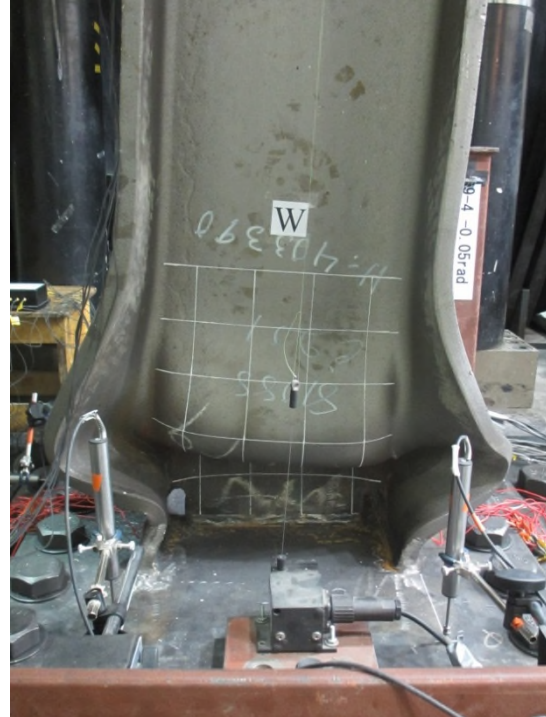
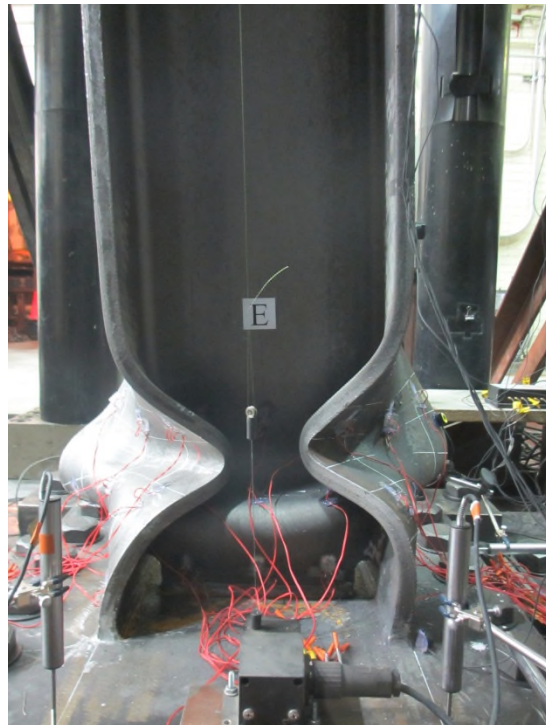
Figure A.57 W-6-25-S-C: Post-test specimen observation

(a) North view

(b) West view

(d) East view

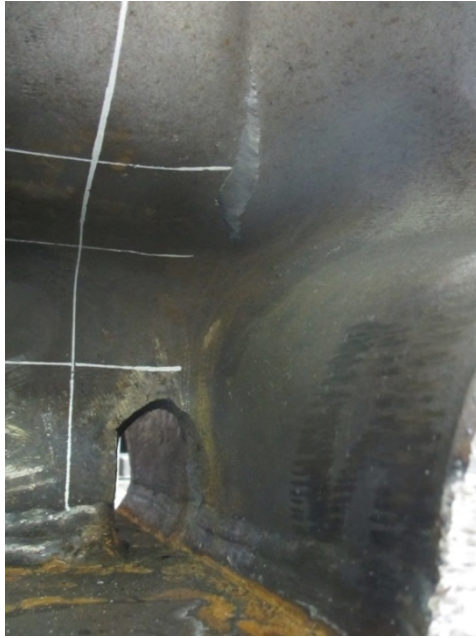
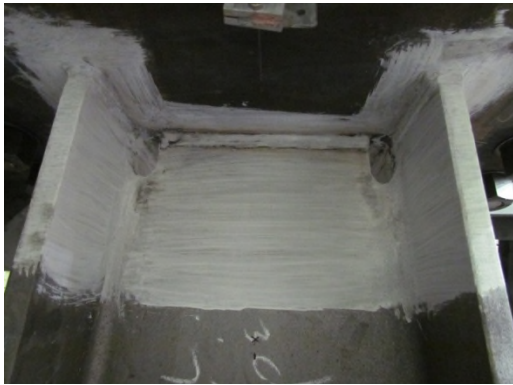
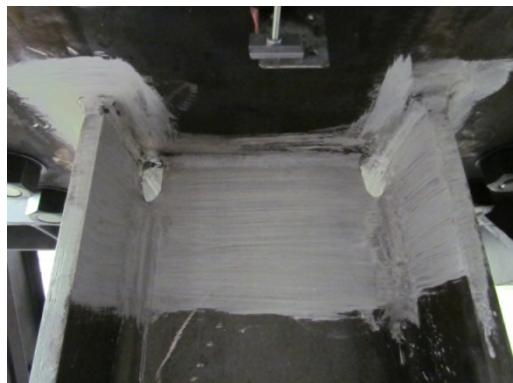
(e) South side K-area (West view)

(f) Top end of west web

(h) Top end of east web

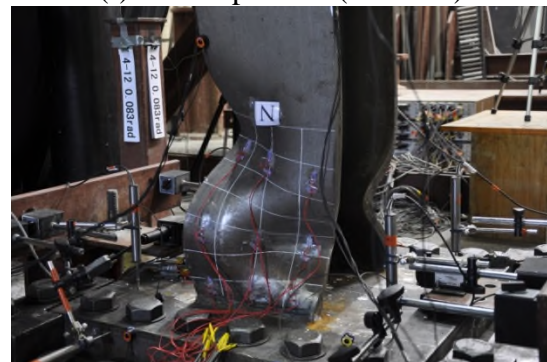
Figure A.58 W-6-25-C1-C: Flange local buckling (North West view)

(h) End of phase 4 (8.3% drift)

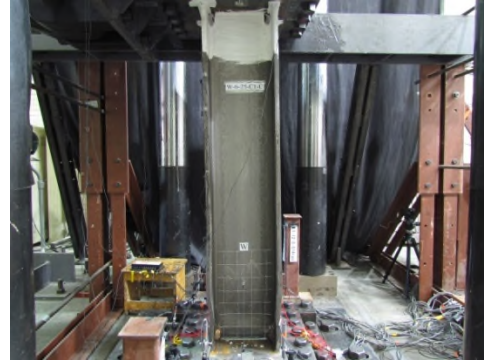
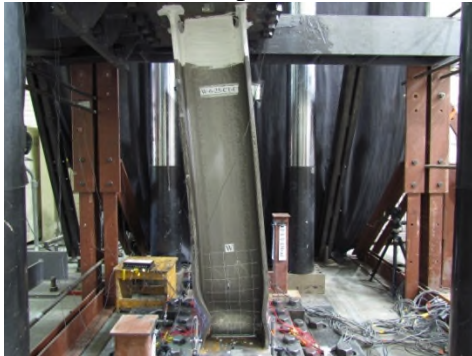
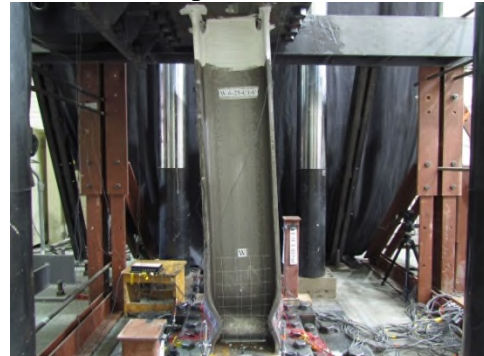
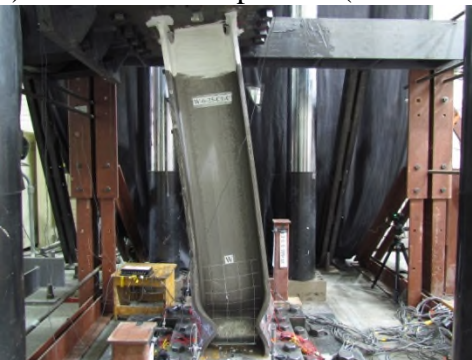
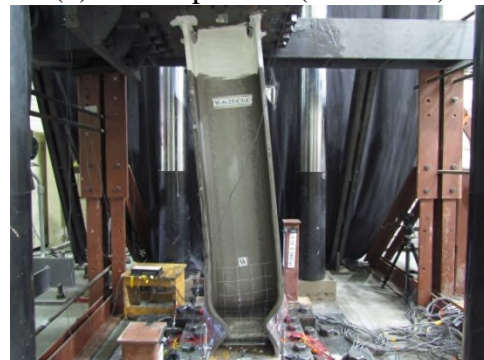
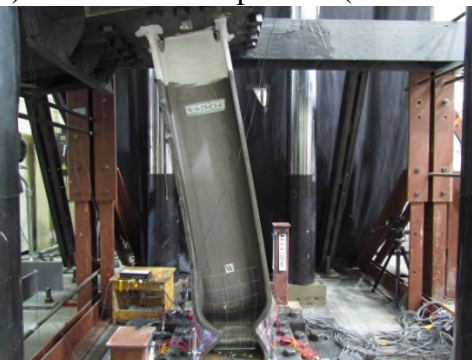
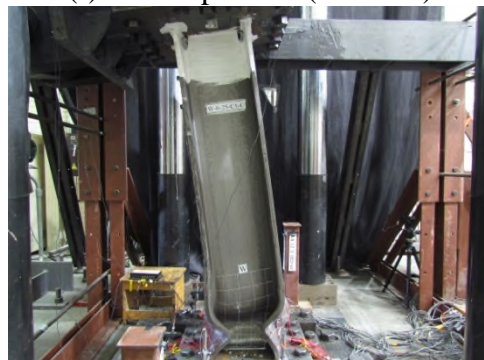
Figure A.59 W-6-25-C1-C: Overall deformed configuration (West view)

(a) 5<sup>th</sup> excursion in phase 1 (5.9% drift)

(b) End of phase 1 (1.4% drift)

(c) 5<sup>th</sup> excursion in phase 2 (7.6% drift)

(d) End of phase 2 (3.7% drift)

(e) 5<sup>th</sup> excursion in phase 3 (9.9% drift)

(f) End of phase 3 (6% drift)

(g) 5<sup>th</sup> excursion in phase 4 (12.2% drift)

(h) End of phase 4 (8.3% drift)

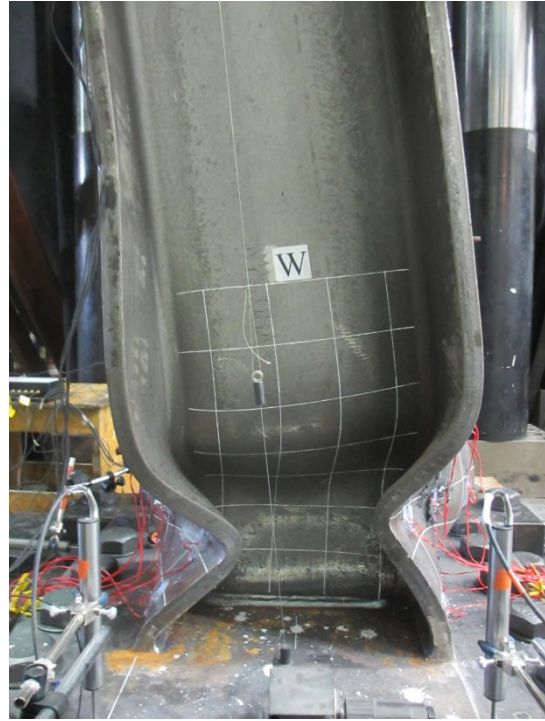
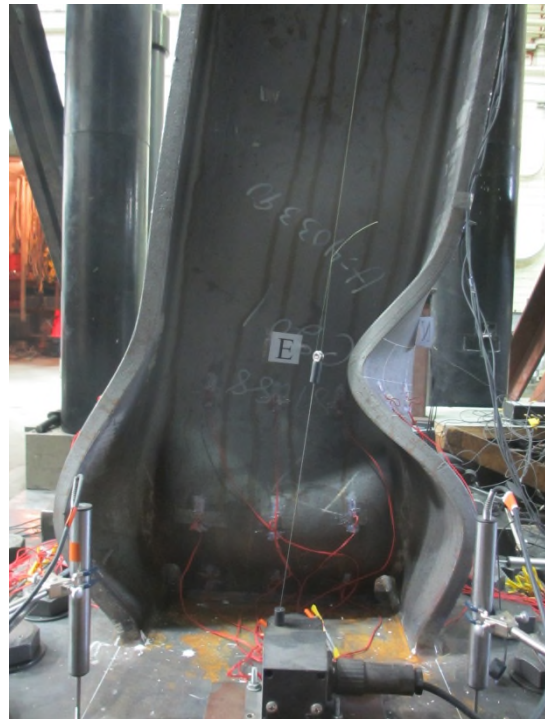
Figure A.60 W-6-25-C1-C: Post-test specimen observation

(b) West view

(d) East view

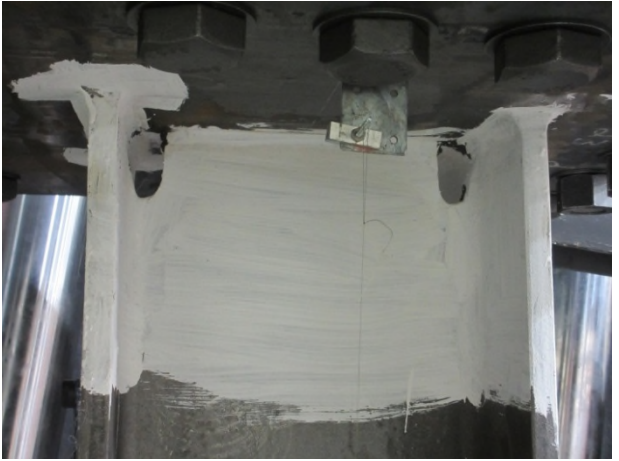
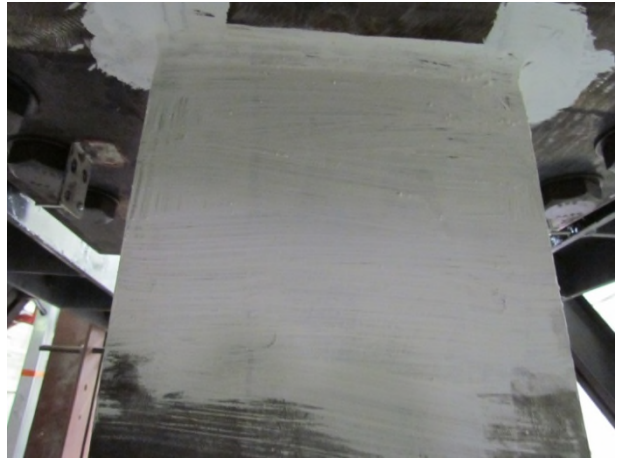
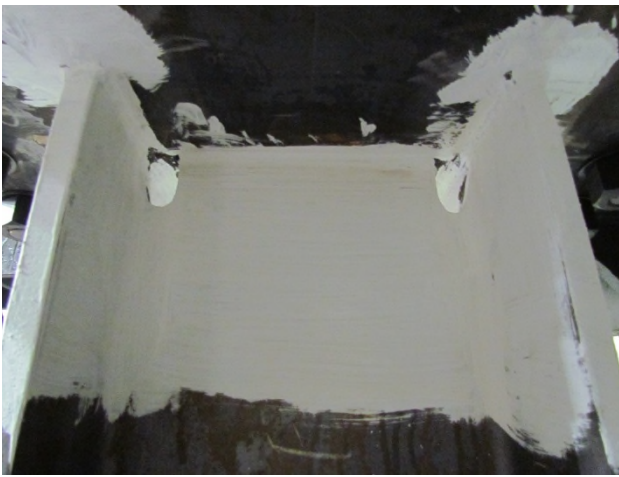
(e) Top end of west web

(f) Top end of north flange

(g) Top end of east web

therefore, the energy dissipation increased compared to the moment hysteresis during Phase 3 loading; thus, the column axial shortening accumulation decreased during Phase 4 loading. After the completion of this loading phase, the column flexural strength reached to 40% of the capping moment, and the axial shortening was more than 5% of the column length. The test was stopped at this point due to the load capacity of the lateral actuator. Note that the torsional distortion of this column was small as shown in Figures A.60a to A.60d. Fracture did not occur in this case. Furthermore, the top end flanges of the steel column did not yield, as shown in Figures A.60e to A.60h.

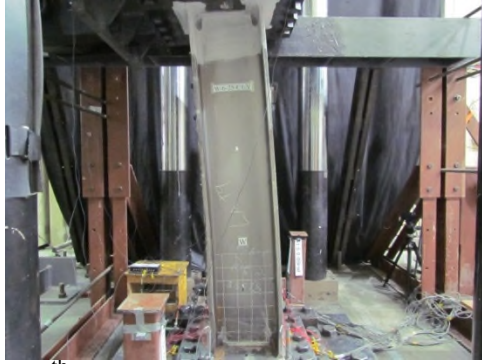
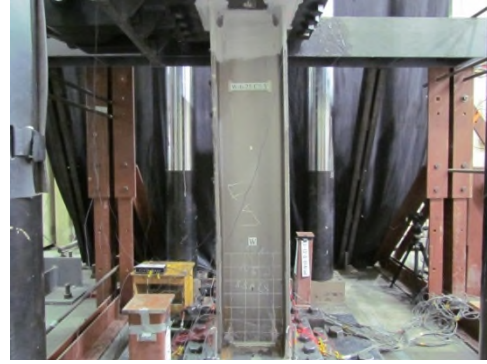
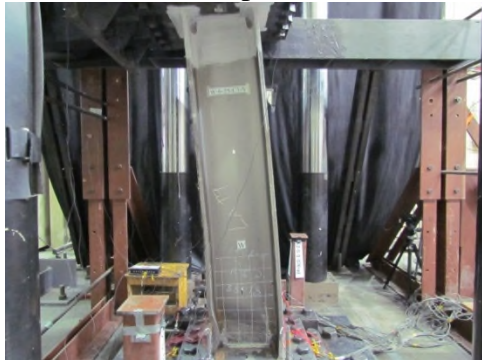
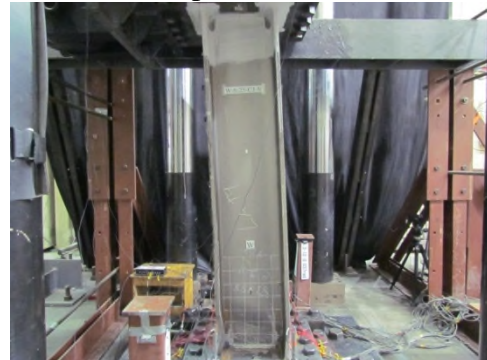
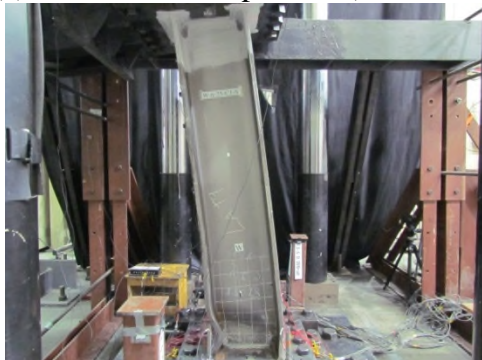
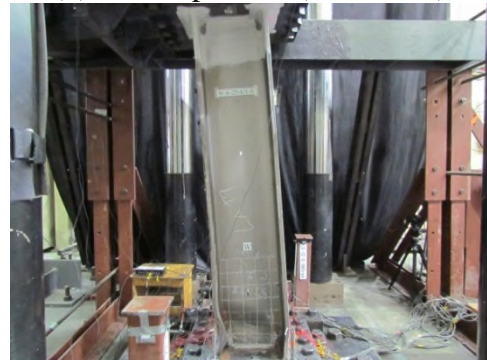
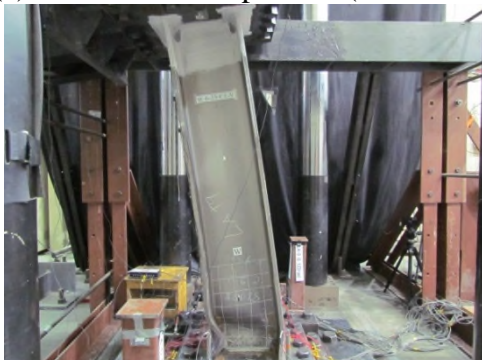
Figure A.62 W-6-25-C1-V: Overall deformed configuration (West view)

(a) 5<sup>th</sup> excursion in phase 1 (5.9% drift)

(b) End of phase 1 (1.4% drift)

(c) 5<sup>th</sup> excursion in phase 2 (7.6% drift)

(d) End of phase 2 (3.7% drift)

(e) 5<sup>th</sup> excursion in phase 3 (9.9% drift)

(f) End of phase 3 (6% drift)

(g) 5<sup>th</sup> excursion in phase 4 (12.2% drift)

(h) End of phase 4 (8.3% drift)

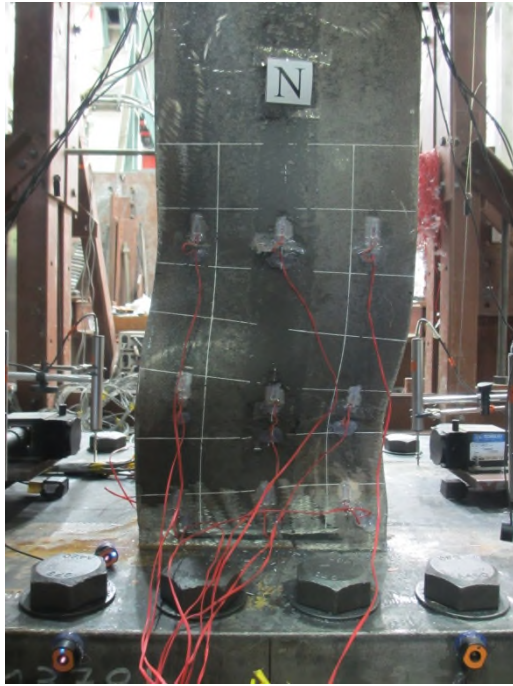
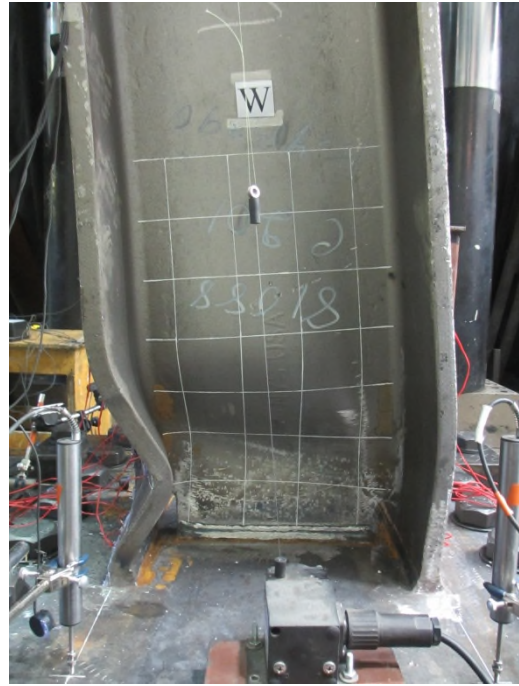
Figure A.63 W-6-25-C1-V: Post-test specimen observation

(a) North view

(b) West view

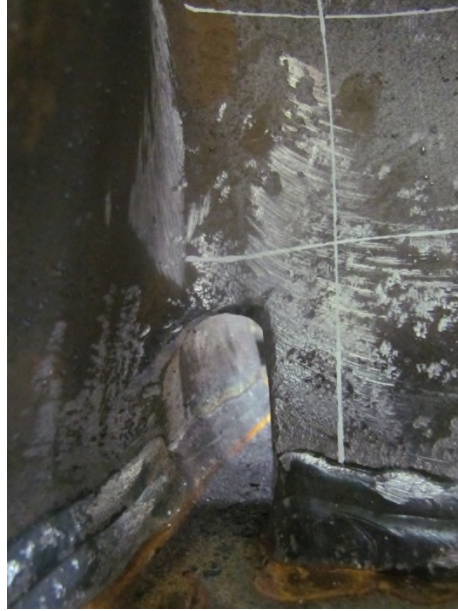
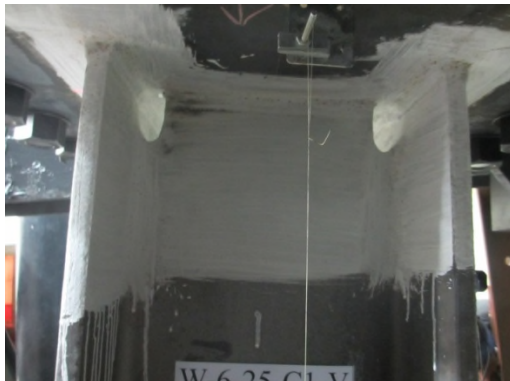
(e) North side weld access hole (West view)

(h) Top end of east web

1 protocol (target drift was 1.8%). However, it was barely notable. The buckling mode had a half wavelength equal to  $0.8D$  and the buckling center was located at a distance equal to  $0.45D$  from the top surface of the column base plate. Because of the axial load variation from compression to tension, the buckling wave did not develop; however, local buckling was much more evident after the end of 5th excursion of Phase 2 loading, which was associated with a 7.6% target drift amplitude as seen in Figure A.61c. A small torsional deflection was observed after Phase 3 loading (see Figures A.61e to A.61h and Figures A.63a to A.63d). Column axial shortening varied linearly with respect to the chord rotation of the steel column. The column flexural strength deteriorated cyclically to about 50% of its capping moment at the end of Phase 4 loading. After the completion of Phase 4 loading, a small crack was observed at the weld access hole near the north column bottom flange as shown in Figure A.63e. The top end flanges of the steel column did not yield, as shown in Figures A.63f to A.63i.
