Using In-Situ Building Fabric Thermal Performance Testing to Calibrate As-Built Models of Low Energy Dwellings in the UK

RAJAT GUPTA AND MATT GREGG

Low Carbon Building Research Group, School of Architecture, Oxford Brookes University, Oxford, UK

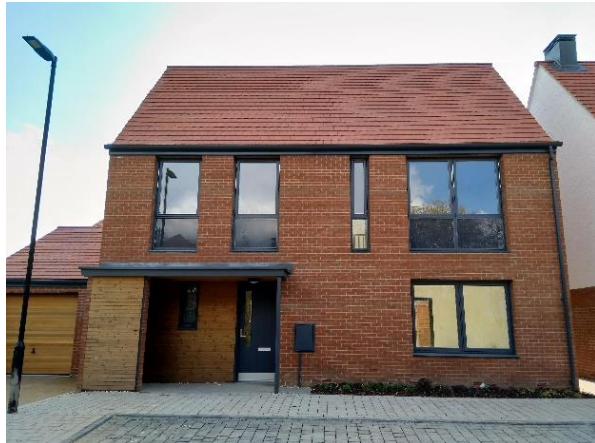
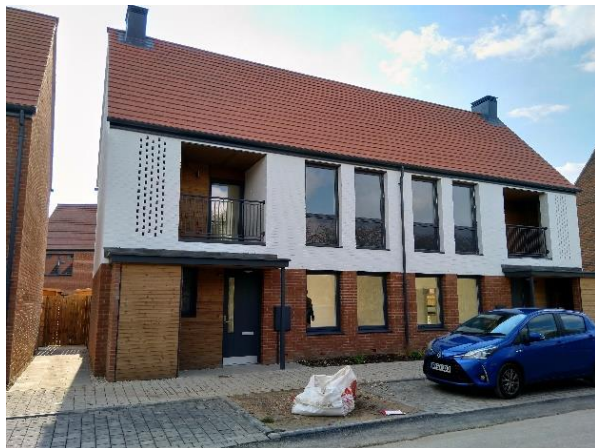
Figure 1: Case study dwellings

The three case study dwellings in the study (Zero Plus project) are shown in Figure 1 on the following page. The dwellings are located in York (UK). The house numbering is from right to left in the images. ZP1 and ZP2 are both 2-bedroom semi-detached properties, consisting of two stories. These two properties are mirrored, and both share the party wall along the lounge wall. ZP3 is a 3-bedroom, plus study detached property, also with two stories.
