Bang Rachan Class Minehunter mission system upgrades: lessons learnt

The Royal Thai Navy Bang Rachan Class Minehunters have been upgraded within a 3 year programme to provide a 15 year life extension with works performed in Royal Thai Navy Dockyard in Phra Chulachomklao, Bangkok.

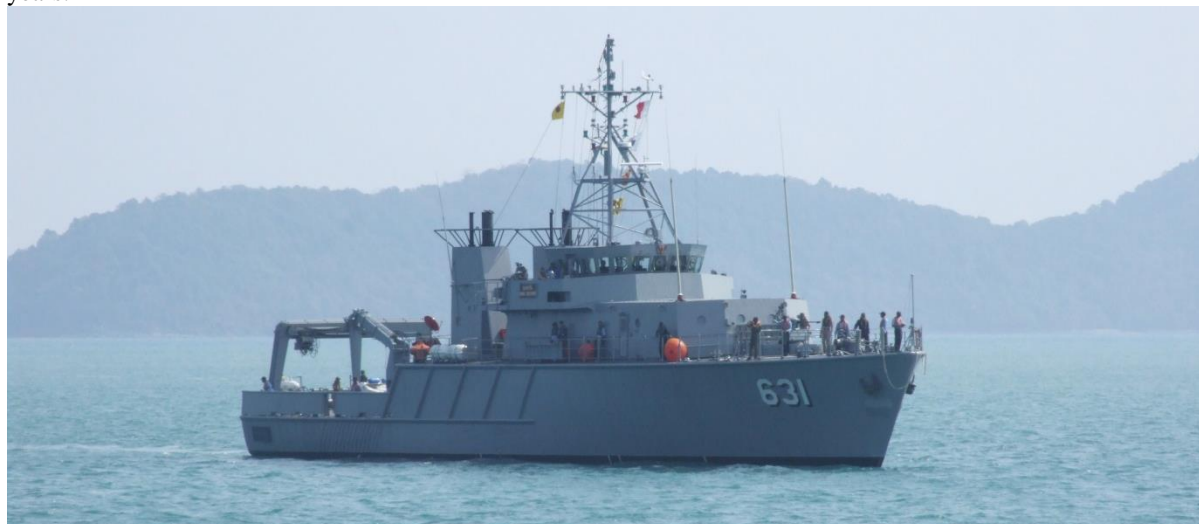
Figure 1. Bang Rachan Class MCM: 48m LOA at 450 Tonnes displacement

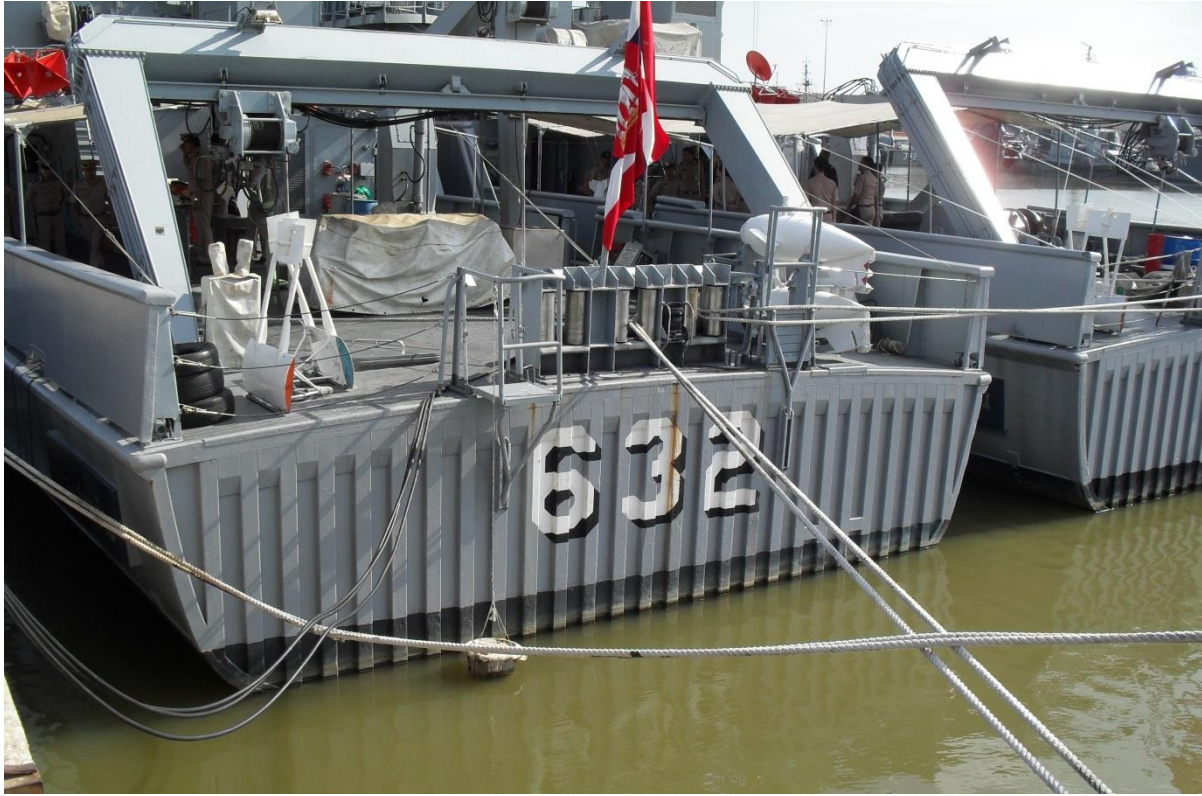
The scope of the upgrade was shipwide, with the vessels still in the water it was impossible to conduct full hull surveys externally. This was a major concern and risk as the vessels are wooden hulled with 3 layers of planking above the waterline and 4 below (figure 2). This planking had been regularly maintained but the vessels had been in service in the tropical water for over 30 years and there was evidence of contact damage and repairs so it was known that there would be significant remedial work required.

Figure 2. Wooden hulls on stainless steel frames, with vessels in the water for over 30 years hull repairs would be necessary, using skills which were fast becoming difficult to find

Initial hull surveys were not undertaken to the full extent they should have been due to the ships remaining in the water. There was no real solution to solving this issue, apart from arranging for dry-docking of the ships before bidding, which would have incurred upfront time and cost penalties. We therefore had to accept the risk.

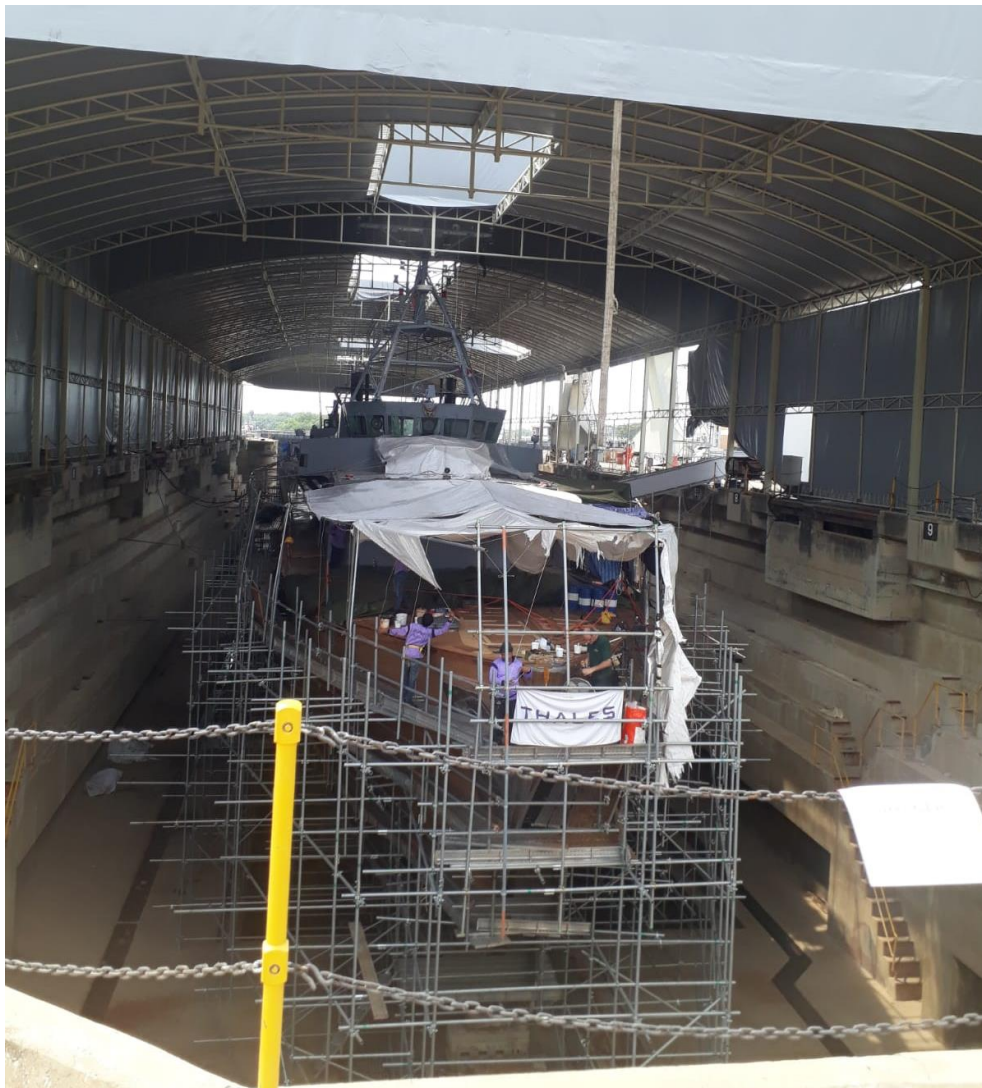
The RTN mandated the refit at their dockyard in Phra Chulachomklao which was 1 to 1.5hrs drive from Bangkok, where suitable accommodation could be secured. This travel time was significant and needed to be factored into the working schedule. Unlike other dockyards, there was no commercial dockyard presence on site and therefore all labour and materials needed to be sourced outside of the dockyard. The dry dock was not covered and the wooden hull repairs took in excess of 6 months and extended into the rainy season.

Figure 4. A tent was built over the open dry dock to protect the wood repairs from the elements

Thales chose to ferry the teams to and from the dockyard in comfortable minibuses departing at 7am and returning to be back at the hotel at 6pm. This gave a full working day on site and the opportunity to sleep or work on laptops during the journey. A local shipbuilding company was contracted to provide good quality workmanship and materials. A 'village' of portakabins (temporary offices) was set up close to the ships to house the teams, materials and workshops. Thales engaged with a contractor to tent over the whole dry dock area.

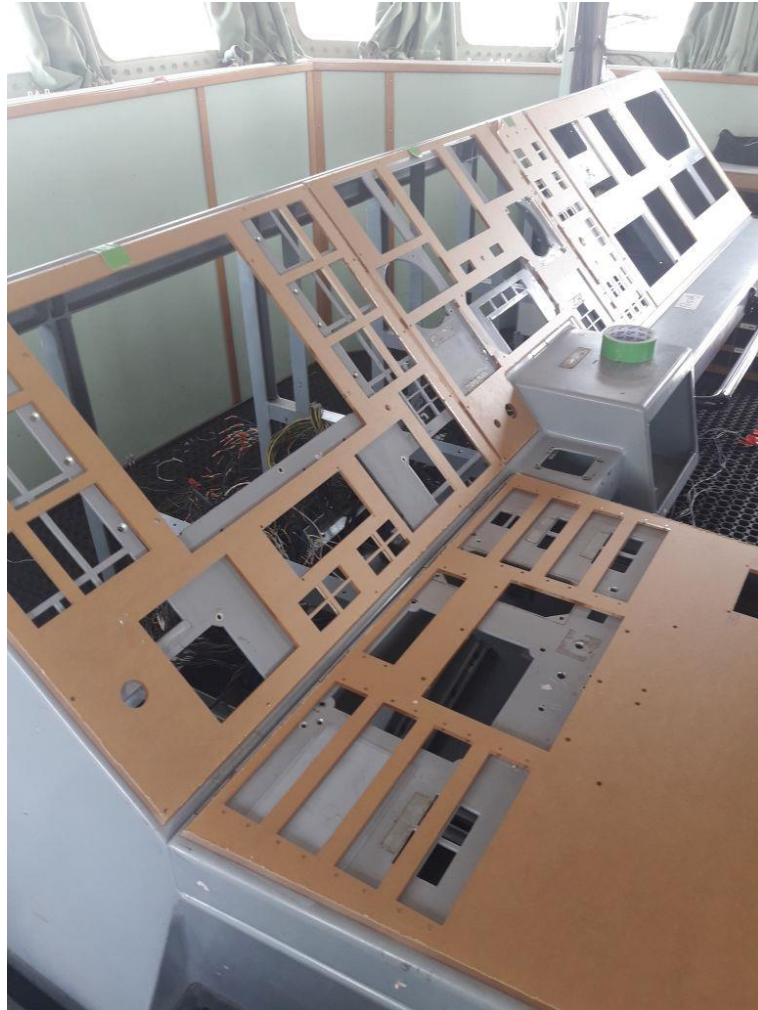
The refit required a significant quantity of equipment to be replaced in the Bridge Console alongside systems that were not being upgraded by Thales. The proposed solution was to replace the fixed console facia with a new modular version designed to accommodate all of the required equipment. However, the complexity of this solution was not fully understood at the outset.

Figure 5. Templates being assessed on the existing Bridge Console Chassis

Once all of the equipment had been stripped out of the console, templates were designed and prototyped onto the console chassis. This highlighted where the chassis need cutting out and where the holes for the mounting fixtures needed drilling. The fitting of the equipment onto the new facia was straight forward (see figure 5) and could be done in an air conditioned workshop. However, the wiring loom of the console took a number of months with technicians working in sweltering conditions, mainly sitting or laying down on the deck. Further difficulty was experienced setting the console to work and tracking down wiring errors. Lessons were learnt were to supply and installed a new entire Bridge Console, manufactured and tested under controlled conditions in a factory (which is what we have done subsequently).

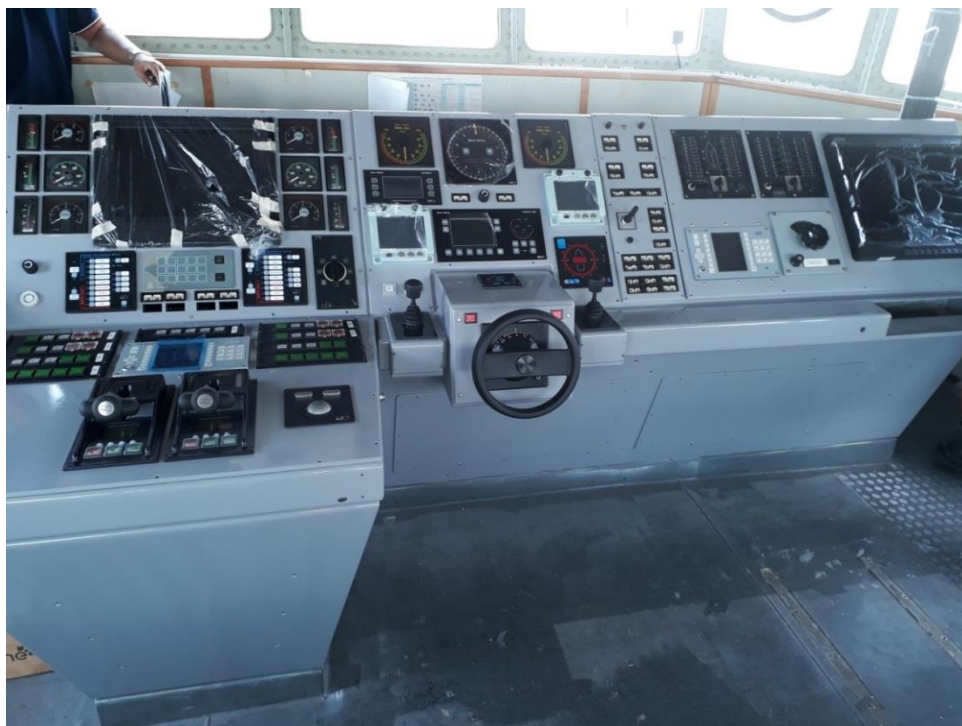
Figure 6. The Refurbished Bridge Console

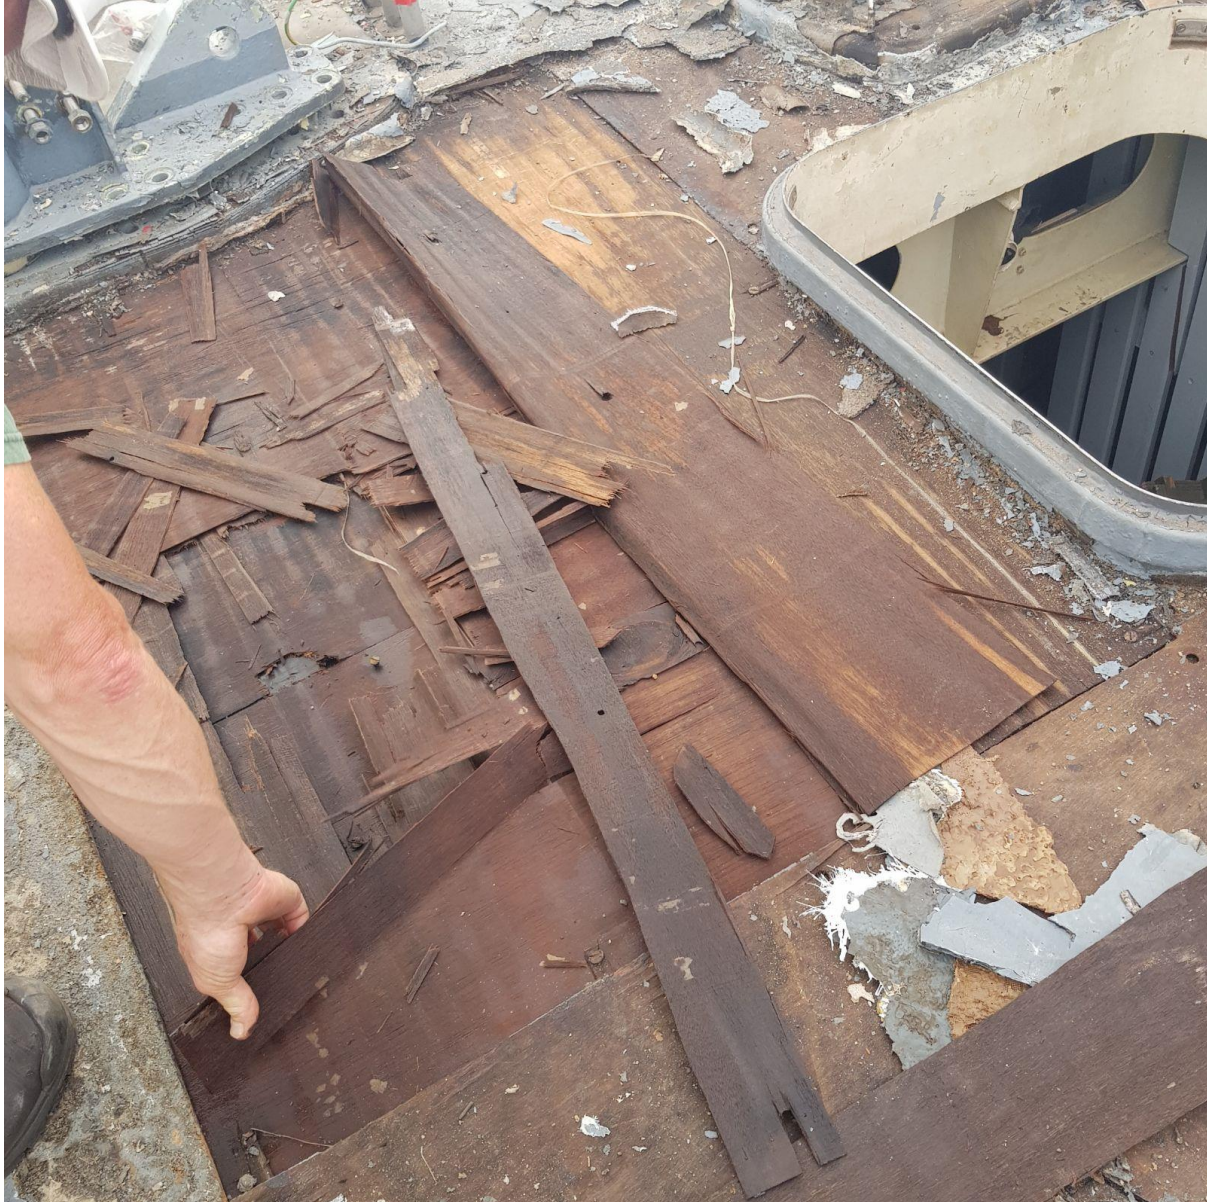
The approach to the deck repairs was to cut out and replace the rotten / damaged areas. However, as the work progressed it became apparent that the surveys performed during the bid phase were not sufficient. The assessed level of repair was inadequate, due to the layered composition of the deck the damage extended far beyond that expected.

Figure 7. The layered nature of the Deck construction masked the extent of the water damage

Thales had to procure additional wood in order to complete the deck repairs. The cost of the additional wood was compounded by the significant additional manpower required to perform the complex patching repairs and in most cases whole sections of deck were replaced rather than repaired. The lesson identified was that future bids need to consider the cost effectiveness of replacing the entire deck both in terms of wood and manpower.
