Preliminary report of liquefaction phenomena triggered by the March 2021 earthquakes in Central Thessaly, Greece

S. Valkaniotis, G. Papathanassiou, Ath. Ganas, E. Kremastas, R. Caputo

March 16 2021

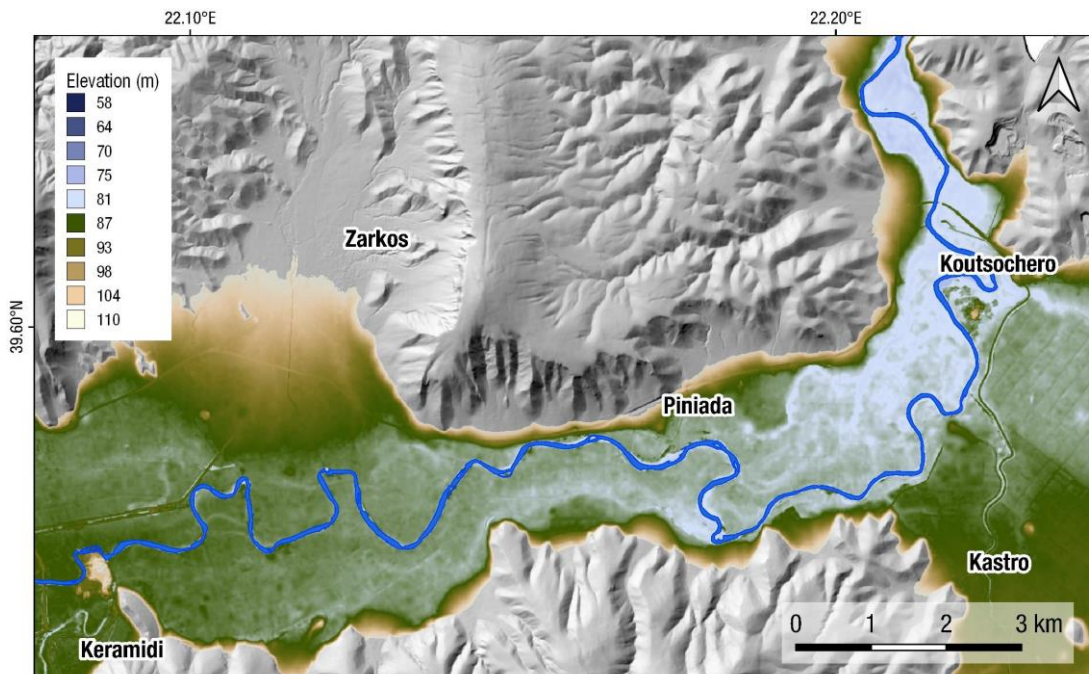
Figure 6. Elevation map of the Pinios river valley strand between Zarko and Koutsochero (only elevations between 58 and 120 m.a.s.l. are shown). A 1-2 km wide valley can be seen to form along the meandering river bed of Pinios river.

The former area is geomorphologically characterized as a flood plain that periodically covered by the flooding material of Pinios river (Figures 5 & 6, Mantovani et al. 2018, Caputo et al. 2021) and it had been classified as highly susceptible to liquefaction by Papathanassiou et al. (2010). In addition, within this liquefiable zone, the Pinios river formed many meanders that are classified as one of the most prone to liquefaction areas; particularly the areas of point bar deposits that developed in the inside bank of Pinios river meanders.

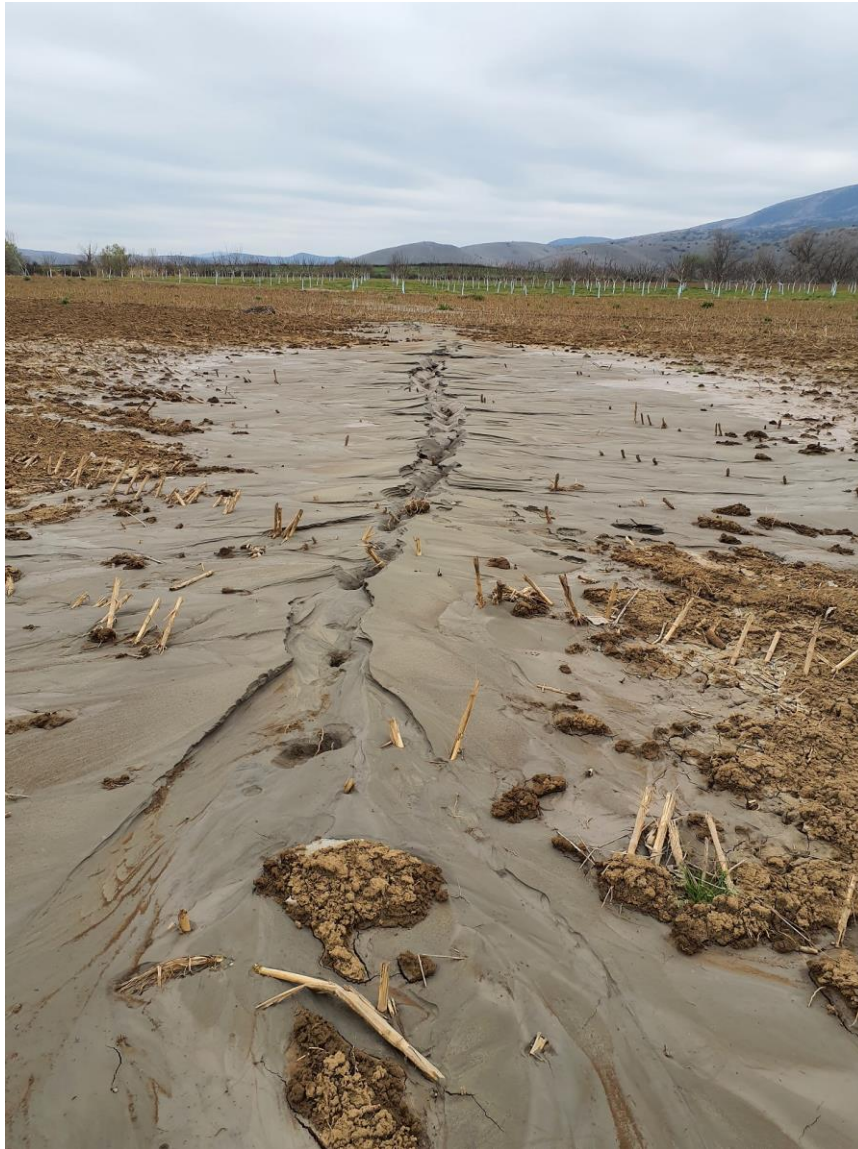
Figure 9. Liquefaction fissure with ejected sand (Photo taken by G. Papathanassiou 07/03/2021).

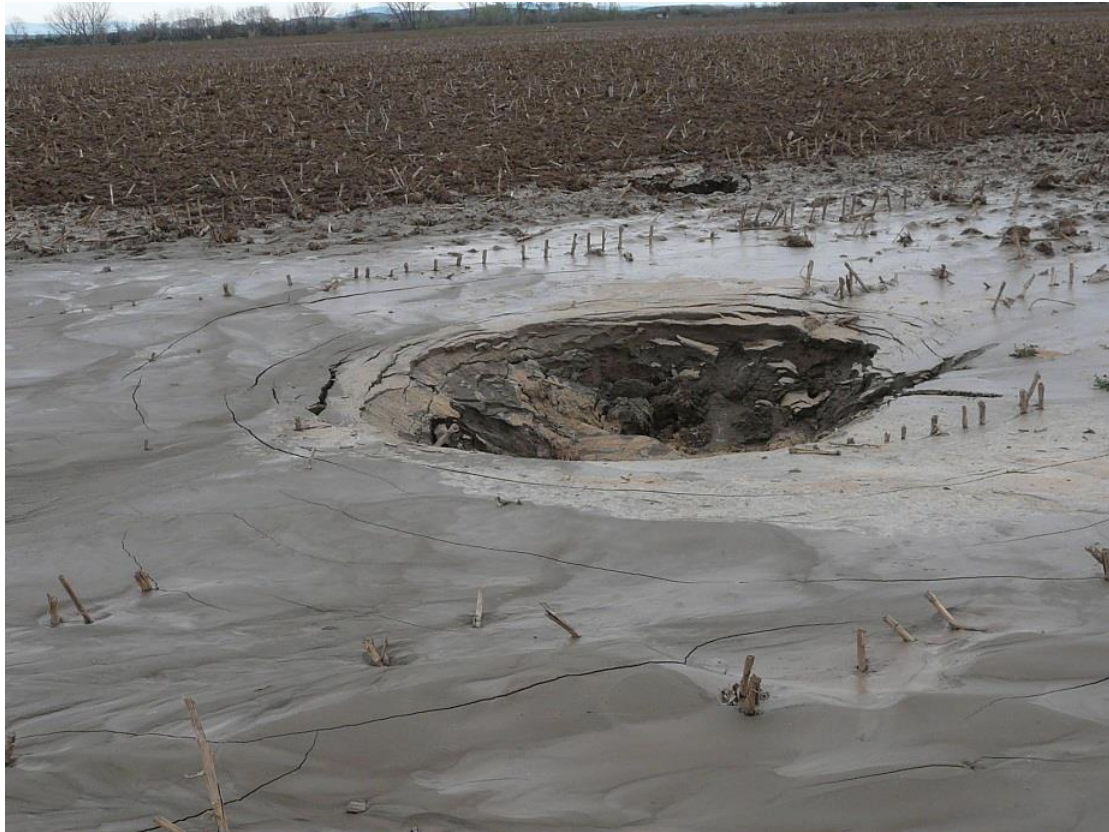
Figure 10. Sand crater (Photo taken by G. Papathanassiou 05/03/2021).

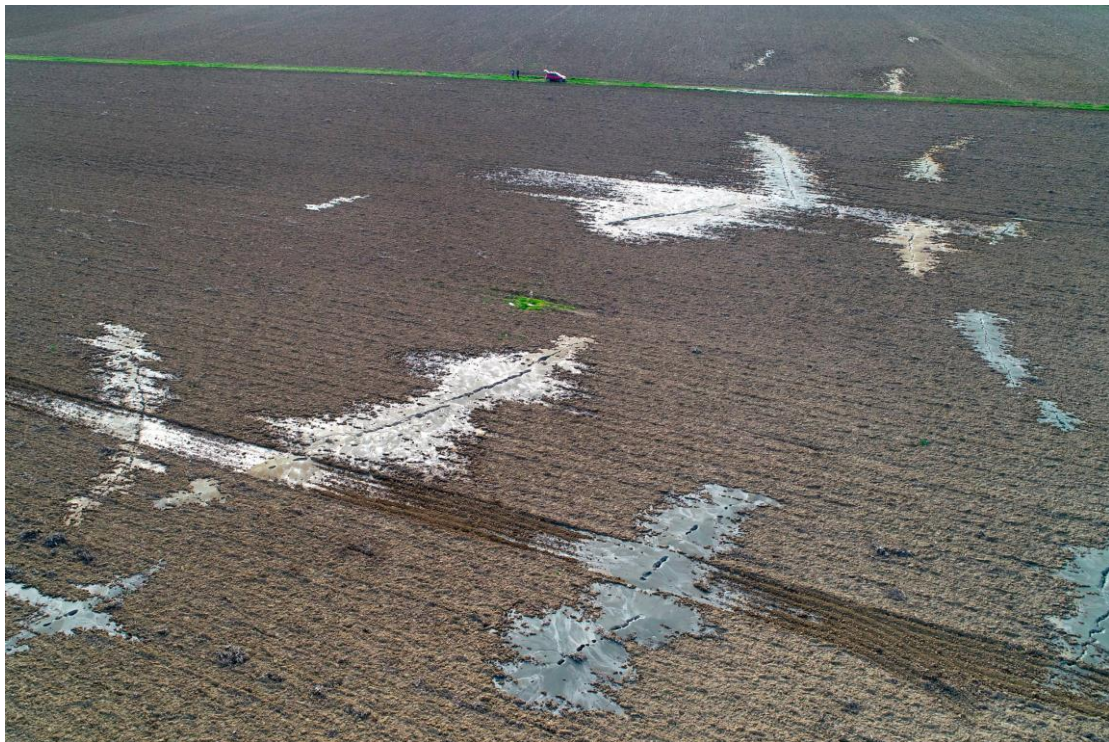
Figure 11. Aerial view of multiple linear liquefaction fissures (Photo taken by G. Papathanassiou 05/03/2021).

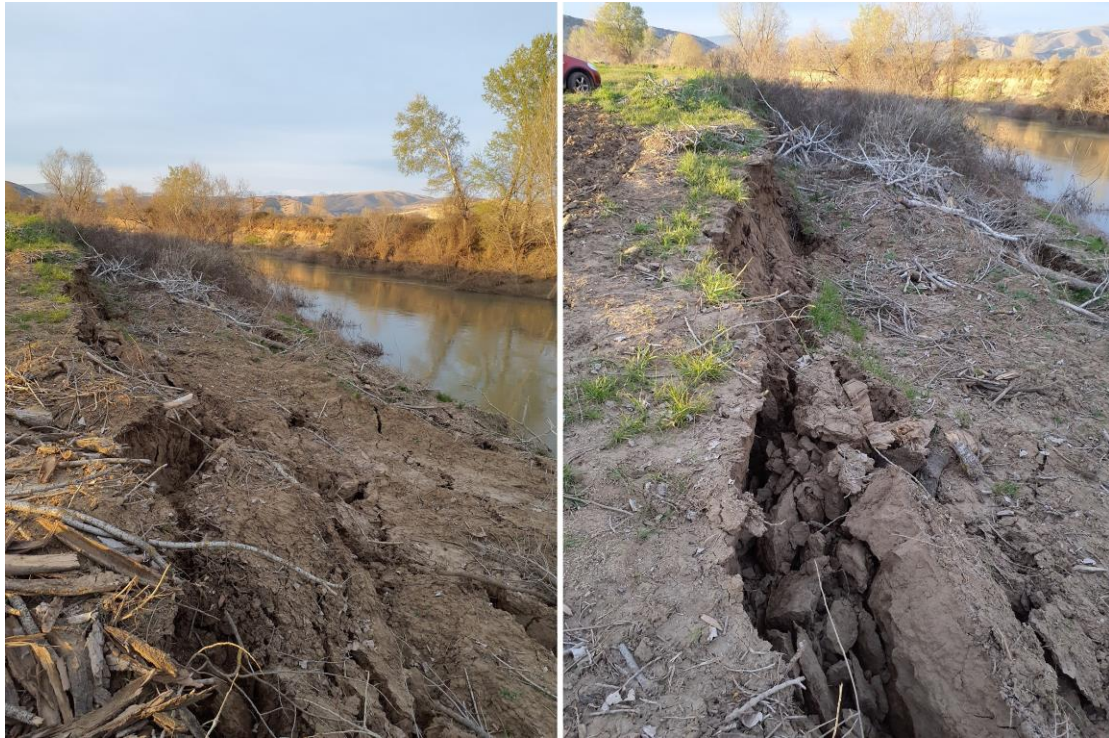
Figure 12. Lateral spreading along Pinios river (Photos taken by S. Valkaniotis 05/03/2021).

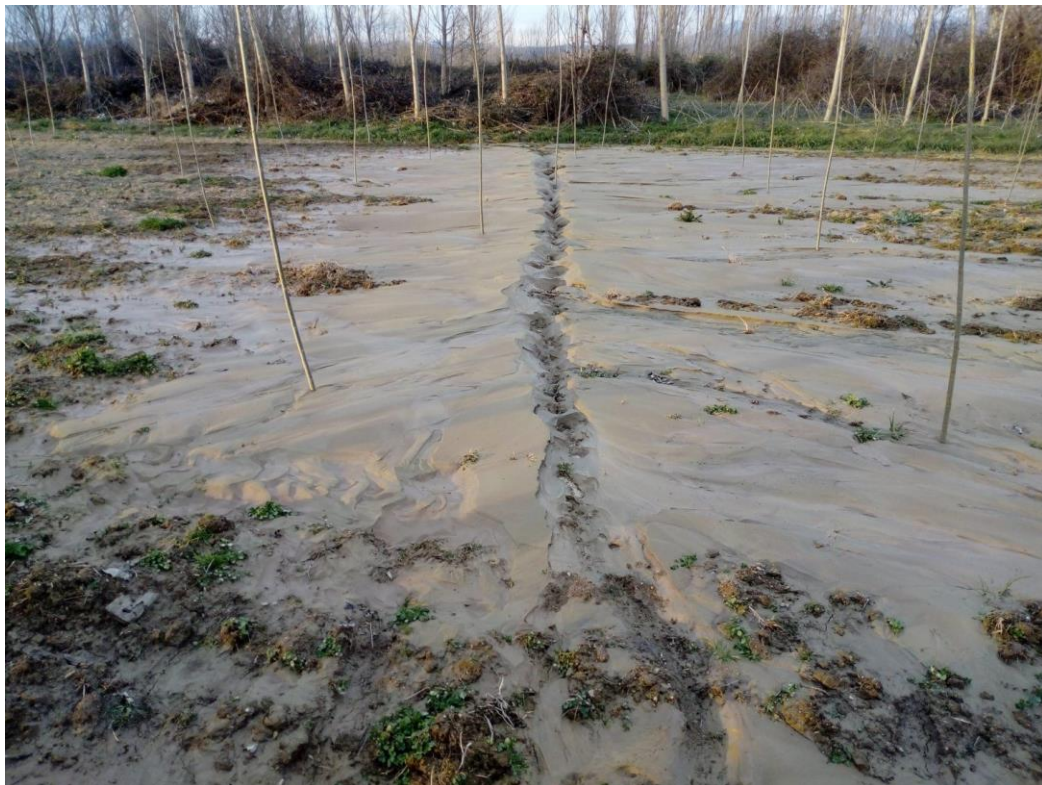
Figure 13. Liquefaction fissure with ejected sand (Photo taken by A. Ganas 06/03/2021).

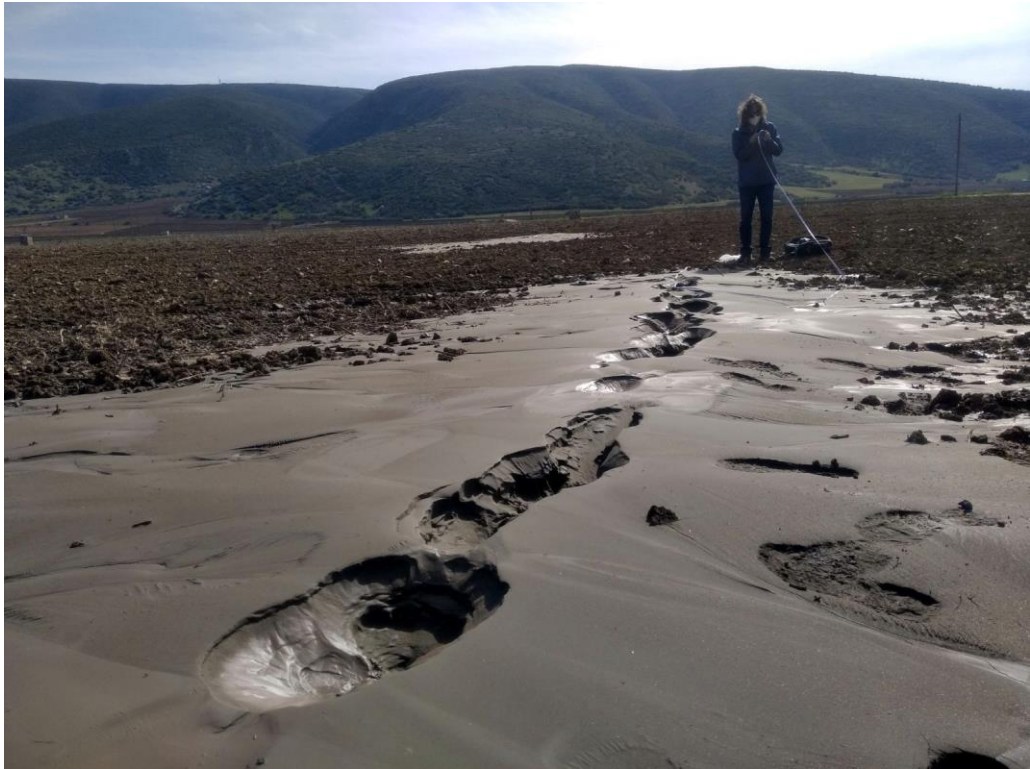
Figure 14. Liquefaction fissure with ejected sand (Photo taken by S. Valkaniotis 05/03/2021).

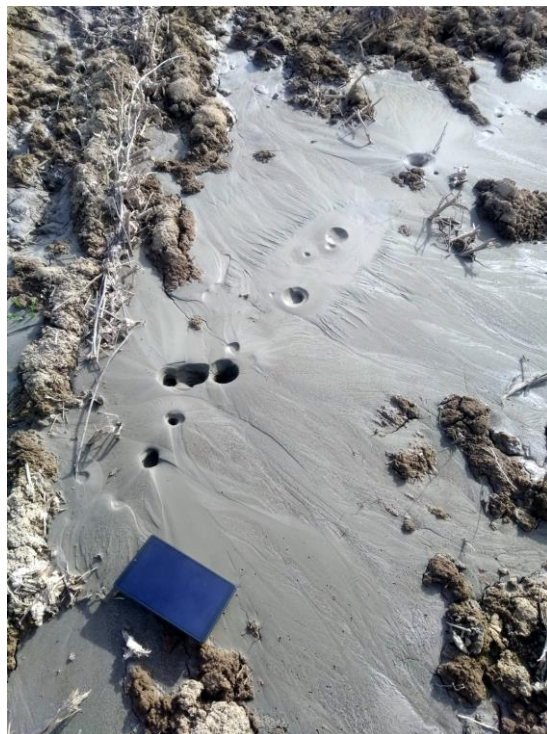
Figure 15. Close-up of liquefaction fissure with small craters (Photo taken by S. Valkaniotis 05/03/2021).
