# Examine the Underlying Causes of Flexible Pavement Deteriorations, Methods of Maintenance and Pavement Condition Rating

**Abstract:** In India, the deterioration of asphalt pavement is a major issue in the road and highway sectors. It may occur due to a variety of factors such as premature aging, improper mix design, inadequate construction, and material quality, the improper structure design of pavement considering traffic, and a lack of preventive maintenance, among others. There are many types of distress in asphalt pavements known as disintegration (raveling, and potholes), fracture (spalling and cracking), and distortion (slippage deformation of permanent). This research aims to perform a physical survey for distress analysis and pavement condition rating using the IRC method. As a case study, four urban flexible pavement roads in the Pimpri Chinchwad Pune area were chosen. The roads are visually inspected to measure the severity to detect the types and extent of the distresses. Based on the severity of the distresses, the IRC method assigns a grade of 0 to 1.0 for poor condition roads, 1.1 to 2.0 for fair condition roads, and 2.1 to 3.0 for good condition roads. As per the

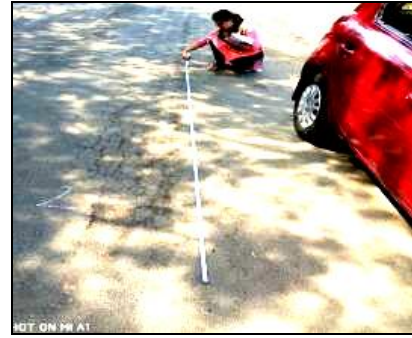
**Alligator Cracking:** This is characterized as a series of interconnected cracks, which resembles the skin of an alligator. These types of cracks occur due to the overloading of heavy commercial vehicles, brittleness of the binder due to aging of the binder.

Fig. 1 Low Severity

**Alligator Cracking:** a) Crack sealing by bitumen emulsions. b) Crack sealing by rubberized and modified bitumen. c) Milling and surface recycling.

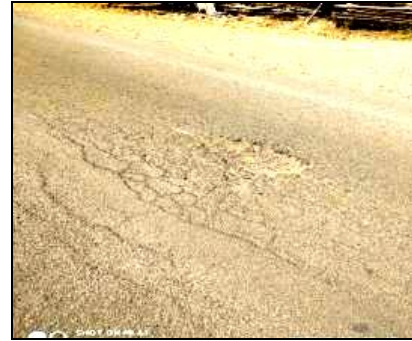
Fig. 2 Medium Severity

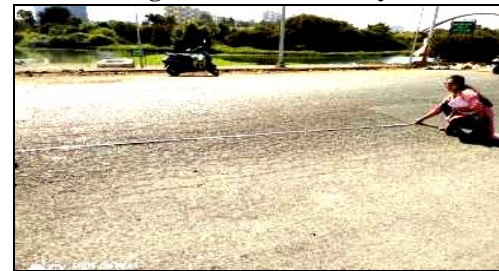
Fig. 3 High Severity

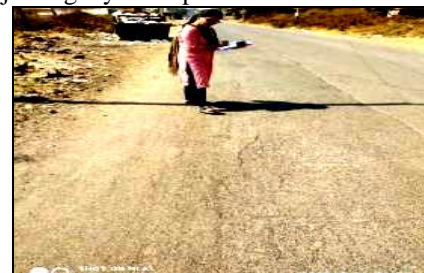
**Longitudinal Cracking:** Cracks that appear parallel to the centerline or along the road are called longitudinal cracks. These are usually caused by alternate wetting and drying beneath the shoulder surface or by improper/weak joints between adjoining layers of pavement.

Fig. 4 Low Severity

**Longitudinal Cracking:** a) Crack sealing preferably using rubberized bitumen. b) Remove and replace the cracked pavement layer with a fresh overlay.

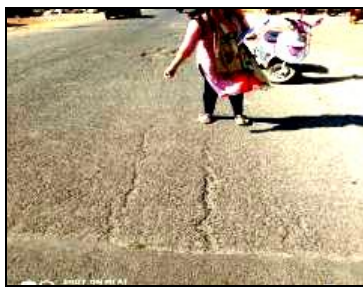
**Fig. 6 High Severity**

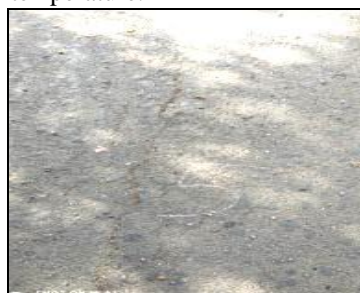
**Transverse Cracks:** These cracks appear in the transverse direction or as interconnected cracks forming series of large blocks perpendicular to the direction of the road. These may occur due to the reflection of crack or joint in an underlying pavement layer, due to shrinkage of bituminous mix on account of low temperature.

**Fig. 7 Low Severity**

**Transverse Cracks:** Transverse cracks may be treated using a slurry seal or rubberized bitumen.

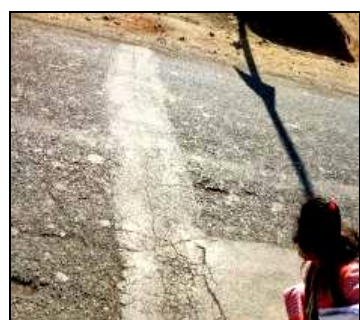
**Fig. 8 Medium Severity**

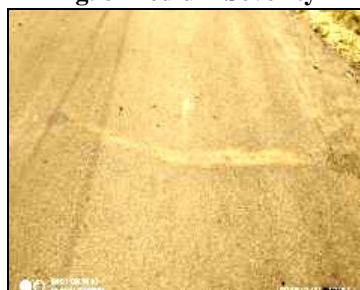
**Fig. 9 High Severity**

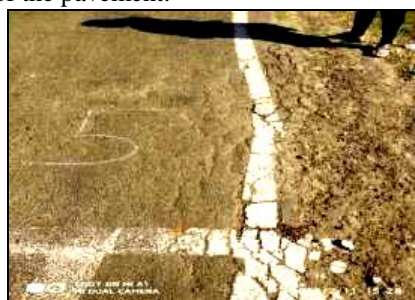
**Edge Cracking:** The cracks which develop parallel to the outer edge of the pavement.

**Fig. 10 Low Severity**

**Edge Cracking:** a) Promote good drainage along the edge of the road. b) Remove the dirty, poor drainage shoulder material and replace it with a more permeable material. c) If the truck traffic is substantial, place a considerably thick structural overlay on the road surface of the order of 75 – 100 mm of hot mix to provide adequate support for heavier vehicle load.

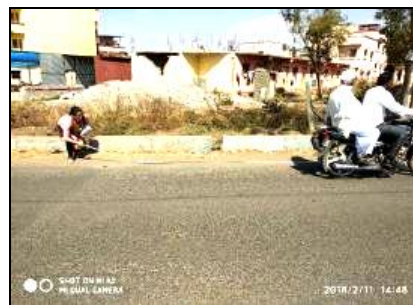
**Fig. 11 Medium Severity**

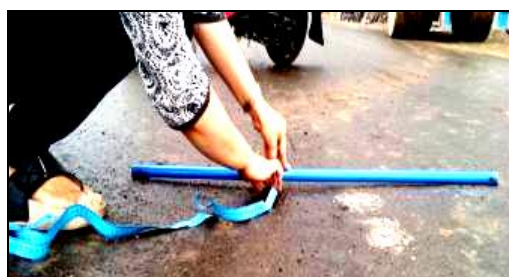
**Rutting:** Rutting is longitudinal depression or groove in the pavement along the wheel path. These occur due to heavy channelized traffic and overloading of vehicles and from unstable asphalt courses due to poor asphalt mix design. (especially use of rounded aggregate, improper gradation, and excessive bitumen binder). It can also occur if there is a lack of adequate subgrade support which causes the whole pavement to settle in the wheel tracks where loads are applied.

**Fig. 12 Low Severity**

**Rutting:** Any layer exhibiting rutting must be removed (milled) completely and replaced with a more stable mix course.

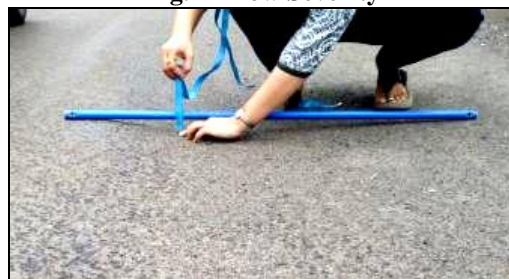
**Fig. 13 High Severity**

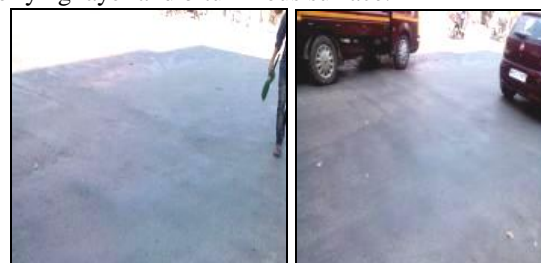
**Shoving:** This is a form of plastic movement within the bituminous layers resulting in bulging of the pavement surface. This occurs due to less mix stability (high proportion of fines, excessive binder, soft binder) in the bituminous surface or base course, and lack of bonding between underlying layer and bituminous surface.

**Fig. 14 Bulging of Bituminous Layer**

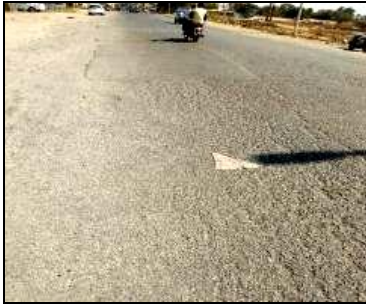
**Raveling:** The dissociation and progressive separation of fine aggregate particles and binder from the bituminous surface is known as raveling. Normally fine aggregates wear away first followed by coarse aggregates. It occurs due to a lack of sufficient cohesion within asphalt mix due to low in-place density or inadequate binder content. Lack of fines in the asphalt mix matrix, especially in the course, segregated areas also cause premature raveling. Aging of asphalt binder can also cause raveling but it takes place after many years of service.

**Fig. 15 Low Severity**

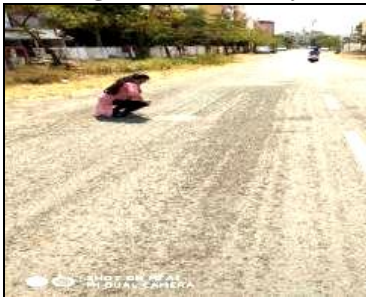
**Fig. 16 Medium Severity**

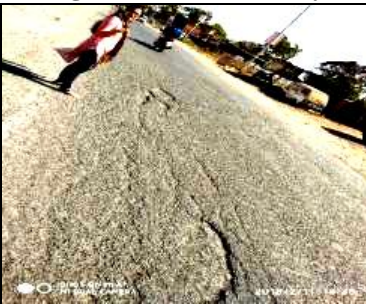
**Fig. 17 High Severity**

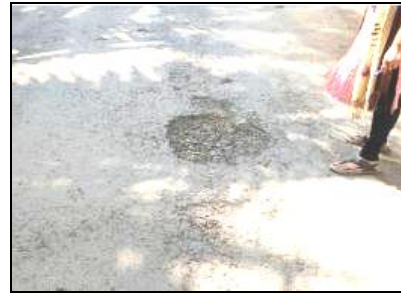
**Potholes:** The various sizes of bowl-shaped cavities in a bituminous surface or extending into the binder/base course are known as potholes. Severe cases of fatigue cracking culminate in the formation of potholes on the asphalt road. Potholes also develop when there is a lack of support from the unbound courses due to excessive moisture.

**Fig. 19 Medium Severity**

**Patching with Hot Mix Asphalt (HMA):** In this method, the pothole is cleaned off loose debris and dirt and a tack coat (usually bitumen emulsion) is applied. Dense graded HMA such as BC grading is then placed in the pothole and is compacted immediately with a roller before the mix cools down to 80 degrees Celsius. Patches should not be made with water trapping asphalt mixes such as Premix Carpet (PMC) and SDBC. These will not last long. For small potholes, either a small roller or a vibratory plate can be used. The HMA should preferably be compacted in 75mm lifts. The compacted patch should be slightly above (3mm to 5mm) the adjacent road surface to allow for further densification by traffic. If properly done, patches with HMA have a reasonably good service life. It is preferred in hot and dry weather.

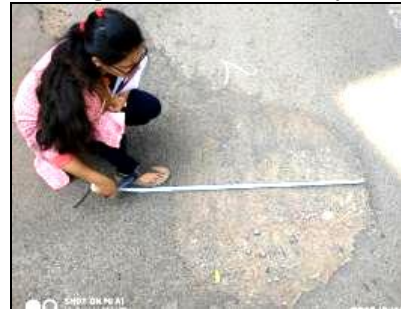
**Fig. 20 High Severity**

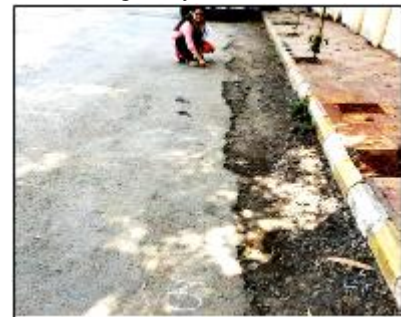
**Edge Breaking:** The common defect in the bituminous surface is edge breaking wherein the edge of the bituminous surface gets broken irregularly.

**Fig. 21 Edge Breaking**

**Edge Breaking:** The affected area's shoulder and sidewalk materials could be completely removed and replaced with a normal segment with vertical sides. Compaction can be done on both the sidewalks and the shoulders at the same time. The shoulders should have enough slope to allow water to flow away.

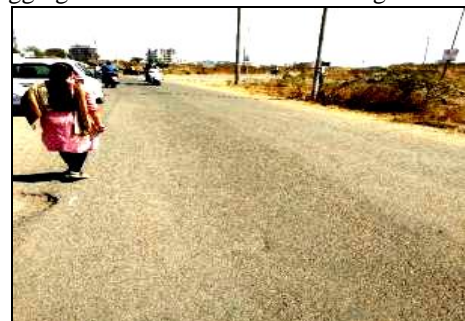
**Bleeding:** A surface having a thin film of excess or free bituminous binder on it, which creates a shiny glass like reflecting surface tending to become soft in hot weather and slippery in cold and wet weather eventually developing low skid resistance. Bleeding may occur due to excessive binder in the mix design or due to poor quality control, low air voids in the compacted mat, use of low viscosity bitumen binder, too heavy tack coat, excessive binder application and/or loss of cover aggregate in case of surface dressing.

**Fig. 22 Bleeding of Bituminous Layer**

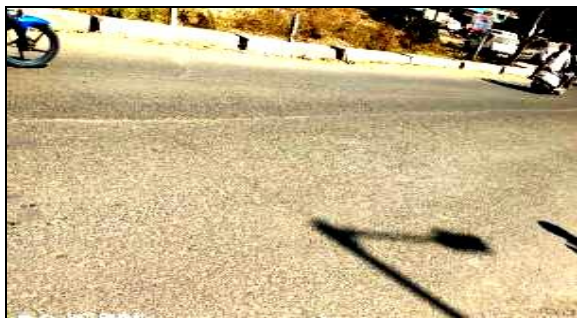
**Fig. 23 Bleeding of Bituminous Layer**

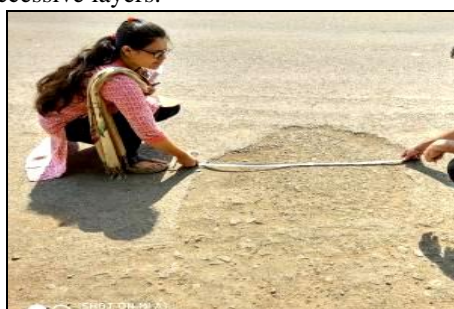
**Slippage:** Slippage is caused by the unusual thrust of wheels in a specific direction due to inadequacy of tack coat, lack of bond between the wearing coat and the lower layer caused by a layer of fine dust, moisture, or both. Failure of a bond between two layers due to excessive deflection of the pavement may also be responsible for slippage of wearing a coat or successive layers.

**Fig. 24 Low Severity**

**Slippage:** Removing the surface coating across the damaged area up to the point that the surfacing and the layer underneath have a strong contact, then patching the area with premix material after adding a tack coat.

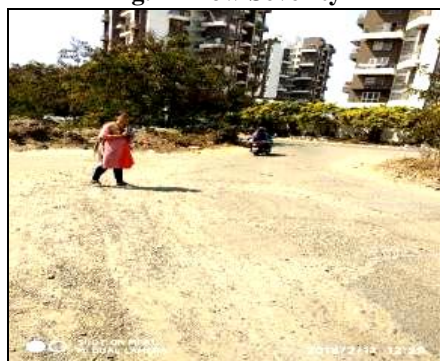
**Fig. 25 High Severity**

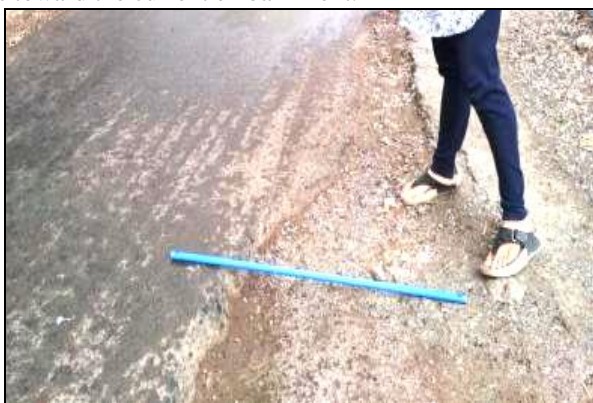
**Settlements:** During a highway expansion scheme, the full differential settlement occurs at the overlapping location between old and new road pavement. When the old road's base is stronger, the maximum settling on the land surface falls toward the current embankment.

**Fig. 26 Settlements**

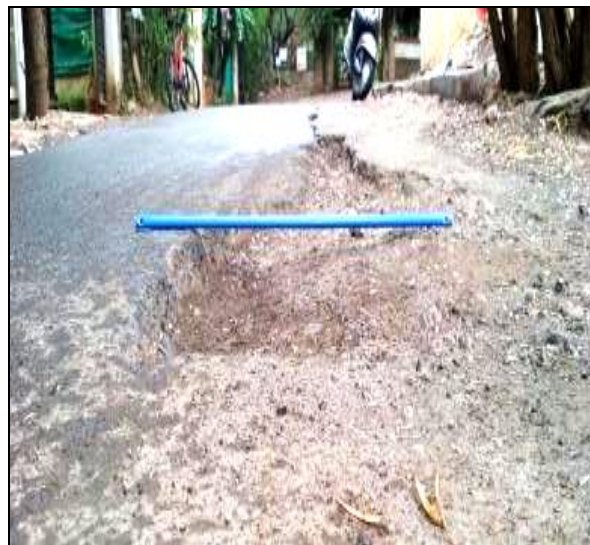
**Fig. 27 Settlements**

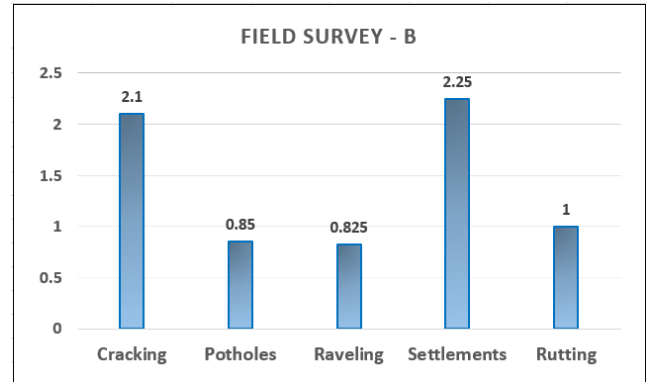
**Graph 2:** Observed distress rating value for Field Survey - B For field survey – B, the final rating value is obtained 1.405 which is between 1.1 to 2.0 and according to that the road is in fair condition.

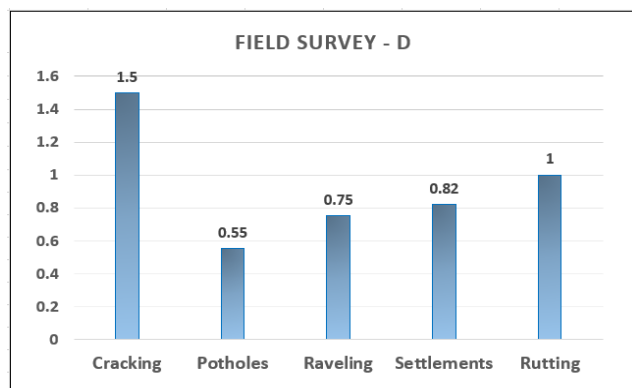
**Graph 4:** Observed distress rating value for Field Survey - D

For field survey – D, the final rating value is obtained 0.924 which is in between 0 to 1.0 and according to that, the road is in poor condition.

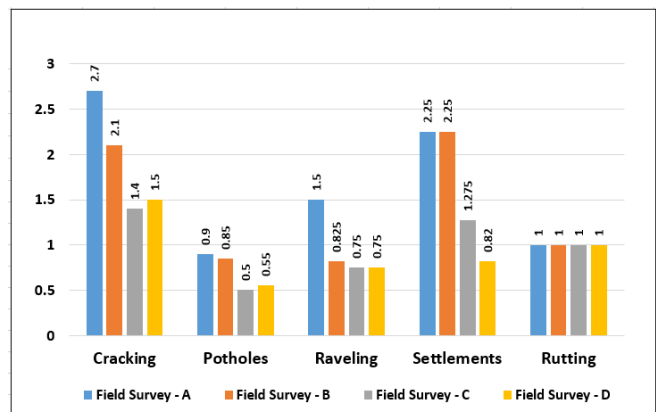
**Graph 5:** Observed distress rating value for Field Surveys. **Field Survey - A:** In Shinde vasti chowk to Iskon temple road, Ravet Pimpri Chinchwad, Pune was rated as Fair Condition road according to IRC method of rating flexible pavements.

**Field Survey - B:** Road besides D’Mart, Survey No 29, Ravet Pimpri Chinchwad, Pune was rated as Fair Condition road according to IRC method of rating flexible pavements.

**Field Survey - C:** Road in front of Dmart, Survey No 29, Ravet Pimpri Chinchwad, Pune was rated as a Poor Condition road according to IRC method of rating flexible pavements.

**Field Survey - D:** Ravet Gaothan school to Livle Gaothan road, Pimpri Chinchwad, Pune was rated as Poor Condition road according to IRC method of rating flexible pavements.
