Accident Hotspot Identification using Geometric Problems and Characteristics in Selected Road of the Dhaka-Aricha Highway (N5)

Md. Yousuf Jamil¹, Mohammad Mizanur Rahman^{2}, Sabrina Sharmin³*

Department of Urban and Regional Planning, Jahangirnagar University, Savar, Dhaka-1342, Bangladesh.

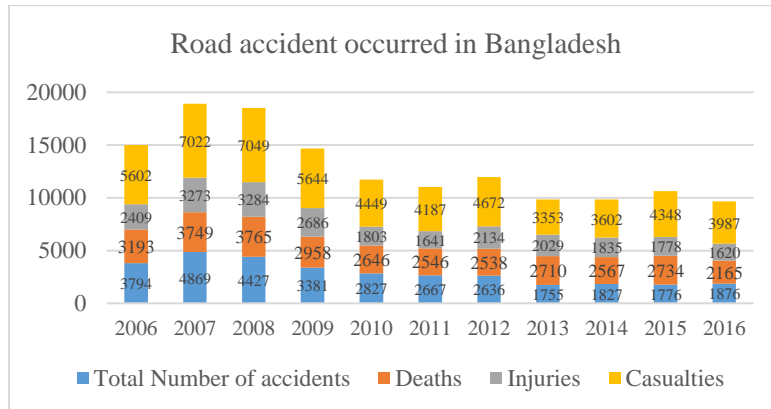
Fig.1:-Statistics of road accidents occurred in Bangladesh [31]

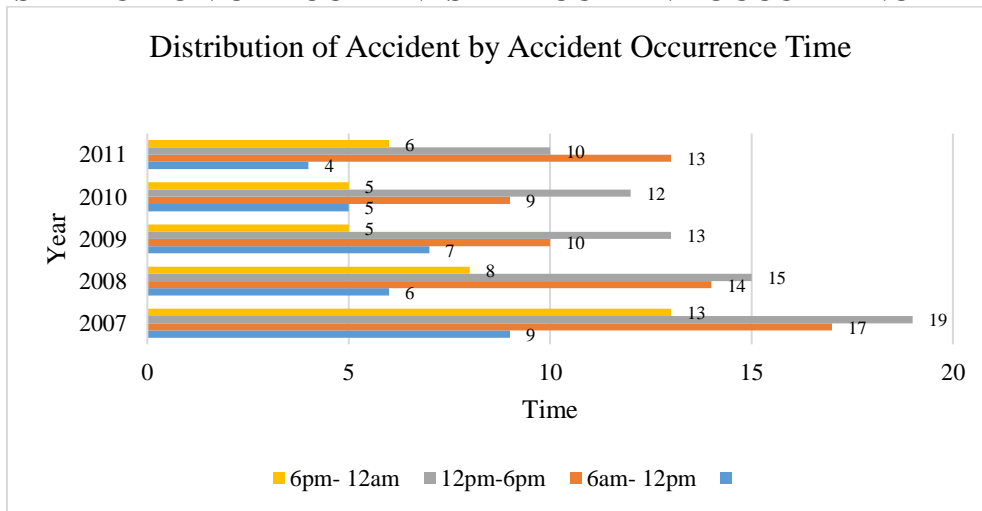
Fig.2:-Distribution of accidents by accident occurrence time

The above figure shows that the highest 69 (40.59%) out of 281 number of accidents occurred in the time between 12pm- 6pm among the five years (2007-2011) data.

Lowest Accidents occurred in the time between 12pm-6am follows it, total 31 accidents out of 281; as the year of 2012-2016 data are available but Accidents Research Institute can not provide this

year data because of their administration bureaucracy. Chart 5.10 show the scenario of Distribution of accidents by accident occurrence time.

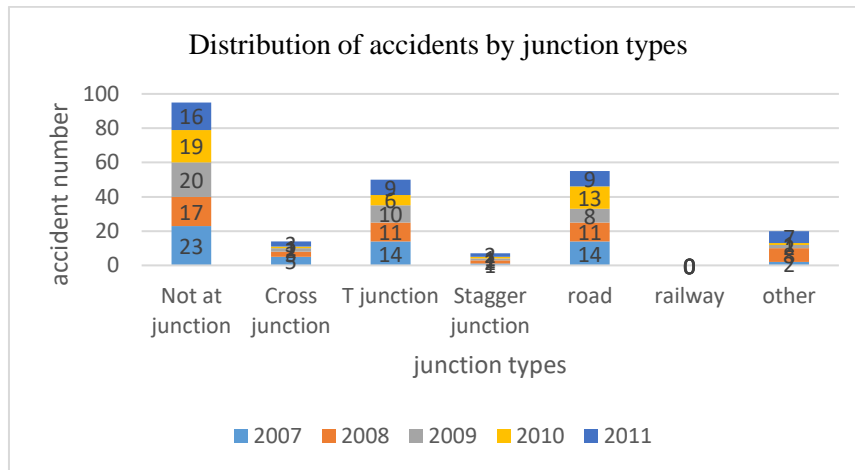
Figure show Total 281 accidents data are defined, which accidents were related with the junction type. Considering junction

types are- Not at Junction as ‘Not-J’, Cross section as ‘Cross’, T-Junction as ‘T-Jun’, stagger Junction as ‘Stag-X’, Round about as ‘Round’, Railway Junction as ‘Rail-W’ and Other. Most accidents were occurred at the ‘Not at Junction’ location and the number is 95. This data is followed by the ‘T-Junction’ location 50 and road location 55 others junction type are not considerable in number.

Source: Accidents Research Institute, BUET, 2018
Fig.3:-Distribution of accidents by junction types

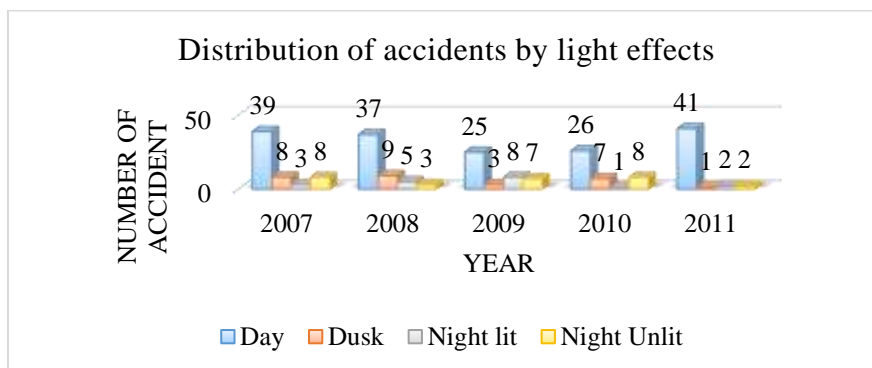
Chart 5.13 show that at daytime the people rushes more than in night. So the numbers of vehicles are higher than the night time. Obviously, the numbers of accidents are more in day than the night. Four types light are considered and these are- Day

Light, Dawn/Dusk, Night Lit and Night Unlit. 2007 is the year for highest accident between the study periods. Day by day, the rate of accident decrease. In all the time in the study period, day time accident were 168, dawn/dusk light 28, night lit 19 and night unlit 28 of total 281 accidents.

Source: Accidents Research Institute, BUET, 2018
Fig.4:-Distribution of accidents by light effects

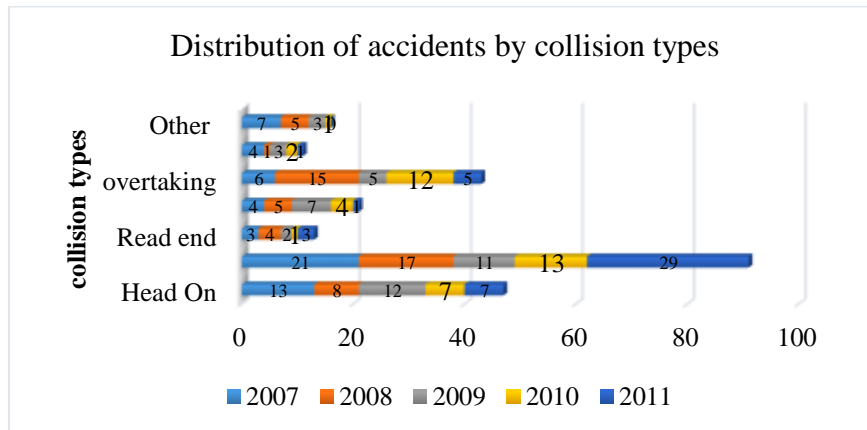
Considering the accident severity from chart 5.14 show that collision types, there are several collision types are considered. This are-Head on, right angle, overturned vehicle, hit pedestrian, hit object on road,

rear end and other. Among these types the ‘Hit pedestrian’ collision is 91 which is the highest number out of 281. ‘Head on’ collision type is in second position and it is 47 out of 281 number of accidents. ‘Overtaking’ collision type follows it, 30 (17.65%) out of 170.

Source: Accidents Research Institute, BUET, 2018
Fig.5:-Distribution of accidents by collision types

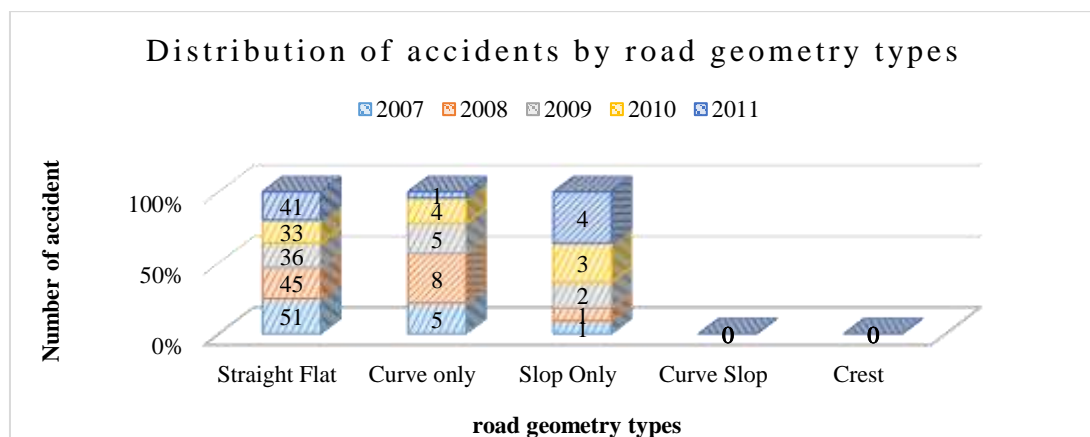
Figure 6 shows that road accidents sometimes depend on the road geometry. In the study area, according to road geometry all roads are straight, a few are curve. So, accidents in the straight roads

are common in the Dhaka-aricha highway. 281 accident occurred in the straight roads in the study period 2007-2011, the highest number in 2007; it was 58 and lowest in 2010; it is clear that, day by day the number of accident is decreased.

Source: Accidents Research Institute, BUET, 2018
Fig 6: -Distribution of accidents by road geometry types

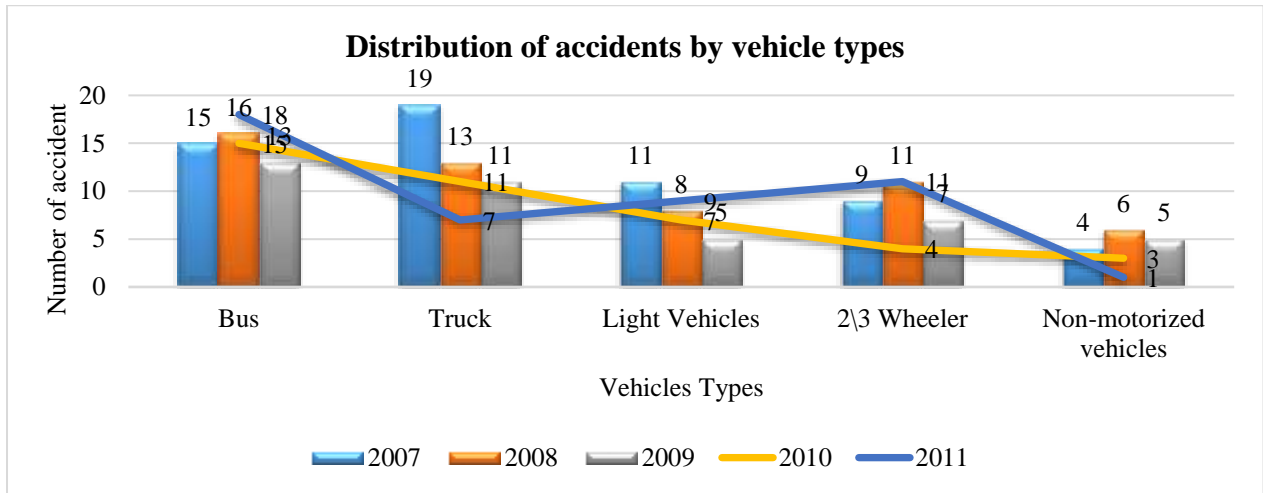
Figure 7 show that all types of vehicles are available in the study area. Although non-motorized vehicles are forbidden in highways, there are a large number of non-motorized vehicles in the Dhaka-Aricha highway. From the data presented in chart

most of the accidents are Bus and Heavy truck related accidents. Light vehicles, 2/3 wheelers, nonnotarized vehicles etc. are responsible for others type of accidents. Bus related accidents are 77 and Heavy truck related accidents are 61 out of 281 number of accidents

Fig.7:-Distribution of accidents by vehicle types

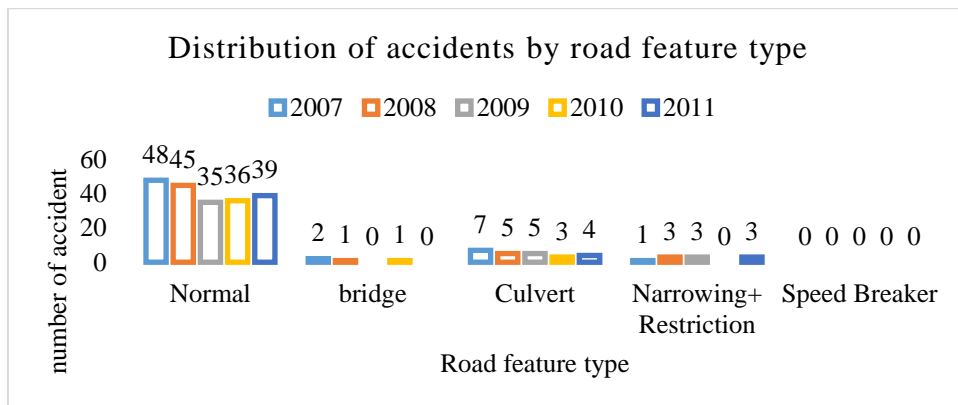
Road feature types are- Norma, Bridge, Culvert, Narrowing Restriction and Speed Breakers. Among all the types 'Normal' road feature type is responsible for the maximum number of accidents in the

study area. From Chart 5.18 Total 203 accidents occurred in 'Normal' road feature types. 2007 is the year where the maximum number (58 out of 281) of accidents occurred in 'Normal' road features type. Other types are not considerable in number

Chart 5.18:-Distribution of accidents by road feature type

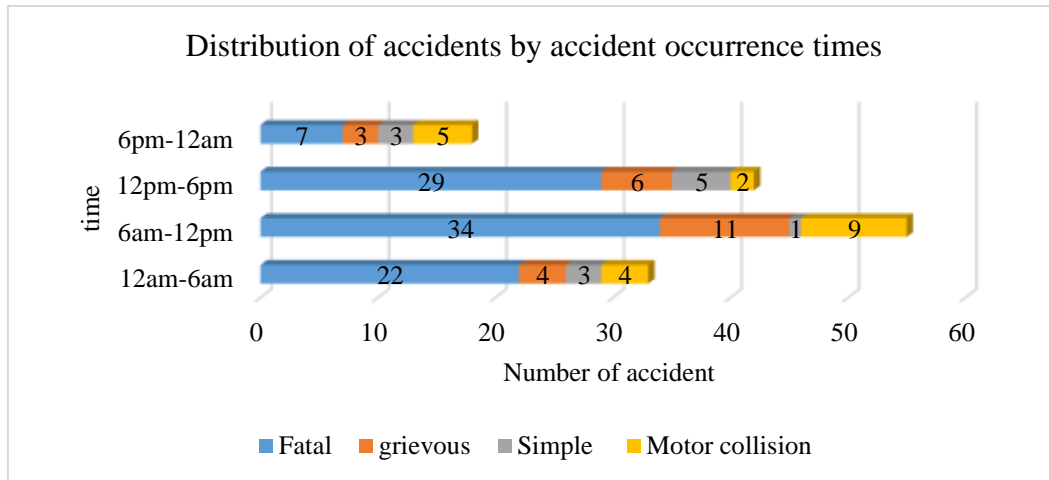
The below figure shows that the highest 55

out of 281 number of accidents occurred in the time between 6am-12pm among the five years (2009-2013) data.

Source: Accidents Research Institute, BUET, 2018
Fig.8:-Distribution of accidents by accident occurrence times

Accidents occurred in the time between 12pm-6pm follows it, total 42 accidents out of 281. 6pm-12am is the third highest number where 33 number of accidents were occurred

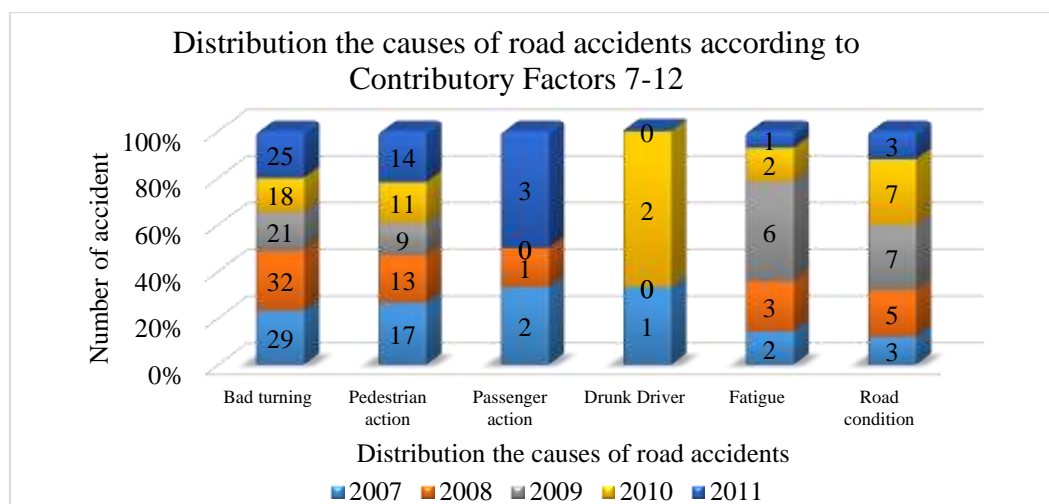
Here the contributory factors are- Bad turning, Drunk driver, Pedestrian action, Driver fatigue, Passenger action and Road condition. Figure 9 shows that, ‘Bad

turning’ is the highest number of occurring accidents, 125 ‘pedestrian crossing is responsible for second highest reason for road accidents, 64 out of 281 accidents. Other factors are not in considerable numbers which are presented in Figure 9.

Fig.9:-Distribution the causes of road accidents according to Contributory Factors 7-12

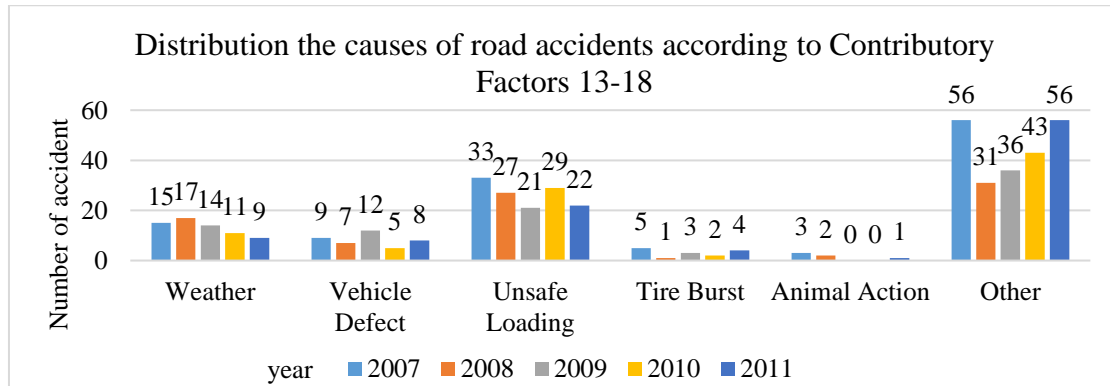
Here the contributory factors are- Weather, Vehicle defect, Unsafe loading, Tire Burst, Animal action and others. From the Figure 10, it shows that among these factors ‘Others’ related factors are the leading

cause for road accidents in the study area during the study period, 222 out of 281. ‘Unsafe loading’ is the second highest cause, 132 out of 281. ‘Weather’ factors follows it, 66 out of 170 accidents. Other factors are not in considerable numbers which are presented in figure 10

Fig.10:-Distribution the causes of road accidents according to Contributory Factors 13-18

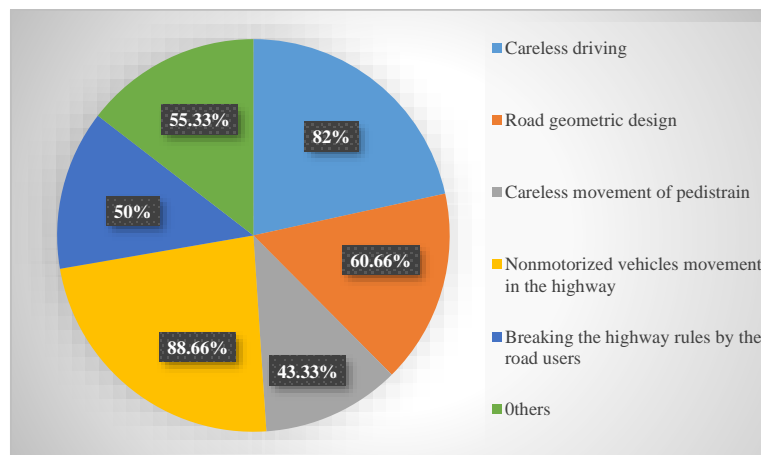
A field survey was conducted among the road users and local people of the study area. The data obtained from the field survey represented in the chart, where the figure 11 shows that Nonnotarized

vehicles movement in the highway is the major cause of road accidents in this highway. 88.66% which is 133 out of 150 respondents. Respondent said that ‘Careless Driving’ and Nonnotarized vehicles movement in the highway is the main causes of road accidents in this highway.

Fig.11:- Analysis of causes of accident that are obtained from field survey in the study area

Other causes are follows it. Among them 15% (83 out of 150 respondents) said for 'Road Geometry Design', 16% (91 out of 150 respondents) said for 'Careless Movement of Pedestrians on the Highway' and 11% (65 out of 150 respondents) said for 'Other' causes which are related to Traffic Jam, Busy Road, Roadside Animals etc.

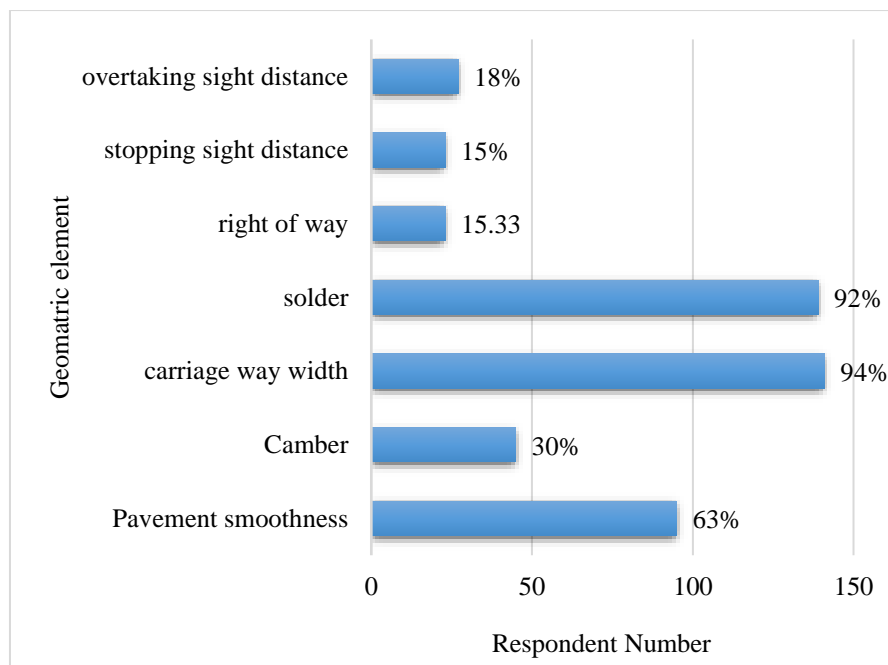
The geometric design of roads is the branch of highway engineering concerned with the positioning of the physical elements of the roadway according to standards and constraints. The basic

objectives in geometric design are to optimize efficiency and safety while minimizing cost and environmental damages. The data obtained from the field survey represented in the chart 5.26, where the chart shows that carriage way width is the main geometric element occurring road accident in the highway respondent said. 94% which is 141 out of 150 respondents. Respondent said that Pavement smoothness solder in the highway is another geometric element occurring road accident in Dhaka aricha highway. Camber, right of way, sight distance, stopping sight distance, overtaking sight distance also geometric element occurring road accident

Fig 12:-*Analysis of geometric elements occurring road accident that are obtained from field survey in the study area*

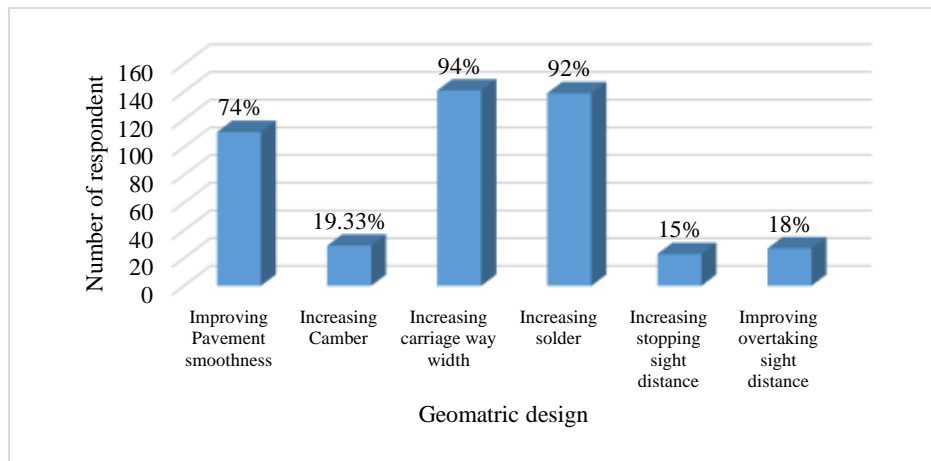
The data obtained from the field survey represented in the chart, where the Figure 13 shows that 94% respondent said

increasing carriage way size which is 141 out of 150 respondents. Respondent said that Improving Pavement smoothness and increasing solder in the highway is for reducing road accident in Dhaka aricha highway.

Fig 13:-Analysis of geometric elements reducing road accident that are obtained from field survey in the study area

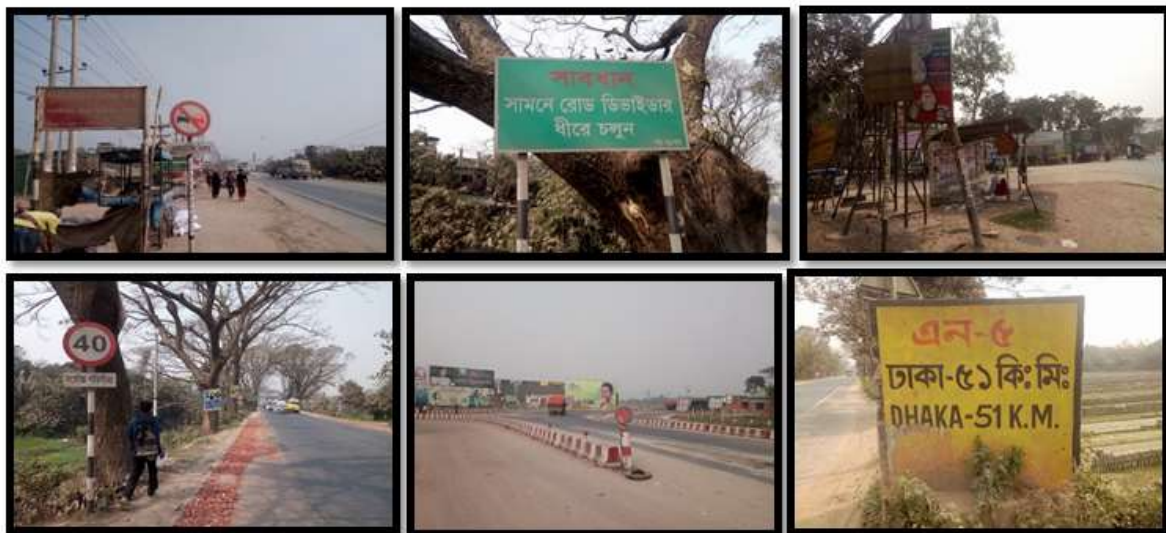
The traffic sign and symbols are sufficient in Dhaka-Aricha highway but it was not well managed. In may accidental black sport, traffic sin are not seen at all because of most of the sing and symbol are broken

or roads are tilted on the side and many dust stays there, which makes them look not right. Terms of public safety, beside the ones, which are present, are not being obeyed properly by the vehicles drivers. So people are always at a risk. Some of the situations are seen in the Figures 14.

Fig.14:-Road Sign and Symbol

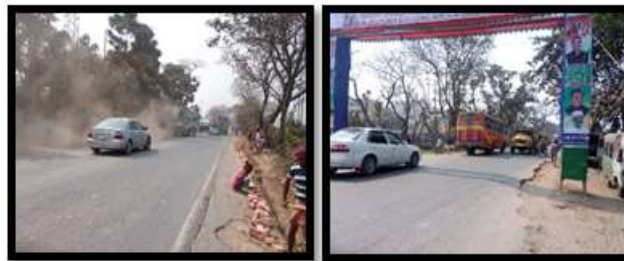
Fig.15:- Lack of shoulder (left place: BihuliaBus stand Right Place: Kamalpur bus stand)
