INCREASING THE RESOURCE OF AGRICULTURAL MACHINES

The object of research is the technological process of increasing the service life of pointed cultivator shares of tillage machines through the use of a progressive method of vibration hardening. One of the most problematic areas is the inadequate study of the investigated technological process of restoring the working bodies of agricultural machines. In order to gain a deeper understanding of the process of vibration processing of the material of these machine parts during their restoration, it is necessary to conduct further experimental studies.

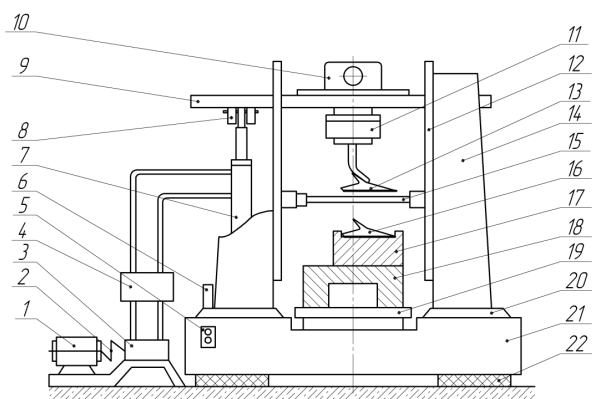
Fig. 1. Diagram of the vibration unit: 1 – electric motor; 2 – clutch; 3 – hydraulic pump; 4 – distributor; 5 – starter; 6 – tank; 7 – hydraulic cylinder; 8 – rubber shock absorbers; 9 – vibration exciter plate; 10 – vibration exciter; 11 – clamping device; 12 – guide; 13 – processing tool; 14 – rack; 15 – screed; 16 – detail; 17 – matrix; 18 – base; 19 – plate; 20 – support plate; 21 – timber; 22 – rubber shock absorber

The process of restoration of cultivator duckfoot was carried out on a vibration unit (Fig. 1).

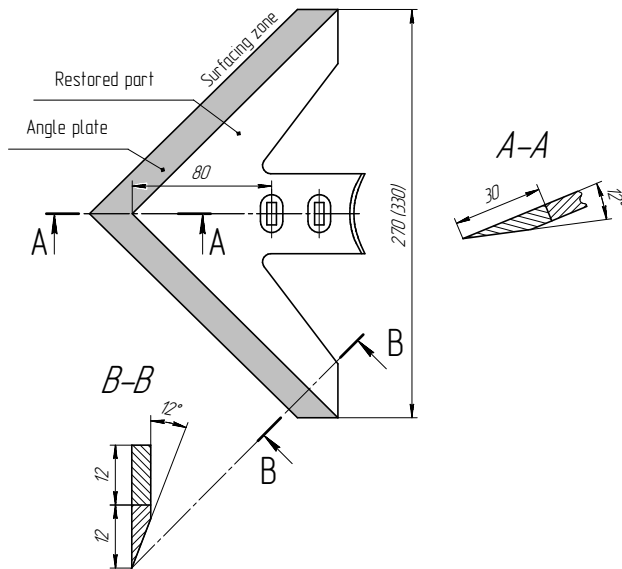
Fig. 2. Scheme of the restored cultivator duckfoot cultivator

Taking into account the above requirement, a technological scheme for the restoration and hardening of cultivator duckfoot has been developed: surface cleaning, trimming of the worn part, sharpening of the cutting edge, surfacing with sormite, welding of corner plates, vibration hardening, quality control.

The angle plate is made by bending at an angle of 60° strip steel 45 (GOST 1050-2013, GB 699-88) 5 mm thick using a press KD2128K (Russia). The press force is 630 kN, the crosshead stroke rate is 140 min^{-1} .

The cutting part of the plate is sharpened at an angle of sharpening of 14° on a universal grinding machine 3Д642Е (Russia).

The workpiece (corner plate) is welded to the restored share with a continuous seam by electric arc welding with a wire with a diameter of 2 mm made of steel grade 08GS (GOST 1050-2013, GB 699); welding current strength – 180 A.

Surfacing of the welded corner plate along the leg perimeter was performed with sormite powder.

Vibration hardening of the duckfoot cutting edges was carried out on a vibration installation with the following parameters: the vibration amplitude of the processing tool is 0.75 mm; vibration frequency 1400 min^{-1} ; hardening time 30 s. The duckfoot was restored by welding an angle plate (Fig. 2).

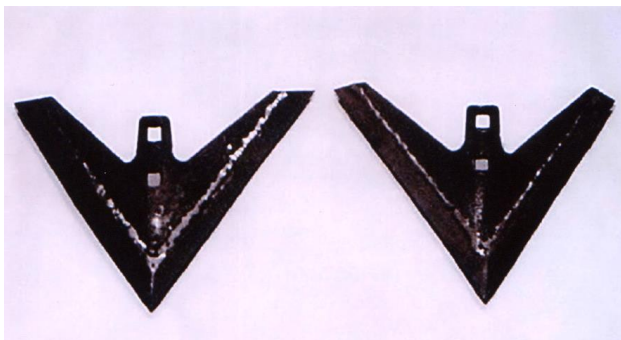
Fig. 3. Cultivator shares restored using the proposed technology

Cultivator shares, restored using the proposed technology, are shown in Fig. 3.
