Conservation Measures for Improving Land Use and Land Cover in Dalvoy Lake Environs of Mysore City

Akshatha N, Shankar B

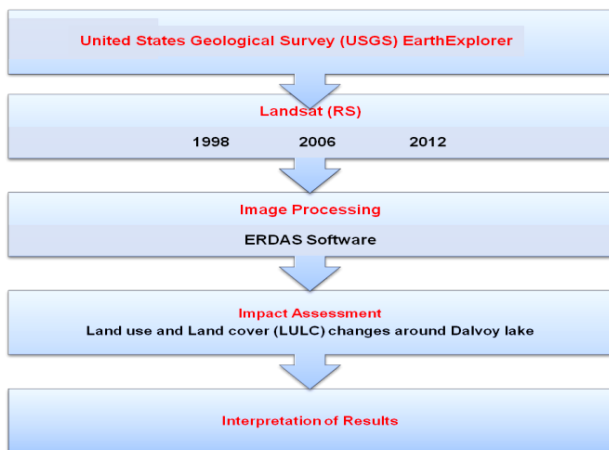
Figure 2 Methodology

Methodology involves qualitative and quantitative data from various primary and secondary sources. Multi resolution remote sensing data of Landsat for period of 1998, 2006 and 2012 were used from USGS earth explorer. The topographic map to a scale 1:50,000 of Survey of India were made use of. Landuse map of 2009 of Mysore Urban Development Authority was employed for Land use analysis. Figure 2 illustrates methodology involved.

Remote sensing (RS) is an effective tool to detect and quantify the impact of spatial and temporal Land use and Land cover (LULC) changes. Various period of LULC is taken for comparative analysis. LULC change is analyzed by considering 2.5 Km radius around Dalvoy Lake covering an area of 1968.99 Ha. Earth Resources Data Analysis System (ERDAS) software contains robust support of both vector data and raster data processing, which is used for image processing. Gaussian maximum likelihood classifier (GMLC) is used since pixel with maximum likelihood is classified in corresponding class.

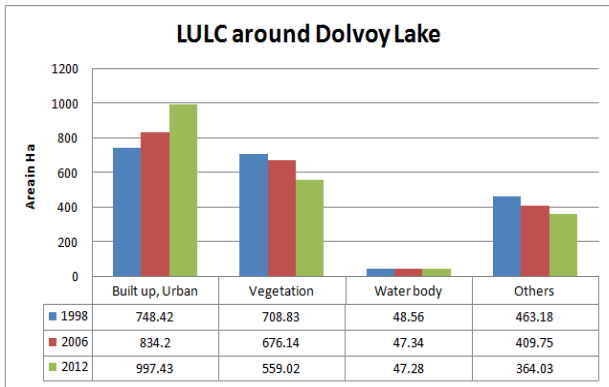
Figure 3: LULC changes around Dalvoy Lake

The built up percentage is increased from 38 % (1998) to 42.5% (2006) to 51.3% (2012) due to different phases of economic growth like public sector, industries, offshoot of private sector.

Percentage of vegetation is declined to 24.75% from 1998 to 2012 due to conversion into residential layouts, industrial activity, transport and communication infrastructure. Fig 3 illustrates graphical representation of LULC changes around Dalvoy Lake and Fig.4 illustrates temporal dynamics during 1998, 2006 and 2012 around Dalvoy Lake.

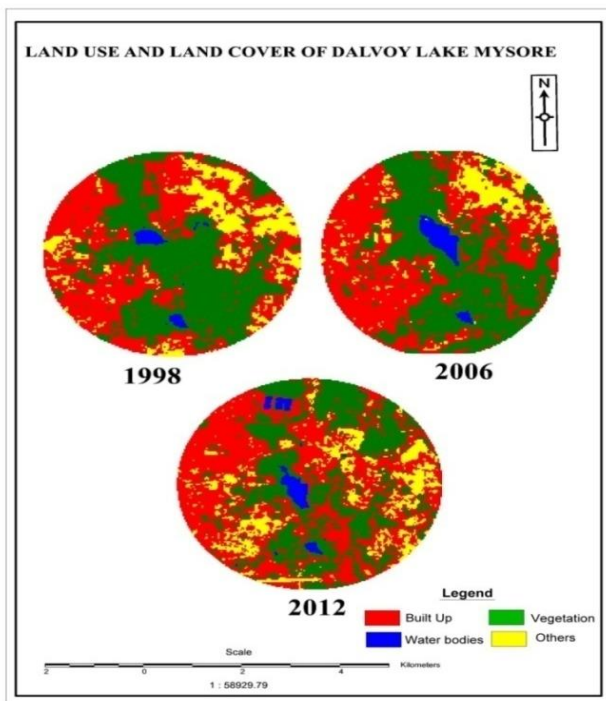
Figure 4: Temporal dynamics Dalvoy Lake in different period

Area of Dalvoy lake is decreased from 48.56 Ha (1998) to 47.34 (2006) to 47.28 (2012) due to anthropogenic activity of land filling/dumping. The change of Land use and Land cover (LULC) around Dalvoy Lake from 1998 to 2012 has enhanced by various pollutants being discharged from different landuse. Encroachment of lake bed has contributed to low storage level. Dumping of building debris has altered the physical, chemical as well as biological integrity of the ecosystem. This has led to water pollution and silt formation finally affecting water holding capacity of lake.

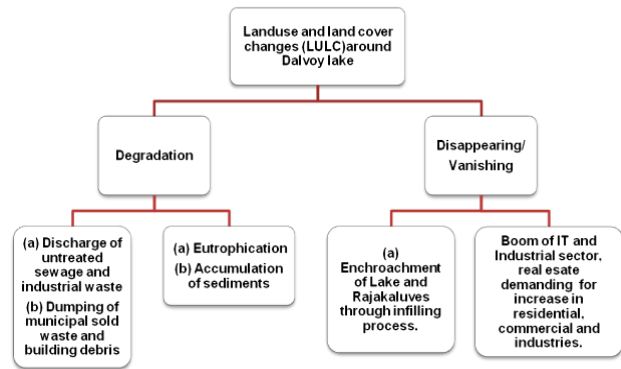
Figure 5: Impact of LULC in Dalvoy Lake Area

Growth of water hyacinth and consumption of water by weeds have also reduced water holding capacity. The Dalvoy Lake is encroached under urban expansion and shrunk due to eutrophication process. Figure 5 illustrates impact of LULC around Dalvoy Lake. Various socio economic, natural and anthropogenic factors are responsible for ecological degradation and shrinking of Dalvoy Lake.

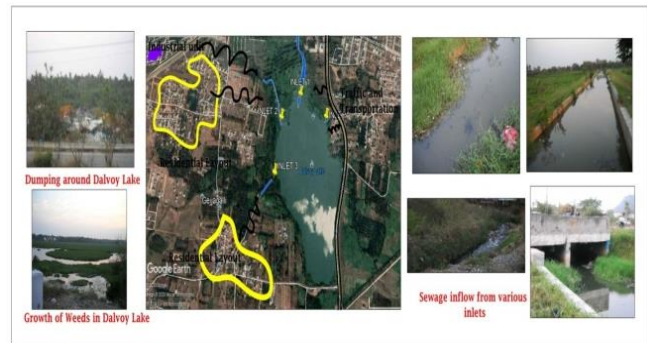
Figure 6 Land use around Dalvoy Lake

(A) **Discharge of Polluted water into Dalvoy Lake:** Dumping of building debris and discharge of untreated domestic sewage, industrial effluents into lake has contributed to low water quality resulting in loss of flora and fauna, pungent smell and finally aesthetics of the lake and its environs is lost. Figure 6 illustrates entry of pollutants and impact of different landuse on Dalvoy Lake.

Discharge of untreated domestic and industrial effluents into Dalvoy Lake pollutes the lake and contaminates ground water as well. Percentage of built-up area has increased around Dalvoy Lake due to growth of industrial sector, residential layouts namely JP Nagar and Siddalingeshwara layout, traffic and transportation infrastructure etc. Change of Land use and Land cover are the main contributors for pollution. Each land use contributes to different amount of pollution like (a) industries - discharge of heavy metals and detergents, (b) agriculture- use of harmful fertilizers, (c) commercial and residential units. Table 3 illustrates analysis of pollutants entering from various inlets into the lake.
