# Historical archaeology of Advent City and Hiorthhamn (Isfjorden, Spitsbergen)

July 22, 2014

**Final report**

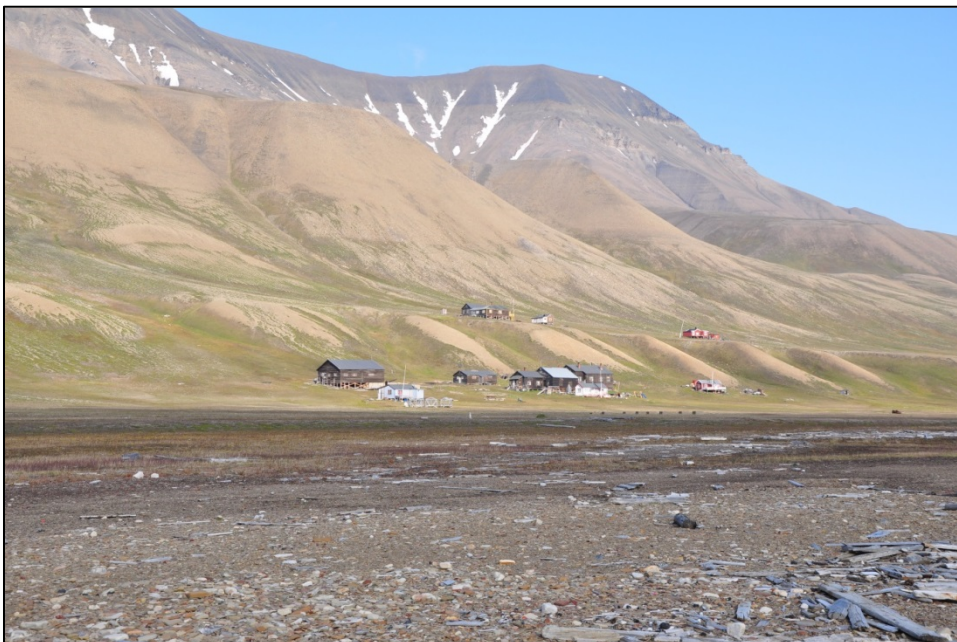
**Fig. 7** Hiorthhamn on July 22, 2015, looking east. (Photo: I. Sjøbakk, 2015.)

The team made the spontaneous decision to walk into the small settlement in search of invasive plant species among the buildings and grass samples for later analysis. It was not until seeing the sturdy concrete foundation of the large building to the left of the photograph that the exciting prospect dawned on Kruse that the buildings from Advent City had not only been brought and reused here but that the very originals had been rebuilt with only minor alterations. In 2015, these buildings would be 100 years old – and still in use.

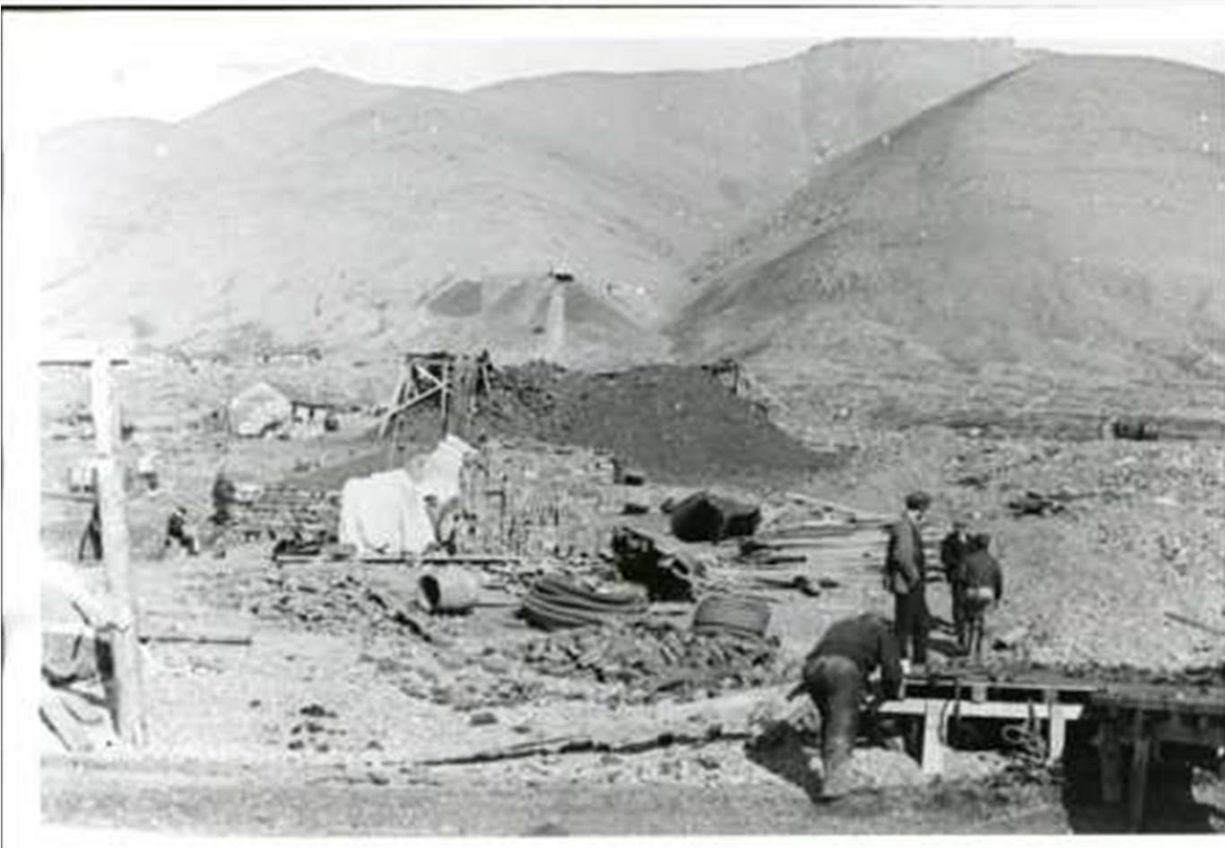
**(B)** The incline being constructed, probably in 1905, looking NE. (Source: Internet.)

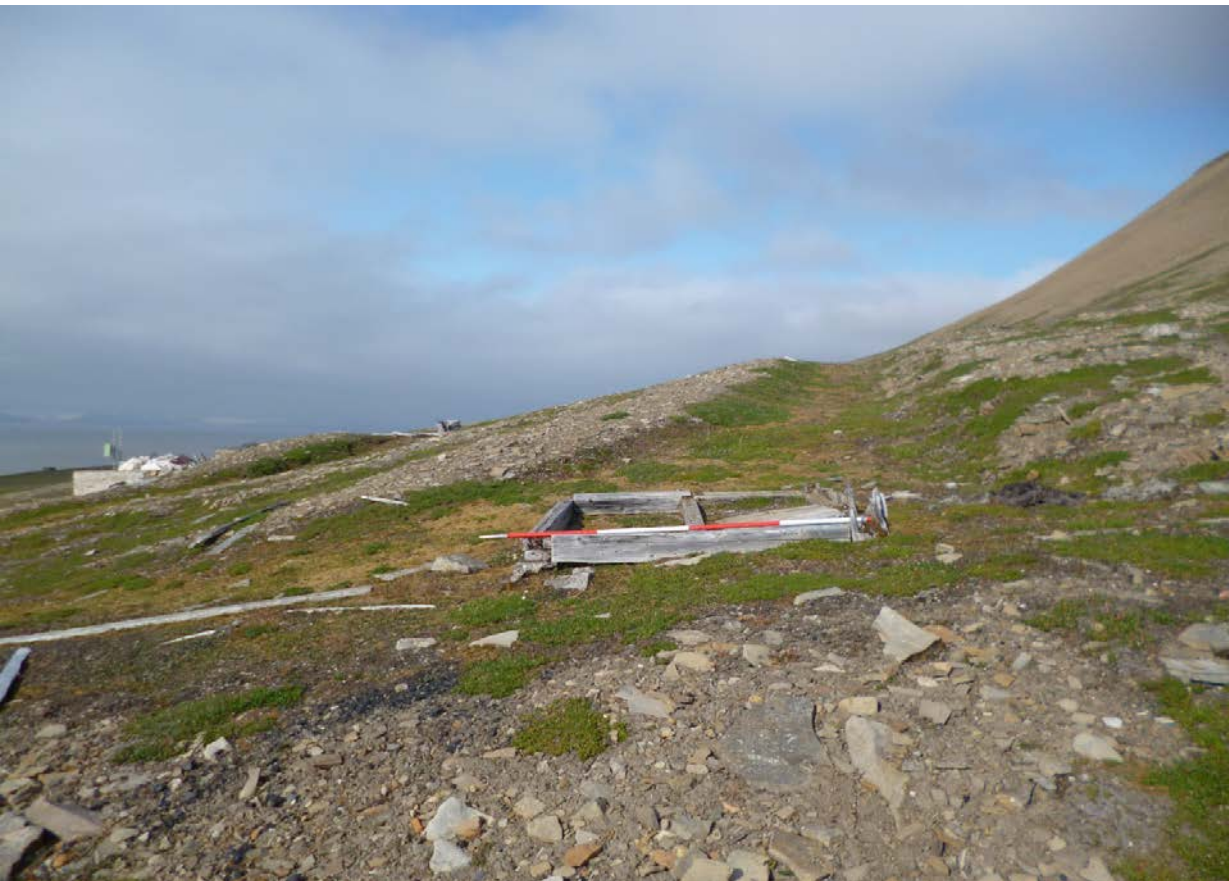
These are the remains of the easternmost outhouse, scale 2m, looking NW. (F. Kruse 2014.)

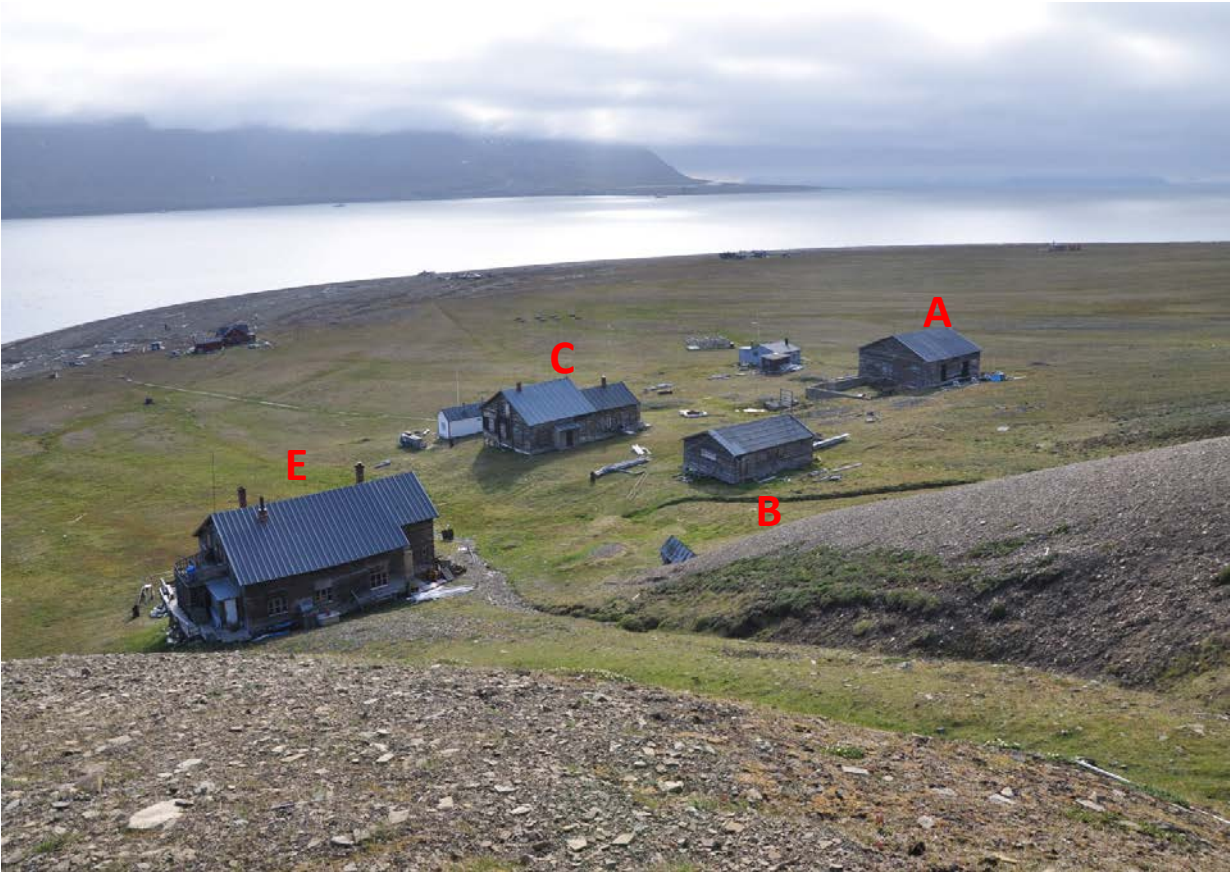
(1) Partial overview of Hiorthhamn. From left to right: building E (large mess hall, bakery), D (sick bay), B (telegraph, general store and provision storage), and A (storage facility, machine shop) in Hiorthhamn, looking W. (Photo: S. Dresscher, 2014.)

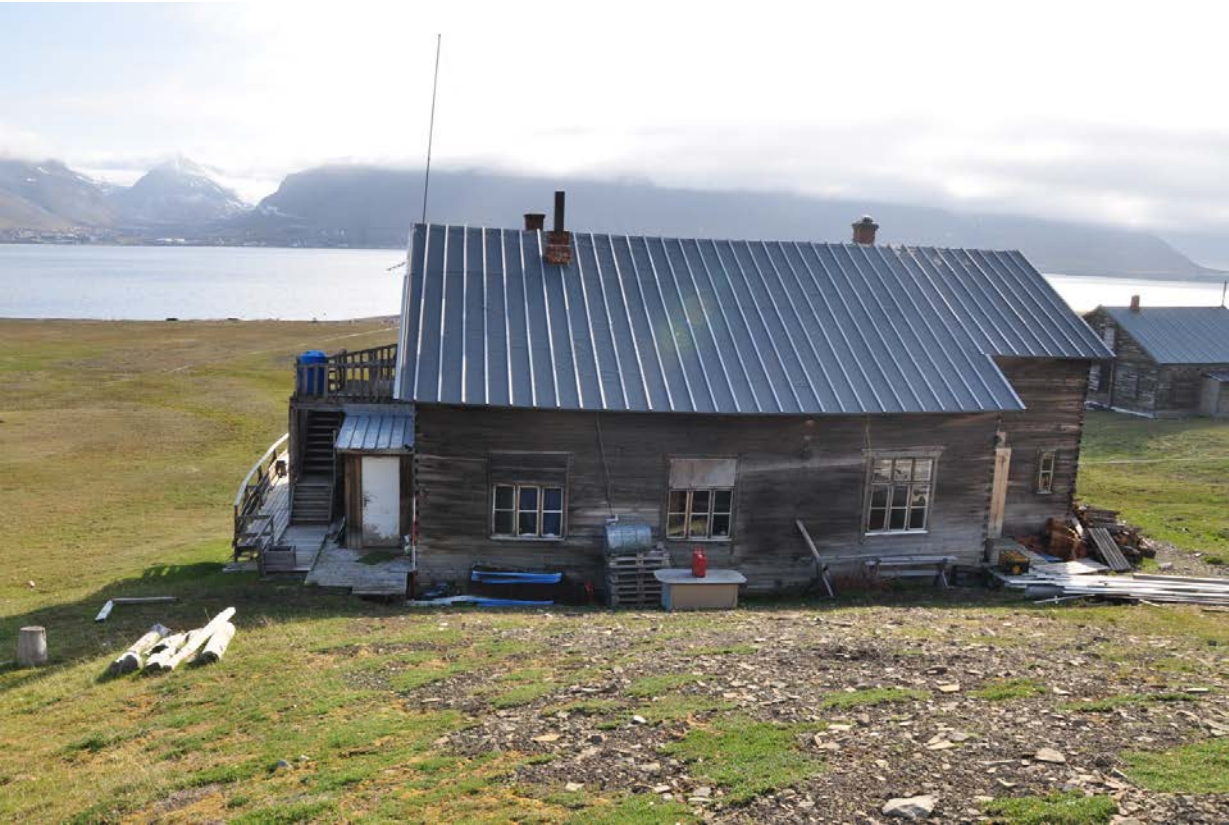
(2) Building E (large mess hall, bakery) in Hiorthhamn, scale 2m, looking SW. (Photo: S. Dresscher, 2014.)

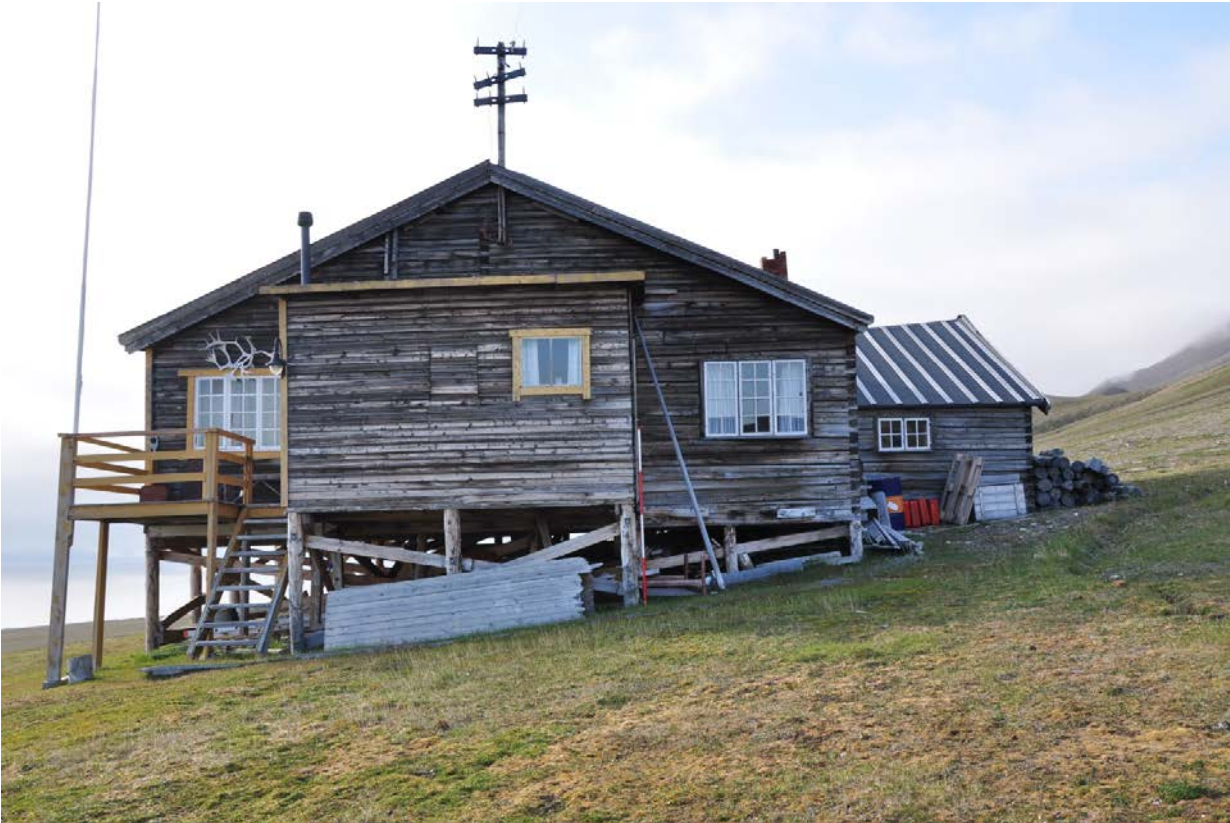
(4) Building F (administration building including telegraph facility) in Hiorthhamn, scale 2m, looking NW. (Photo: S. Dresscher, 2014.)

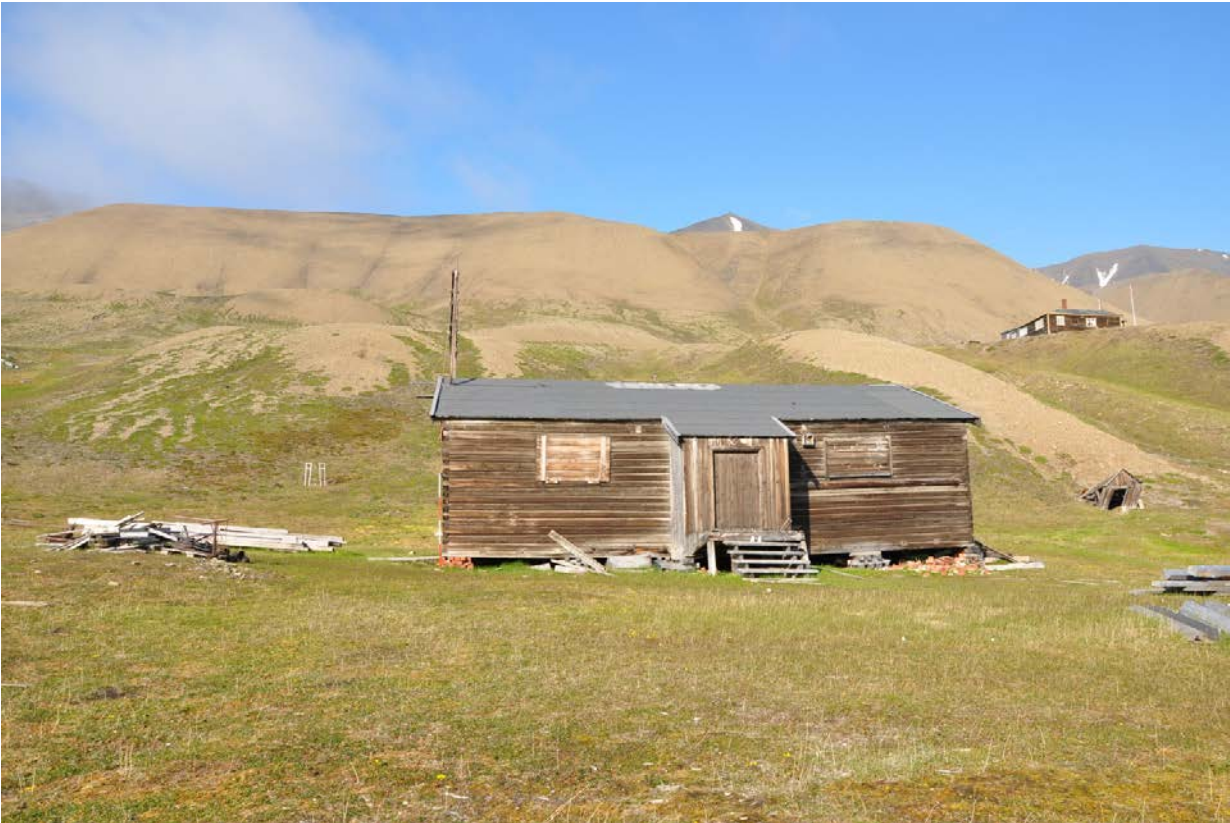
(6) Building B (telegraph, general store and provision storage) in Hiorthhamn, scale 2m, looking NE. (Photo: S. Dresscher, 2014.)

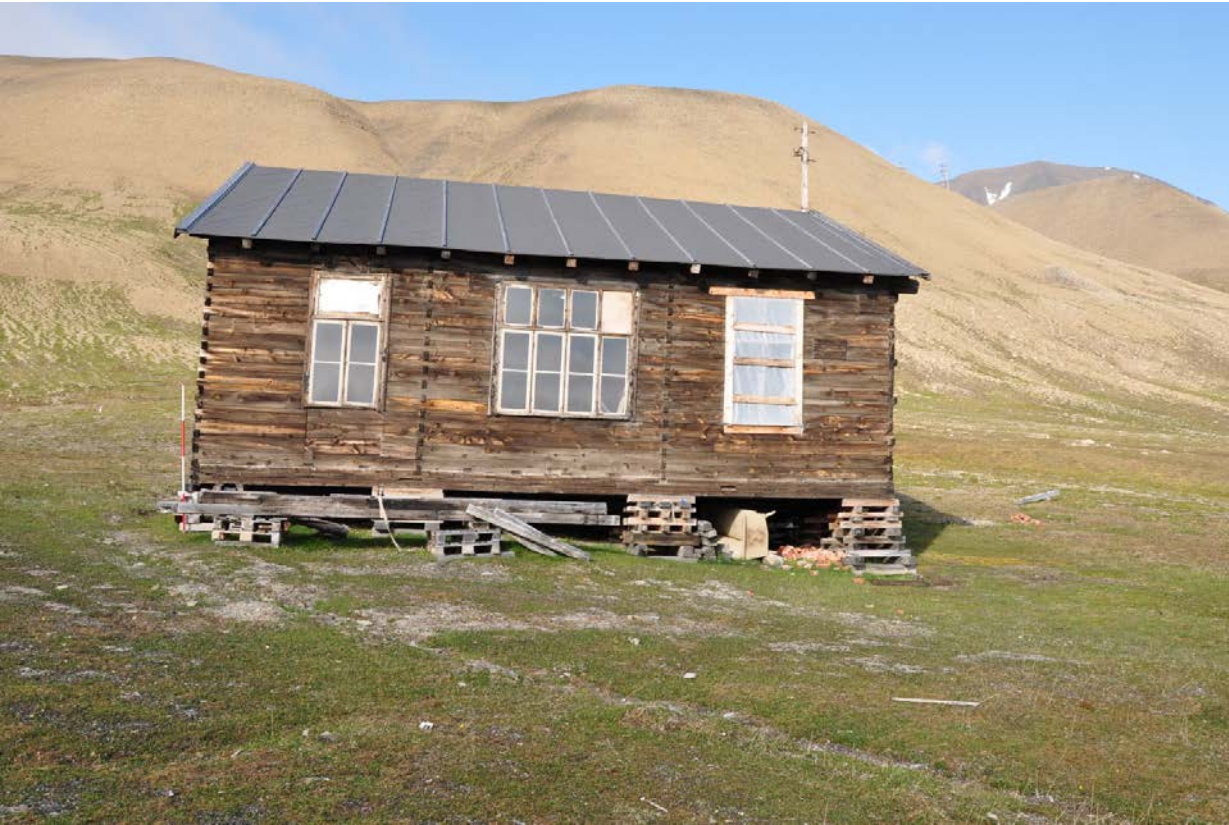
**(8)** Building G (living quarters) in Hiorthhamn, scale 2m, looking NE. (Photo: S. Dresscher, 2014.)

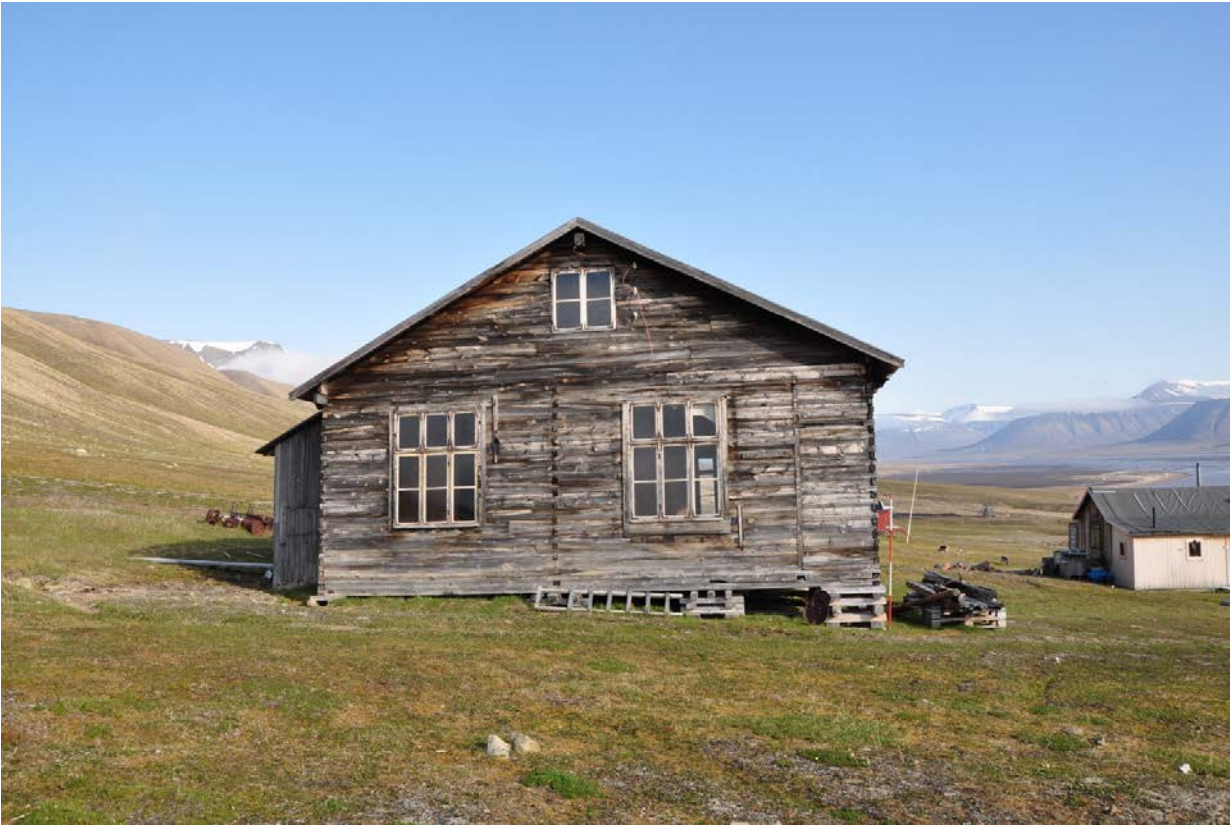
(9) Building G (living quarters) in Hiorthhamn, scale 2m, looking SE. (Photo: S. Dresscher, 2014.)

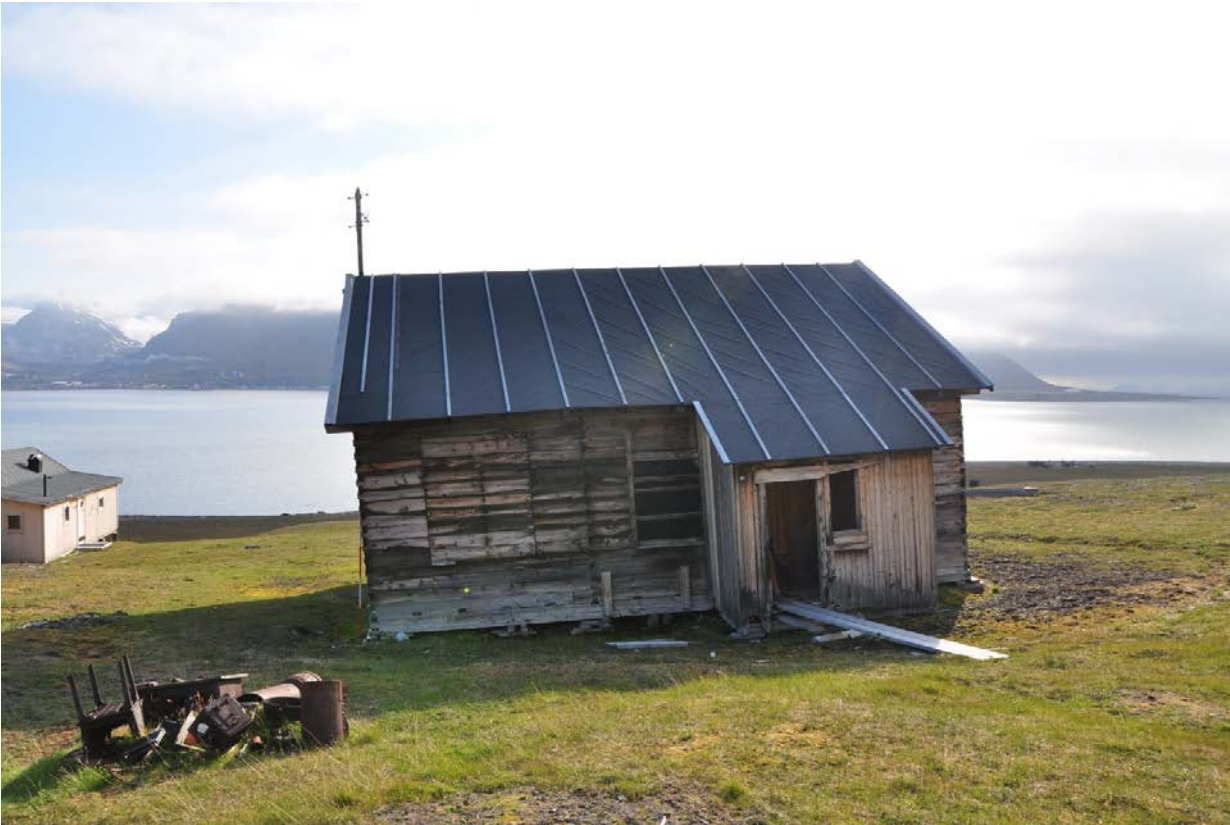
(10) Building G (living quarters) in Hiorthhamn, scale 2m, looking SW. (Photo: S. Dresscher, 2014.)

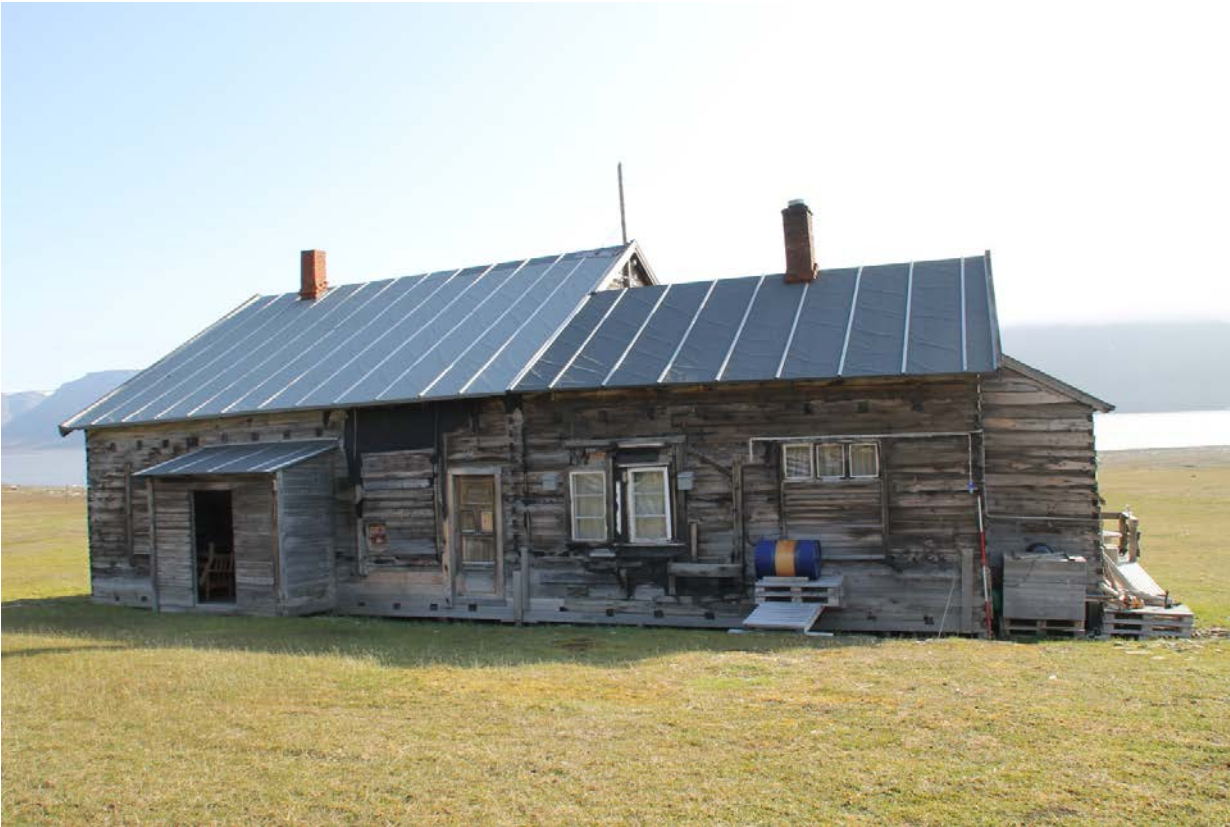
(6) Building C (living quarters) in Hiorthhamn, scale 2m, looking SW. (Photo: S. Dresscher, 2014.)

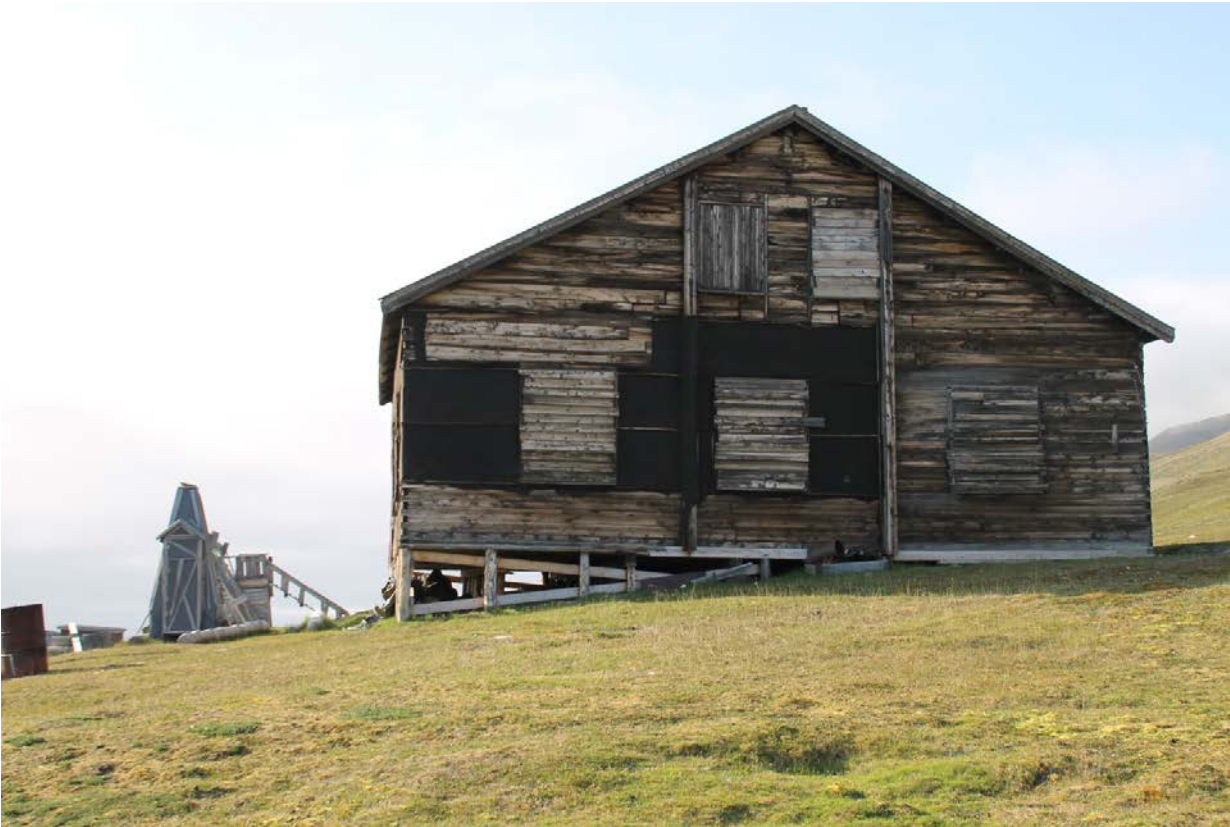
(11) Building C (living quarters) in Hiorthhamn, scale 2m, looking NW. (Photo: S. Dresscher, 2014.)

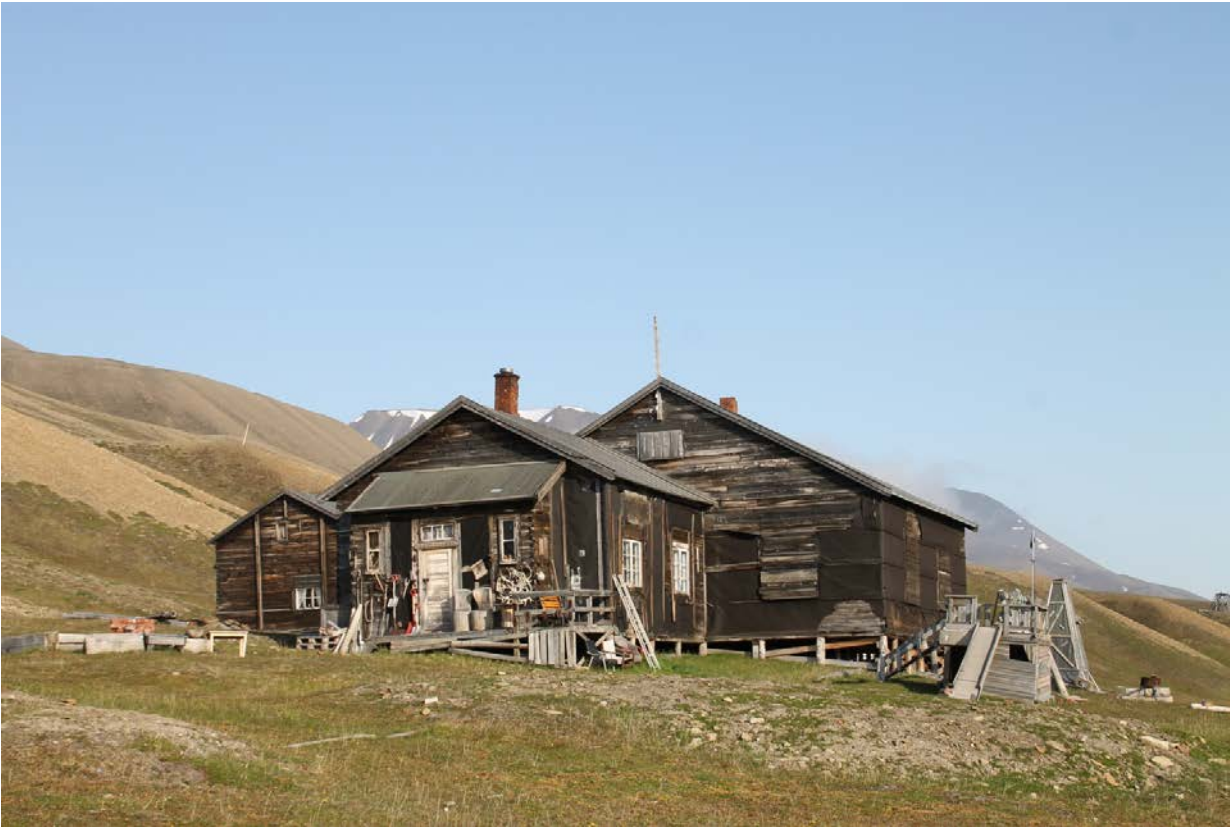
(12) Building C (living quarters) in Hiorthhamn, looking E. (Photo: S. Dresscher, 2014.)

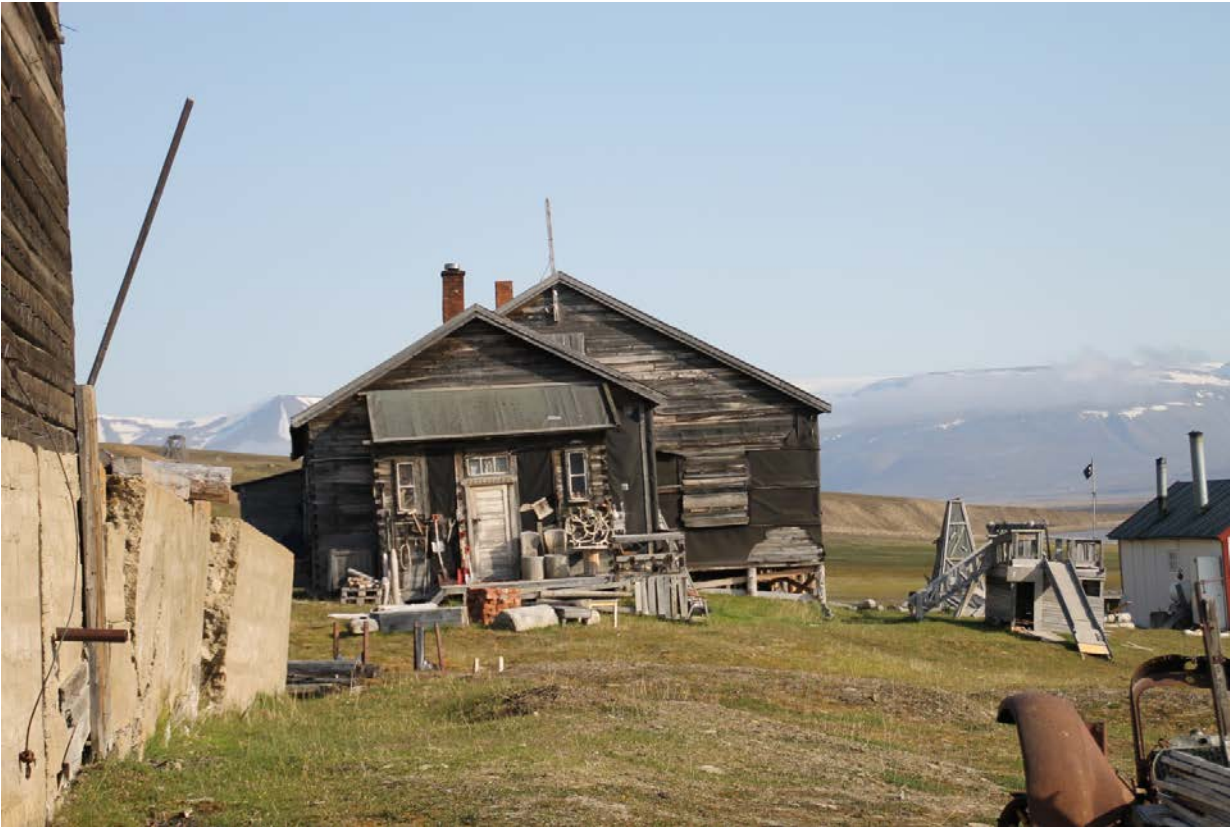
(13) Building C (living quarters) in Hiorthhamn, looking SE. (Photo: S. Dresscher, 2014.)
