Frigga Kruse

Human Impact at Advent City (RiS ID 10516)

August 5 – August 16, 2016

History in Photographs I: site formation processes

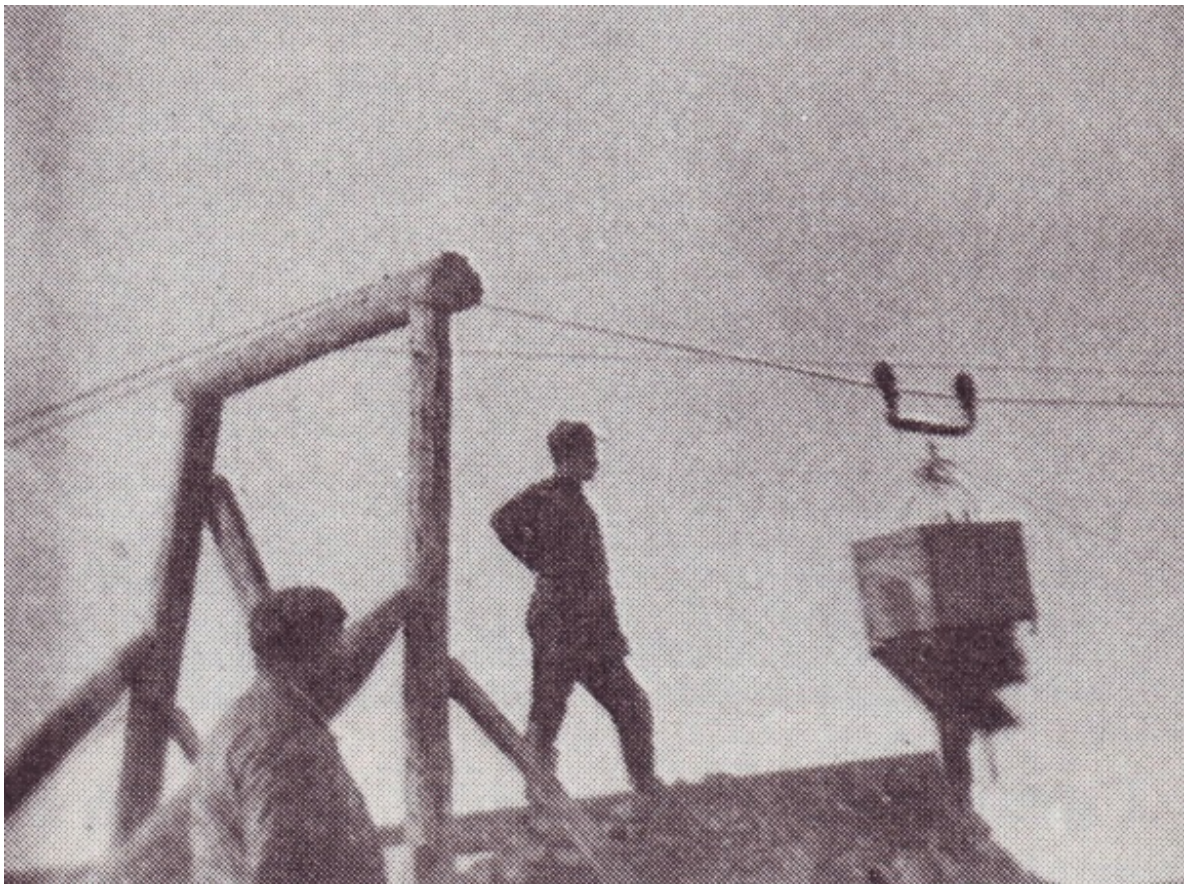
First ropeway constructed at Advent City in 1903. (Photo in Hoel 1966: 557)

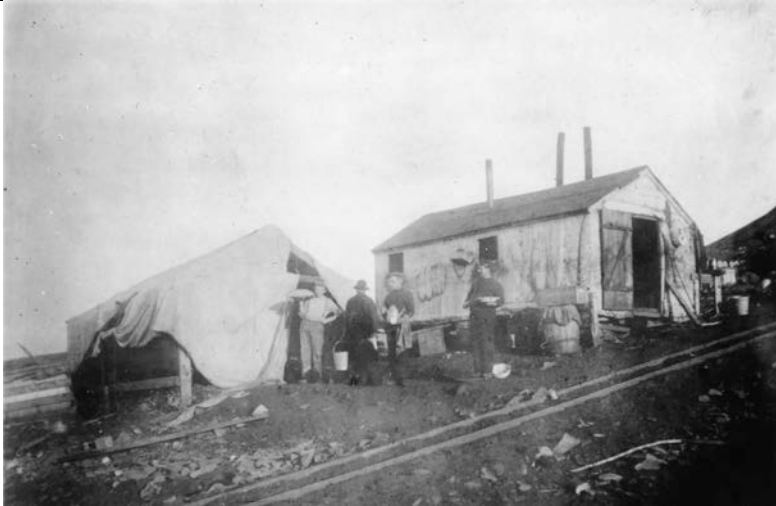
Photo S.A. Fangen 1905, in Hoel 1966: 562

Summer 1904

REPLACEMENT MESS

no proof

(unless the building was replaced by or re-used as stables: Kruse 7b, Askeladden 93035-17)

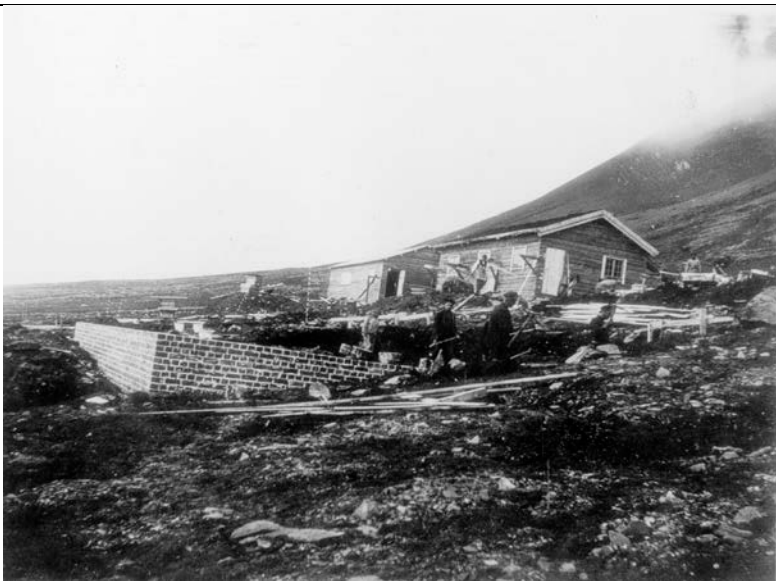
Norwegian Polar Institute, Photo Library, np002341 (S.A. Fangen)

WORKERS' BARRACK almost finished

Kruse 5c

WORKERS' BARRACK under construction

Kruse 5a

MANAGER'S HOUSE under construction

Kruse 6d

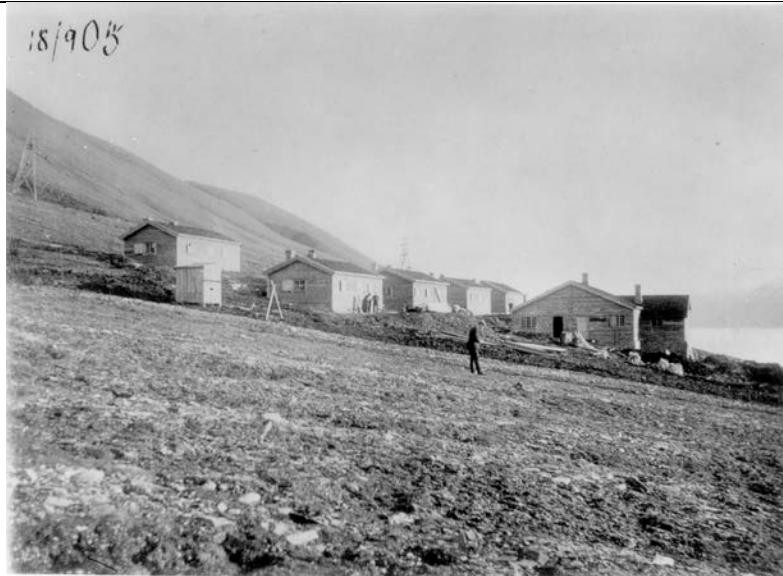
Photo S.A. Fangen 1905, in Hoel 1966: 566,
also Norwegian Polar Institute, Photo Library, np002340

WORKERS' BARRACKS

Kruse 5a, 5b, 5c, 5e, 5f (not 5d)
Askeladden 93035-20, 21, -, 24, 25
(not 28)

MANAGER'S HOUSE

Kruse 6d
Askeladden 93035-22

2 DOUBLE-ROPEWAY TOWERS

Kruse 2a
Askeladden 93035-5

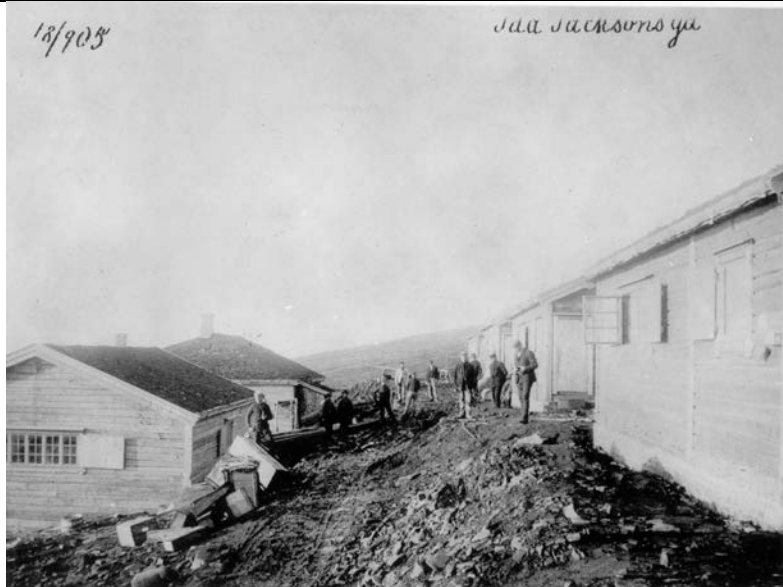
Norwegian Polar Institute, Photo Library, np002339 (S.A. Fangen)

Summer 1905:

WORKERS' BARRACKS

Kruse 5a, 5c, 5e, 5f
Askeladden 93035-20, 21, -, 24

MANAGER'S HOUSE

Kruse 6d
Askeladden 93035-22

LARGE STOREHOUSE

Kruse 6a
Askeladden 93035-19

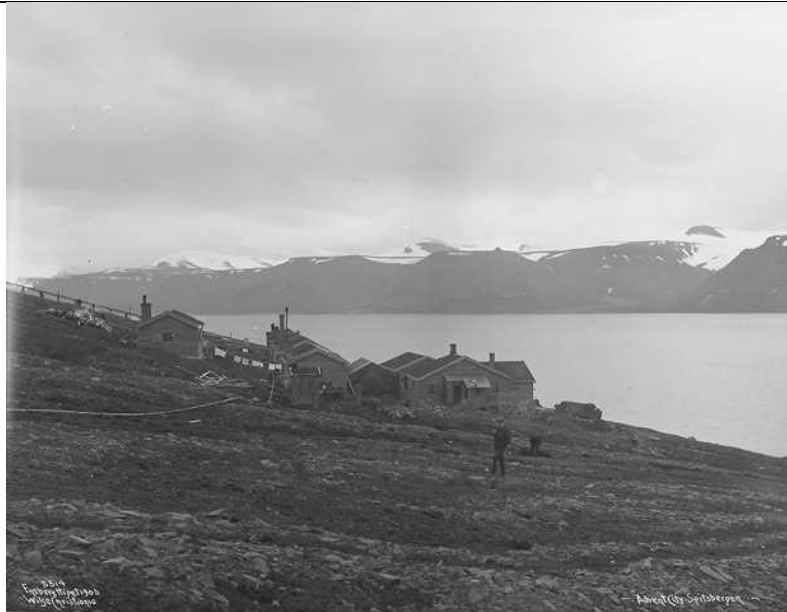
Norsk Folkemuseum, Fotosamlingen, A.B. Wilse, NF.W 05514

WORKERS' BARRACKS

Kruse 5a, 5b, 5c, 5e, 5f (not 5d)
Askeladden 93035-20, 21, -, 24, 25
(not 28)

INCLINE

Kruse 3a
Askeladden 93035-7

WATERPIPE

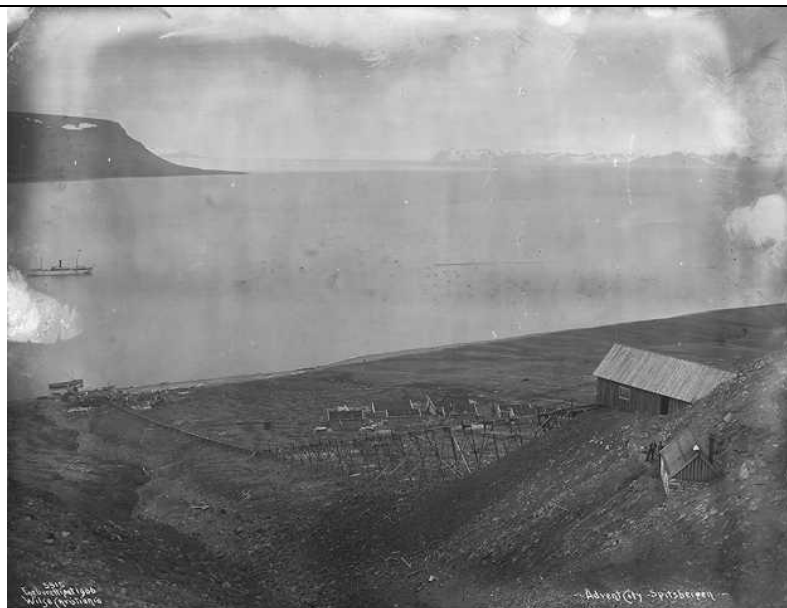
Norsk Folkemuseum, Fotosamlingen, A.B. Wilse, NF.W 05515

Summer 1906

ROOF OVER MINE ENTRANCE

Kruse 1a
Askeladden 93035-1

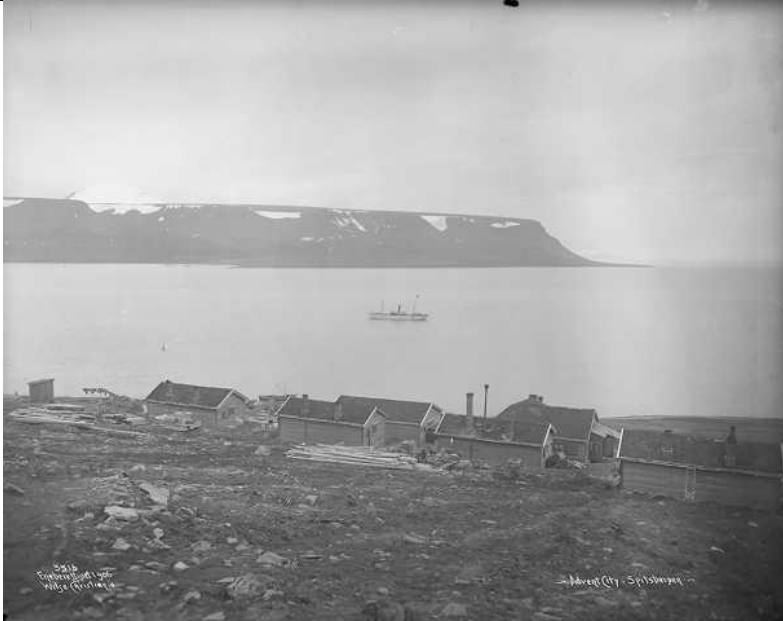
Norsk Folkemuseum, Fotosamlingen, A.B. Wilse, NF.W 05516

Summer 1906

WORKERS' BARRACKS

Kruse 5b, 5c, 5e, 5f (5a not visible; 5d not built)
 Askeladden 93035-20, 21, -, 25 (24 not visible, 28 not built)

MANAGER'S HOUSE

PRIVY (EAST)

surveyed during fieldwork 2016

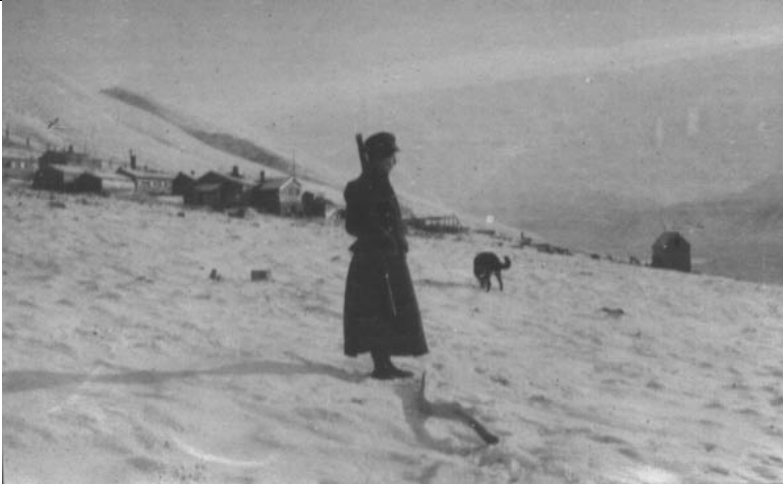
www.kinck.no, KINCK_10083

"OFFICE" under construction
Kruse 6b
Askeladden 93035-16

"OFFICIAL HOUSE" under construction
Kruse 6a
Askeladden 93035-13

WORKERS' BARRACK under construction
Kruse 5d
Askeladden 93035-28

STABLES
Kruse 7b
Askeladden 93035-17

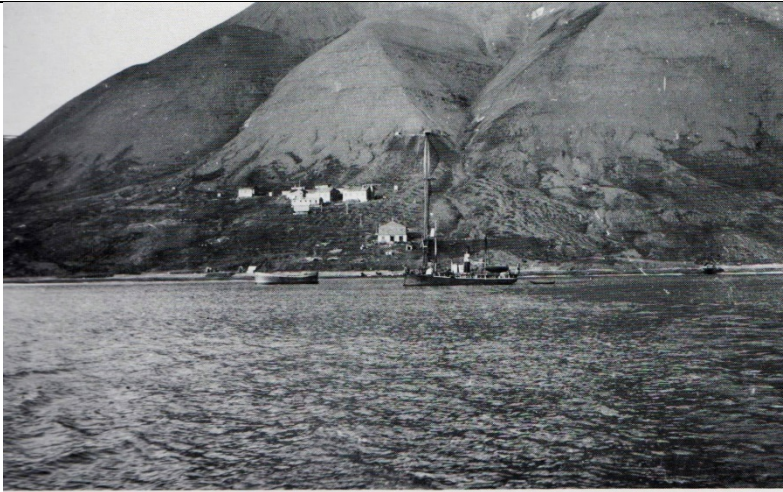
Hoel 1907, in Hoel 1966: 567

ROOF OVER VENTILATION ADIT

Kruse 1b
Askeladden –

ENGINE HOUSE

Kruse 9
Askeladden 93035-9

ELECTRICITY POSTS

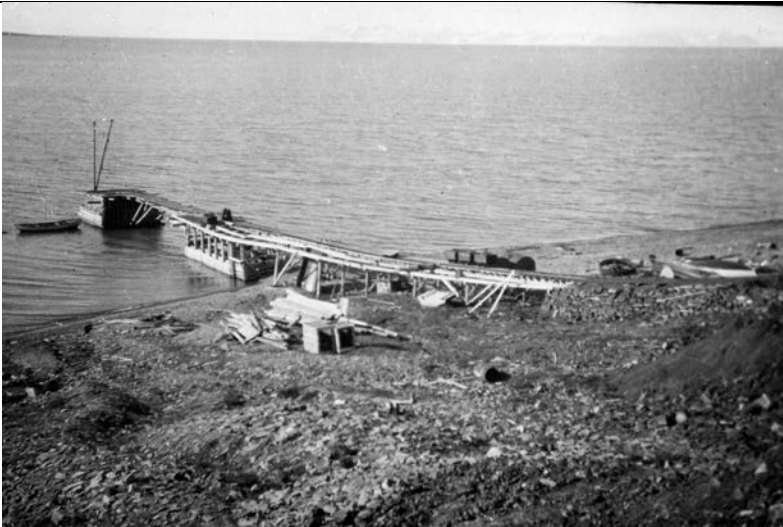
038-070 (Miles Oglethorpe private collection)

Summer 1907

PIER

Kruse –
Askeladden –

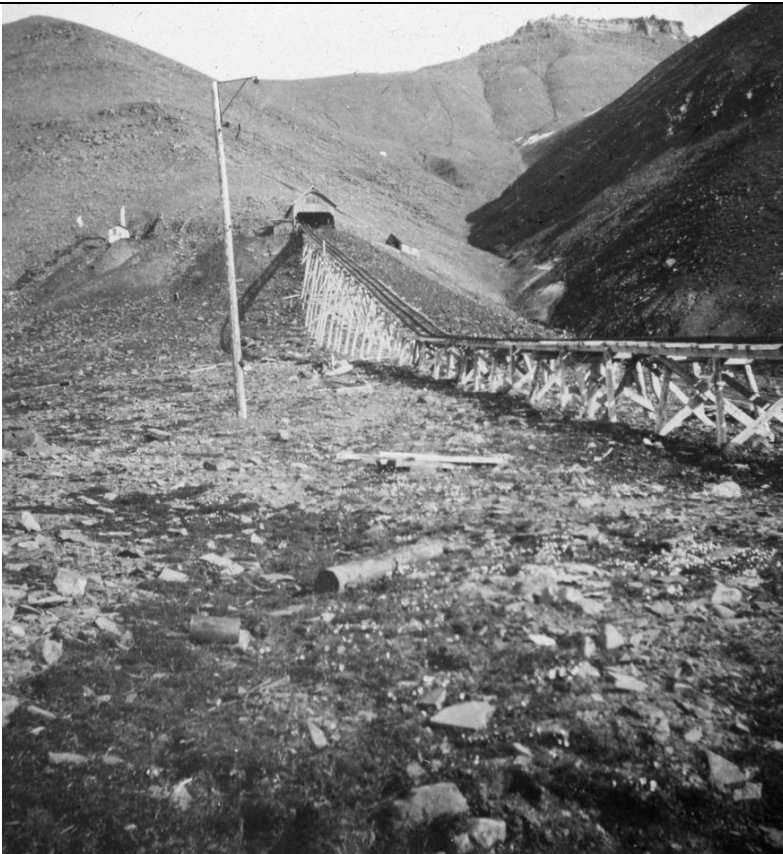
038-106 (Miles Oglethorpe private collection)

ROOF OVER MINE ENTRANCE

mine entrance:
Kruse 1a
Askeladden 93035-1

INCLINE

Kruse 3a
Askeladden 93035-7

ROOF OVER VENTILATION ADIT

ELECTRICITY POST

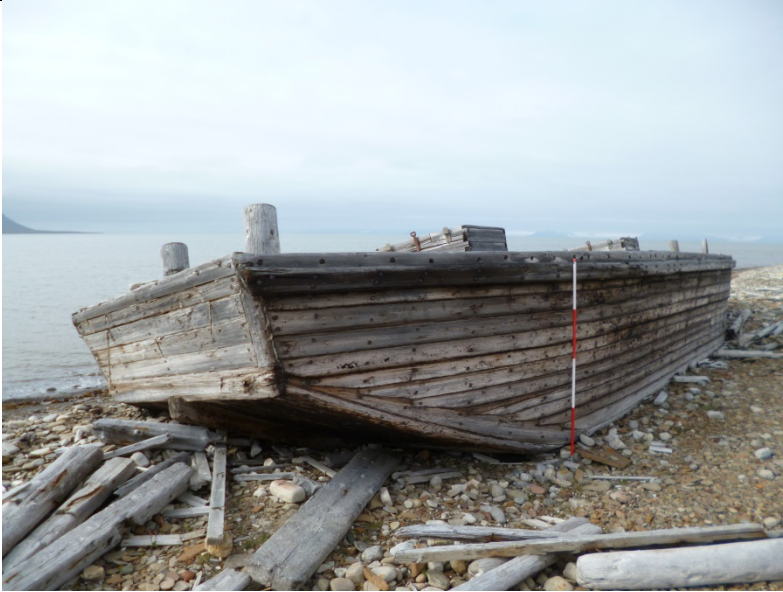
Kruse 2014.

Although it is not known whether the Arctic Coal Company or anyone else purchased hulks for the construction of **barrack barges**, it is the best explanation for this wreck (Kruse 10, Askeladden 93034) at Advent City.

Neither a coal lighter, water boat, or pontoon are fitting.

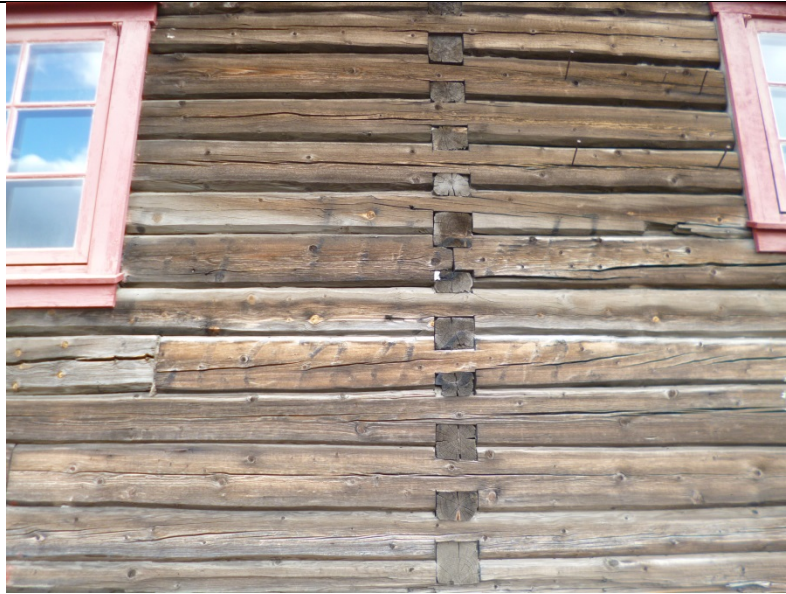
F. Kruse, fieldwork August 2016.

“M older building” at Hiorthhamn is an original **WORKERS’ BARRACK** from Advent City.

The text reads “[...]ck Hiorth Eiendom” and suggests that Hiorth used this as a claim hut.

The left window has been enlarged since to overlap with the text.

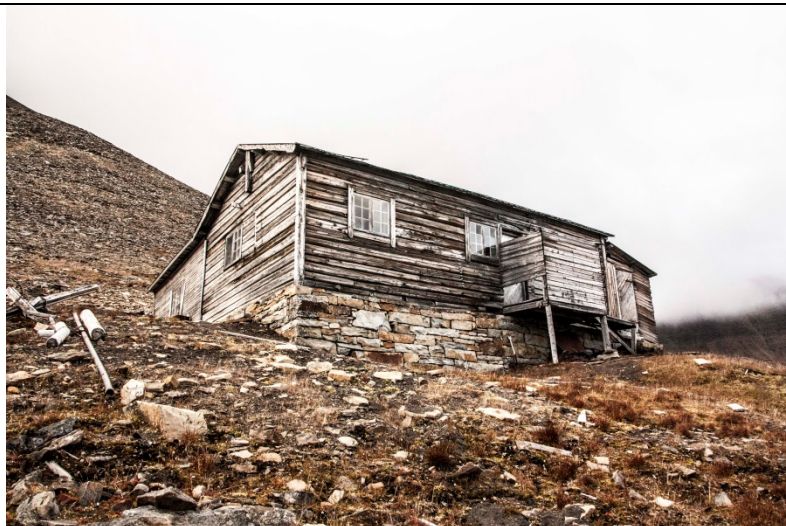
Martin “from Lyr Camping”, site visit August 2016.

This building up at the mine at Hiorthhamn is also an original **WORKERS’ BARRACK** from Advent City.

The origins of the various extensions is unclear.
