The object of this study is the technology of bus bodies and the formation of recommendations for design body-work subject to the regulated durability of the body introduced into production. Advancing the technology of manufacturing bus bodies implies improving anti-corrosion protection, using new polymeric materials, and reducing the length of welds.

DEVELOPMENT OF BUS BODY TECHNOLOGIES IN TERMS OF CORROSION AND DURABILITY

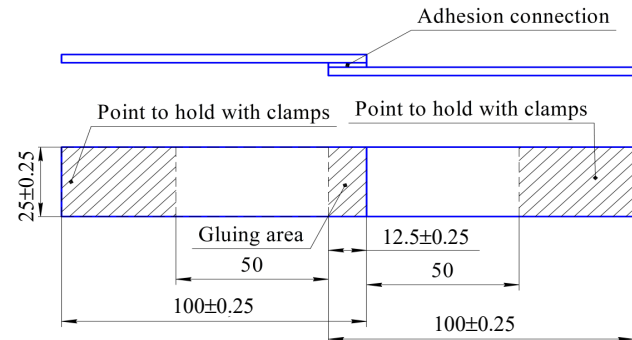
Test samples consist of two strips of materials studied, glued together, overlapping each other. Fig. 1 shows the shape and size of the test samples used in the research.

Fig. 1. The shape and size of the test samples used in the research

- the samples were made of the same materials as the elements of the bus body;
- the displacement of the width when gluing two halves of the sample did not exceed 0.5 mm;
- the longitudinal axis of the glued sample has no curvature in the plane of the adhesive seam;
- parts of the extruded glue at the ends of the adhesive seam were cleaned before the test;
- 7 samples were taken for testing with each gluing technology;
- after gluing, the samples were aged for at least 12 hours before the test;

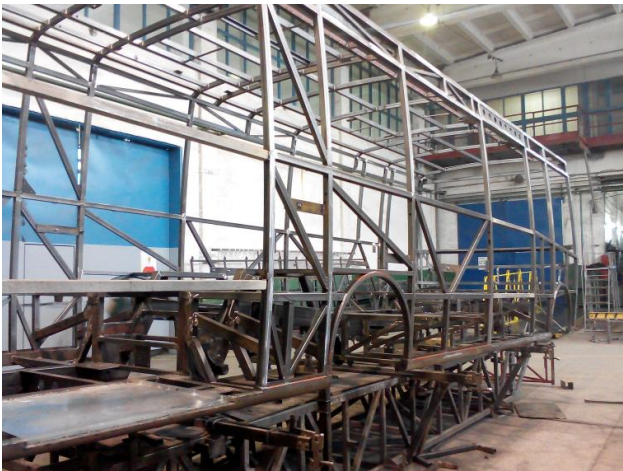
After welding, the frame of the bus body does not have a protective coating (Fig. 2).

Fig. 2. Bus body frame after welding

If one welds the cladding to such a body, and then carry out corrosion protection, as it was before, then there will be

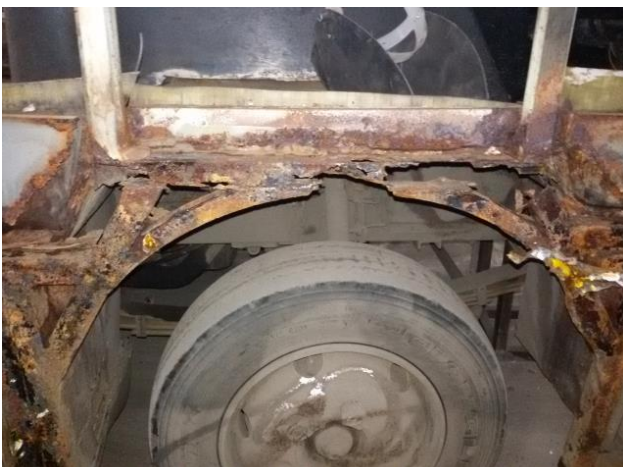
a completely uncovered metal between the cladding and the body frame. As a result, from the first day of operation, the corrosion process will develop intensively. Such a bus will be operated until the body frame itself is destroyed under the influence of corrosion. Outside, such a bus will look quite decent. In addition, buses in these places that are welded (closed cavities) cannot be controlled during operation. In practice, there have been numerous cases when the body was removed from the frame and it simply fell apart. The consequences of such an imperfect design can be seen after 5–9 years of operation of the bus with the body of a bearing structure (Fig. 3). Very rarely, operating organizations, in order to close the uncovered metal, blew an anticorrosive agent (such as «Movil») under pressure in the gaps between the frame and cladding. This required removing all internal body cladding. At the same time, the bus was idle and all this required financial and labor costs. As a result, the service life increased slightly and these costs were not in vain. However still, the consequences of such an imperfect design can be seen after 5–9 years of operation of the bus with a body of a non-bearing structure (Fig. 3).

Fig. 3. Destruction of the frame of the bus body under the influence of corrosion

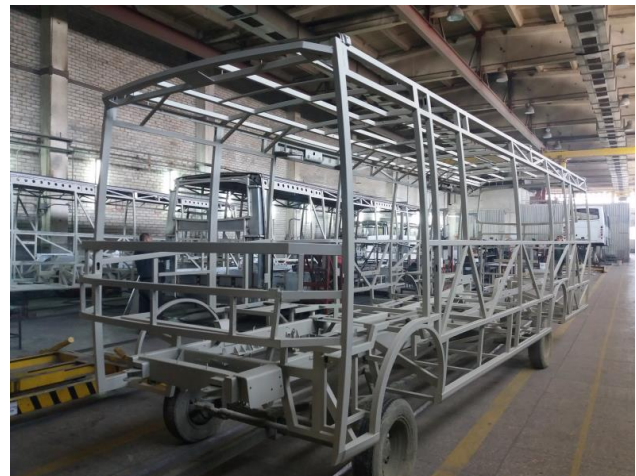
The first option provides for a preliminary coating of the body frame with high-adhesion anticorrosive primer according to ISO 12944-1:2017. In this case, the welding sites of the cladding are sealed with paint adhesive tape. Then, after the primer dries, the painting tape is unstuck, and the uncovered areas are covered with conductive primer. Figure 4 shows a body frame that is already covered with highly adhesion anticorrosive primer.

Fig. 4. The body frame of the bus, which is covered with high-adhesion anticorrosive primer

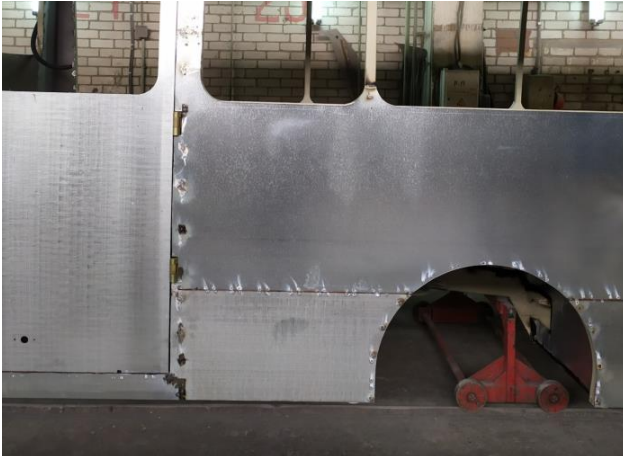
After drying of the conductive primer, two-sided galvanizing cladding is welded (Fig. 5). These buses use glued rear and front cladding masks to increase corrosion resistance and durability. The front and rear bumpers are also made of fiberglass. Unlike masks, bumpers are attached mechanically. Since the roof of the bus is subject to the least corrosion damage, the roof cladding of the bus is proposed to continue to be made of steel sheets without zinc coating. Steel sheets are welded. After a full cycle of welding and gluing of the front and rear masks, the body is transported to the shop of draft painting operations. There, the body is prepared, covered with anticorrosive primer of the Helios brand. Body elements directed to the roadway are covered with a special anticorrosive mastic of the Dinitrol brand.

Fig. 5. The body frame of the bus, which has welded cladding with double-sided galvanizing

The new Ataman D093S2/S4 school buses use simplified technology, which also introduces some advanced technical solutions. Side steel panels with double-sided galvanizing (Fig. 5) are welded to a body previously covered with high-adhesion anticorrosive primer. Moreover, in the welding sites, conductive primer is applied. Closed cavities are treated in the same way as that proposed in schemes in Fig. 6–8. Such buses have been in operation since 2015 in all regions of Ukraine. The condition of the bodies of school buses «Ataman» D093S2/S4 is somewhat better than the A092N6. This is due to the fact that the city buses A092N6 carry passengers with periodic overloads (during rush hour) with an average annual run of 70–100 thousand km. The annual run of school buses does not exceed 20 thousand km. Thus, as real operation shows, it is im-

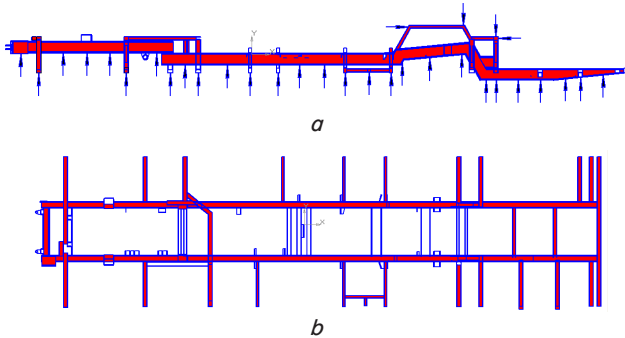
As a result of the analysis of restoration repairs of bus bodies, it was established that the body frame is subject to intensive corrosion processes only below the windowsill beam. Moreover, the frame of the front part of the body is securely protected by a front mask and bumper. In addition, the front of the bus is better ventilated and dried from the heated engine. Therefore, the treatment of closed cavities is proposed as follows. Treatment, first of all, must be applied to the base frame by 100 %, since corrosion destruction of the base frame leads to the impossibility of further operation of the bus (Fig. 6).

Fig. 6. The scheme of treating the frame of the base of the bus body: *a* – side view; *b* – top view

In the places of supply of anticorrosive liquid, technological holes with a diameter of 10 mm are drilled, in which Dinitrol substance is supplied under a pressure of 10–15 kgf/cm². For normal penetration of anticorrosive fluid, the temperature in the room of the paint shop should not fall below 20 °C. Then, after the excess anticorrosive liquid leaks from the technological holes, they are closed with special plugs.

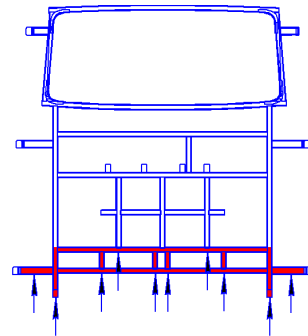
The frame of the back of the body corrodes under the rear bumper since dirt and moisture accumulate in this place. In winter, when the roadway is sprinkled with salt-sand mixtures against icing, an aggressive environment for intensive corrosion development is formed under the rear bumper. Therefore, the bottom of the frame of the back of the body requires external treatment with mastic, and the inner cavities with Dinitrol anticorrosive liquid. Fig. 7 shows the scheme of application of anticorrosive fluid in the closed cavities of the frame of the back of the body.

Fig. 7. The scheme of treating the frame of the back of the bus body

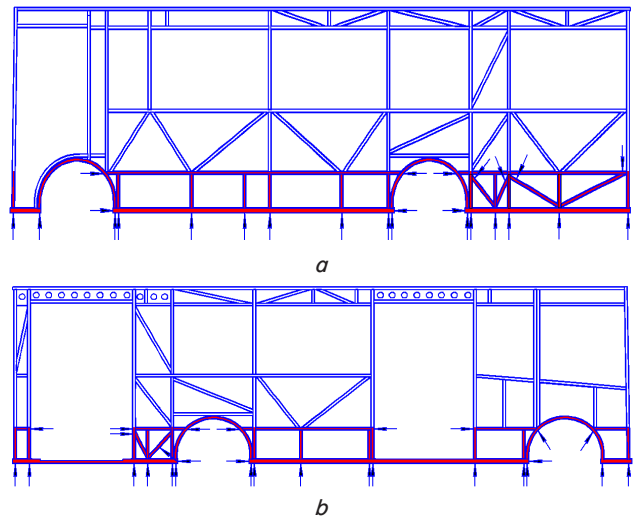
corrodes below the windowsill beam. Taking into consideration the fact that according to the new technology, the body frame is proposed to be first treated with primer, and then welded cladding, the corrosion intensity should significantly decrease below the windowsill beam. Therefore, it is proposed to treat closed cavities below the windowsill of the following elements: thresholds and the frame of wheel arches. All other pipes at the level of luggage and auxiliary compartments are also subject to treating: air filter compartment, fuel tank compartment, autonomous heater compartment, battery compartment. In addition, in the open compartments, frame pipes are externally covered with anticorrosive mastic. Fig. 8 shows the scheme of treating the frames of both sides of the bus.

Fig. 8. The scheme of treating the frames of the right and left sidewalls of the bus body: *a* – the frame of the left sidewall; *b* – the frame of the right sidewall

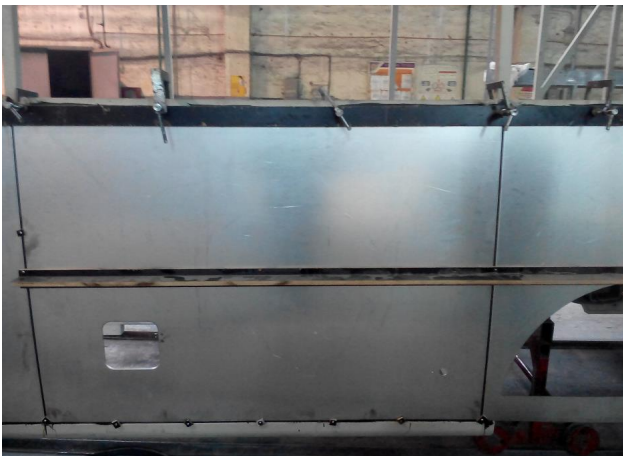
after welding will be completely covered with high-adhesion anticorrosive primer, with the exception of welding sites for roof coverings. In the places of welding roof edging, the body frame is covered with conductive primer. Side panels are made of sheets with double-sided zinc coating. It is proposed to form edges around the perimeter of metal sheets for gluing and increasing rigidity. It is proposed to glue these panels with the help of universal adhesive mixtures Sicaflex, which have not yet become widely used in the automotive industry. To increase adhesion, the body frame, and the cladding of the side panels in the gluing areas are pre-coated with the Primer liquid, which improves adhesion properties. Thus, this body manufacturing technology involves gluing all the cladding panels (plastic – front and rear masks, with double-sided galvanizing – side panels), except for roof cladding. Roof cladding is made of steel rolled steel without galvanizing. Figure 9 depicts the body of the bus, which is made according to the second version of the technology.

Fig. 9. The body of the bus with glued side panels with double-sided zinc coating

As a result of improving the technologies of the bus body in terms of corrosion and durability, new promising technologies for the production of bodies using modern polymeric means have been obtained. Materials that have not been previously used in the automotive industry have been proposed. According to existing technologies, the body was not covered with primer at all before welding the elements of the cladding (Fig. 2). According to the new technology, a full coating of the body frame with high-adhesion anticorrosive primer (Fig. 4) ensures an increase in the durability of the bus body. This technology was introduced on buses of the «Ataman» brand, manufactured at AT «Cherkasy bus» (Ukraine). Unlike previous modifications, on these buses «Ataman» A092N6, the closed cavities are treated according to schemes in Fig. 6–8, through technological holes. The use of technological holes based on design documentation under factory conditions prevents weakening of the body in the case of self-drilling of holes in their absence. Side cladding from steel sheets with double-sided galvanizing is glued (Fig. 9) and all fixed glass windows are glued.

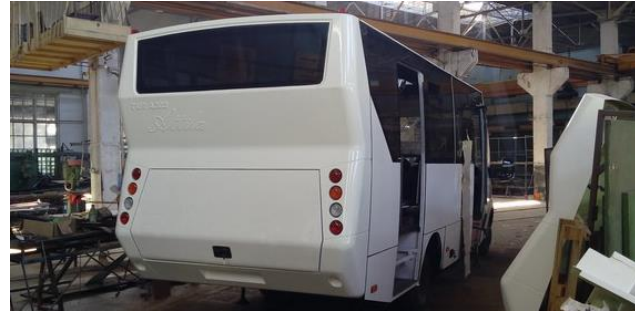
maximum number of polymeric materials. This increases the corrosion resistance of the bus body and reduces its mass. This technology differs from the previous one in that the side panels of the body cladding are made of polymer sheets with a double-sided coating of aluminum film (the type of Alucobond). Such sheets are glued according to the technology of the second option (Fig. 10).

Fig. 10. The body of the bus, the side panels of which are sheathed with polymer sheets with a double-sided coating of aluminum film (the type of Alucobond)

In this version of the technology of manufacturing the body of the bus (Fig. 10), the front and rear masks are made of fiberglass panels.

The use of front and rear masks made of fiberglass makes it possible under the conditions of production to quickly reconfigure production in accordance with the new design solutions of the bus body (Fig. 10). Side panels made of Alucobond material have an ideal flat surface for painting. Between the glued side panels, to compensate for temperature and mechanical deformations, gaps of 5–10 mm are provided. To preserve the proper aesthetic appearance, these gaps are filled with sealant for pasting. In addition to the proper aesthetic appearance, sheets of Alucobond material in combination with sealed pasting provide a decrease in noise effects during the operation of the bus.
