## **Introducing the Rehabilitation Policy in Order to Safeguard the Built Heritage**

### **Case Study: Hammam El Masry in Alexandria**

## 2. Case study: Hammam El Masry at Mina El-Basal District in Alexandria

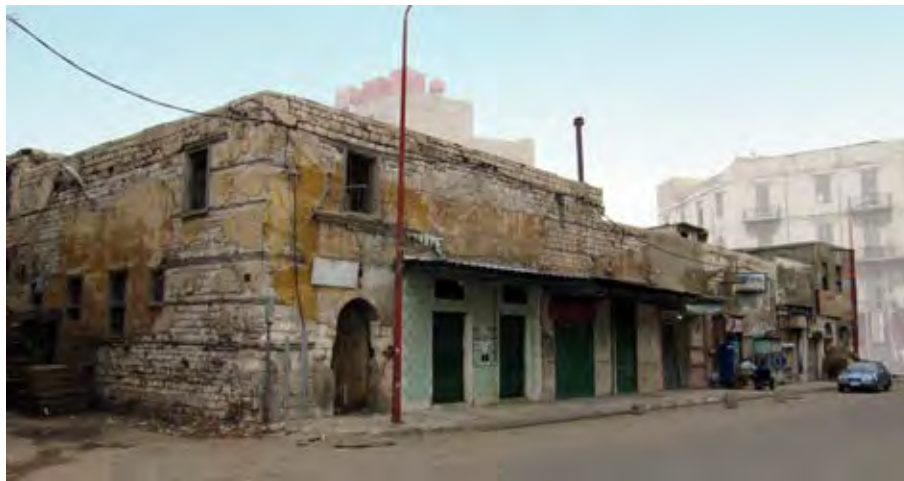
Figure 1. A panoramic view for Hammam El Masry taken from the main street of Escal Elghelal in Mina El-Basal Source: Image taken by the Researchers

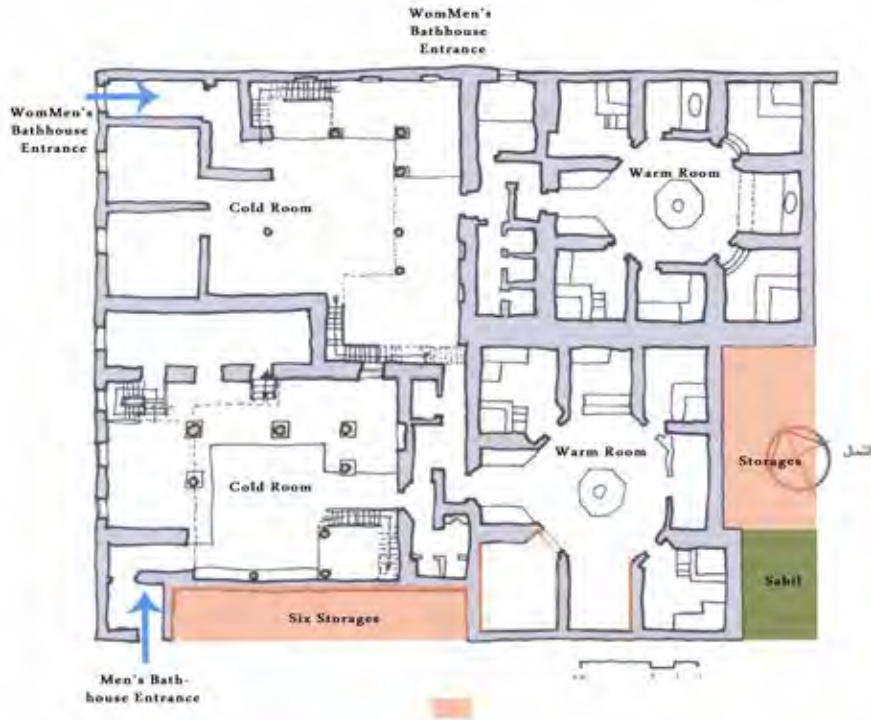
- Two adjacent bathhouses, one for men and another one for women.
- Seven storages: six of them are located on the south elevation and one is located on the west elevation.
- “Sabil” which is located on the south-west corner of the building.
- A space to put wet towels and for fuel storage, its door open from the north side.

- Fireplace and a well which was reached from the towel room.
- A housing floor on the upper floor, which was suspended on El Maghaz and El Sabil, and it contains seven rooms.

Figure 2. (a) Shows the original spaces usage of the bathhouse

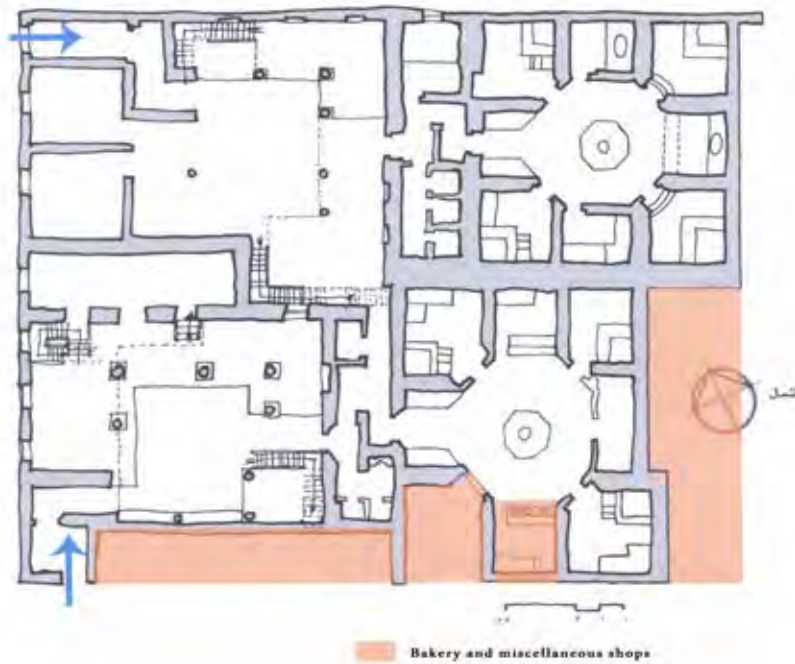
Figure 3. (b) Shows the existing spaces usage of Hammam El Masry Source: (Awad & AbelHafiz, 2007) modified by the Researchers

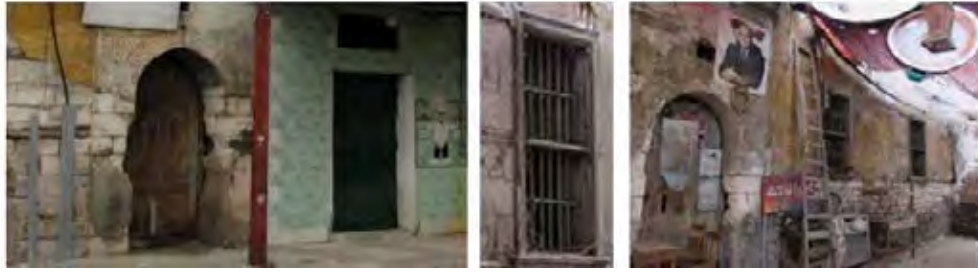
1. The demolishing of the upper floor.
2. The building structure is exposed and the exterior walls plaster is removed from several parts.
3. visual disturbance by electric cables as well as by the addition of ceramic tile on the shops elevations.
4. The corrosion of the metallic features of the building windows and the demolition of its glass.

Figure 4. Images show the defective points in the external facades of the bath house, Source: Image taken by the Researchers

Element	Condition	Materials	Suggested rehabilitation process
External walls of facades	Good	-Small and medium stone. -The building blocks are interspersed with mid or large veins of wood. -Walls are covered with thick layer of mortar in a yellow color.	-Protect and maintain masonry surfaces. -Cleaning of masonry surfaces. -Repair of stone walls and careful removing by hand-raking of deteriorated mortar and other added ceramic tiles
External doors	Good	Wood with its natural color (Dark Brown)	-Protection and maintenance of the doors -Cleaning of timber - Repair of timber
External windows	Bad	Timber, glass and steel	- Need replacement

The first stage is to remove any labels, paints or any exotic materials from the building facades.

- The second is to rebuild the demolished second floor which was once used as a residential floor
- The third is to restore the main usage of the spaces to their original use, such as; el sabil which is used recently as a grocery shop, and one of the iwans and the maghtas , situated in the men bath are also used as shops
- In addition to restoring the storage spaces around the bathhouse , which are currently used as a bakery and a cotton storage. These should be included into the complex to support the rehabilitation process and to be used as bazaars selling related product such as organic soaps, bathing equipment and natural cosmetics. It is recommended that the bazaars should follow the structural form of the building in order to maintain the building character and the context in which it is located.

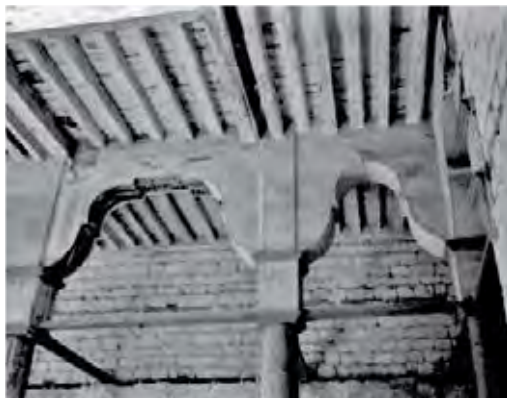
Figure 5. (a) : image showing the arches inside the men's cold bath

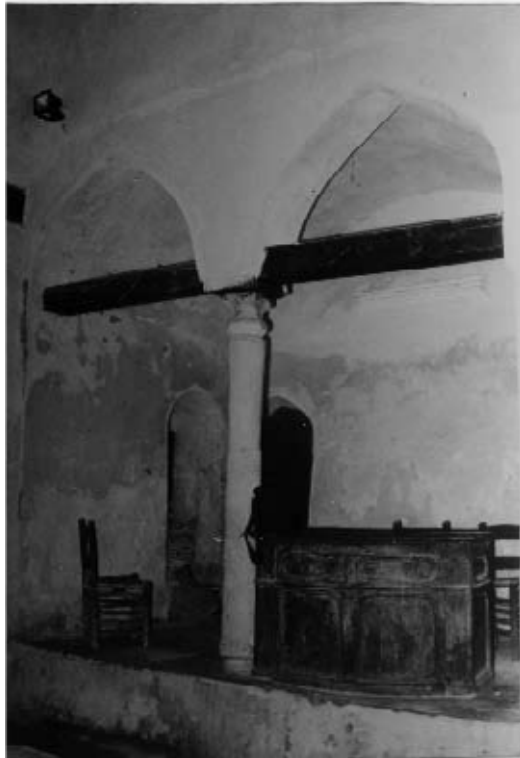
Figure 6. (b): image showing the mater's bench (deket elme'alem) Source: (Awad & AbelHafiz, 2007)

Handrail	bad	timber	-Need repair and partial replacement
Master bench	Very bad	timber	-Need replacement

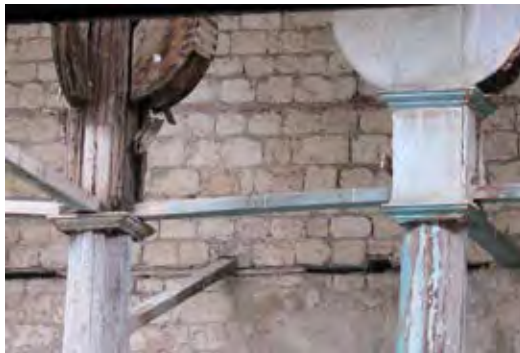
Figure 7. (a): image showing the wooden posts condition inside the men's cold

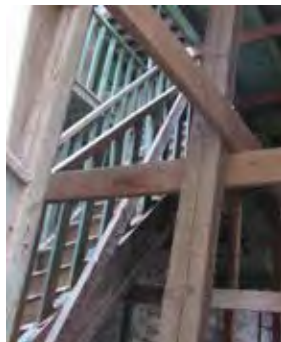
Figure 8. (b): image showing the wooden staircase to the second floor Source: (Awad & AbelHafiz, 2007)

Element	Condition	Materials	Suggested rehabilitation process
The fountain	Good in men's bath very bad in women's bath	Stones covered with tiles of marble	-Protect and maintain existing stones. -Cleaning and repair of marble -Replacement of drainage pipes.
Roofs	Very bad	Timber Clapboard painted with green color	-Protect and maintain existing wood. -Repair of broken parts. -Replacement of missing and deteriorated part of wood. -Coating the wood with waterproof materials.
Columns	Good	Circular timber columns painted with green color. They have square stone bases with height 45 cm	-Protect and maintain existing wood. - Repair of broken part of timber column and stone base.
Arches	Good	Built from thick sticks of Alboghdadly timber coated with a thick layer of mortar	-Protect and maintain existing wood arches - Repair of broken parts
Stairs	bad	timber	-Need repair and replacement for some parts to unsure safe vertical circulation

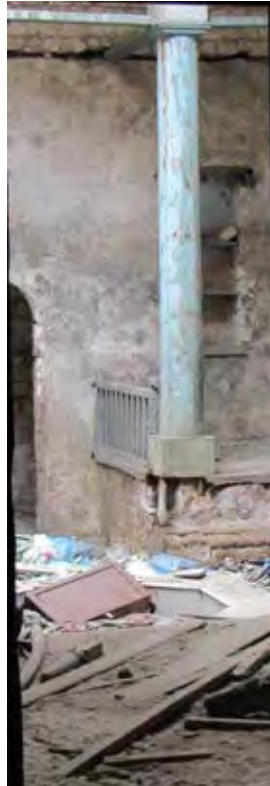
Figure 9. (a): shows the master's bench and the fountain in the women's cold room

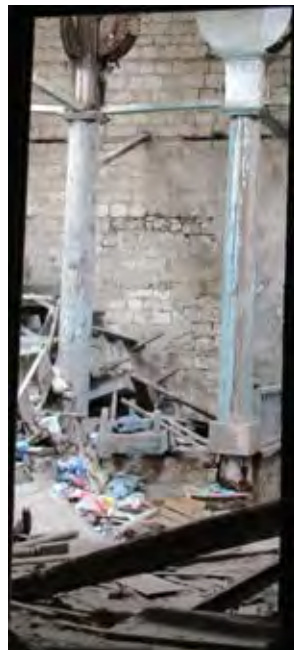
Figure 10. (a): Showing the amount of trash and the mess in the current situation

- Renewal and replacement of water system;
- Renewal and replacement of sewage system;
- Renewal and replacement of electrical system;
- Windows are faulty and need total redoing, doors are good and need refinishing.
- Replacement of the plaster work which has deteriorated and flaked in places;
- The general cleanliness of the buildings, and the different types of flooring;
- Roofs have many defection and need recovering and protection from rainwater disposal.

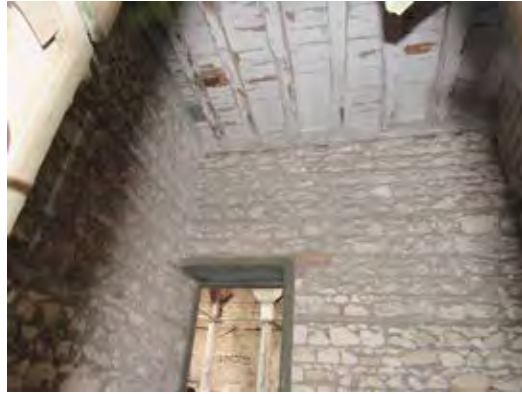
Figure 11. (c) showing the inner walls and the timber ceiling condition in the women's cold room, Source: Image taken by the Researchers

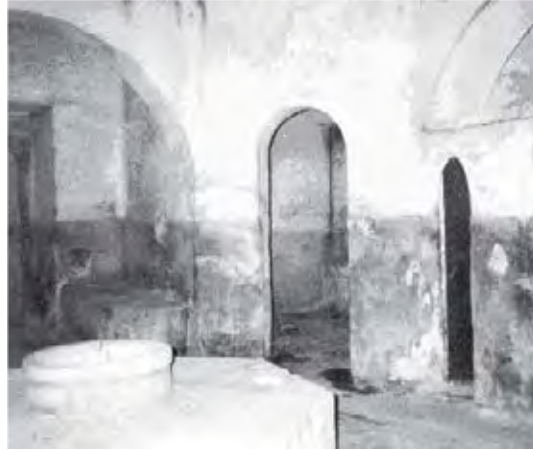
Figure 12. (a): shows the octogonal central fountain in the women's warm room

Element	Condition	Materials	Suggested rehabilitation process
The fountain	Good in both men's women's bath	Stones covered with tiles of marble	-Protect and maintain existing stones. -Cleaning and repair of marble -Replacement of drainage pipes.
Roofs	Good	Nine domes made of brick. The domes contains multiple holes covered with glass	-Protect and maintain existing domes. -Repair of bricks. -Replacement of glass -Coating roof with insulation materials.
Arches	Good	Built from masonry bricks coated with a thick layer of mortar	-Protect and maintain masonry - Repair of deteriorated brick - Repainting in same color
Doors of the four shower rooms	Good	Timber doors painted in green color	-Replacement of doors. -Repainting in same color
The basin	Bad	Marble	-Repair of the marble basin - Replacement of drainage pipes.

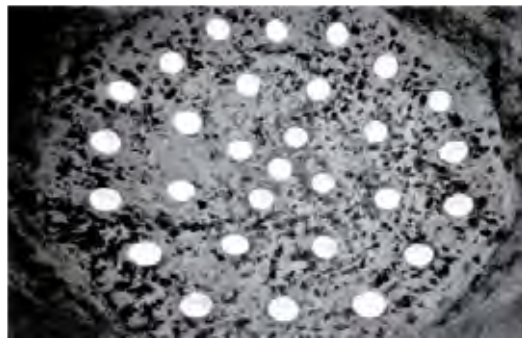
Figure 13. (b) Shows the main domed roof of the men's worm room, Source: (Awad & AbelHafiz, 2007)

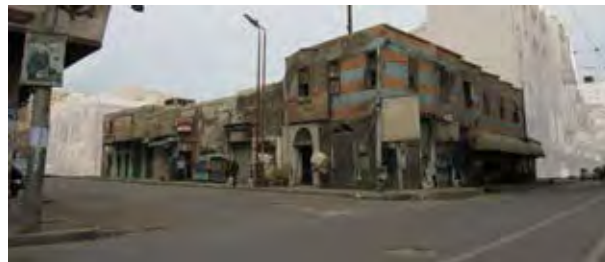
- Streets are paved

- The building is locating on two major streets
- It is easy to access the site with public and private transportation
- Electric, drainage and sewerage systems exist on site
- The use of the existing urban infrastructure will be a strength point for the rehabilitation process.

Figure 14. image showing the services condition and the streets around the building  
Source: Image taken by the Researchers
