The effect of the reciprocal relations of the deterioration symptoms in different building materials in some of historic Cairo's buildings

Essam H. Mohamed¹¹Archaeology conservation Department, Faculty of archaeology, South valley university, Qena, Egypt,Email: Essam.mohamed@arch.svu.edu.eg

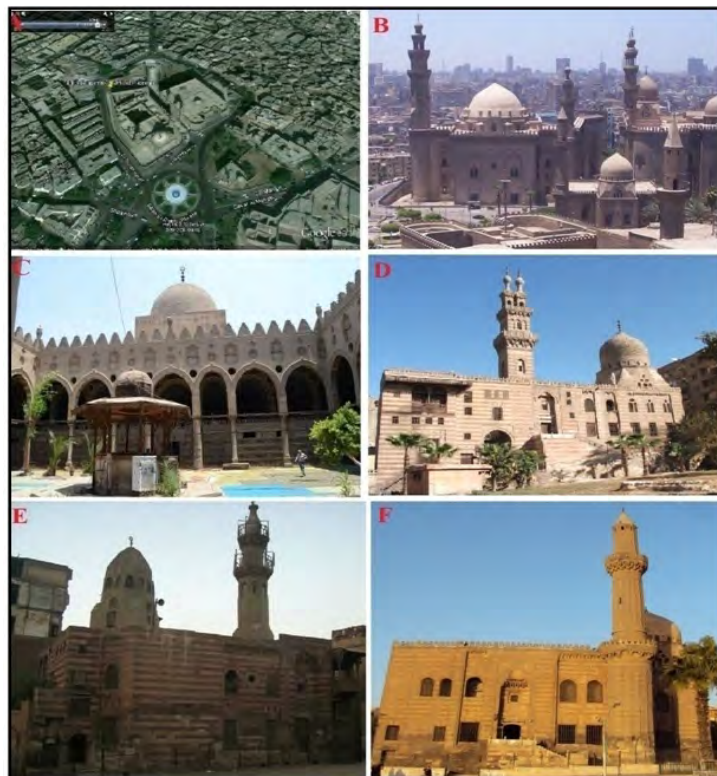
Figure 1. A- Case studies sites(Google earth) B- Madrasaof Sultan Hassan C- Al maridani mosque D- Madrasa of Qanibay alammah E- Madrasa of Gawhar al-Lala F- Al MahmoudiaMosque

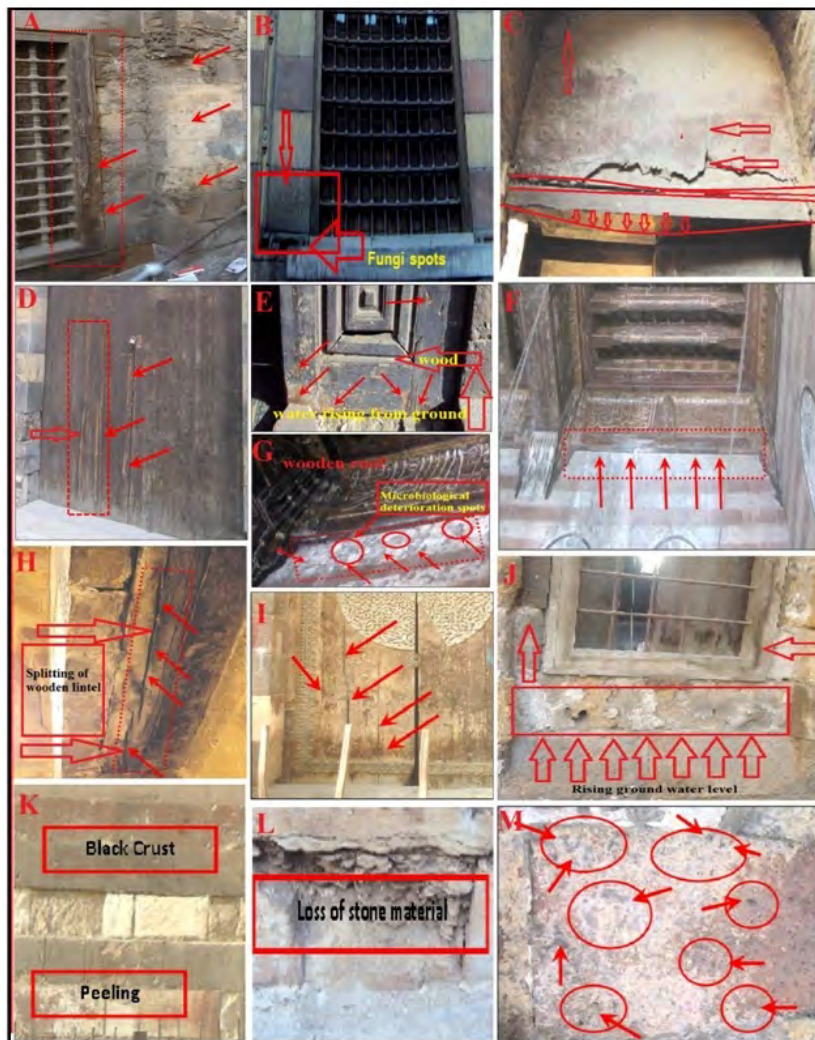
2.2. Symptoms of deterioration (Figure 2)

- Loss of stone material and separation of wooden texture addition to accumulation of dust and salt particles inside wooden texture (Al maridani mosque, Figure 2A).
- Splitting in wooden lintel (Madrassa of Qanibay alammah, Figure 2H) .
- Loss of stone material, and separation of wooden texture addition to accumulation of dust and salt particles inside wooden texture (Al maridani mosque, Figure 2J).

- Deflection of wooden lintel (Madrasa of Qanibay alammah, Figure 2C).
- Flaking and crumbling of paint layer (Al Mahmoudia Mosque, Figure 2E).
- C rack and flaking of paint layer of wooden door (Madrasa of Sultan Hassan, Figure 2D)
- Splitting in wooden door and the paint flakes with thick layers dropping off in big particles (Madrasa of Gawhar al-Lala, Figure 2I).
- Pitting on the limestone surface (Al Mahmoudia Mosque, Figure 2M).
- Black spots on limestone surface cause biological damage (Al Mahmoudia Mosque, Figure 2B).
- Loss of stone material (Madrasa of Sultan Hassan, Figure 2L).
- Black crust and peeling (Madrasa of Gawhar al-Lala, Figure 2K).

Figure 2. Deterioration features of limestone and wooden elements of a case studies : A-Loss of stone material and separation of wood texture, (Al maridani mosque), B-Fungi spots on limestone's surface (Madrasa of Qanibay alammah), C- Deflection of wooden lintel due to fissures in wall, D-Cracking and flaking of paint layer of wooden door (Madrasa of Sultan Hassan), E-Flaking and crumbling of paint layer, F-Separation of wooden roof from wall (AlMahmoudia Mosque), G- Black spots on limestone surface, H- Splitting in the wooden lintel, I-Splitting in wooden door and the paint flakes with thick layers dropping off (Madrasa of Gawharal-Lala), J-Loss of stone material, and separation of wooden texture , K-Black crust and peeling , L-Loss of stone material, M- Pitting in limestone surface.

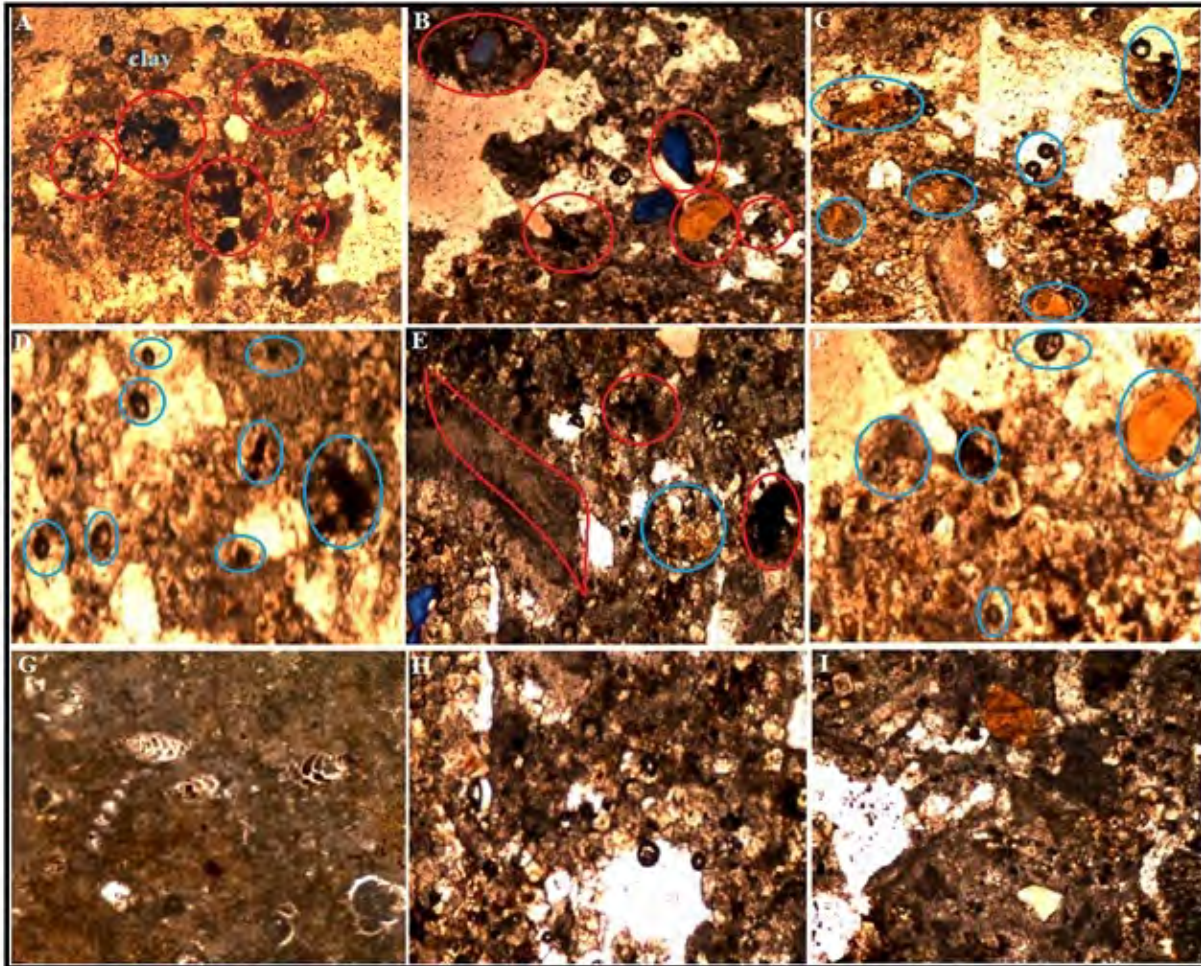
The examination of a thin section of limestone samples under polarized light microscope (PLM) that showing all samples are mainly consist of calcite, dolomite, and quartz, as secondary minerals, addition to clay minerals, fossils and iron oxides were found between grains, our observation that deteriorated samples are contained coarse grains of calcite, also found clay minerals, gypsum, iron oxides, between grains. The interstitial spaces in limestone texture fill with a fine mosaic texture of calcite crystals, as well as the presence of fragments of quartz crystals and various types of fossils, we conclusion that The presence of clay minerals, gypsum salt and iron oxides is facilitated from limestone weathering.

Figure 3. The examination of the limestone samples under polarized microscope shows: A- Showing an increase in porosity, clay minerals, iron oxides, and coarse grains of calcite in limestone texture (Al Mahmoudia Mosque), B- Thin section showing coarse grains of calcite, gypsum, cavities and iron oxides between grains (Al maridani mosque), C- showing high iron oxides between grains, clay minerals and cavities (Madrasa of Qanibay alammah), D-Coarse grains of calcite, clay minerals and cavities (Madrasa of Sultan Hassan), E- High clay minerals, iron oxides, cavities, and coarse grain of calcite (Madrasa of Gawhar al-Lala), F- showing coarse grains of calcite, cavities and iron oxides between grains (Madrasa of Sultan Hassan). G-I- Different kinds of fossils, fine grains of calcite and little cavities.

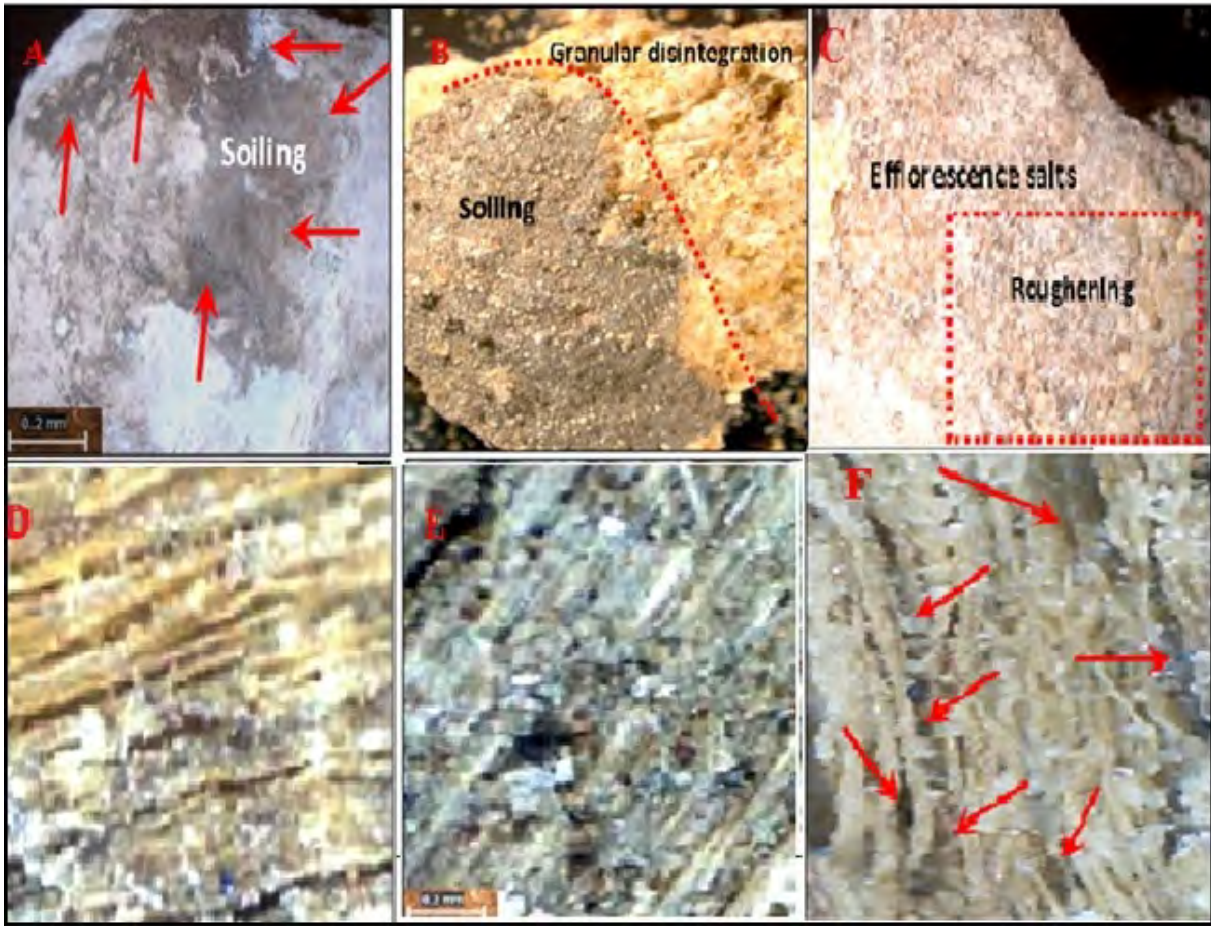
Limestone samples are investigated by Stereo Microscope, showing roughening and soiling in limestone surface, addition to Granular disintegration and accumulation of dust and salt particles on stone surface (Figure 4 A, B, C). Wood samples which investigated, show ing accumulation of dust between wood fibers, addition to separation of fibers due to the effect of moisture, and crystalline salts was found between fibers (Figure 4 D, E, F).

Figure 4. StereoPhotomicrographs of stones and woods. A-Showing roughening and soiling in limestone surface (Madrassa of Sultan Hassan), B- Granular disintegration and accumulation of dust and salt particles on the limestone surface (Al Mahmoudia Mosque), C-Efflorescence salts and roughening with limestone surface (Al maridani mosque), D-Accumulation of salts crystals between wood fibers addition to separation of fibers (Al maridani mosque), E- Separation of wood fiber and found crystalline salts between fibers (Madrassa of Qanibay alammah), F- showing damage of wooden fibers and crystalline salts was found between fibers (Madrassa of Gawhar al-Lala).

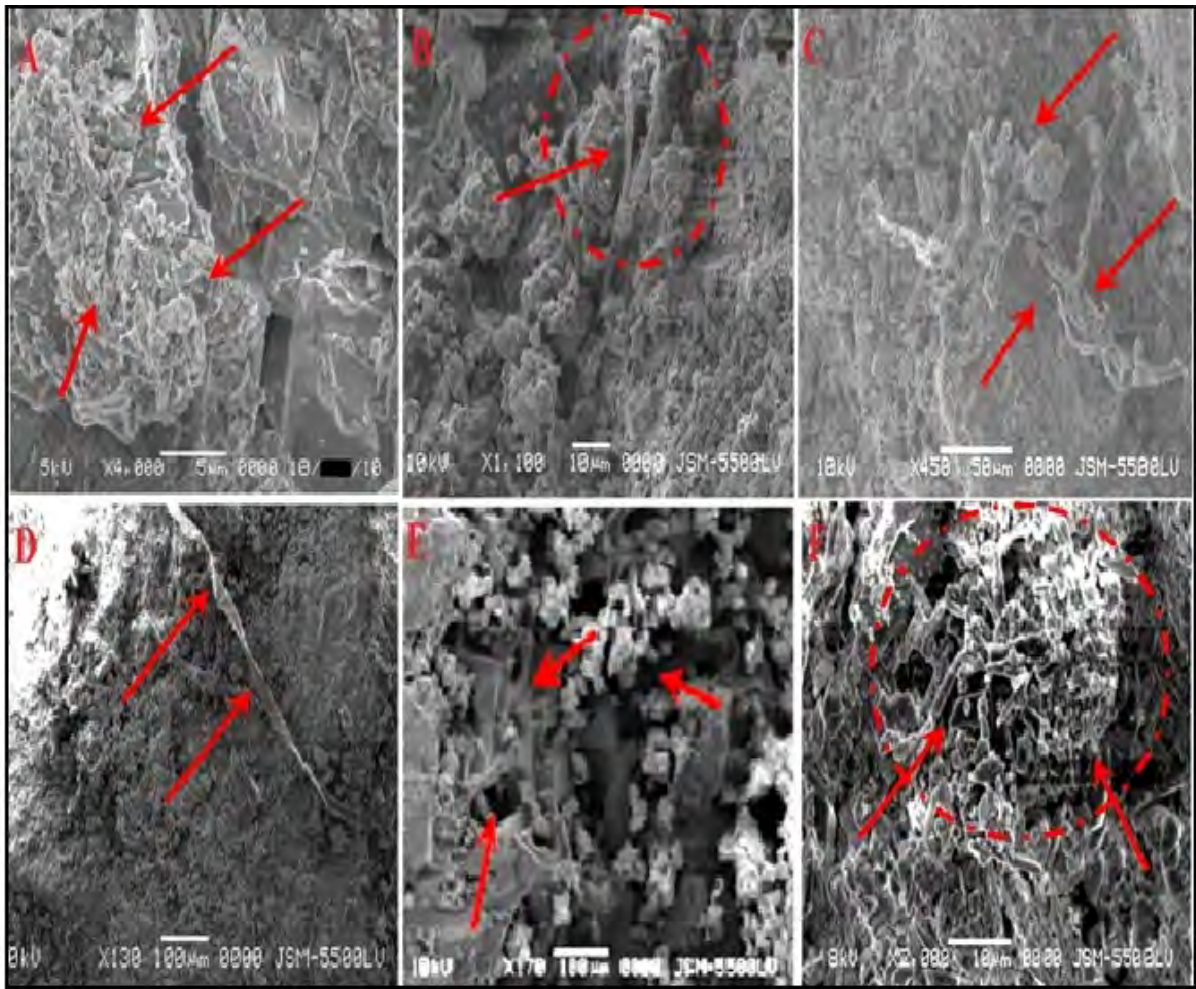
SEM image of limestone samples showed disintegration between calcite crystals and dense of halite and gypsum crystals which covers the pores of the stone, addition to loss of binding materials, and there is fungal hyphae penetrated mineral crystals of limestone. (Figure 5 A, B, F).

Deterioration and corrosion observed in calcite crystals, loss of the binding materials, we observed an increase in the size of stone pores, micro cracks, loss in Internal Structure result of internal stresses between the mineral crystals due to re-crystallization of the salt inside stone pores, addition to fungal infection was observed (Figure 5 D, E, F).

Figure 5. SEMPhotographs of limestone and woods. A-Showingthe deterioration of mineral crystals and crystalline salts and loss of bindingmaterials (4000X), B- Showing damage of calcitecrystals and loss of bonding materials addition to found fungi infectionbetween grains (1100X),C- fungi between minerals crystals of limestone(450X), D-fungal hyphae inside mineral crystalsand found disintegration of grains (130X), E-loss of bonding materials and corrosion of mineral crystals (170X), F-Deterioration of mineral crystals and loss ofbonding materials, fungal hyphae is found between the minerals crystals(2000X).

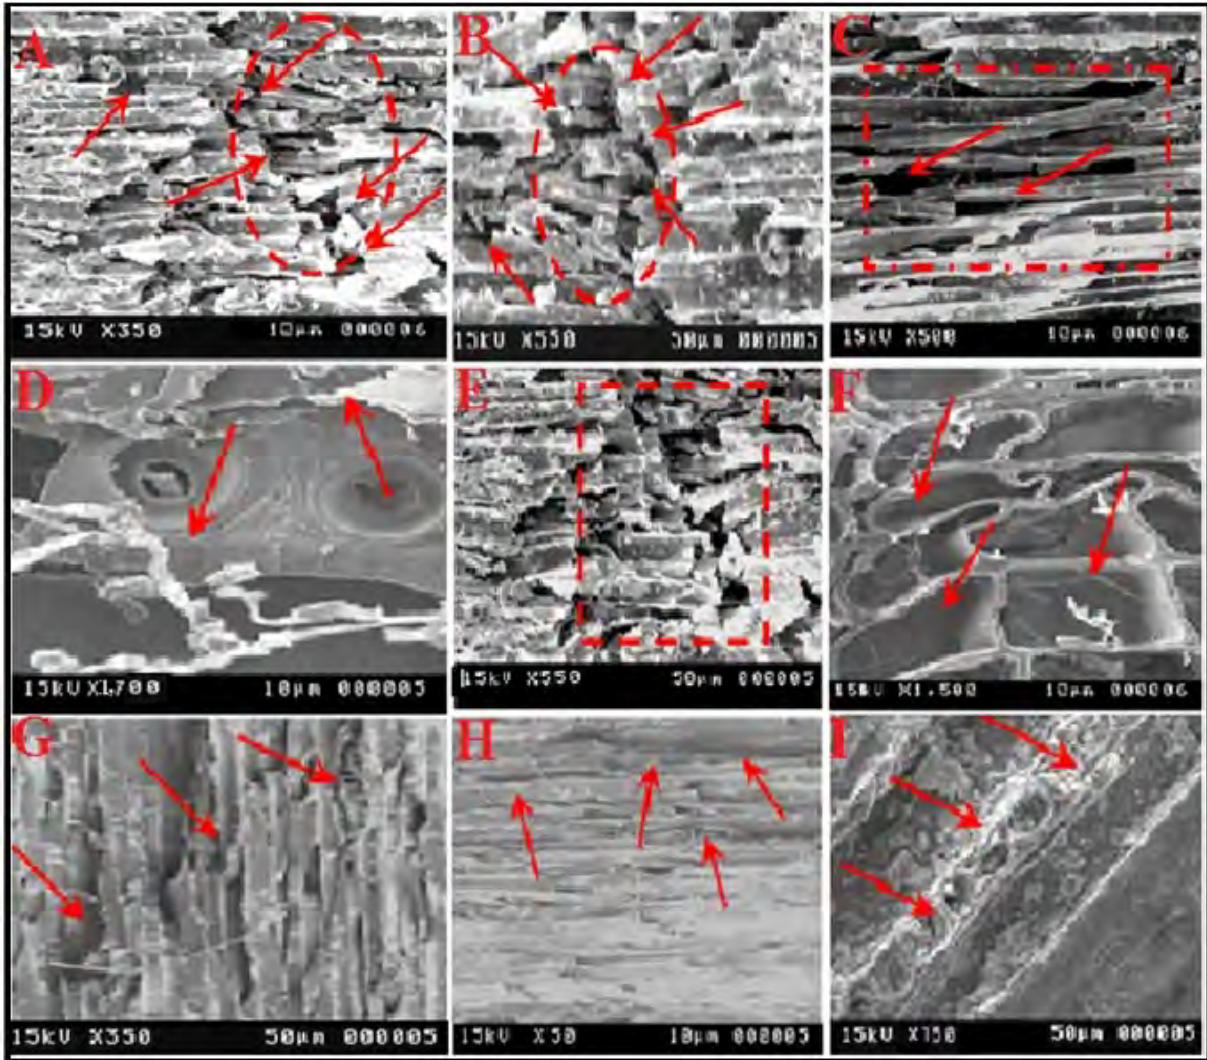
SEM image of the wood samples showed Damage to cells and Crystallization of Salts between wood fibers, the examination is shown damage to wood fibers, also an observation detachment of anatomical elements and Fungal hyphae is penetrated wood fibers (Figure 6 A, B, D, E). Loss of wooden fibers was observed using SEM examination and Separation of wood cells (Figure 6 C, F, G, H, I).

Figure 6. SEM Photographs of woods. A-Damage of wood cells and Crystallization of Salts between wood fibers (350X), B- Destroyed wood fibers show from examination (550X), C- Detachment of anatomical elements D- Fungal hyphae is penetrated wood fibers and crystallization of salt between fibers (1700X), E-Damage of wood fibers and a detachment of anatomical elements (fibers) (550X), F- Crystallization of Salts between wood fibers (1500X), G- Separation of wooden fibers, loss of wooden fibers and destroyed of cells (350X), H-Separation of wood cells (50X), I- Damage to cells and loss of wooden fibers due to re-crystallization of salts in fibers (150X).

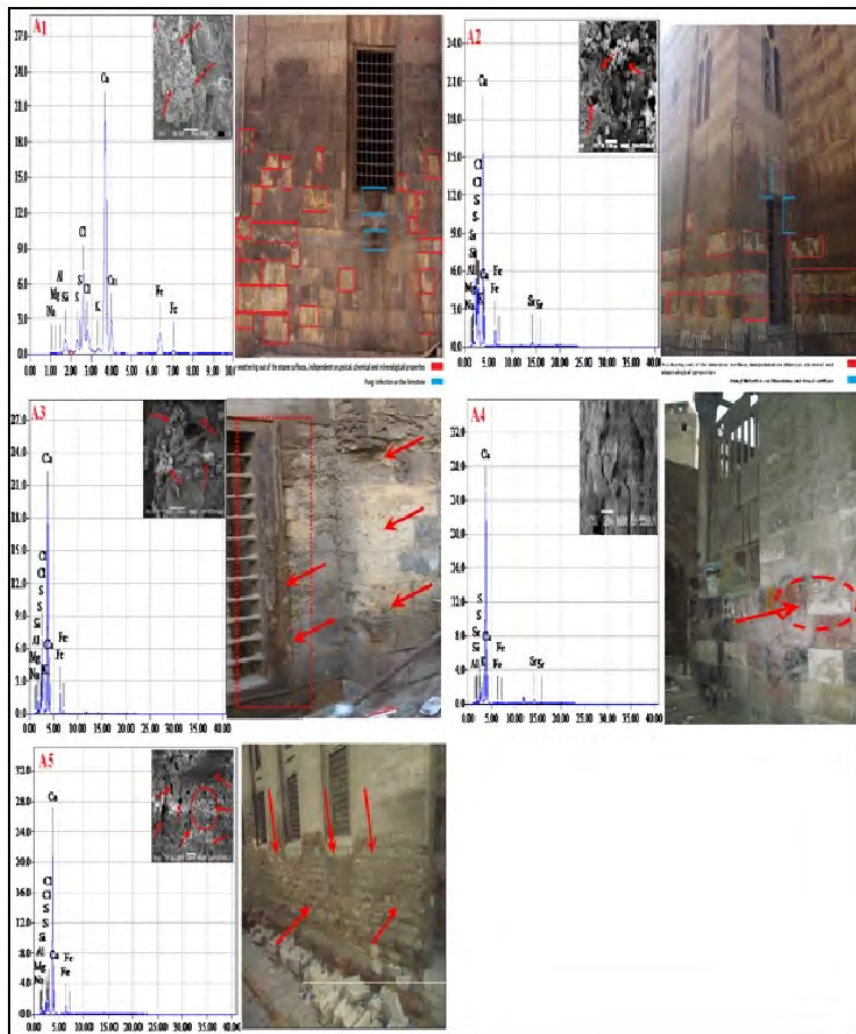
The EDX analytical methods were performed to identify the deteriorated samples of limestone to evaluate their different components. The investigation results are shown in (Table 1) and (Figure 7). An EDX micro analysis of the samples indicated that there are elements found in deteriorated samples were caused accelerating weathering of the limestone according to their concentration in the stone as follows: the deteriorated samples contain of increase in the following elements' concentration : Na (6.4%), Mg (2.16%), Si (6.05%), Cl (8.0%), Al (1.27%), Fe

(4.57%), these elements was evidence in finding halite salts, clay minerals and iron oxides in which deterioration the limestone more than the limestone samples contains of decrease in the previous elements' concentration.

Figure 7. EDX analysis pattern of the limestone samples : A1- Al Mahmoudia Mosque, A2-Madrasa of Qanibay alammah, A3- Al maridani mosque, A4- Madrasa of Gawhar al-Lala, A5- Madrasa of Sultan Hassan

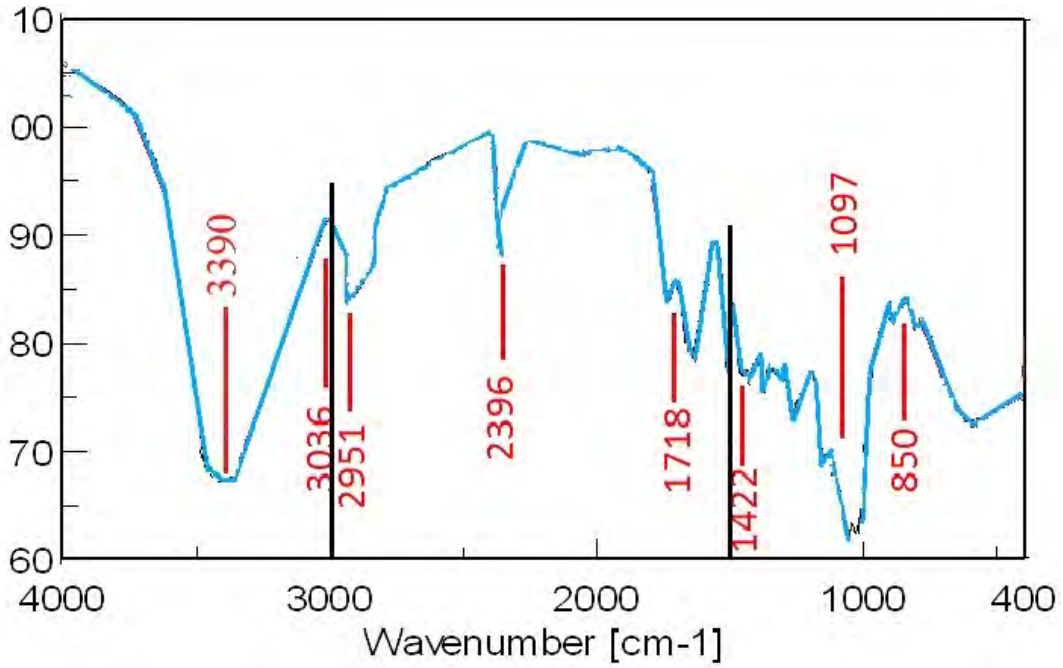
The results of FTIR analysis of the deteriorated wood samples are shown in (Figure 9,10) that most changes occurred in the chemical compounds in the area around (3422 -850cm⁻¹), such as Decrease of the intensity band of C=O=C stretching around (1156 cm⁻¹), due to breaking of cellulose chains and the occurrence of depolymerisation.

Decrease of C=C stretching band around (1520 cm⁻¹) due to loss of lignin, due to fungal degradation, also FTIR analysis shown decrease of the intensity band of unconjugated C=O stretching around (1790 cm⁻¹) due to the decrease in the hemicellulose amount of the deteriorated samples (according to, Zidan, et.al.2016). Decrease of O-H stretching around (3422 cm⁻¹), by the decrease in Cellulose, Lignin and hemicelluloses amount.

Figure 10. FTIR Spectra Transmittance of the deteriorated wooden samples

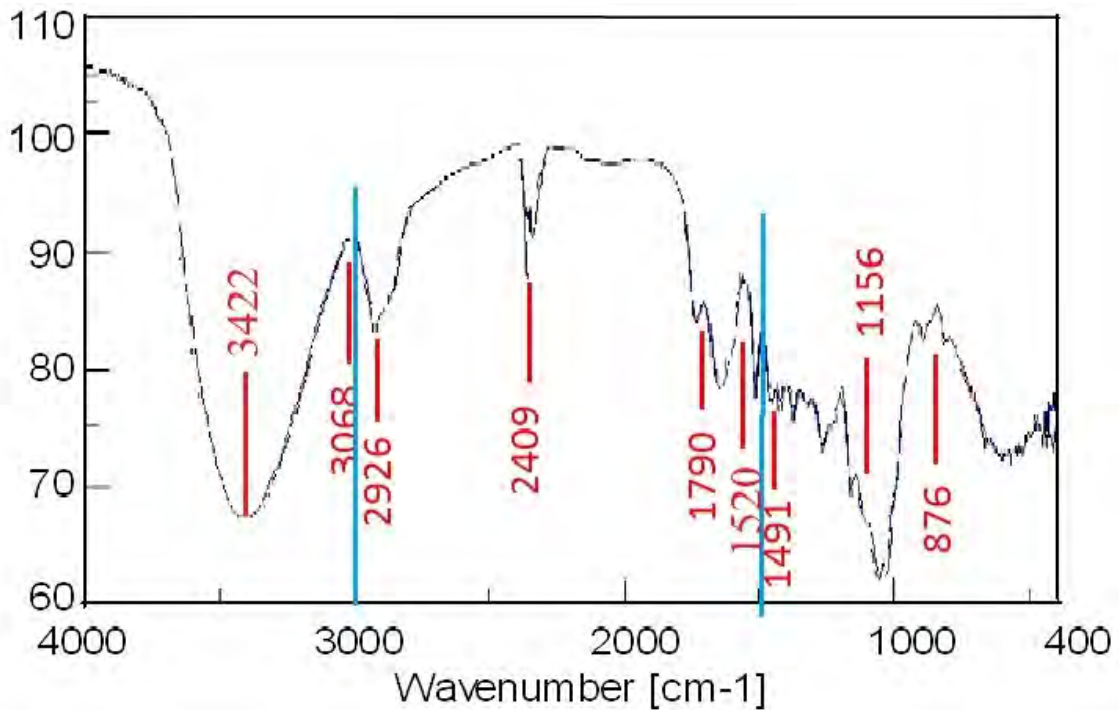
Figure 11. FTIR Spectra Transmittance of the deteriorated wooden samples

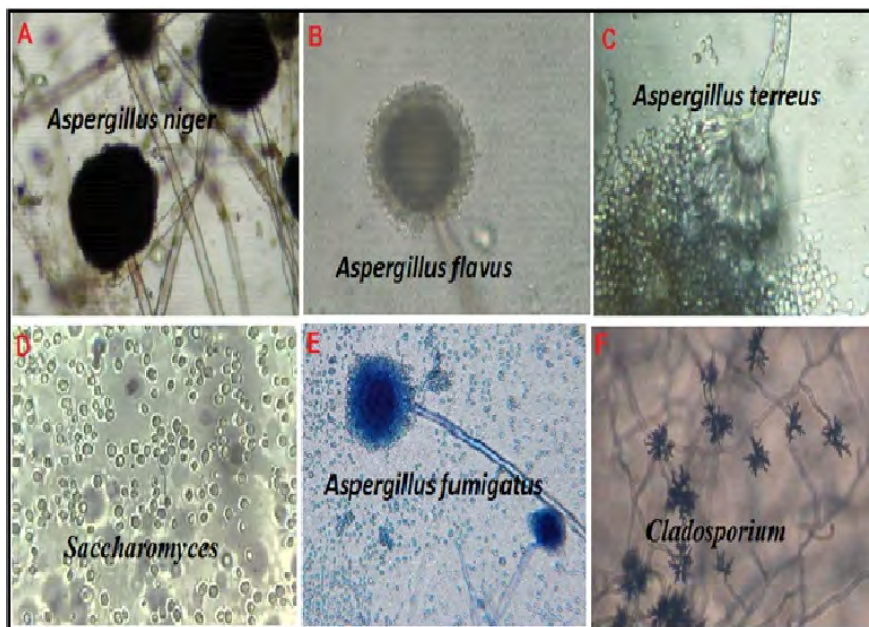
The limestone and wood Samples were investigated by (SEM), the examination was shown evidence of micro-biological attack. Isolated fungi were found in various parts of limestone and wood used in archaeological sites (case studies), six fungal species were isolated from infection samples, showing following : *Aspergillus flavus*, *Aspergillus terreus*, *Aspergillus niger*, *Aspergillus fumigatus*, *Clado Sporium*, *Saccharomyces* (Figure 10, A-F).

We observed that all limestone samples which found adjacent to the wooden elements used in the buildings (case studies) were the most infected with fungal infection, due to that wood as an organic material i s one the most of the factors that help the growth of fungi.

Figure 12. Microscope photographs of isolated fungi from surfaces of the limestone and wooden elements
