Study on the Repairing Techniques of Near- Modern Historical Residences in Nanjing, China: The case study of the West Cabbage Garden Conservation project

This article first gives a brief introduction to Nanjing's near-modern history and summarizes the characteristics and problems of residences during this period. Then, this article takes an architectural renovation and conservation project undertaken by the authors as an example to introduce the strategies and modern methods adopted in the conservation of the historical residences.

3. History and Project Overview

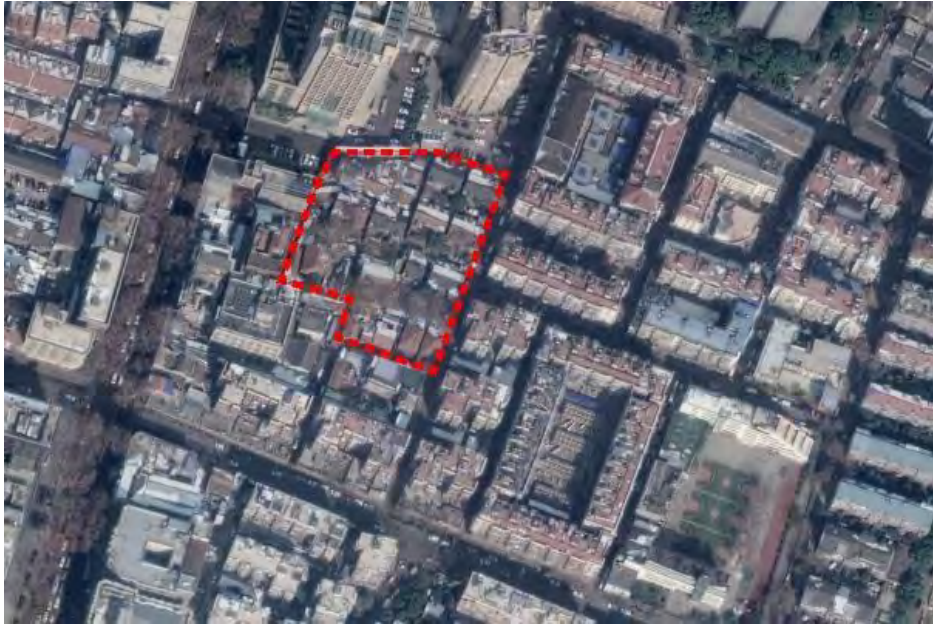
Figure 3 Site plan (Image source: drawn by the author)

The West Cabbage Garden historical area is located in the northern section of the commercial street of Taiping South Road, Baixia District, Nanjing (Figure 2, 3). It is very close to the city's busiest city centre. Surrounded by modern urban buildings, this two- and three-story architectural heritage stands out (Figure 9). The West Cabbage Garden historical area is the epitome of Nanjing's near-modern residential construction and real estate development.

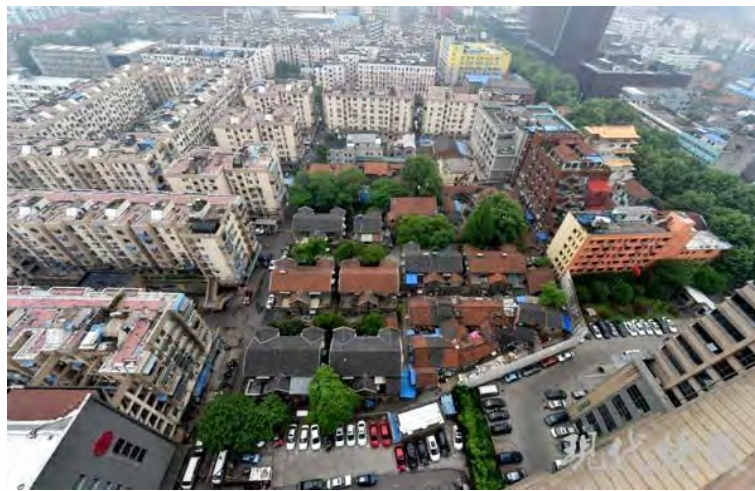
Figure 5 Aerial View of the West Cabbage Garden (Image source: xdkb.net)

In less than 1 hectare of the area, West Cabbage Garden includes 14 architectural heritages which were built during the 1930s (Figure 5). West Cabbage Garden has high historical value, artistic value and architectural technology value. It is the epitome of Nanjing's residential construction and real estate development boom in the 1930s, and they were also the residences of more than ten famous celebrities. West Cabbage Garden witnessed the changes in the way of living in Nanjing's near modern society, and also left many intangible cultural heritages such as celebrity anecdotes.

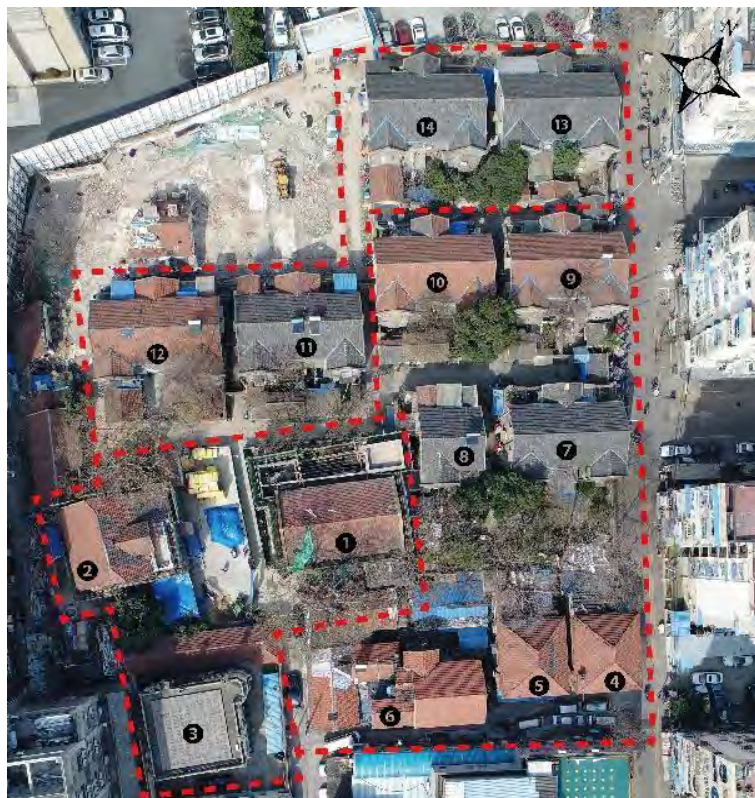
Figure 6 Site plan (Aerial photo, image source: drawn by the author)

The No. 1 to No. 3 building is the first phase of the project and is now close to the end of conversation. The No. 4-10 building is the second phase of the project. The second phase of the project has just begun. No. 11-13 is the third phase of the project, and the conversation design has been completed (Figure 6). Among them, Building No. 7 and Building No. 9-14 have the same form and they were built in 1937.

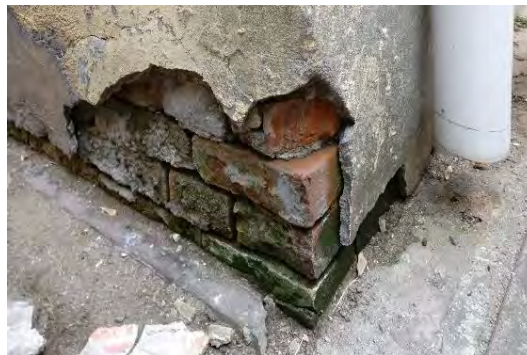
Figure 11 The brick foundation is eroded. (Image source: photographed by the author)

Due to the lack of basic bearing capacity of the building, we have taken measures to expand the base width after calculation. The new base cushion is not lower than the original base cushion. At the joint of the new and old foundations, the two are connected as a whole by chiseling, cleaning, brushing the interface agent, and adding the steel bars.

We burrow the hole on the original strip foundation wall, then wear the reinforced concrete beam, make the foundation at both ends of the beam, and the beam concrete is cast into the whole with the original foundation wall. Before injecting the concrete, we will grind and clean the original foundation and apply a layer of concrete interface agent to increase the adhesion of the new and old concrete foundation. For the widened part, the foundation is laid with the same rammed layer of thickness and material as the original base layer (Figure 14,15).

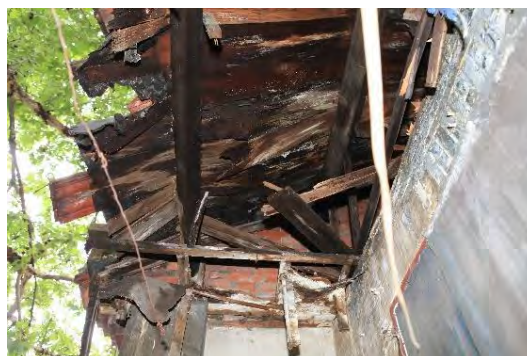
Secondly, the wood components are extensively damaged. The wooden components of Nanjing's historic residences include wooden doors and windows, wooden stairs, wooden slabs, wooden trusses and some of the roofs on them. The climate in Nanjing is rainy and humid, suitable for the survival of termites. Therefore, the common problem faced by these wooden components is that they are easily destroyed by termites, which causes the decay of wood. The doors and windows are prone to cracking due to long-term rain and sun exposure. A large amount of windows and doors were damaged, fell off and leaked air. This has led to a significant reduction in the insulation and thermal insulation properties of the building, making it difficult to meet modern use needs. The roof of some buildings leaked, causing the wooden trusses and the boards above them to rot (Figure 12).

Figure 12 The roof of some buildings leaked r. (Image source: photographed by the author)

There are two main problems with the roof truss. First, the wood is partially decayed due to the foraging of termites and the leakage of rain. Secondly, the iron pieces connecting the nodes are loose and rusted (Figure 21). We try to preserve the original wooden roof truss system (Figure 22) and replace the damaged wooden components. First, identify and replace the damaged components, completely re-form according to the size, process and materials of the original components, and then strengthen the joints with steel bolts, etc., and finally carry out termite anti-crack treatment.

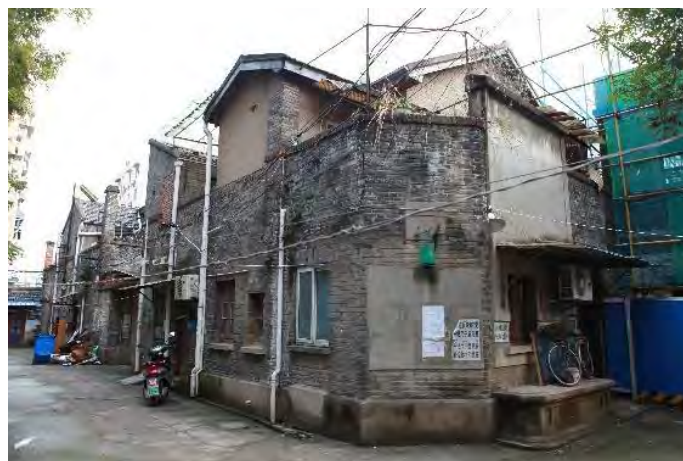
Thirdly, the buildings lack the infrastructure needed for modern living, such as air conditioning system, water supply and sewer pipes, sewage pipes, power systems. These residences were originally built without an air conditioning system, because at that time the air conditioner was just invented and China imported very little. Nowadays, air-conditioning is an indispensable equipment in the building. The air-conditioning installed by the residents not only destroys the historical features of the building, but also creates greater harm to the fragile wall. Some residences were originally designed for one family but later distributed to many families for use together. Therefore, a lot of toilets and kitchens have been added, and a lot of water pipes and wires have been added. The exposed pipes have negative impacts on the historical features of the buildings (Figure 13). Lastly, many residences also had illegal construction issues. In recent 60 years, because many families live together in one residence, users changed the interior of the building. The integral structure of the building was damaged and the internal functions were altered drastically.

Figure 13 The exposed pipes have influenced the historical features of the buildings. (Image source: photographed by the author)

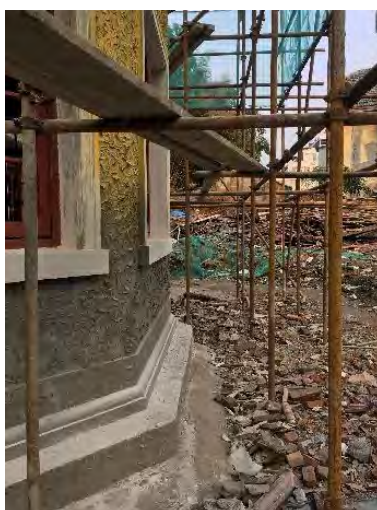
Figure 14 The building foundation that has been reinforced. (Image source : photographed by the author)

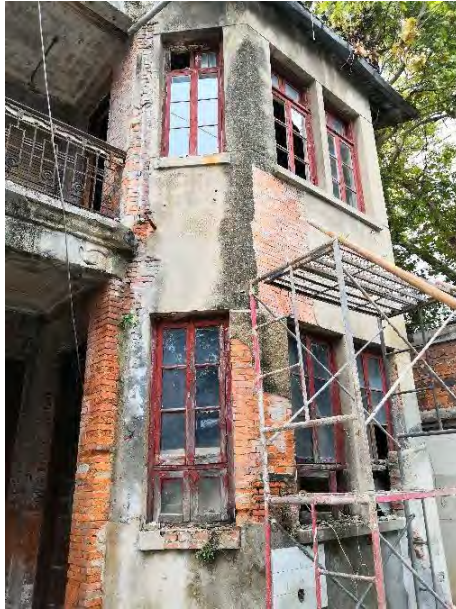
Figure 17 Carefully peeled off the cement mortar and restored the historical appearance (Building No. 2, image source: photographed by the author)

The exterior wall of the building was originally a clear red brick wall. Later, when the residents were repairing the building, they were painted with cement mortar to cover the original wall. In the repair, we carefully peeled off the cement mortar and restored the historical appearance of the building (Figure 17). Some bricks on the surface of the wall have been powdered and damaged due to long-term weathering. Our severely damaged bricks are partially removed, replaced with old bricks of the same material, and integrated with the original wall.

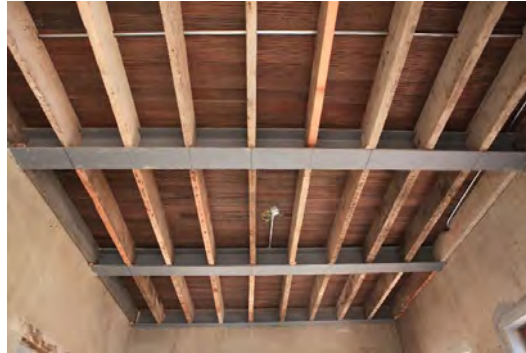
Figure 19 Replaced the original wooden beams with I-beams (Image source: photographed by the author)

Since the building will be used for commercial purposes after repair, the load on the floor is greatly increased compared to the original. We replaced the original wooden beams with I-beams (Figure 19,20), re-laid the original wooden keels between the steel beams, laid the original wooden floors on the log keels, and laid the original diagonal supporting wooden members between the wooden keels. The steel beam is placed inside the wall and bonded with cement mortar. In order to achieve the best effect of the added steel beam, special reinforcement must be applied to the joint between the steel beam and the wall. Otherwise, the brick wall may produce a large crack before the steel structure begins to function.

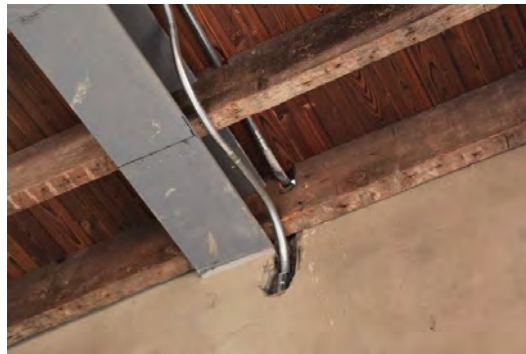
Figure 20 The steel beam is placed inside the wall and bonded with cement mortar (Image source: photographed by the author)

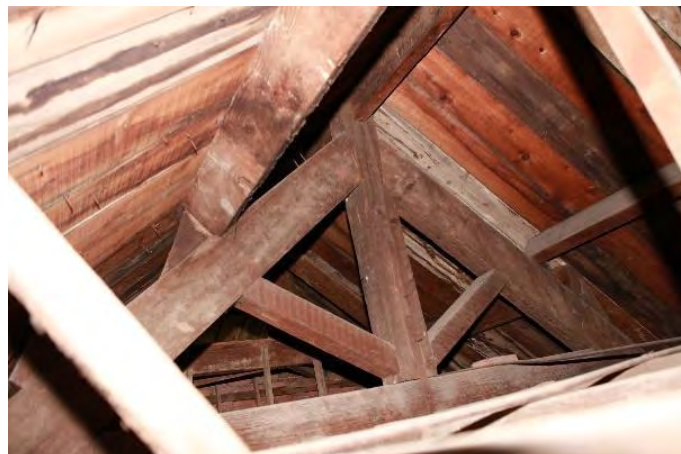
Figure 21 Roof truss of building No.2 before conservation (Image source: photographed by the author)

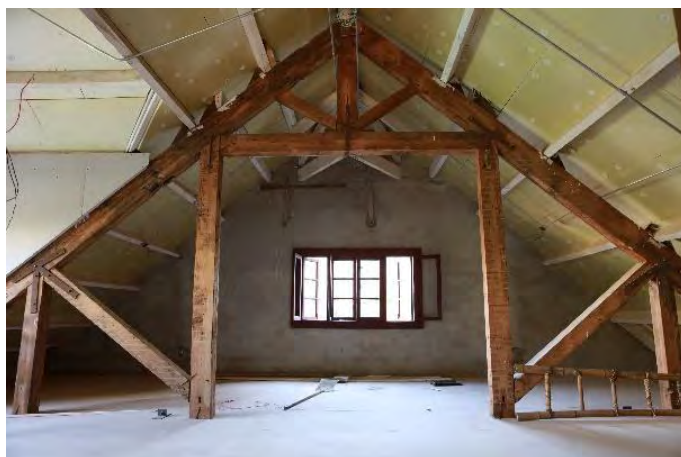
Figure 22 Wooden roof truss system of building No.2 during conservation (Image source: photographed by the author)

The building slope roof is supported by a wooden truss, the wooden board is placed on the roof truss, and the tile is directly tiled on the board, generally using clay tiles. There are two main problems in this way: first, the thermal insulation performance does not meet the current requirements, and heat loss will quickly occur. Secondly, the rain and penetration resistance is weak, and the waterproof property of the building is achieved only by the physical properties of the tile itself.

We added a layer of insulation to the board, and the insulation used 4cm of high-density polystyrene insulation. The specific construction method is to lay a layer of high-performance modern coil waterproof material on the wooden board, and then make the insulation layer. After the insulation layer is completed, a layer of waterproof material is laid on the insulation layer, and the wood strip is applied on the wood. Hang the tiles above the wood strip. Through this approach, problems such as moisture, water, leakage, and heat insulation can be better solved.

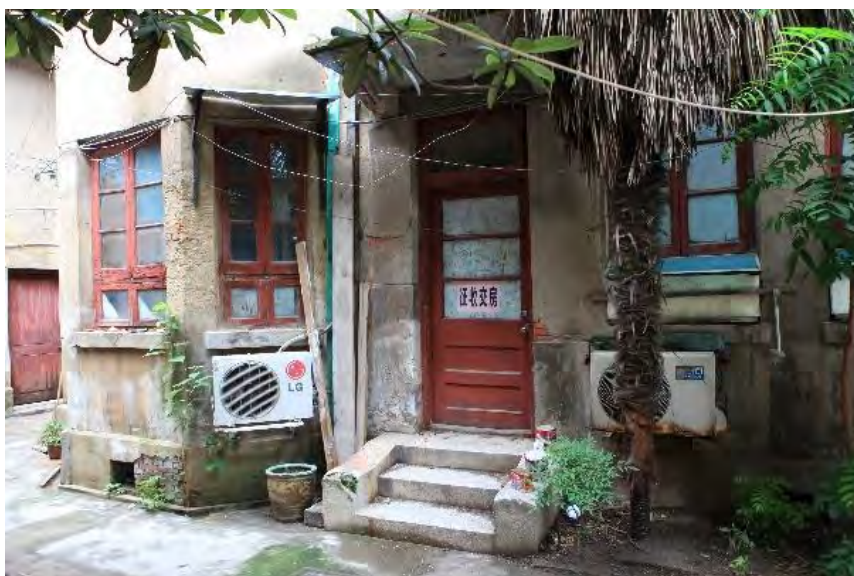
Since the fireplace has been unable to adapt to modern living requirements, the vast majority have been left unused by the residents. Residents installed a lot of air conditioners, and the placement of outdoor units had become a problem (Figure 23). Since the outer wall of the building is brick wall. After years of use and weathering, its strength is relatively weak. The residents fixed the air-conditioner outside the building directly on the outer wall of the building, which caused great damage to the building, which was not conducive to building safety or aesthetics.

Figure 23 Residents installed a lot of air conditioners before conservation (Building No. 2, image source: photographed by the author)

So we removed all the small air conditioners that were added, used a central air conditioning system, and repaired the damage of the wall. Place the outdoor unit of the central air conditioner on the outside of the building. When conditions permit, it can be placed under the adjacent window sill, or in the flower bed, to make appropriate enclosure shielding, without affecting the structural system of the building itself.

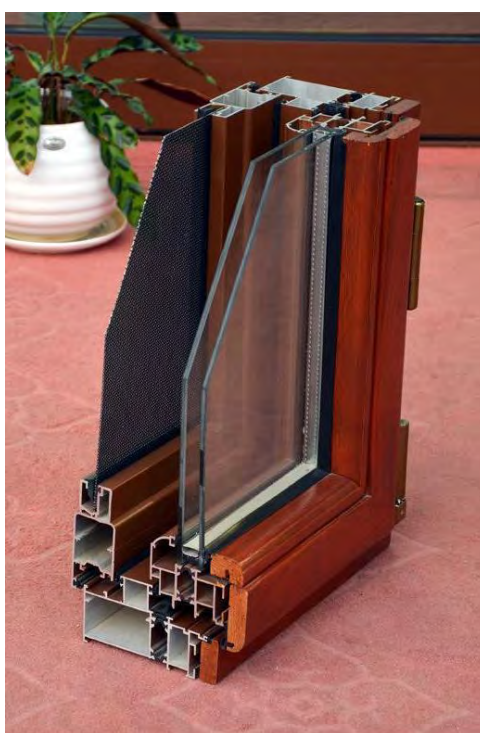
Figure 24 Aluminum-wood composite window

Nanjing's near-modern residences use a large number of wooden doors and windows, taking wooden doors and windows as an example, generally single-layer glass, usually glass thickness of 3mm-5mm, wooden window frame. The problem of this external window system is very obvious. Its heat insulation and heat insulation performance are very poor. After years of use, the window has many cracks, which leads to air leakage. We replaced the wooden window system with a modern Aluminum-wood composite door and window system, and the outer layer is made of wood-wrapped aluminum alloy, making it a historical style (Figure 24). This window uses double-layer insulating glass, a glass thickness of 6mm, a hollow layer of 8mm-10mm, plus another 6mm of glass. The thermal insulation performance of this kind of window is greatly improved compared with the wooden window, which can meet the requirements of China's current building codes, while maintaining the appearance of historic buildings.

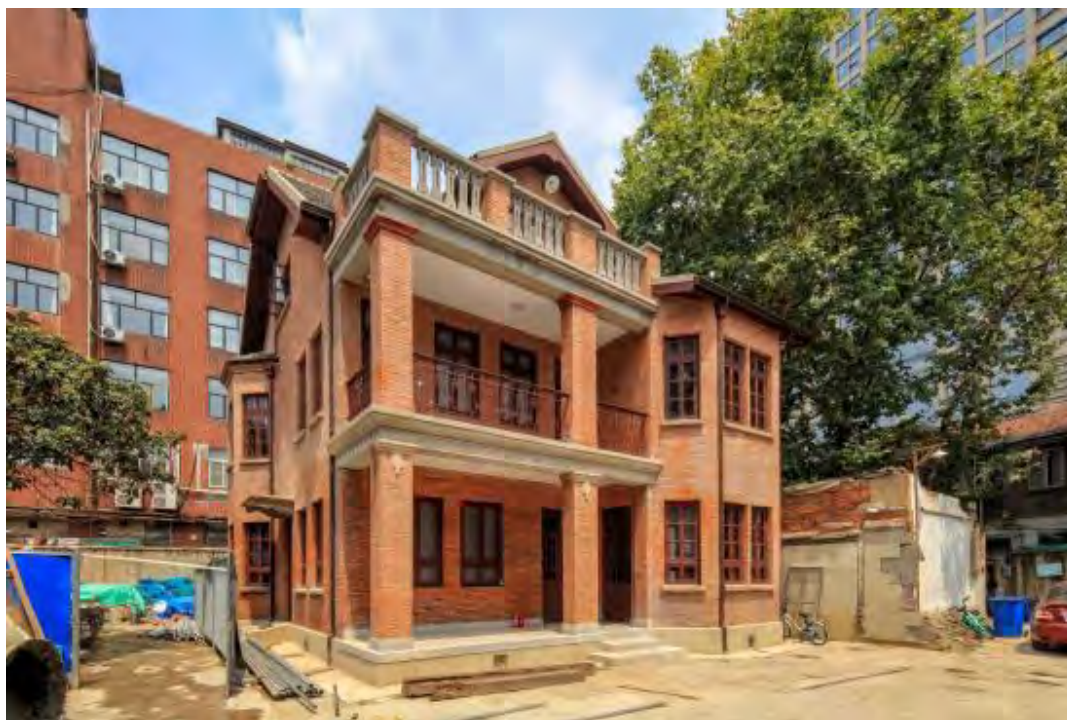
Figure 25 Building No.2 after conservation (Image source: photographed by the author)

For the overall appearance and features of West Cabbage Garden area, restoration methods are taken to restore its original appearance, so that its value is preserved (Figure 25) . From a perspective of the city, the exhibition and restoration of West Cabbage Garden area, as a landmark, could promote the city status, and well preserve the historical value, scientific value and architectural value of the residences. Although West Cabbage Garden area is situated in a new city area and surrounded by many new buildings, the outstanding features of West Cabbage Garden could still bring profound historical memories to people.
