A Preliminary Structural Survey of Heritage Timber Log Houses in Tonsberg, Norway

A PRELIMINARY STRUCTURAL SURVEY OF HERITAGE TIMBER LOG HOUSES IN TØNSBERG, NORWAY

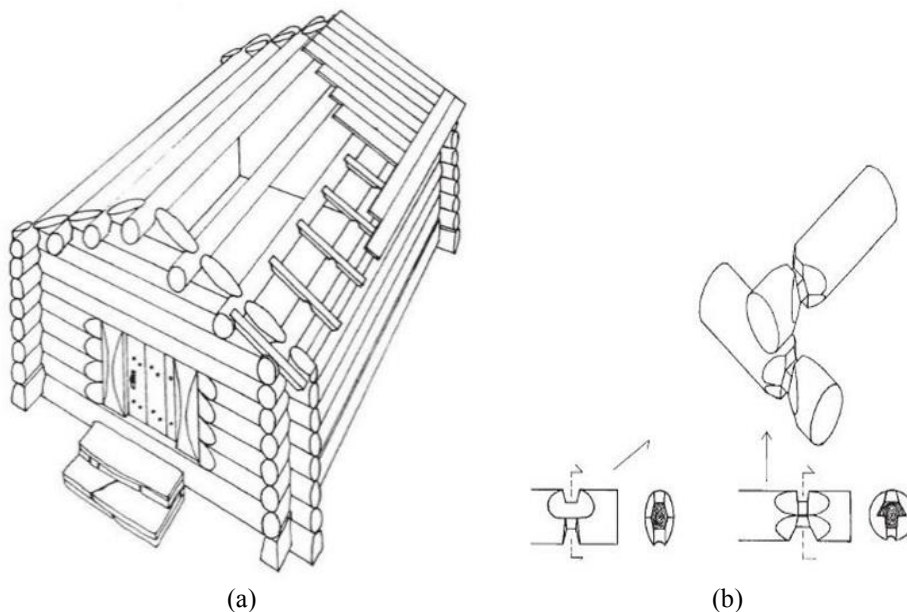
Figure 1: (a) Typical Log house schematic view, (b) Typical log house corner connection detail [2]

Log houses are one of the ancient timber structural systems. In a log house structural system, the horizontal timber logs are laid on top of each other and the stability of the structure is provided by the corner joints where the wall planes interlock, as illustrated in Figure 1. The log house system is used in northern European countries and in the central Alpine region, which also extends into several eastern European countries. The technique can also be seen in Japan, China and North America. The low heat conductivity of wood is taken advantage of in this structural technique for high insulation of the building, which is very important for countries with harsh winters [2].

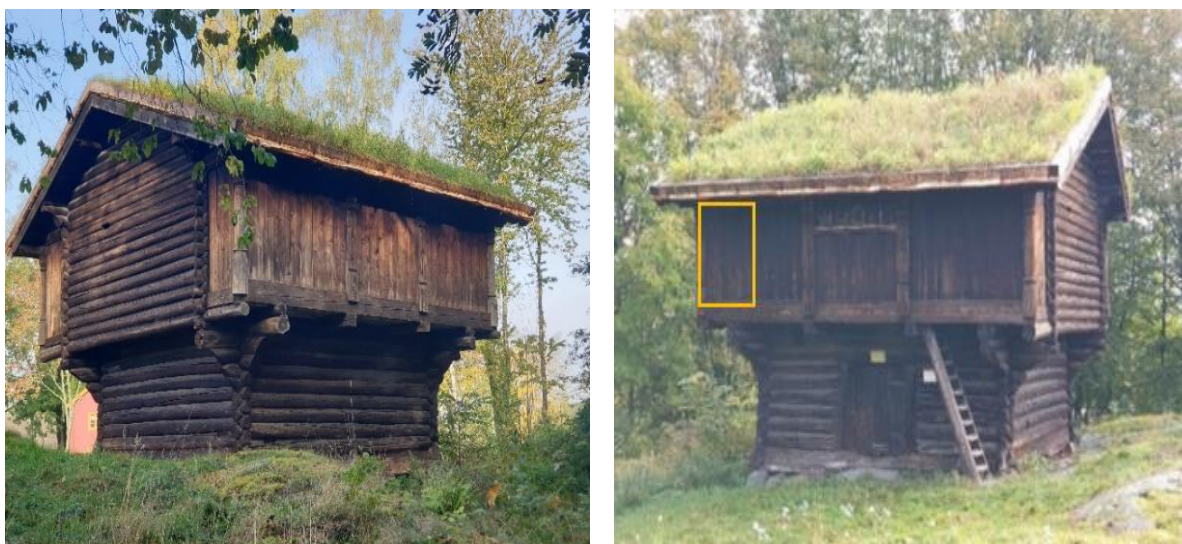
Figure 3: Heierstad Loft case study from two different views

The building has a rectangular plan measuring about 8×9 metres, and a total height of about 9 metres. It is built (logged) of large softwood pine or spruce logs, with a simple gable roof construction. The roofing material is traditional, consisting of coarse wooden boards, a layer of birch bark and turf. The exterior surface has been treated with tar. Two views of the building and details of the roof and connections are shown in Figure 4.

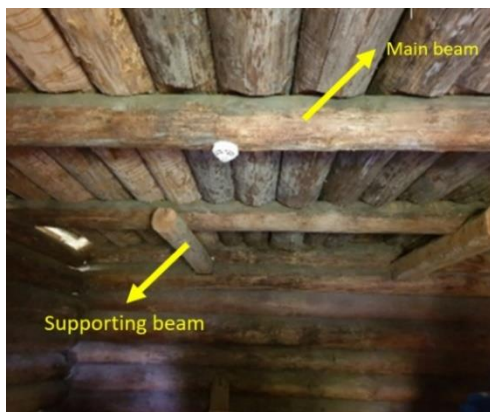
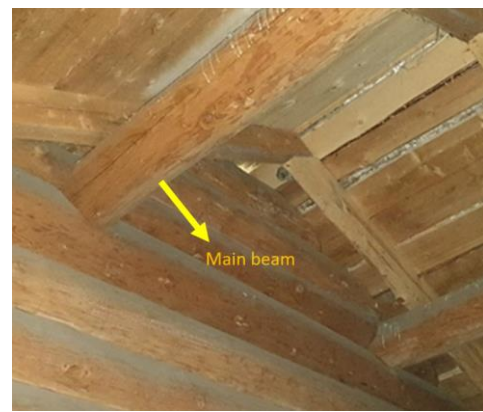
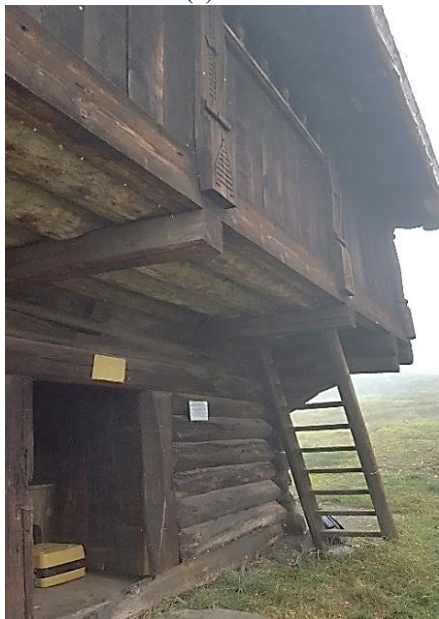
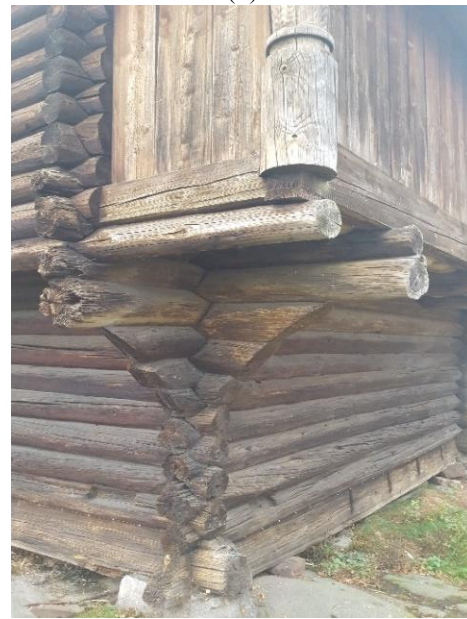
Figure 4: (a) Connection details inside the building for the 1st and (b) 2nd storey roof, (c) structural details of the 2nd floor system, (d) connection detail of the corner joint

As it is illustrated in Figure 4(b), two supporting beams are employed, and the main beams are laid orthogonally on them. All the roof system's timber logs of the second floor are laid orthogonally on the main beams. However, due to the lower dead and live loads on the second roof compared to the first roof, the supporting beams have not been utilised and the roof system's logs are laid on the main beams as it is shown in Figure 4(c).

The area of the second floor is more than the first floor. As it is illustrated in Figure 4(d), this issue can lead to overturning of the building and in order to tackle with this risk, the main beams of the first floor are continued and as it is shown in Figure 4(e), upper logs are longer in the corner joints.

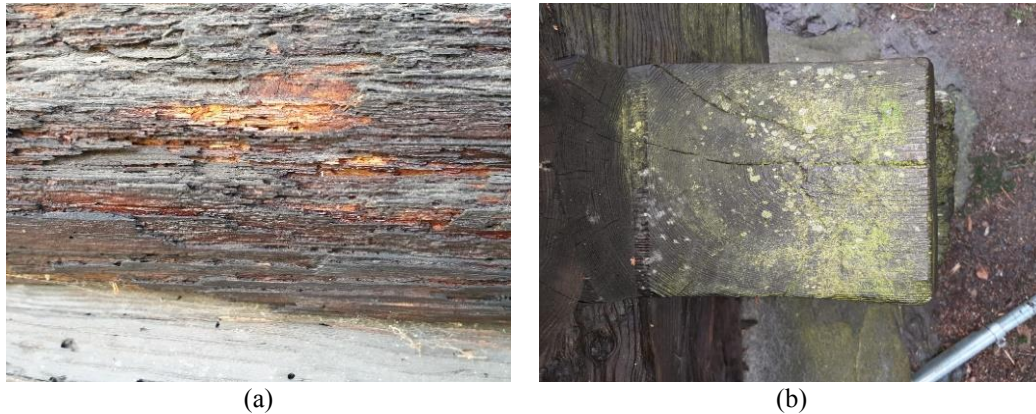
The building is in good condition in general, but it requires continuous maintenance. The most relevant degradation factors are general weathering, high humidity levels, biological decay (see Figure 5) and foundation settlement.

Figure 5: Biological defects in Heierstad Loft

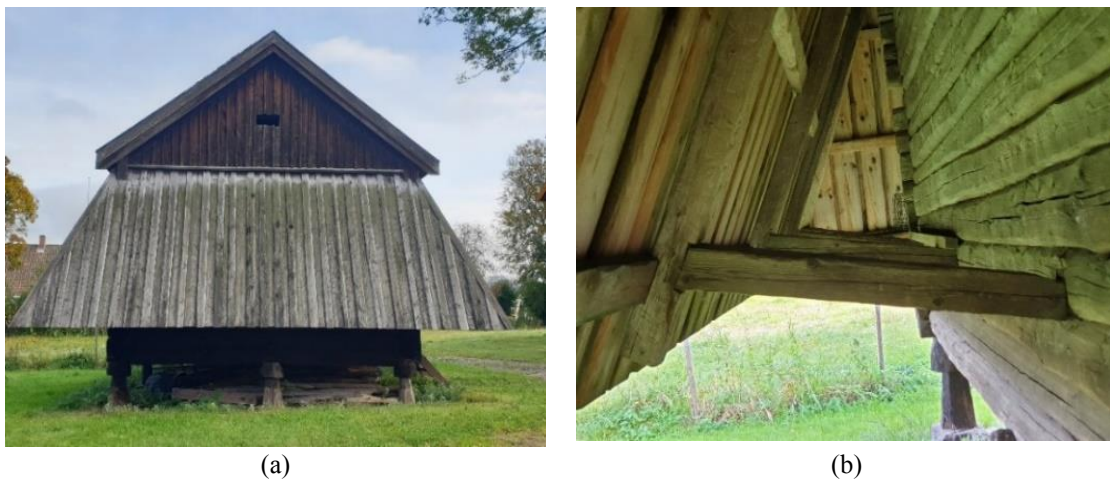
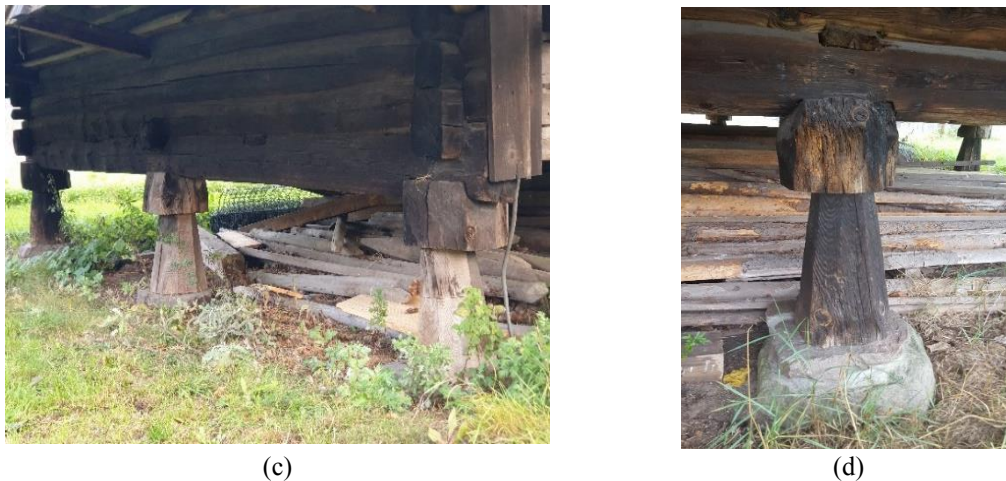
The building and its structural details are shown in Figure 6. As it is illustrated in Figure 6(d), the floor system is laid on the short timber columns which are on stone foundations. The main surrounding beams of the floor are simply connected to the columns without any constraints for rotation.

Figure 6: (a) Fadum Storehouse view, (b) Structural detail inside the coating, (c) Timber short columns under the building, (d) detail of the simply connected timber column

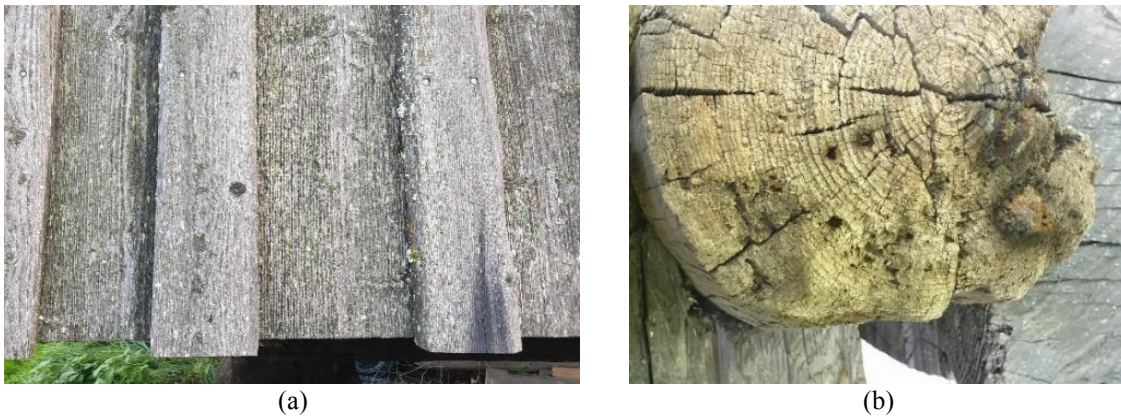
This building is generally in good condition but some deflection in main surrounding beams can be seen as well as biological damages Figure 7 shows some of the biological damages in logs and on the coating.

Figure 7: (a) Lichen attack to the coating, (b) Insect attack on the timber logs

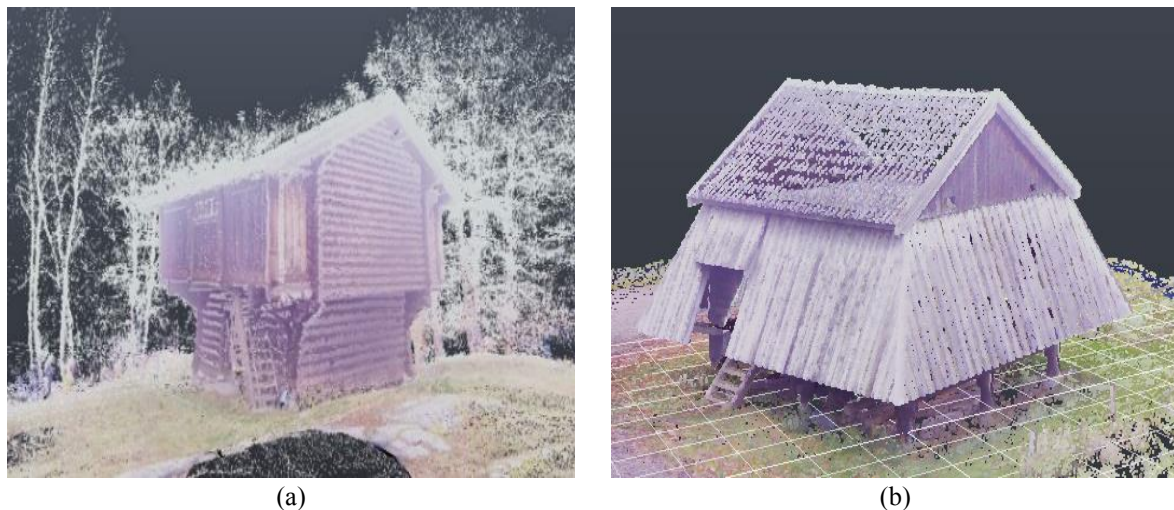
When utilising ReCap to perform the registration process, it was not possible to achieve fully automatic merging, and a manual approach was therefore chosen to complete the process. Based on this, at least three common points in two sequential scans were picked up to execute the registration and to obtain good merging results. Throughout this process, all the labelling rules and notes used in the field were taken into consideration in order to select the right scans to be merged together. The result is shown in Figure 8 for the two case studies.

Figure 8: Raw point cloud data for (a) Heierstad Loft, (b) Fadum Storehouse

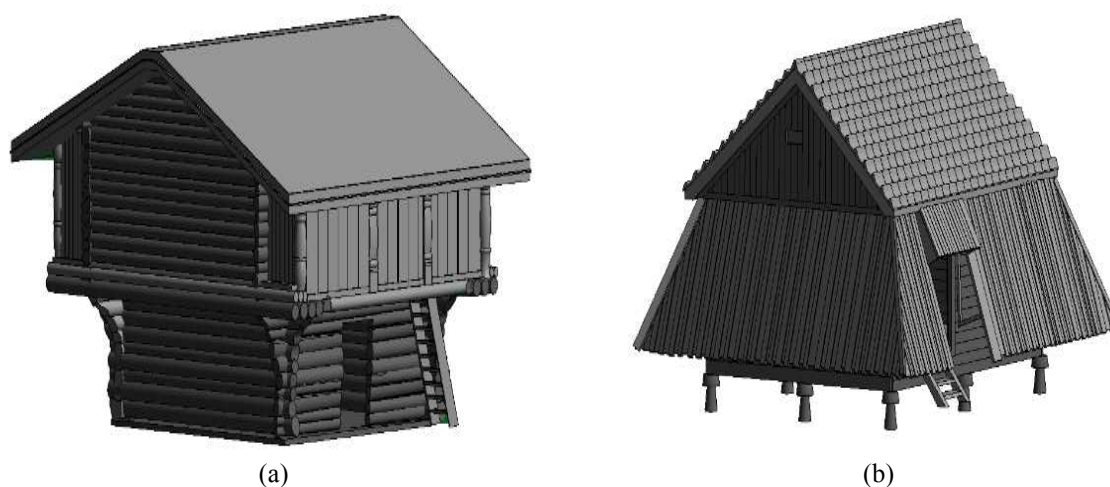
seen in Figure 9, the number of logs and their thickness have been identified and precisely depicted in the BIM file.

Figure 9: BIM drawing files of (a) Heierstad Loft, (b) Fadum Storehouse
