TECHNOLOGICAL METHODS OF PREVENTING SLOPE ANGLE VIOLATIONS IN THE MINE. MEASURING SLOPE ANGLES.

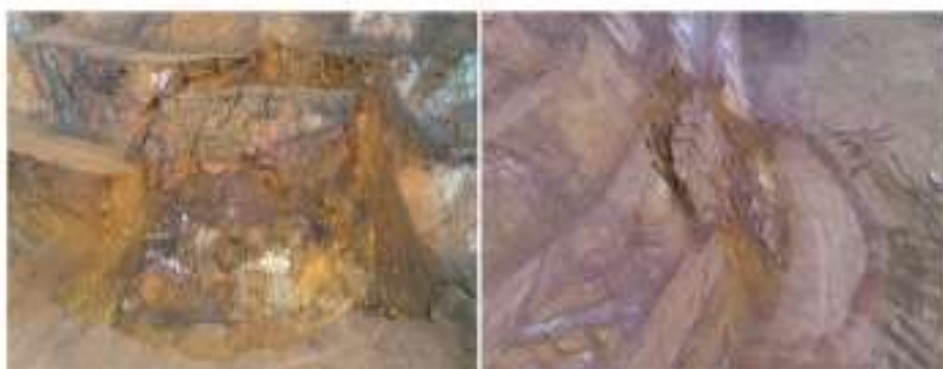
Fig. 3. Aerial reconnaissance of planar sliding failure mechanism at BHP mine.

The 24 m high planar failure in Fig. 3 was back-analyzed to refine the original geotechnical design shear strength parameters to enable add rigor to the geotechnical model and enable better prediction of future ground behavior as mining continues. The 3D LE model was developed such that it is spatially large enough to enable subsequent re-evaluation of future pit slope stability and alternative designs, if required. The updated geotechnical model including the location and orientation of the failure plane (shale bedding) and updated stratigraphic wireframes derived from UAV photogrammetry were utilized in the 3D LE back-

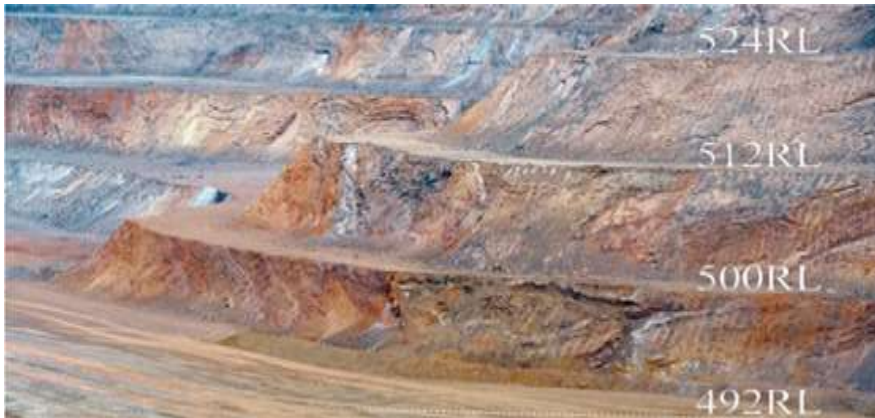
Fig. 6. Pit slope with initial 8 m high failure contained within a rock fall catchment bund on 26 October 2019–pit floor 492 RL

Also visible are several areas of local bench crest losses. Excavations progressed vertically downward 8 m (pit floor 492RL), undercutting a pervasive shale band and initiating a bench failure as shown in Fig. 6. Further excavation, vertically downward 4 m (pit floor 488 RL) was successful in extracting ore and achieving the planned pit design; however, further deterioration of the initial bench failure was observed. Failure propagation was evident on 26 November 2019 as shown in Fig. 7. The rate of failure may have been exacerbated by 0.8 mm of rainfall that occurred on 27 November 2019, resulting in the 24 m high failure shown in Fig. 8.

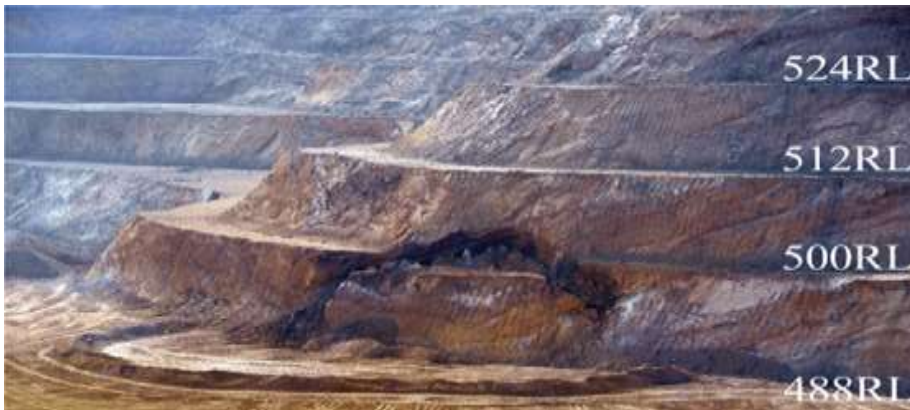
Fig. 7. Pit slope failure propagation to 15 m high contained within a larger failure catchment bund on 26 November 2019–pit floor 488 RL.

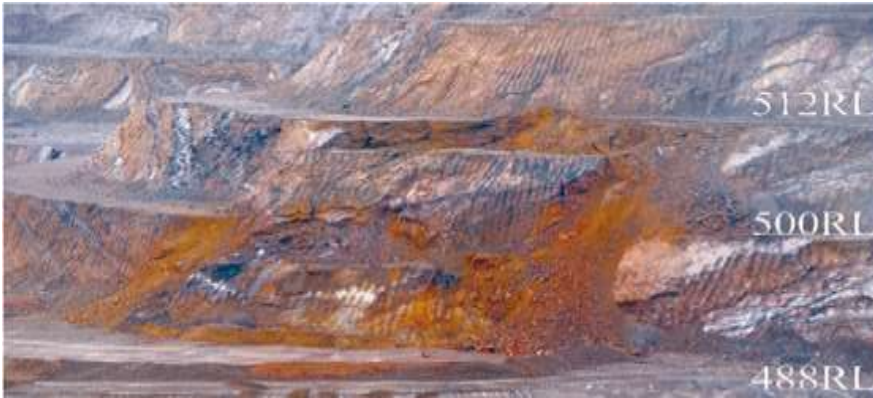
Fig. 8. South wall failure propagation to 24 m high on 27 November 2019–pit floor 488 RL specific drilling and laboratory testing provide a means of assessing variation in shear strengths and material density. Slope stability analyses are undertaken considering the effects of anisotropy: (1) bedding scale anisotropy can and should be modelled using directional shear strength models in 2D or 3D; and (2) banding scale anisotropy is best modelled using discrete weak bands in both 2D and 3D models rather than with directional shear strength models. The use of directional shear strength models for banding scale anisotropy allows the weakness plane to appear ubiquitously in this slope, rather than at its actual discrete location. This may result in over-conservatism. Seery conceptually compared using ubiquitous directional shear strength models against discretely located shale bands within the Dales Gorge Member of the Brockman Iron Formation. Seery concluded that the directional shear strength model does not necessarily honor the geology, particularly due to the widely spaced shale bands in the Dales Gorge Member. In order to achieve an optimal slope design, it is necessary to understand the geology, and have the ability to discretely model banding scale anisotropy (i.e. discretely model shale bands) coincidentally with bedding scale anisotropy. Notwithstanding this, it remains appropriate to use a ubiquitous shale band strength model however where the position of discrete shale bands is not known. As slopes become exposed with mining progression, a detailed reconciliation process is used to validate the location of shale bands and enable a transition from a ubiquitous shale band strength model to discretely modelling banding scale anisotropy.

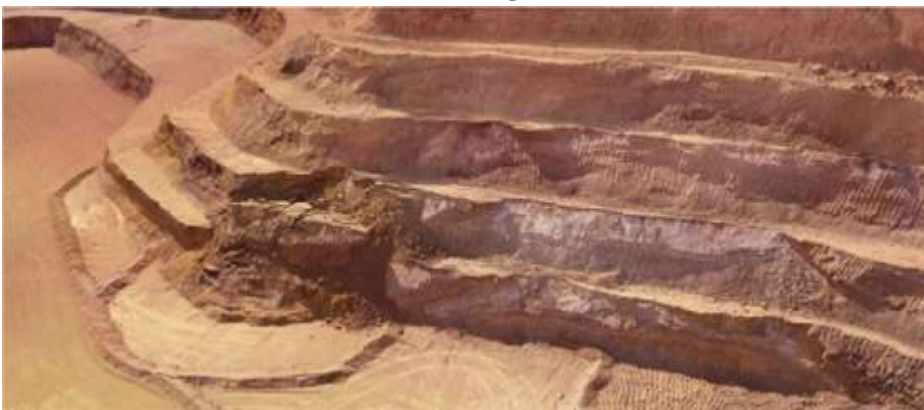
Fig. 10. 3D model developed from UAV photogrammetry with the planar failure on the left hand side near the convex slope profile. Lighter colored material on the right hand side where repetitive bench crest losses have occurred shows near-planar shale bedding planes. Shape accuracy is <math><5\text{ cm}</math> without GCP.

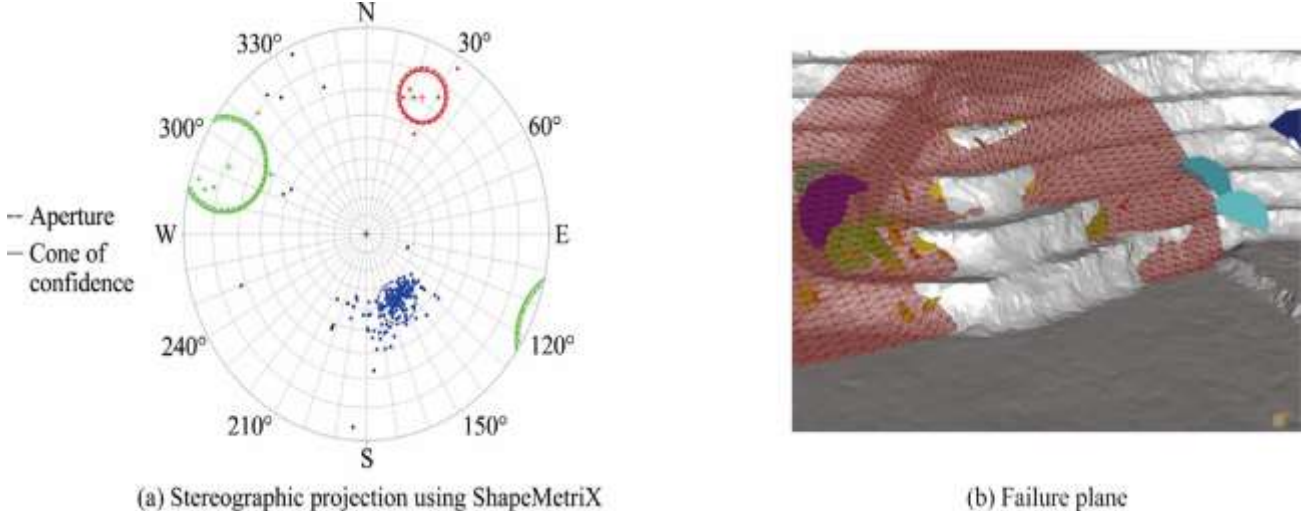
Fig. 12. Stereographic projection showing bedding planes: 40—/333 (blue) and joints: 72—/205 (red) and 79—/113 (lime) in ShapeMetriX and planar sliding failure plane (shale band) re-evaluated in GEM4D to create a wireframe mesh from utilizing the imported geological structures which are represented as colored disks. (For interpretation of the references to colour in this figure legend, the reader is referred to the web version of this article.) representation of the problem such as geometry, spatial

A total of 198 geological structures including bedding planes and joints were mapped using ShapeMetriX (Fig. 12) and imported into a 3D CAD package (GEM4D) where the failure plane was modelled as a 3D surface. The failure plane was a distinct shale band that was located near the MacLeod-Newman geological contact. The orientation, or rather, the dip of this shale

band was approximately 3—5— shallower than predicted in the pre-mining geological model, resulting in undercutting near the base of the slope (i.e. the pre-mining geological model was highly reliable).

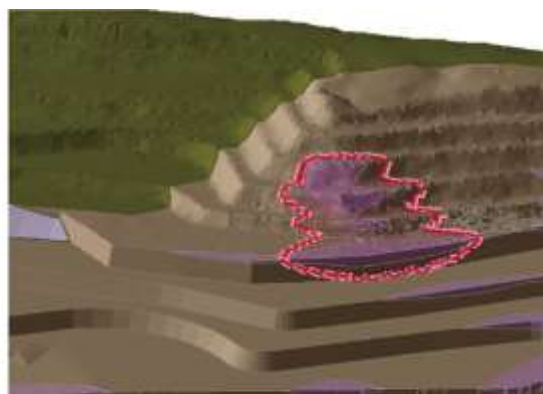
(b) FoS=1.20 for 48 m high multiple bench slope

(2) FoS = 1.20 for a 48 m high multiple bench slope was identified and complied with the DAC (Fig. 18b). Notwithstanding this, slope validation will routinely continue with mine progression to ensure that if any significant deviations to the geotechnical model are observed, they can be acted upon.
