PATA DAYS 2022: International workshop on Paleoseismology, Active Tectonics and Archaeoseismology.

Following the historical traces of the 1909 Lambesc earthquake

Field trip guide - 26 & 30 sept. 2022

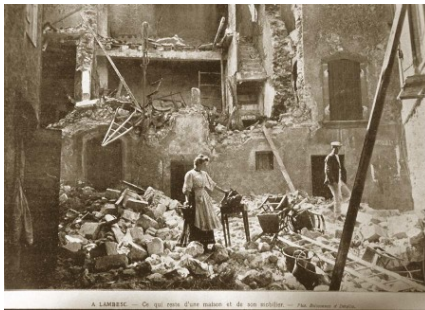
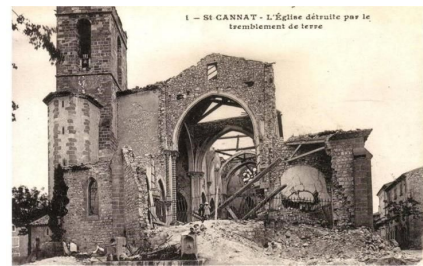
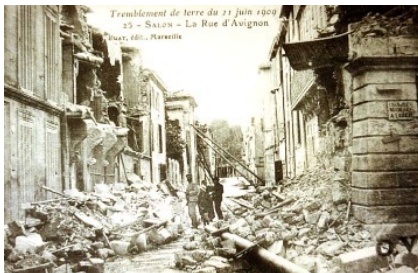
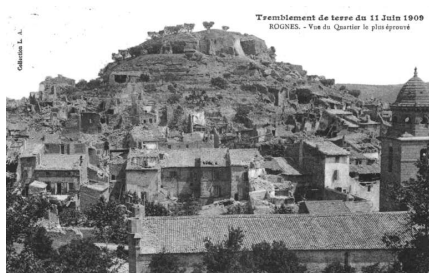
Figure 1: Postcards created from photographs of damage in the devastated villages.

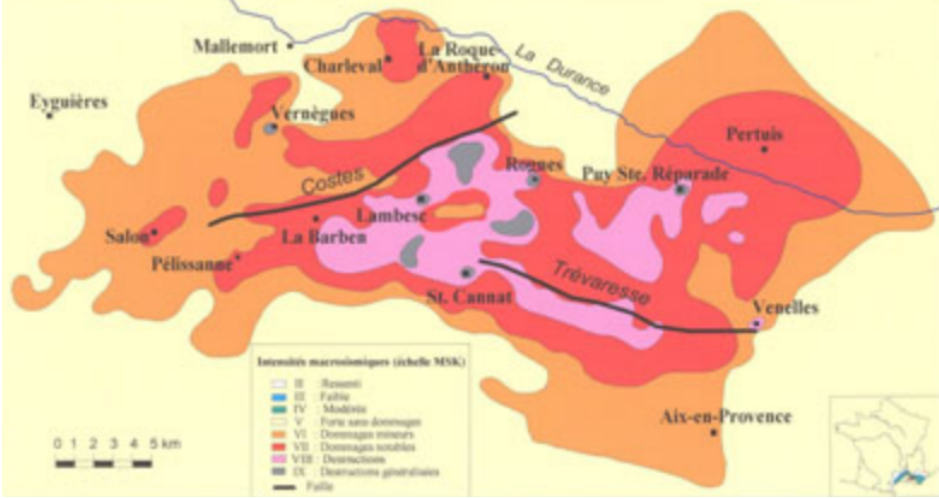
Figure 2: Distribution of the damage and location of the Trévaresse fault ([1]).

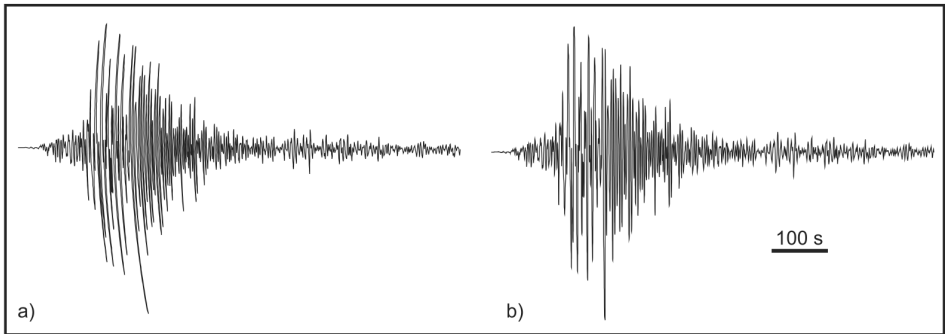
Figure 3: An example of an original historical seismogram recorded at Strasbourg; (a) before processing, (b) digitized and corrected. From Baroux et al [8].

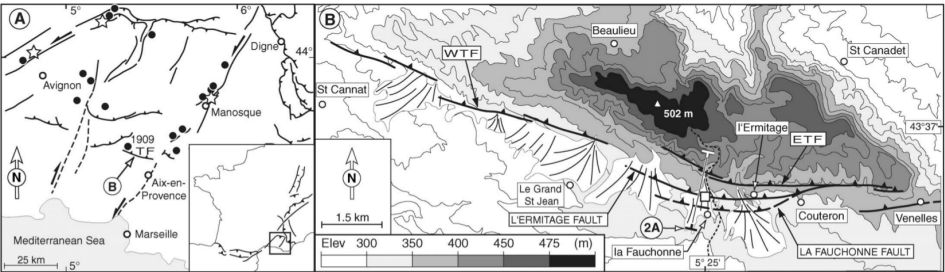
Figure 5: Figure from [14]. A: Structural map of western Provence showing $M \geq 4$ historical earthquakes (black dots; Levret et al. [12]) and sites of documented paleoseismicity. TF—Trévaresse fault. B: Map of Trévaresse ridge anticline and its piedmont showing Trévaresse reverse fault system and T2 alluvial fans. WTF, ETF—western and eastern segments of main Trévaresse reverse fault, respectively; T1 fan terraces are not shown due to their small size; thick dashed line—la Fauconne Creek.

Several trenches intersecting the Trévaresse fault (Fig. 5) helped to establish the geological history of this fault ([13], [14]).

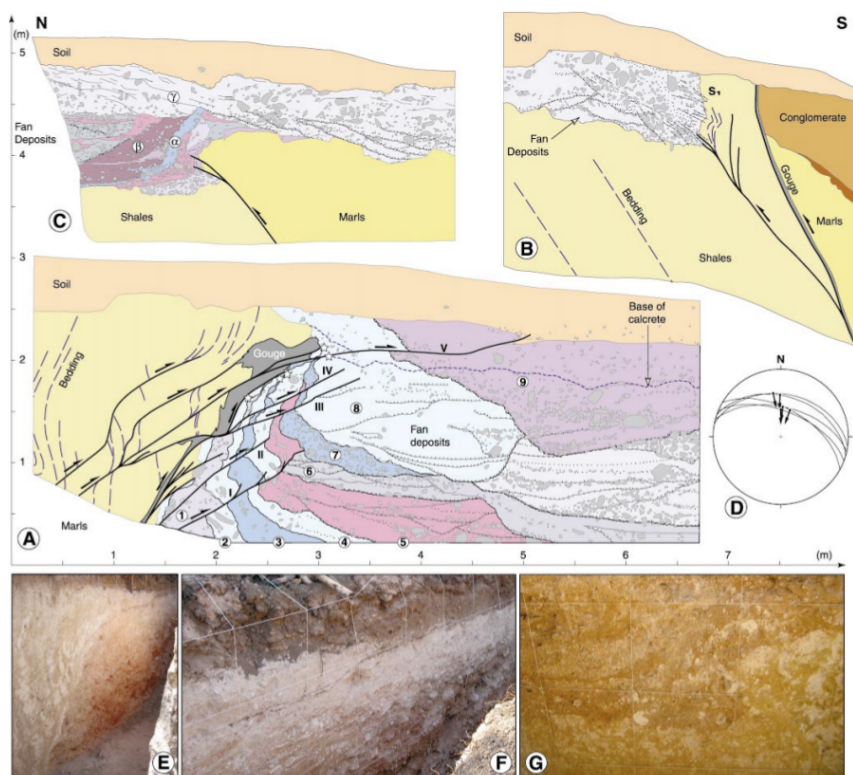
Figure 6: Figure from [14]. "A, B, and C show logs of trench located in Fig. 5. In A, I–V refer to fault splays. Sedimentary units 1–7 are colluvial wedges. Units 5 and 6 show more pronounced alluvial characters downstream. Silty-sandy unit 8 is homogeneous and shows rare channels, whereas unit 9 marks latest sedimentary discharge recognized in the trench. S 1 —cleavage. D: Coseismic striae measured on fault splays in fan material; measurements are indicated by white stars in A. E: Oblique view of l'Ermitage fault zone shown in A. F: Detail of emerging ramp of fault splay V in A showing reverse offset of calcrete duricrust and bottom of soil horizon. G: View of flexural-slip fault shown in C; grid has 50 cm mesh." [14]

These studies have shown that other earthquakes equivalent to that of Lambesc but much older (for several thousand years) had already occurred on this fault (Fig. 6).

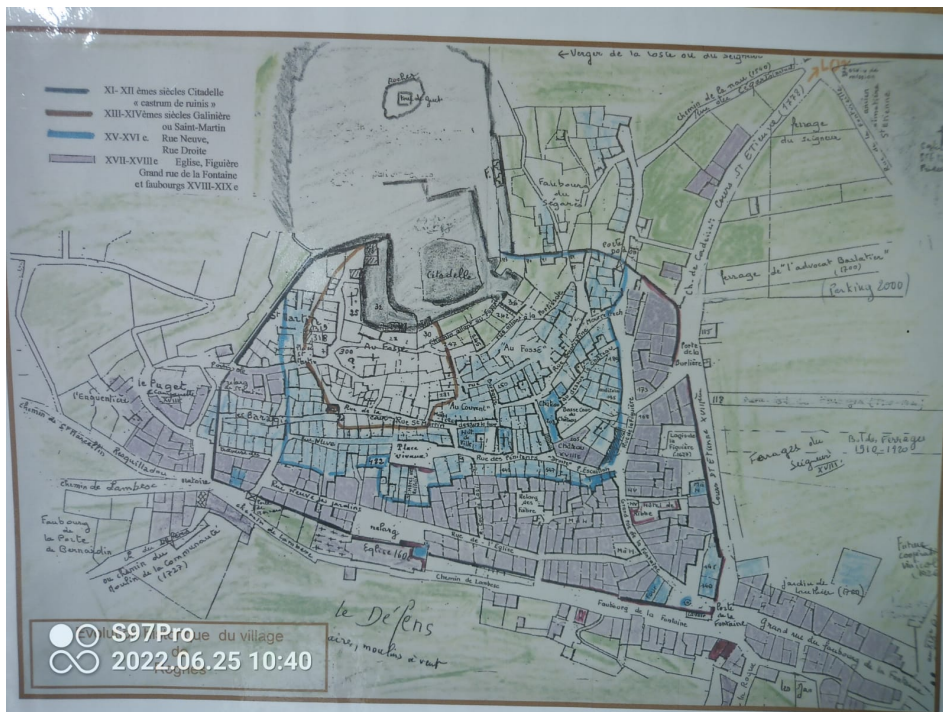
Figure 7: Historical evolution of the village of Rognes plotted on a map from 1837. Grey: district built in XI-IIth century ("castrum de ruinis"). Brown: district built in XIII-XIVth century. Blue: district built in XV-XVIth century. Pink: district built in XVII-XVIIIth century. Source: "Les Amis du Patrimoine de Rognes".

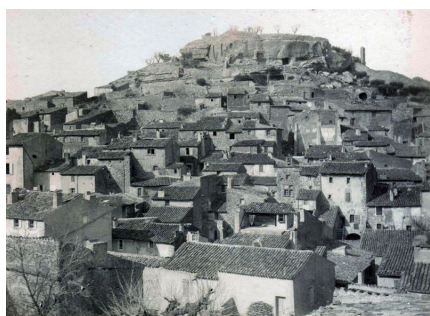
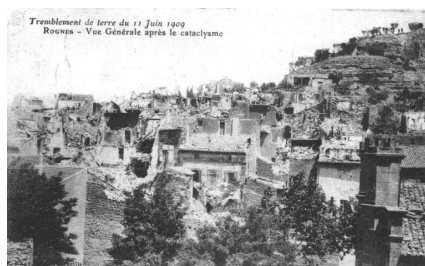
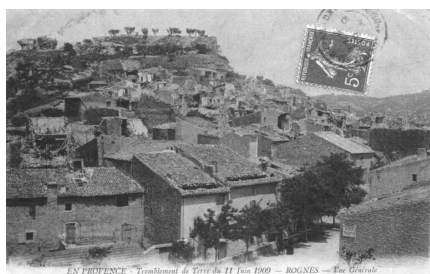
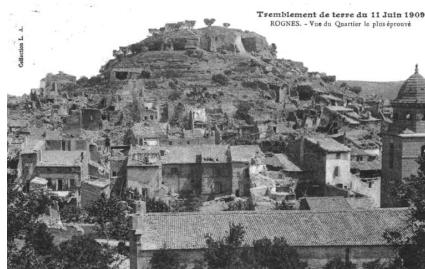
Figure 8: Postcards created from photographs of damage in the devastated Rognes. (Source: Les Amis du Patrimoine de Rognes)

In 1909, the village of Rognes was located on the side of the Foussa (Fig. 8a). The Provençal earthquake totally destroyed the houses surrounding the summit (Fig. 8b, 8c, 8d). Only a wall from the beginning of the XVIIth century is still standing. The houses located at the foot of the hill suffered less. Today the houses built on the slopes are modern, while those at the foot are traditional.

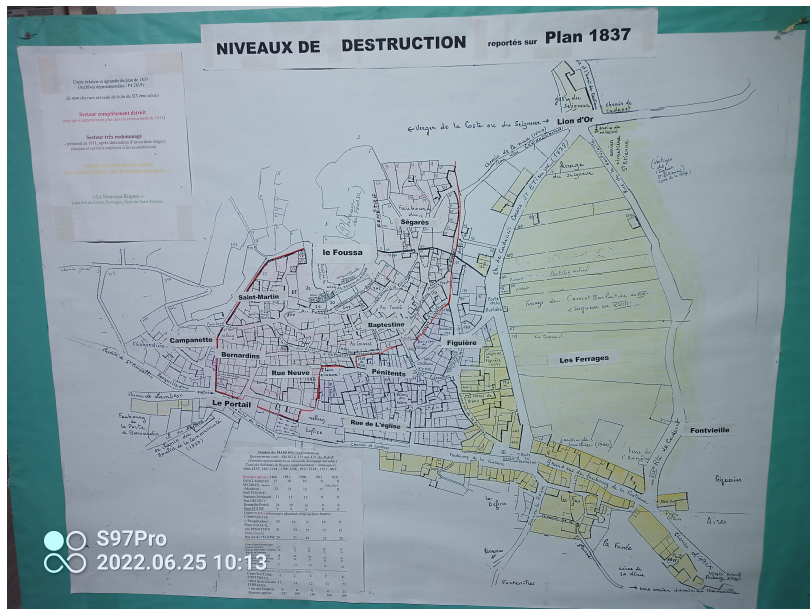
Figure 9: Distribution of the damage during the 1909 earthquake reported on a map of 1837. Red: destroyed. Purple: highly damaged. Yellow: Slightly damage. Green: rebuilt district after the 1909 earthquake. Source: "Les Amis du Patrimoine de Rognes", archives départementales: P4 2819.

Fig. 9 shows more precisely the distribution of the damage around Rognes reported on a map of 1837 (before the earthquake). The houses surrounding the "Foussa" were almost destroyed (in red). The second belt suffered significant damages (destruction of roof, in-plan mechanisms). The houses far from the "Foussa" were

more spared (yellow).

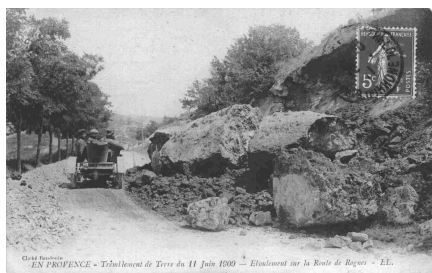
(a) Landslide along the road to Rogne.

Figure 10: Photo of Rognes before the securing operation of the military engineers. An inscription indicates the rock that will be exploded. In the center a cloud of dust indicates a house that collapses at the moment of the photo.

and stone blocs broke apart (Fig. 10a). By falling on the houses below, they have significantly increased the damage. The authorities decided to remove the last rocks presenting a risk of collapse and forbid the summit's occupation to avoid exposing the population. The rockslides that you can observe today are not those caused by the earthquake but the results of the action of the military engineers to secure the site. (Fig. 10b).

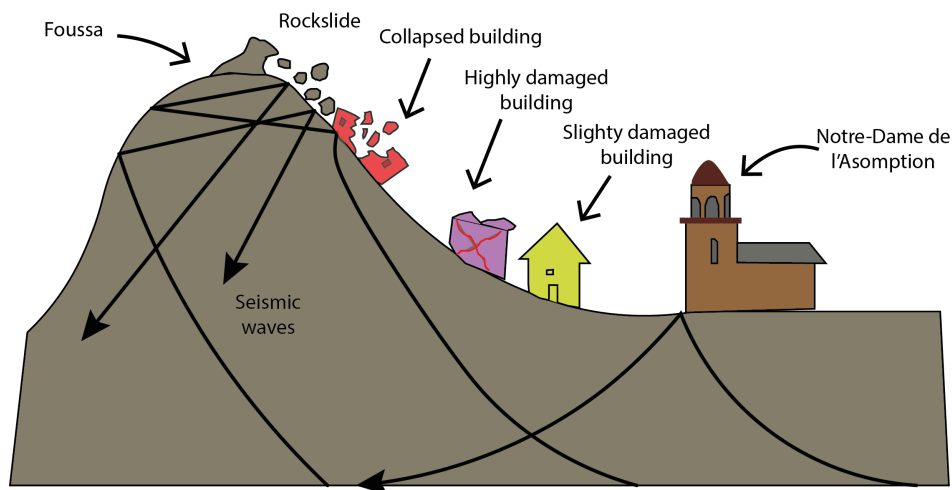
Figure 11: Illustration of the topographic site effect in Rognes highlighted by the distribution of damage.

The village of Rognes, the highest point of the massif de la Trévaresse, had to suffer even more significant damage due to its topographic configuration, which amplified the ground motion (topographic site effect, Fig. 11). High buildings

The overlapping distribution of damage to the topography and the period of construction of the buildings (older buildings in the center) shows the relationship between the different factors that led to such damage (topographic site effects, vulnerability class A/B according to EMS98).

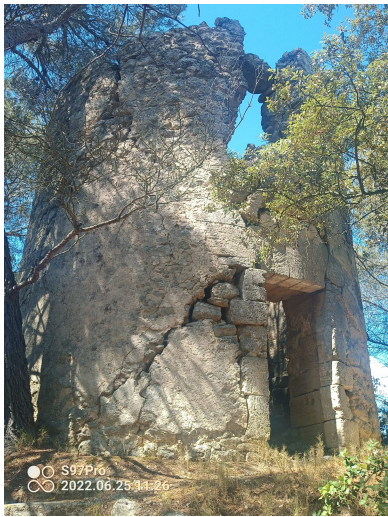
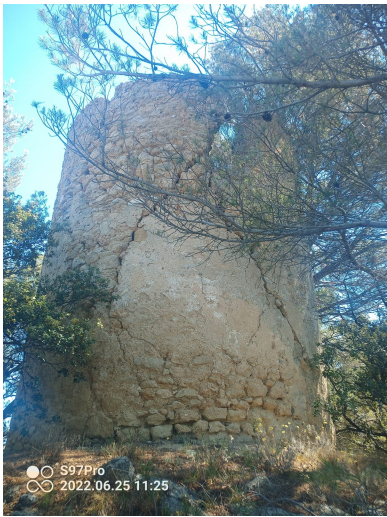
Figure 13: Photos of the Défens windmill with in-plane failure mechanisms.

Before going back down to the village to have a closer look at the buildings, let's observe a vestige that felt the 1909 earthquake. Many windmills were built in the area of Rognes (Fig. 12). Most of them were already abandoned at the beginning of the 20th century. We will stop in front of one of the mills of Le Défens (Fig. 13a-13b).

The damage observed is typical of the damage caused in Rognes during the earthquake. The wall of the windmill highlights in-plane failure mechanisms (Fig. 14) which is typical of the response of a cylindrical structure (strong wall cohesion).

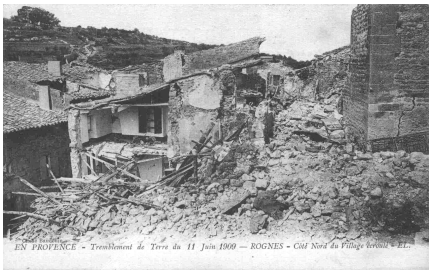
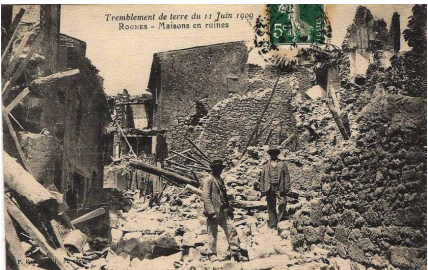
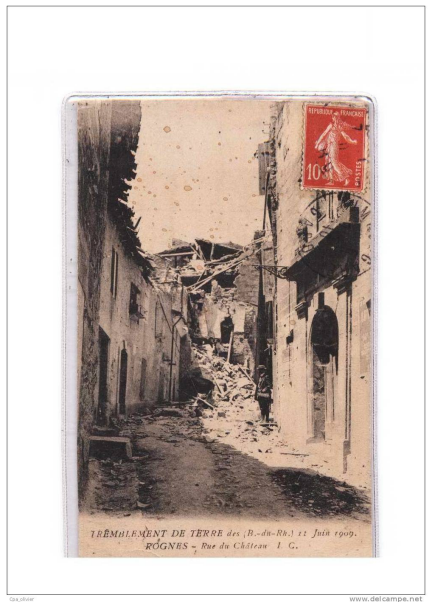
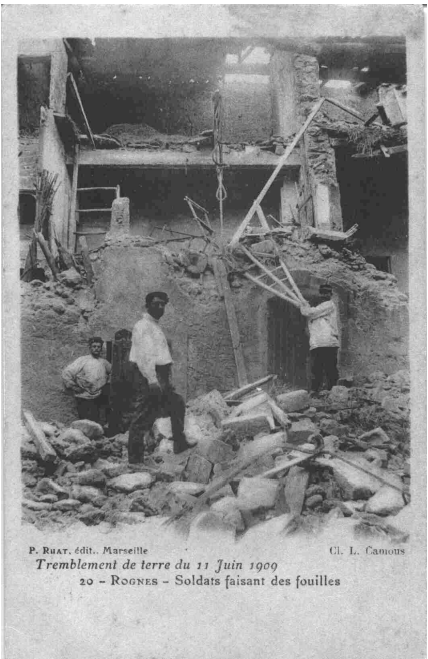
Figure 15: Postcards created from photographs of damage in the devastated Rognes.

Looking at the photographs of the damaged building, you can identify the classic mechanisms of collapse (Fig. 14). Some streets of Rognes are almost destroyed (Fig. 15a- 15b). The buildings built in the outer part of Rognes are less damaged (Fig; 15c). After the disaster, three companies of the 55th army came to help the rescuers (Fig. 15d).

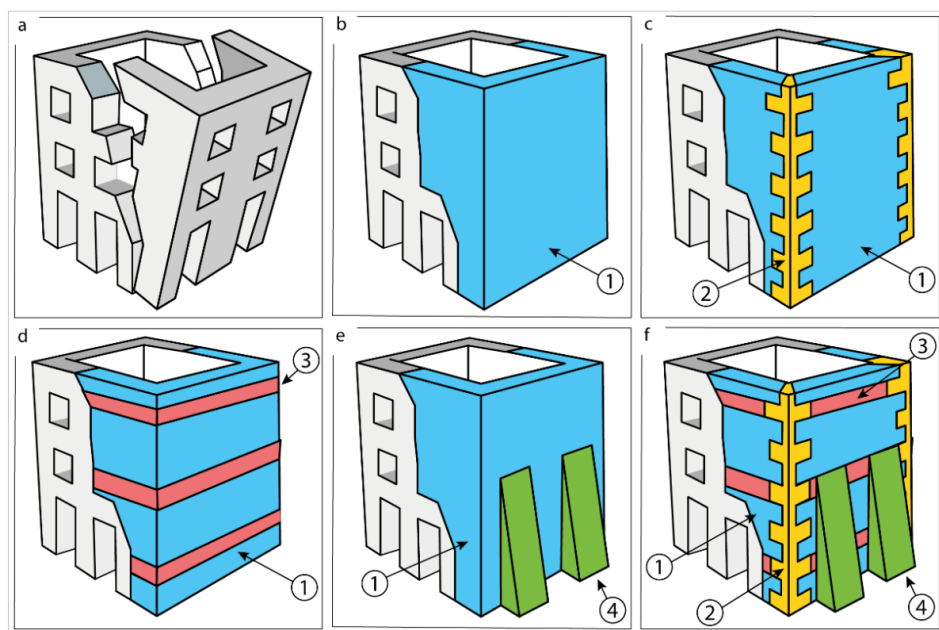
Figure 17: Repair strategies associated with overturning with two side wings (a). (b) Reconstruction strategy (element 1 in blue). (c) Corner chainage technique (element 2 in orange). (d) Brick (element 3 in red). (e) Buttresses (element 4 in green). (f) Combined repaired and reinforcement techniques.

an overturning with two side wings. A first reconstruction strategy is to build up the collapsed wall (Fig. 17-b). A second strategy is to add a corner chainage to the wall reconstruction to link the facade to the side walls and avoid a facade collapse (Fig. 17-c). A brick chainage can also be used to connect the building walls and reinforce the connection between the walls (Fig.17-d). Buttresses are sometimes added to prevent further tilting (Fig.17-e). Finally, all these seismic techniques can be combined (Fig. 17-f).

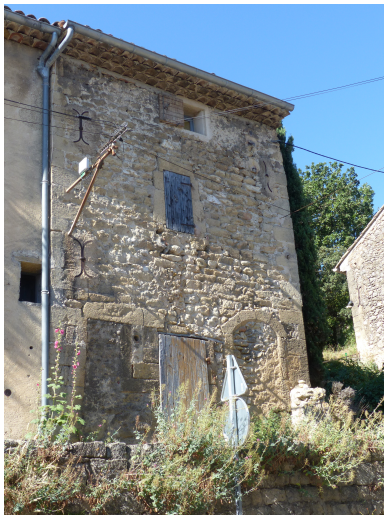
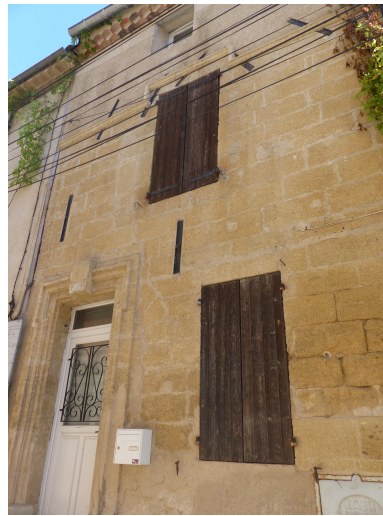
(a) Stone masonry with tie rods to link floors with the facade (Avenue de Lambesc, Rognes).

(b) Stone masonry with tie rods to link floors with the facade (Rue de l'église, Rognes).

Figure 18: Exemple of reinforcement in Rognes.

Because of the high mass of masonry building and the low quality of mortar, the problem of high compressive forces occurs in the elements of structures built from stone. The horizontal components of the compressive forces are balanced using tie rods and anchors. These techniques allow to prevent collapse under abnormal loading in static condition, or out-of-plane mechanisms (Fig. 14) induced by seismic loading. Like most of the villages in the Trévaresses area impacted by the 1909 earthquake, you will notice the presence of many ties on the facades of the buildings⁴ (Fig. 19).

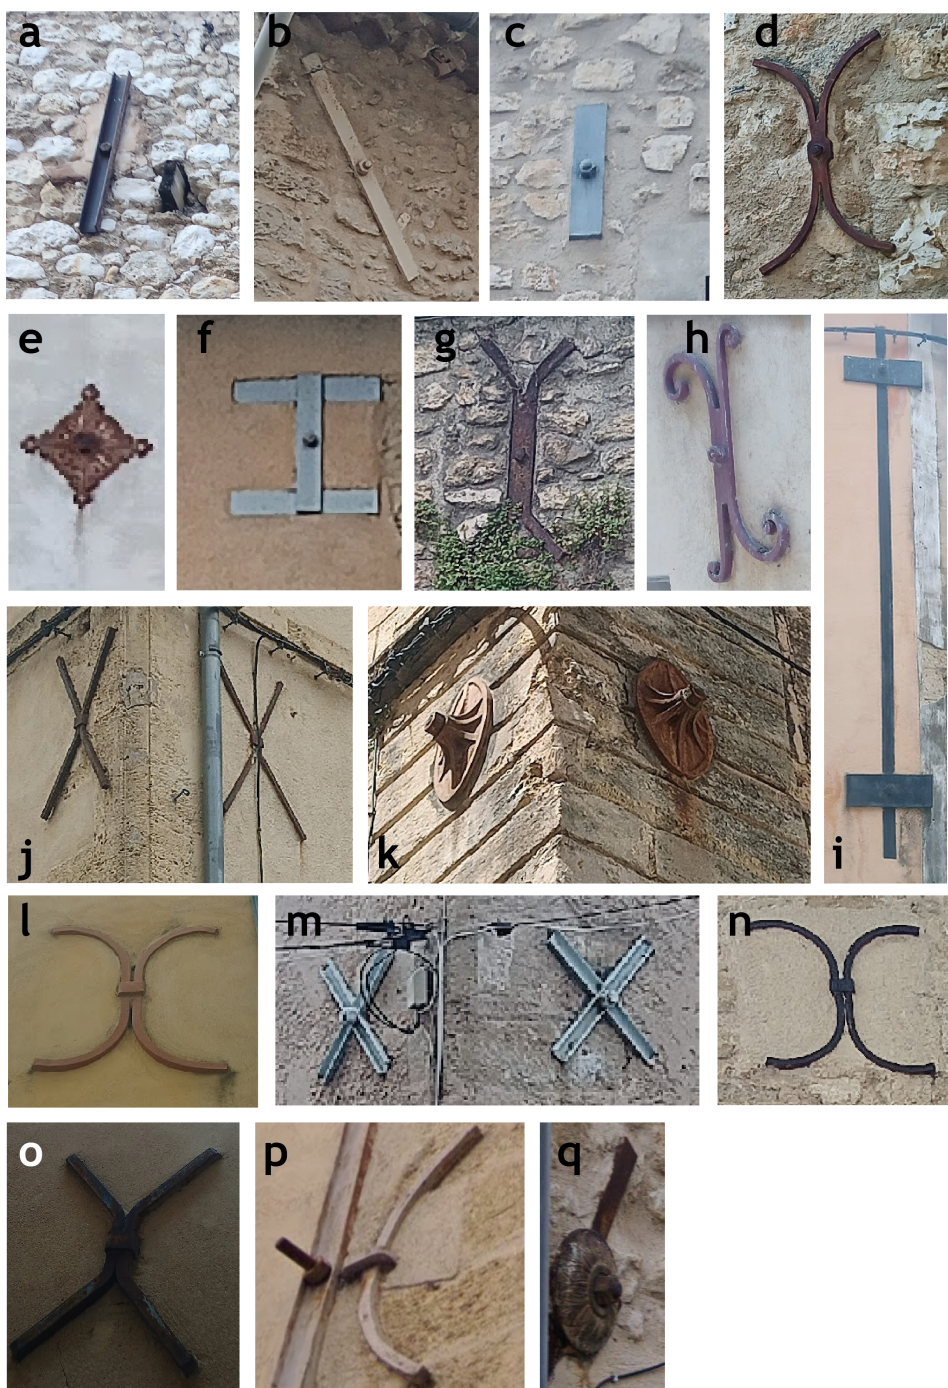
Figure 19: Typology of tie rods used in Lambesc (e, f, g, h, j, k, o), Saint-Cannat (a, b, c, d, l, m, n) and Rognes (i, p, q)

⁴The use of false ties has been identified in the region. Following the earthquake, some inhabitants installed faketic rods to receive compensation. You can distinguish them from the real ones by the absence of nuts.

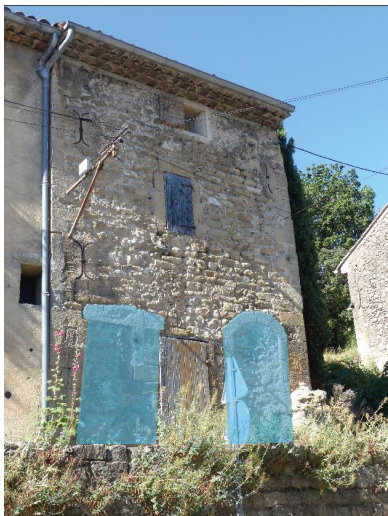
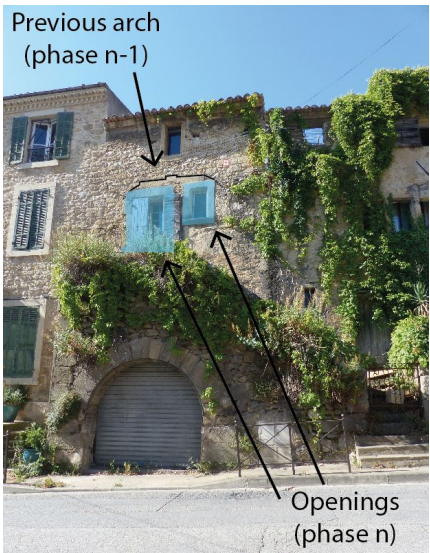
(a) Filling of two openings (in blue) close to the building corners (Rue de l'église, Rognes)

(b) Filling of a previous arch and arrangement of two openings

Figure 20: Exemple of arrangement in Rognes.

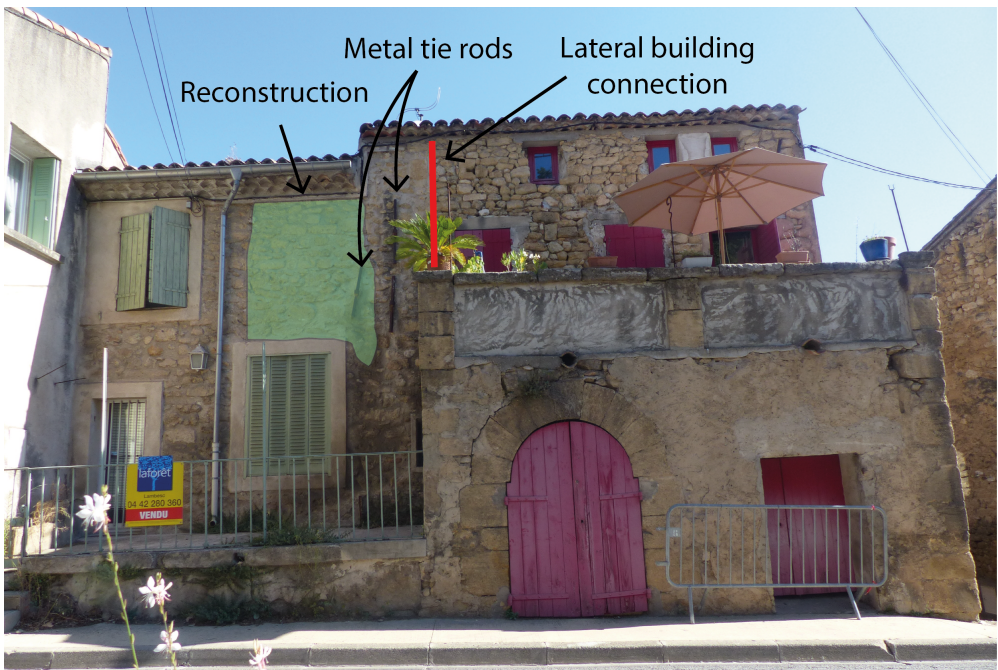
Figure 21: Reconstruction along two buildings (Avenue de Lambesc, Rognes).

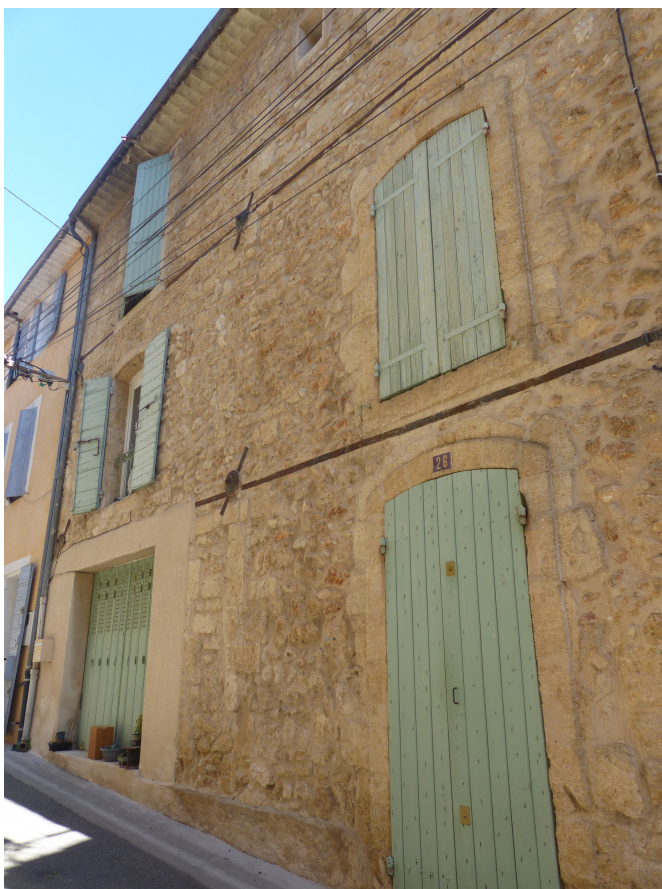
Figure 22: Reconstruction along the window (first floor). Metal tie rods.
