Preliminary mapping of liquefaction phenomena triggered by the February 6 2023 M7.7 earthquake, Türkiye / Syria, based on remote sensing data

Taftsoglou M. ¹, Valkaniotis S. ¹, Karantanellis E. ², Goula E. ³, Papathanassiou G. ³

The report is available in the Zenodo repository: https://doi.org/10.5281/zenodo.7668401

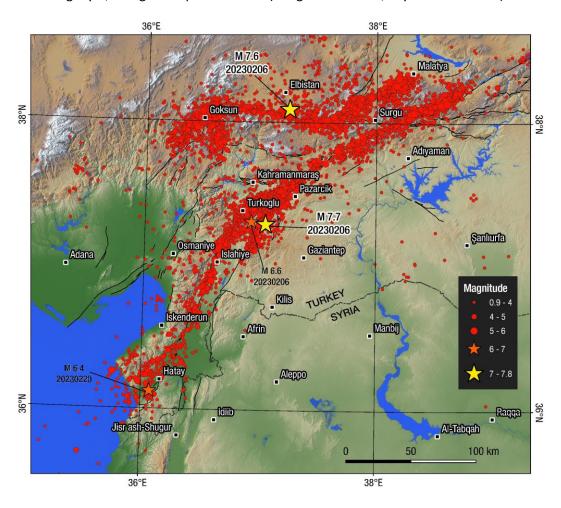
Figure 1. Overview of aftershocks for the M7.7 and M7.6 earthquakes. Extent of aftershocks mark the ruptured fault segments. Epicenter locations from AFAD catalogue (06/2/2023 - 21/2/2023).

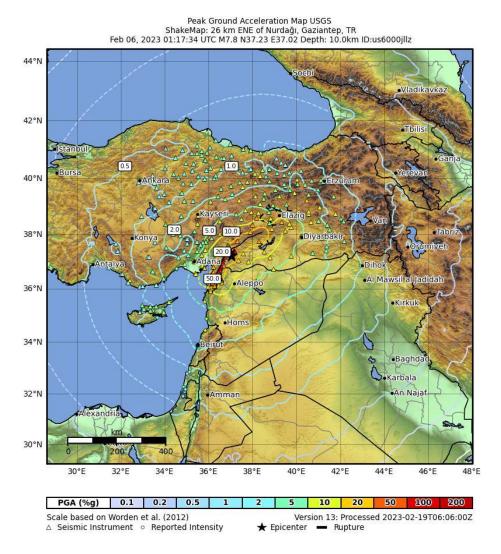
Figure 2. Peak Ground Acceleration map, from the USGS ShakeMap for the M7.7 earthquake.

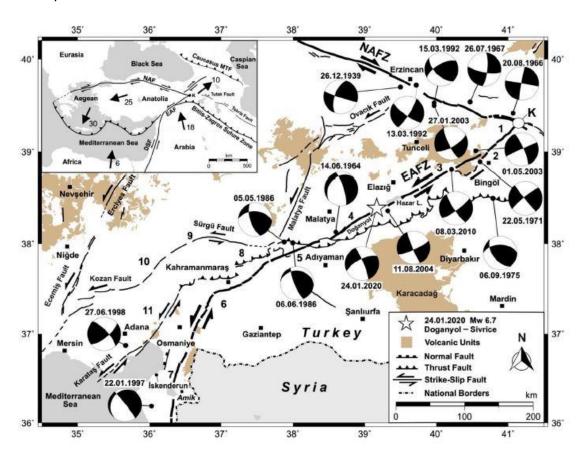
Figure 3. Summary and location map (from Taymaz et al. 2021) of the East Anatolian Fault Zone (EAFZ) composed by interpretations and observations of Şaroğlu et al. (1992a, 1992b) and Duman and Emre (2013). 1: Karlıova segment; 2: Ilica segment; 3: Gökdere restraining segment; 4: Palu segment; 5: Pütürge segment; 6: Ekenek segment; 7: Pazarcık segment; 8: Sürgü fault segment; 9: Çardak fault segment and Göksun releasing stepover; 10: Savrun fault zone and 11: Karataş releasing bend along with major volcanic fields (e.g. Karacadağ). Inset box at the upper-left displays the regional tectonic setting, comprising relative motions of the Arabian and African plates, central Turkey and the southern Aegean Sea relative to Eurasia modified after Taymaz et al. (1991b), Tan and Taymaz (2006), Yolsal-Çevikbilen et al. (2012, 2014) and references therein. The black arrows with numbers indicate direction of tectonic motion relative to Eurasia and velocity (mm/yr) obtained from GPS data (McClusky et al. 2000). DSF: Dead Sea Fault; EAFZ: East Anatolian Fault Zone, K: Karliova Triple Junction; MTF: Main Thrust Zone; NAFZ: North Anatolian Fault Zone.

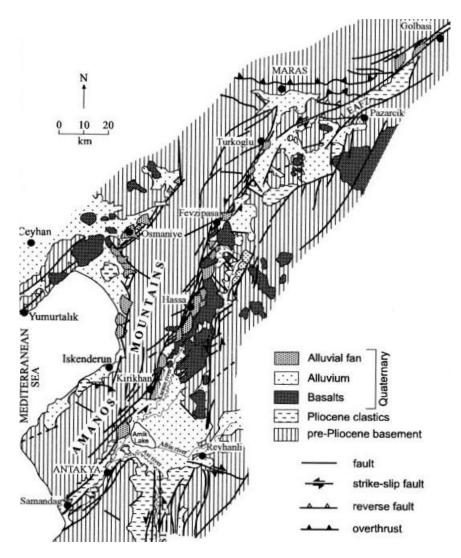
Figure 4. Regional geological map of the Karasu Rift. (simplified from 1:500000 by Rojay et al.2001) DST: Dead Sea transform fault zone, EAFZ: East Anatolian fault zone.

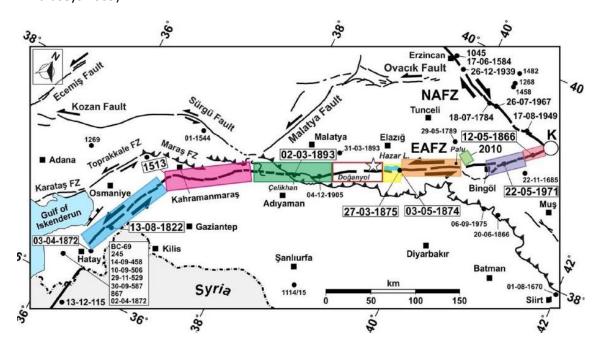
Figure 5. Surface breaks of the active fault segments highlighted in colours produced by large earthquakes along the EAFZ (Ambraseys 1989; Ambraseys and Jackson, 1998; Duman & Emre, 2013). February 06 2023 M7.7 earthquake ruptured through the 1822, 1513 and 1893 ruptured segments. The rectangle box outlined in red-lines spots the locked fault "seismic-gap" filled by the 24 January 2020 M_w 6.7 Doğanyol-Sivrice earthquake (white star). EAFZ: East Anatolian Fault Zone; NAFZ: North Anatolian Fault Zone. Large white circle marked with K spots the location of Karliova triple junction. Figure from Taymaz et al. 2021.

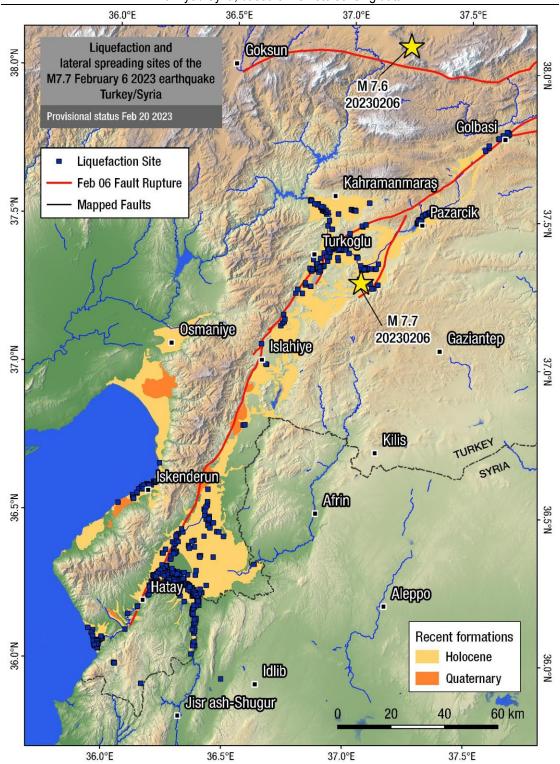
We have identified 760 sites with liquefaction and lateral spreading features, along a 250km section of the East Anatolian Fault Zone rupture (Figure 6). The northernmost area where we were able to identify liquefaction phenomena was Golbasi lake, at the NE part of the M7.7 earthquake rupture. Mapping at a higher latitude was limited by snow cover and limited availability of VHR imagery. From the extent of the mapped liquefaction phenomena, we consider those to be triggered by the first M7.7 rupture, early in Feb 06, and do not include liquefaction from the second M7.6 earthquake to the north.

Unexpectedly, most liquefaction and lateral spreading sites manifested along and near coastal sites, fluvial valleys and drained lake/swamp areas, covered by Holocene loose sediments. The following figure shows the distribution of mapped liquefaction sites along the fault rupture and shows that most concentrations are found in Holocene sediment-filled basins.

Figure 6. Overview map of liquefaction and lateral spreading sites identified and mapped using satellite imagery. Areas with major concentrations of liquefaction manifestations are Amik plain north of Hatay/Antakya, the extensive fluvial basins near to the M7.7 epicenter and the coastal plains of Hatay/Antakya and Iskenderun. Simplified geology from MTA (2002).

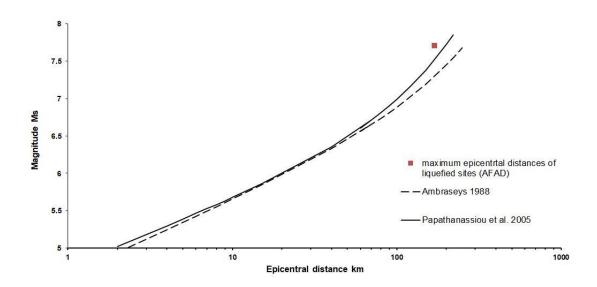
Figure 7. Maximum epicentral distance and comparison to the proposed curves for the assessment of liquefaction susceptibility (Ambraseys 1988, Papathanassiou et al. 2005 & Papathanassiou et al. 2016).

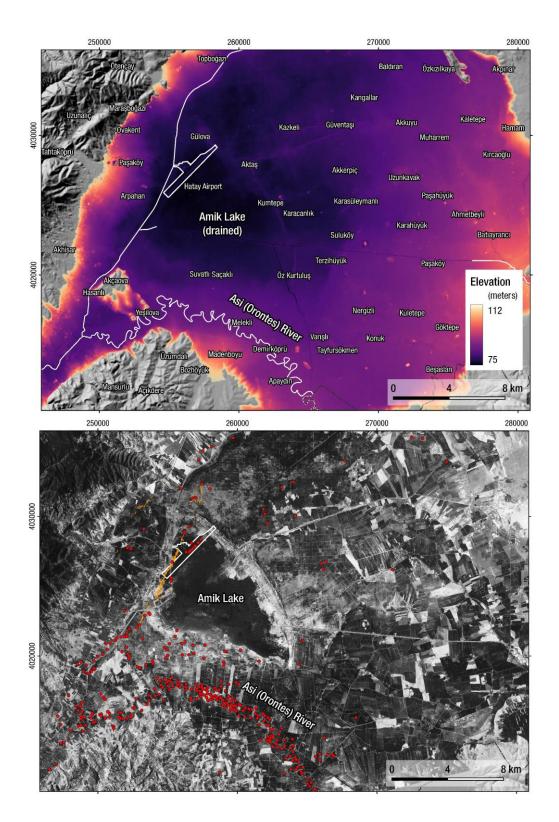
The area most affected by liquefaction and lateral spreading is Amik plain and Orontes (Asi) river plain, north of Antakya (Figure 8). Amik (Amuq) plain is a transtensional sedimentary basin, formed in the meeting point of Eastern Anatolian Fault Zone and the Dead Sea Fault Zone (Coskun 1994, Yener et al. 2000, Karatas 2014). Amik plain is covered by Holocene fluviolacustrine sediments above a succession of Tertiary sediments with a thickness of 200-300 meters. The central-western part of the plain was covered by Amik lake, drained in the early 1970's. Three main rivers are exiting through Amik plain, Kara Su from the north, Afrin river from the east and Orontes (Asi) river from the south. Orontes river is exiting to the south through Antakya, while Afrin and Kara Su are being drained by an extensive canal system.

Figure 8. Above: Elevation map of Amik (Amuq) plain, north of Antakya. Low elevation areas (dark) mark the extent of the drained Amik lake. Hatay airport and the major canal to the west, with Asi (Orontes) river meander to the south. Elevation source: Copernicus DEM. Below: Corona declassified satellite imagery from 1969, showing the last extent of Amik lake. Liquefaction related phenomena are marked with red, and orange lines show the mapped earthquake surface ruptures and cracks through the Hatay airport.

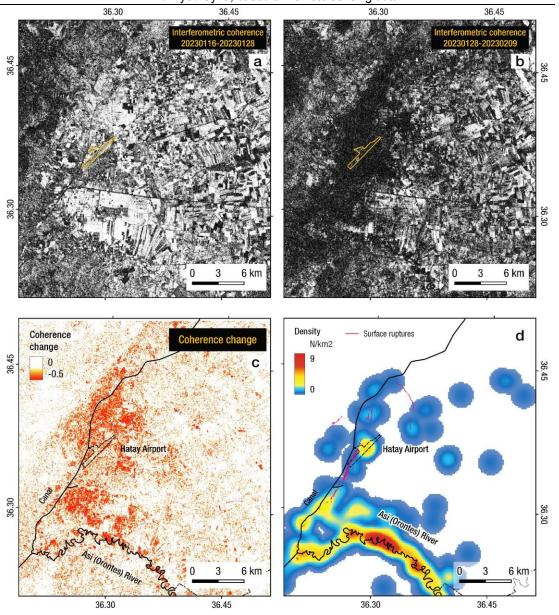
We used interferometric coherence from processing pre- and co-seismic pairs of Copernicus Sentinel-1 SAR imagery. Loss of coherence is an indication of possible widespread liquefaction and lateral spreading at a location. While interferometric pairs from the M7.7 earthquake had a number of difficulties, including masking of the signal by the wide deformation of the main fault ruptures, they provided a guide for identifying candidate locations (Fig.10).

Figure 9. Interferometric coherence of Amik plain area from before the earthquake (a) and co-seismic interval (b). Darker colors correspond to coherence loss due to ground surface disturbance and land cover changes. Distribution of high values of coherence change between the two datasets (c) coincides with high density of mapped liquefaction features (d) to the south and south-west, flooded areas along the western canal, and also along the NNE-SSW axis of co-seismic ruptures west of the airport.

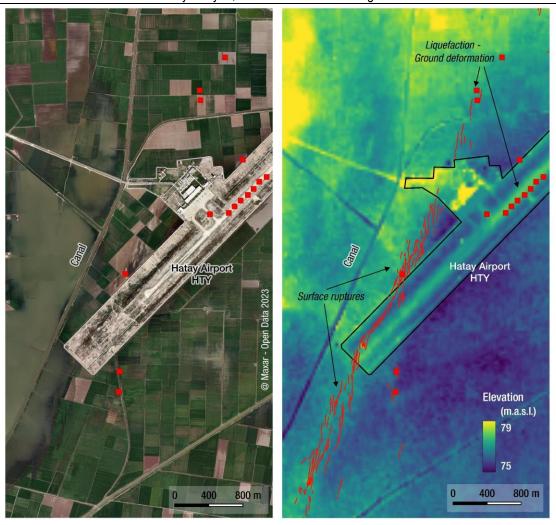
The southernmost branch that ruptured during the M7.7 earthquake, is found along the western part of Amik basin, with extensive surface ruptures. Surface ruptures from this segment damaged the westernmost part of Hatay airport and the main water canal, leading to local flooding of large areas of the former lake. Reported damages on the airport runway are attributed not to faulting but deformation of the runway embankment/fill by liquefaction related phenomena. Liquefaction sites were mapped mostly in the surroundings of the former lake bed and along the meanders of Orontes river. Flooding of Orontes river along Asi valley up to the border of Turkey-Syria masked a large number of liquefaction phenomena. We managed to map a portion of the later-submerged area from an image acquired in February 06.

Figure 10. Left: post-earthquake satellite imagery of Hatay airport in Amik plain (Maxar Open Data program). Right: mapped surface ruptures and ground cracks (red lines) and liquefaction related phenomena (red symbols). Fault rupture crossed through the western area of the airport, but damage to the runways is attributed to liquefaction and failure of the runway fill. Elevation source: Copernicus DEM.

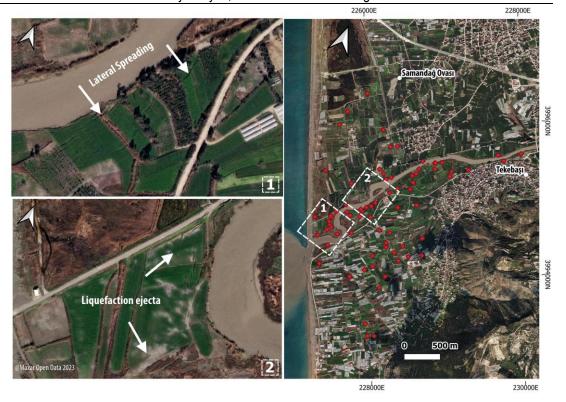
A significant number of liquefaction and lateral spreading phenomena was also mapped in Iskenderun port city, Golbasi lake and the coastal plain of Samandag, where Orontes river is exiting through Antakya city.

Figure 11. Liquefaction and lateral spreading sites at the coastal plain south of Antakya. Most of the sites are found along the course of Asi (Orontes) river and over abandoned fluvial features.

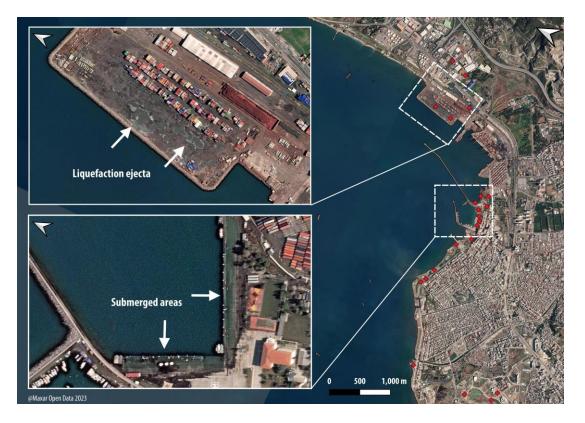
Iskenderun (Alexandretta) port city was severely damaged due to widespread lateral spreading and liquefaction along it's coastal front. Large areas were inundated and sections of piers were submerged due to lateral spreading (Fig.12).

Figure 12. Liquefaction and lateral spreading sites at the port city of Iskenderun. Most of the sites were found along the coastal front and within the reclaimed port facilities and piers of the old port. Insets show liquefaction ejecta and submerged sections of piers. Widespread lateral spreading and subsidence was manifested along a > 6km section of the coastal front.

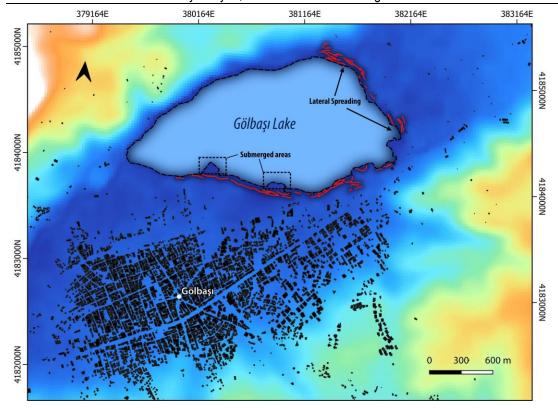
Gölbası lake is formed within a series of pull-apart basin along the main strand of Eastern Anatolian Fault Zone. We mapped extensive lateral spreading deformation along the northern, eastern and southern coast of the lake, where a few areas were visibly submerged in post-earthquake imagery. Damaging liquefaction and lateral spreading occurred also within Gölbası town (Fig. 13 & 14).

Figure 13. Widespread lateral spreading along the coastline of Gölbası lake (red lines). A small delta and parts of southern coast were submerged due to lateral spreading deformation.

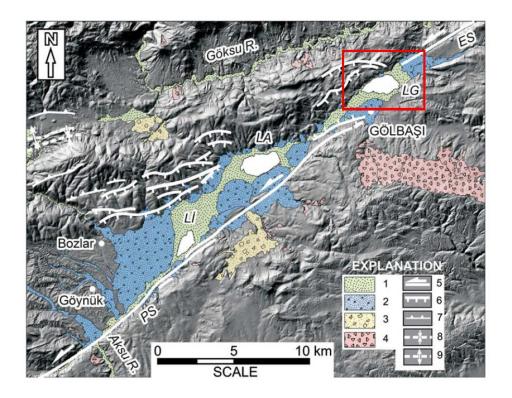
Figure 14. Active fault and Quaternary geological map of the Lake Gölbası releasing stepover and its vicinity, from Duman & Emre (2013). Inset box shows the location of previous Figure 13. ES, Erkenek segment; PS, Pazarcık segment; LG, Lake Gölbası; LI', Lake Inekli; LA, Lake Azaplı; R, river; (1) Holocene river bed and lake deposits; (2) Holocene fan deposits; (3) undifferentiated terrace deposits; (4) landslide deposits; (5) left-lateral strike-slip fault; (6) normal fault; (7) Southeastern Anatolian Thrust Zone; (8) syncline; (9) anticline.

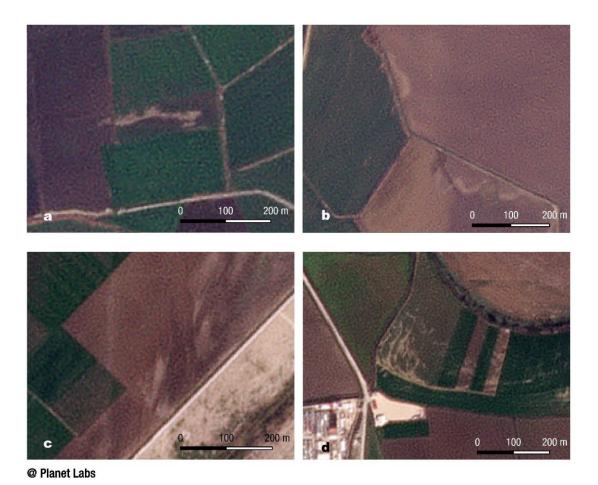
In this last section, we present a number of different types of liquefaction phenomena identified in optical satellite imagery along the M7.7 earthquake rupture. Work in progress involves acquiring and examining new imagery over the affected areas, detailed mapping of the sites and of individual liquefaction features (Figure 18) and study of the paleogeography and fluvial settings in order to extract useful insights for future susceptibility studies (Taftsoglou et al. 2022).

Figure 15. Examples of liquefaction phenomena mapped with Planet imagery; a) Liquefaction fissure (37.346N,36.869E), b) liquefaction ejecta (37.536N,36.875E), c) liquefaction ejecta along the surface ruptures west of Hatay airport (36.354N,36.272E), d) liquefaction fissures and sand boils (36.237N,36.3572E).

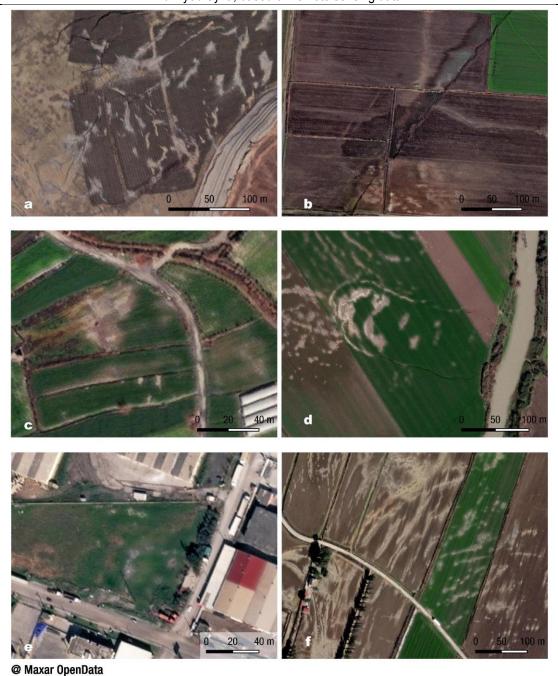
Figure 16. Examples of liquefaction phenomena mapped with very high resolution Maxar Open Data imagery; a) Liquefaction fissures and sand boils (37.50N,37.288E), b) liquefaction material ejected from surface fault rupture (37.404N,36.904E), c) sand boils and craters (36.048N,35.974E), d) liquefaction fissures, sand boils and lateral spreading along Asi (Orontes) river (36.252N,36.236E), e) liquefaction craters in Iskenderun, near the port (36.605N,36.201E), f) liquefaction fissures and sand boils (36.2566N,36.349E).

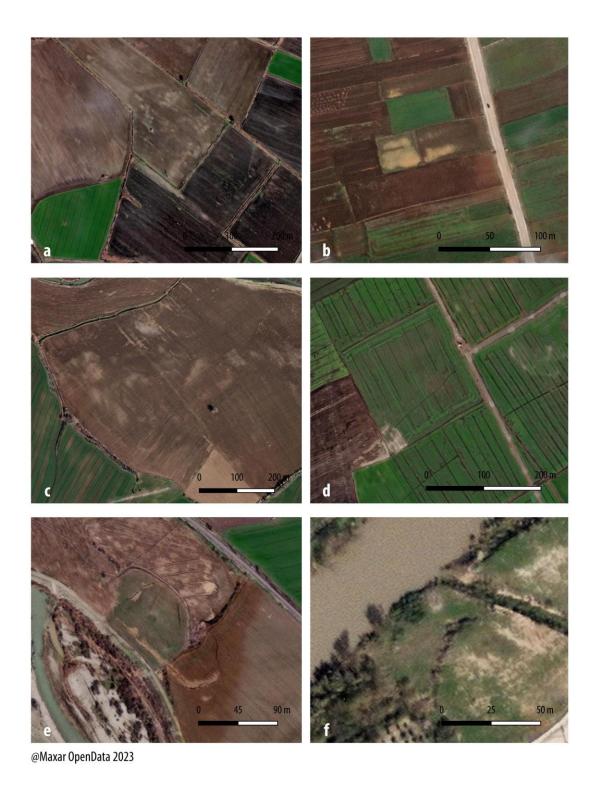
Figure 17. Examples of liquefaction phenomena mapped with very high resolution Maxar Open Data imagery; a) Liquefaction ejecta (37.391N,36.908E), b) liquefaction ejecta (35.988N,36.051E), c) sand boils and fissures (37.543N,36.869E), d) liquefaction ejecta (37.333N,36.868E), e) lateral spreading and sand fissures (37.407N,36.919E), f) lateral spreading along Asi (Orontes) river (36.065N,35.988E).

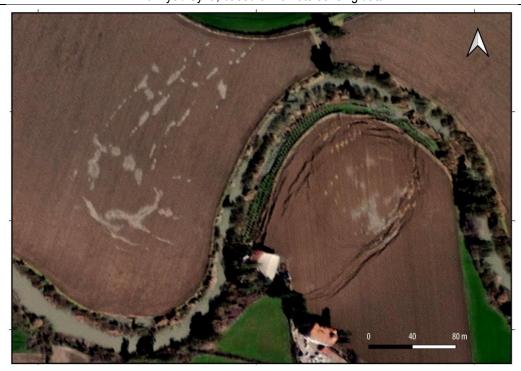
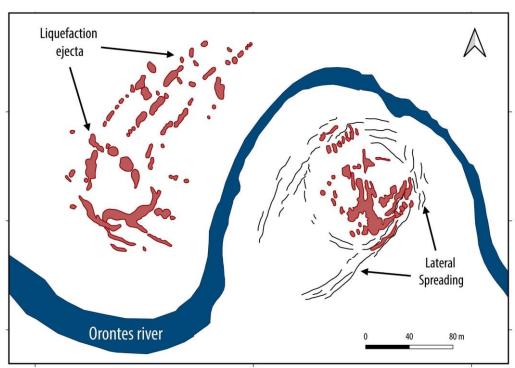
Figure 18. Work in progress; mapping liquefaction and lateral spreading features in detail. An example from Orontes (Asi) river, north-east of Antakya. VHR imagery from Maxar Open Data Program (above) and mapped individual features (below).
