HyDelta 2

WP6B – Safety – Suitability of Assets and Working Methods

D6B.2A - Report on ignition scenarios when using inflatable gas stoppers // D6B.2B - Report on ignition test results

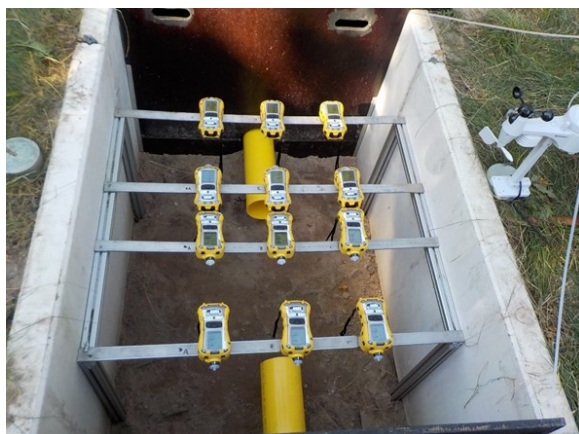
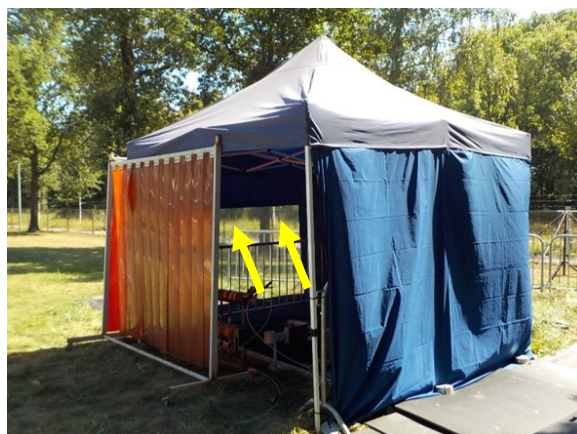
Photo 1 and Photo 2 The working pit and tent used to shield the wind

During the measurements, three of the four tent sides were completely closed. The other side was partially closed using the red screen as visible in the picture. When Chapter 4 mentions one side being half open, this refers to opening the section as indicated by the yellow arrows in the picture.

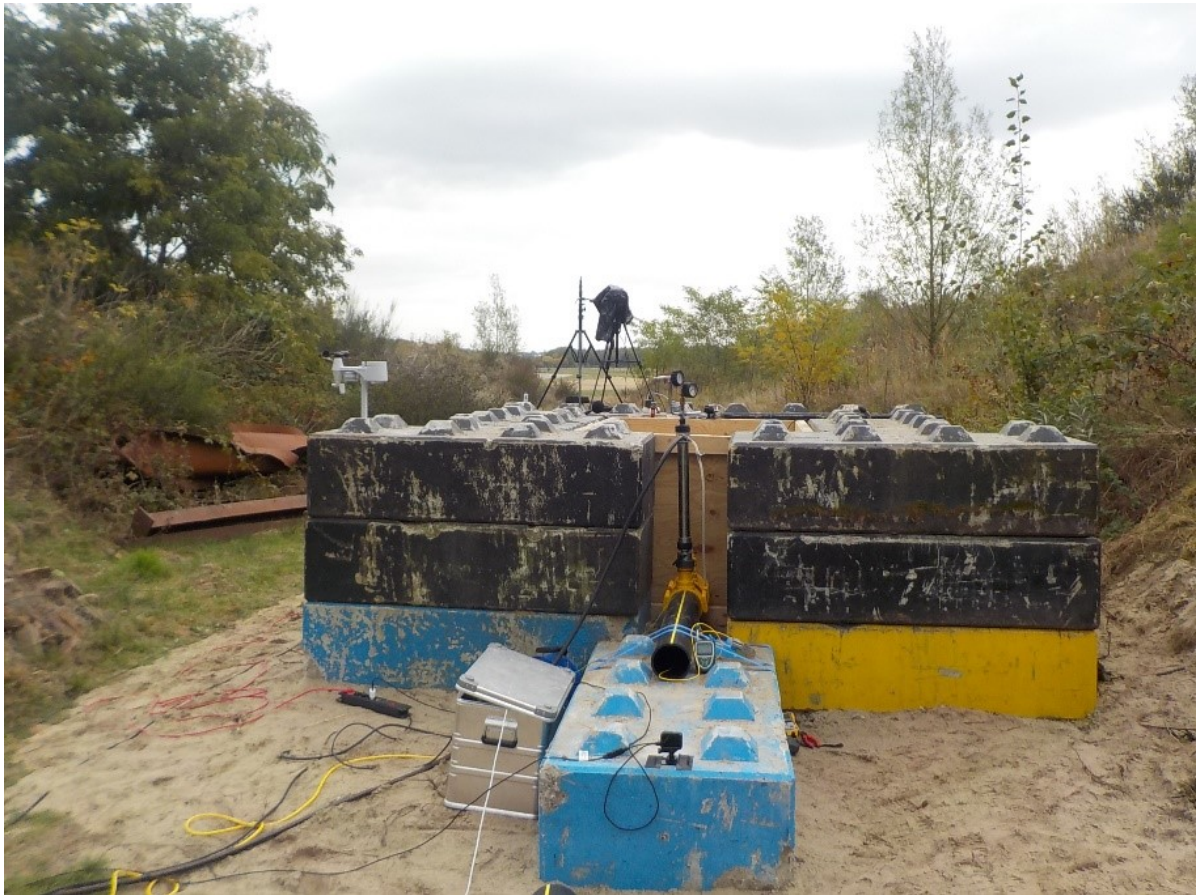
Photo 3 The setup with the 1 metre pipe.

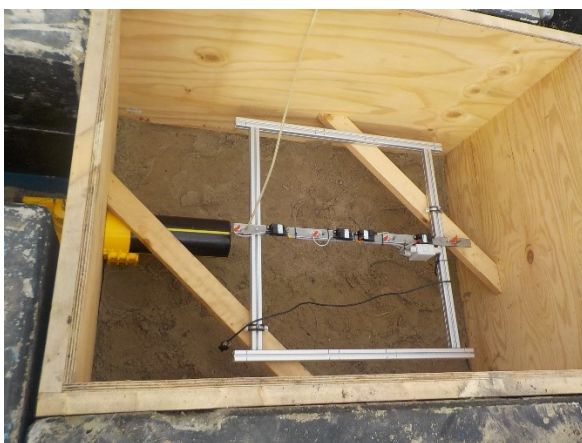
Photo 4 and Photo 5 The position of the spark igniters.

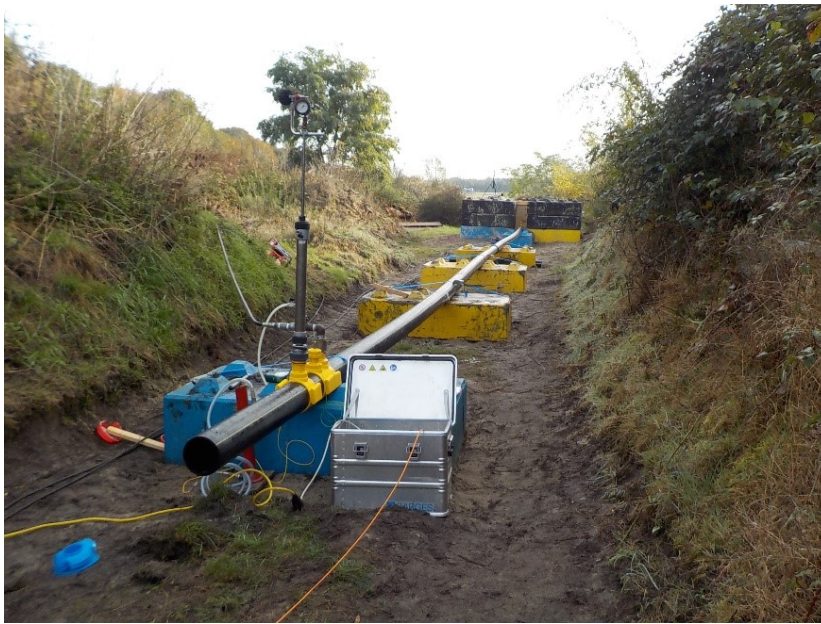
Photo 6 The setup with the 20 metre pipe

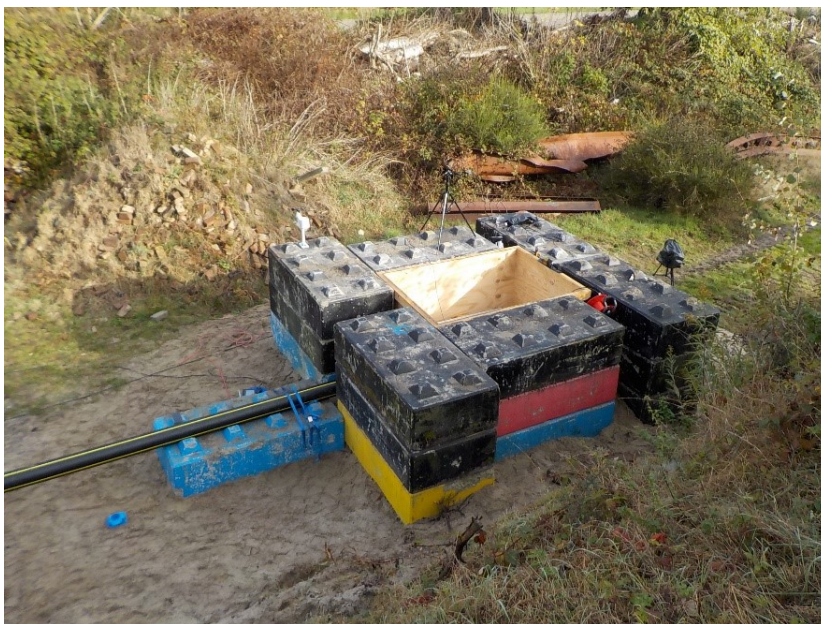
Photo 7 Overview of the working pit

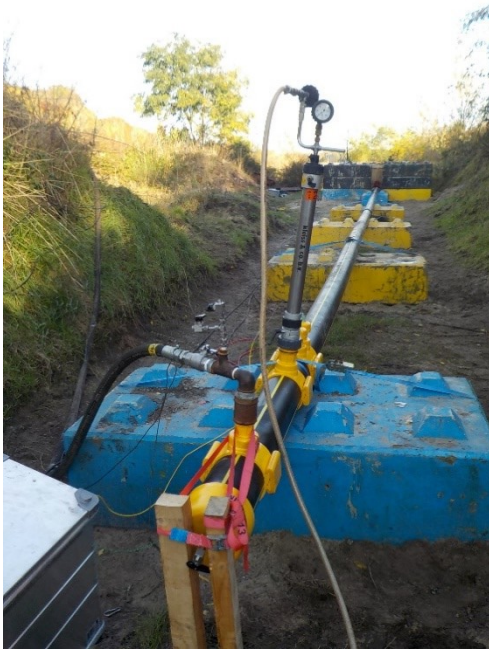
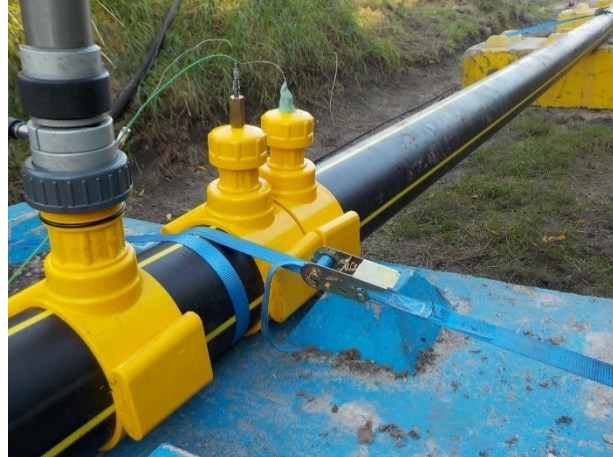
Photo 10 and Photo 11 The measurement setup as used when setting a stopper in case of a gas fire.

Photo 11 shows the saddles containing the pressure sensor and temperature sensor

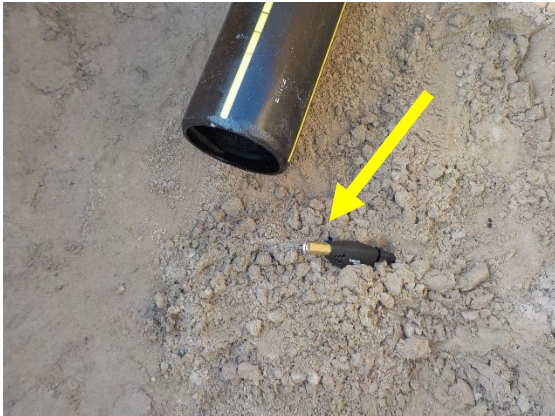
Photo 12 shows the position of the gas burner as the ignition source and Photo 13 shows the spark igniters as the ignition source

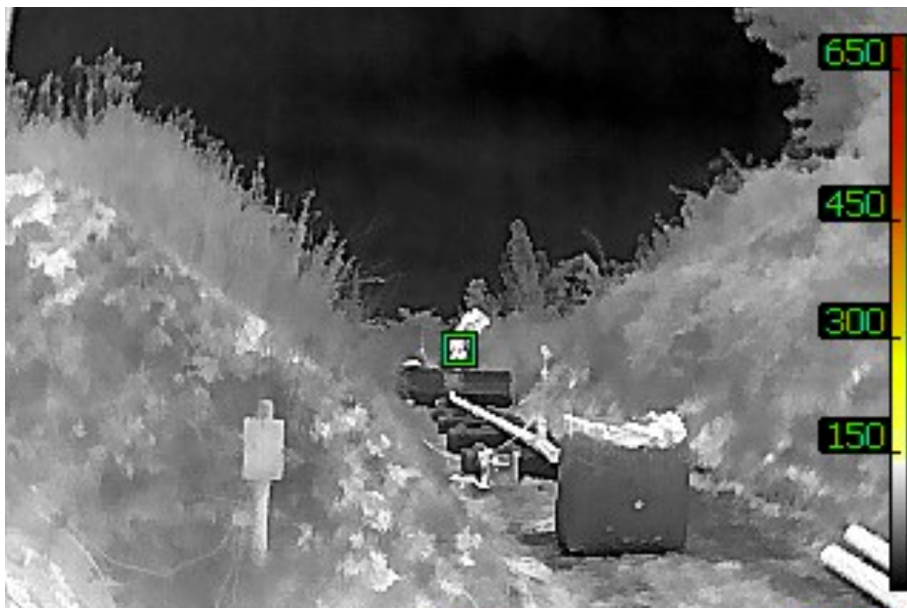
Photo 17: Thermal image measurement 27 (15m³/h H₂)

photo 17 and photo 18 show the thermal images at the delayed ignitions for hydrogen and natural gas, respectively. The natural gas flame is slightly larger and has a higher temperature. Orange/red spots can be seen in the thermal image of the natural gas flame, indicating temperatures of around 450°C.

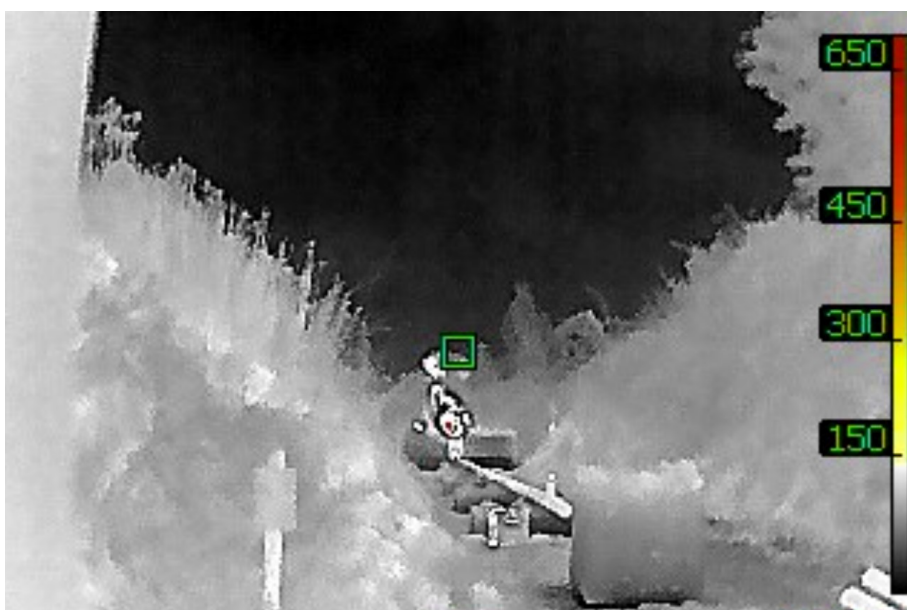
Photo 18: Thermal image measurement 34 (8m³/h natural gas)

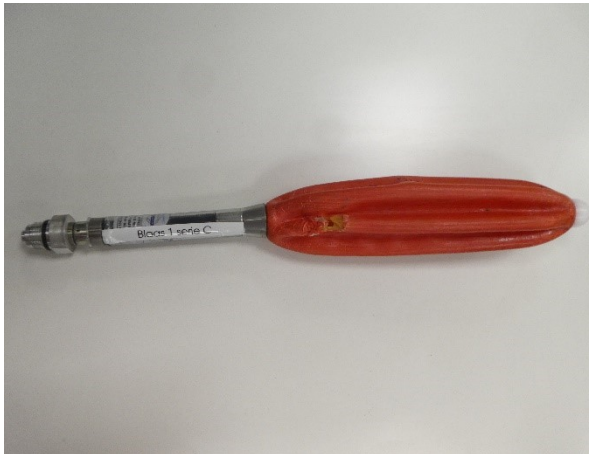
Stopper C1; damaged with measurement 1 – direct ignition of natural gas

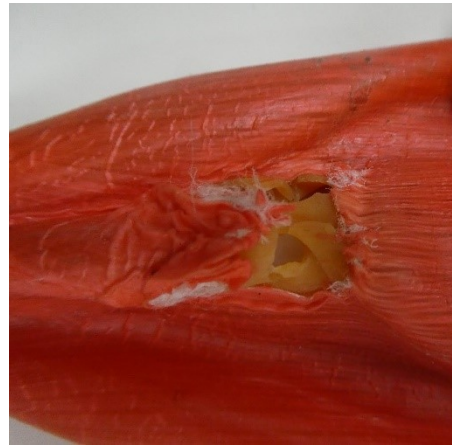
Stopper C1; a hole created due to excessive temperature

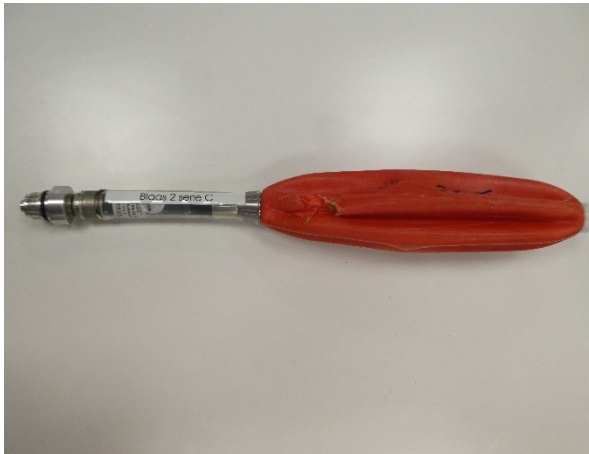
Stopper C2; damaged with measurement 2 – direct ignition of natural gas

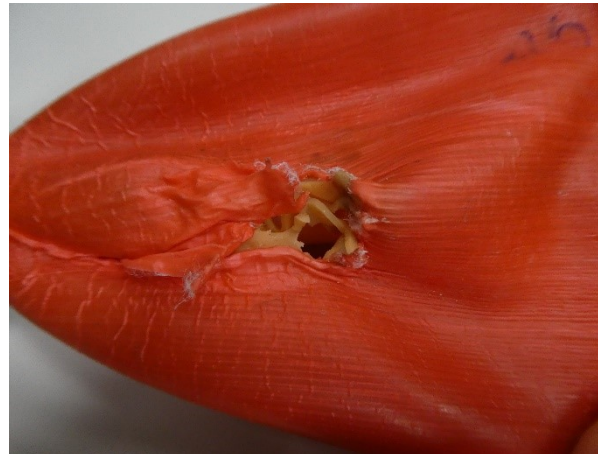
Stopper C2; a hole created due to excessive temperature

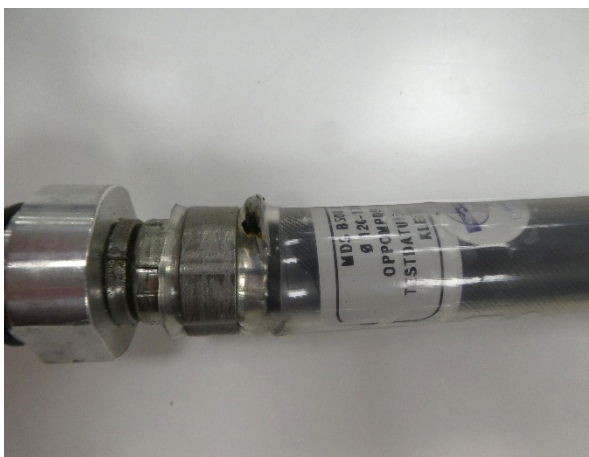
Stopper C2; damaged at lance connection (damage due to melting)

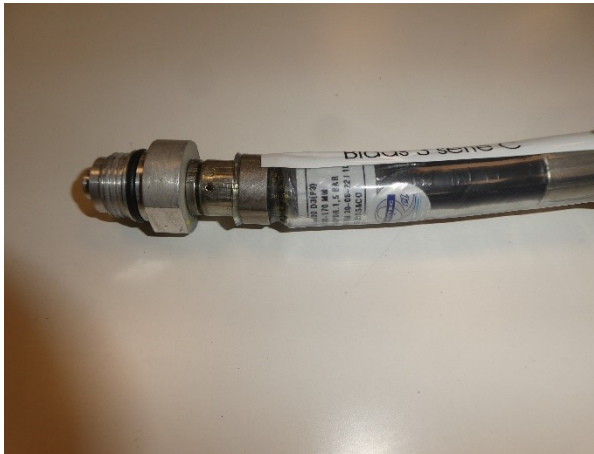
Stopper C3; damaged with measurement 3 – direct ignition of hydrogen, damaged at lance connection (damage due to melting)

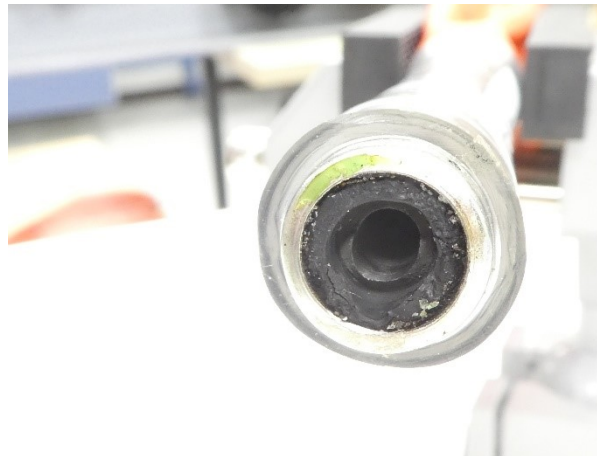
Stopper C7; a detail of the broken part of the connection

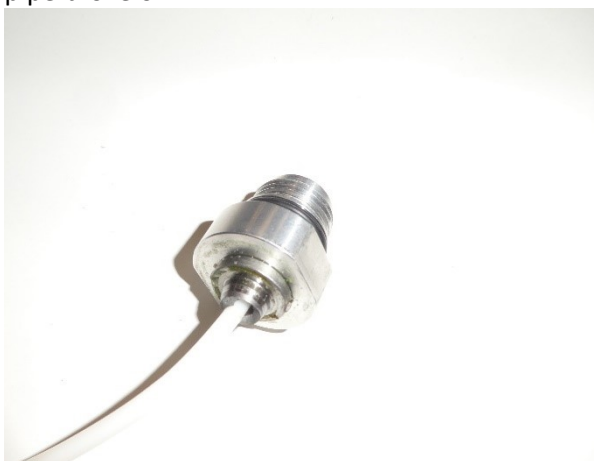
Stopper C7; a detail of the broken part of the lance connection

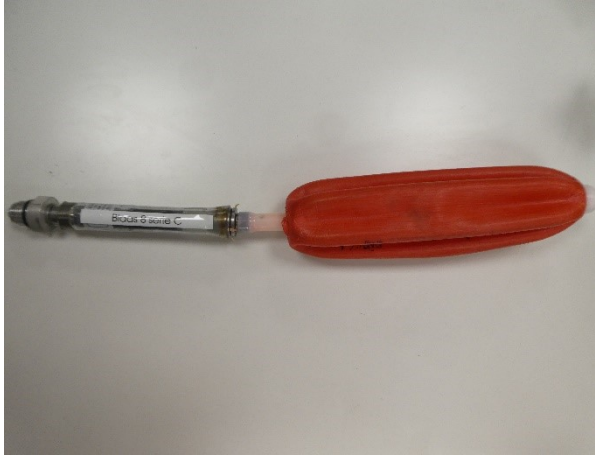
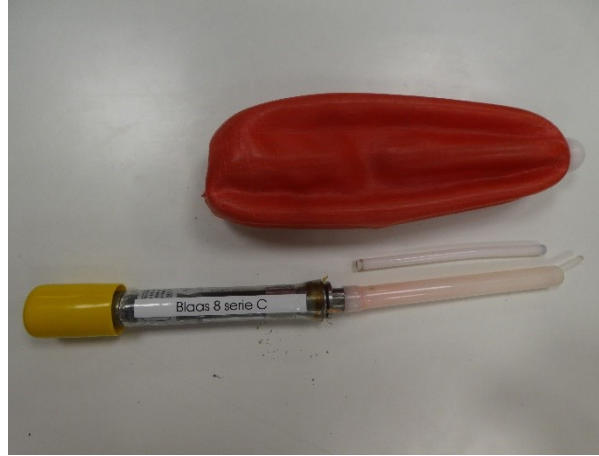
Stopper C8; in measurement 22 (direct ignition of hydrogen in a 20 metre pipe), the stopper detached.
