Retrofit Overlay With Fishing Net Reinforcement For Substandard Concrete Masonry In Coastal Areas

ABSTRACT

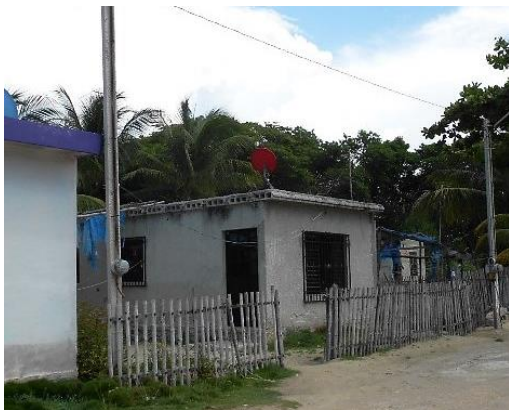
a) Typical substandard concrete masonry dwelling in Progreso (Yucatán, Mexico) (credit: F. Matta)

Figure 1: Vulnerability of substandard masonry in coastal areas of Central America and Caribbean.

Nearly 40 percent of the Earth's population lives along coastlines. These areas are especially vulnerable to natural hazards due to extreme weather and the effects of climate change. For example, recent hurricanes such as Matthew in 2016 showed the destructive effects of high winds in coastal areas in the Caribbean and the US, especially in relatively low-income areas where substandard construction is common. Substandard masonry made with cinder blocks is a predominant construction material for dwellings in the coastal areas of Central America (e.g., Figure 1a) and the Caribbean.

Local substandard concrete masonry is typically made of hollow-core concrete blocks having a compressive strength around 3-5 MPa, often with minimal or no internal reinforcement. In fact, a

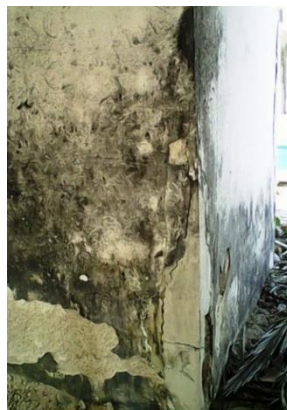
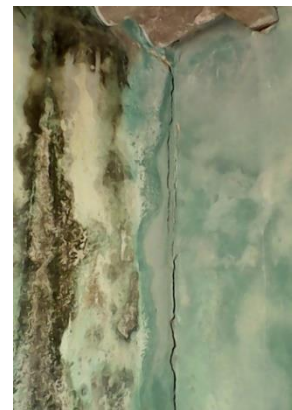
b) Exterior weathering and damage (credit: J. Biles)

c) Interior weathering and damage (credit: J. Biles)

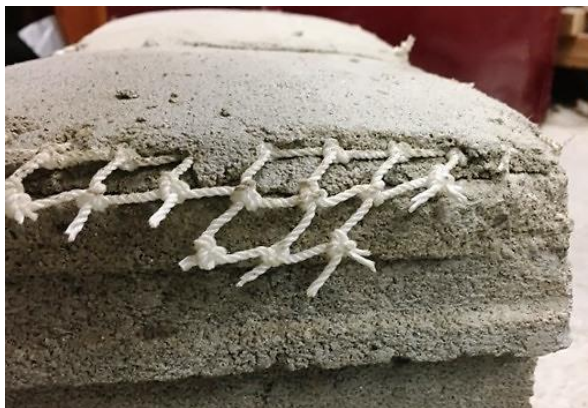
a) Overlay reinforced with #21 nylon fishing net and bonded onto concrete masonry substrate

The overlay reinforcement consists of one layer of fishing net made of knitted nylon strands having a nominal diameter of 1.75 mm (Figure 2a), herein referred to using the commercial designation '#21'. The net has a mesh side length (i.e., on-center spacing) of 15 mm in both orthogonal directions, resulting in a nominal strand cross-sectional area of 160 mm²/m.

A ready-mix Type N cement mortar was used as the cementitious matrix. Through a laboratory trial-and-error process (Mousa, 2017), the water-to-binder ratio was set to 0.55 to ensure sufficient workability, encapsulation of reinforcement, and adhesion onto typical concrete masonry substrates (Figure 2a). The mortar compressive strength of 18.4±1.15 MPa and flexural strength of 3.4±0.30 MPa were characterized according with ASTM C109 (ASTM, 2016) using six specimens, and ASTM C348 (ASTM, 2014) using five specimens, respectively.

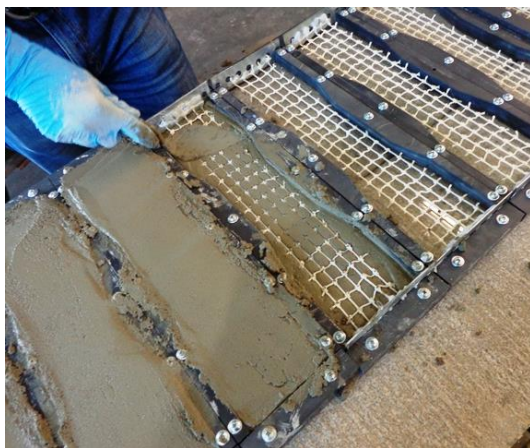
a) Casting of fishing net-reinforced cementitious overlay specimens

Fishing net-reinforced cementitious overlays were prototyped in the form of dogbone specimens for the purpose of uniaxial tensile characterization. Three specimens included one layer of #21 fishing net reinforcement and three specimens included one layer of gauge #19 steel mesh reinforcement. The overlays were cast in dogbone-shaped acrylic molds with total length of 406 mm, and length and width of the test region of 102 mm and 76 mm, respectively (Figure 3a). One layer of reinforcement (either #21 fishing net or gauge #19 steel mesh) was sandwiched between two layers of mortar. Each strand of the fishing-net reinforcement was slightly pre-tensioned prior to casting the top mortar layer (Figure 3a). The specimens were demolded after 24 hours and cured in wet burlap for 28 days.

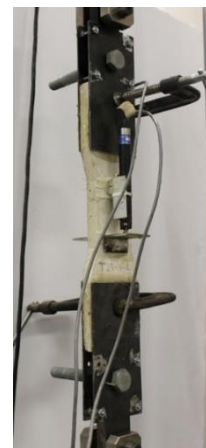
b) Uniaxial tensile test setup

c) Close-up of dogbone specimen

The overlay specimens were tested under uniaxial tensile loads using a servo-hydraulic test frame (Figure 3b-c). A clevis-grip setup (Arboleda et al., 2016; ACI, 2020) was used as a suitable means to investigate the interaction between reinforcement and cementitious matrix (Focacci et al., 2022), in addition to comparatively assessing load capacity and post-crack elongation for the two different reinforcements. The load was applied at a displacement rate of 0.2 mm/s, and was measured with a 10-kN load cell. The total elongation was measured over a gauge length of 95 mm using two displacement transducers, which were mounted symmetrically onto the front and back face of the specimen (Figure 3b-c). The data were acquired at a frequency of 100 Hz using two synchronized data acquisition systems.

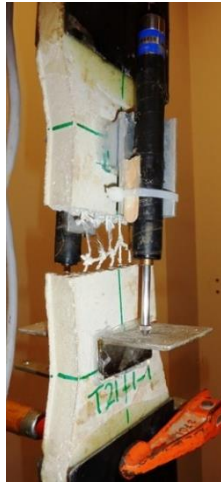
a) Typical failure mode of fishing-net reinforced overlay

The fishing net-reinforced specimens failed due to rupture of the nylon strands (Figure 5a). Unlike typical fabric-reinforced cementitious matrix (FRCM) composites (ACI 2020) where distributed transverse crack patterns develop, the specimens exhibited a single crack along a knot line due to the relatively low stiffness of the knitted fabric. This behavior was recently reported also by Truong et al. (2021) based on results of uniaxial tensile and bending tests on mortar specimens reinforced with polyethylene fishing nets. Failure occurred at an average load of 23.8 kN/m (Figure 5b). Multiple strands unraveled and ruptured simultaneously, indicating that the mortar matrix is effective in distributing axial forces among the strands, and that the knots did not act as a weak link in the reinforcement. In addition, the 0.78 kN/m standard deviation of the failure load indicates consistency in behavior up to rupture of the strands.

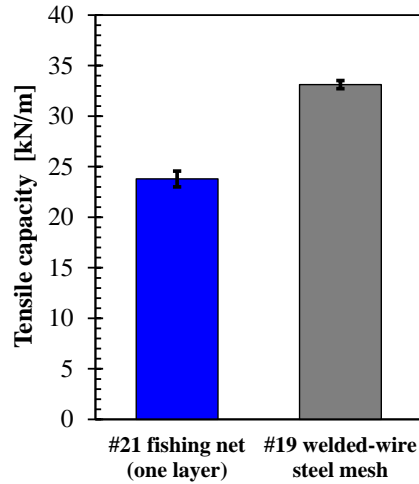
b) Tensile load at failure of fishing net- and steel mesh-reinforced cementitious overlays

The tensile capacity of the fishing net-reinforced overlay is comparable to that of the steel mesh-reinforced overlays, which failed due to rupture of one or more steel wires at an average load of 33.1 kN/m (standard deviation = 0.40 kN/m). For the representative materials and configurations reported herein, these results indicate that the fishing net reinforcement can provide comparable load-carrying capacity to steel mesh reinforcement with comparable consistency.

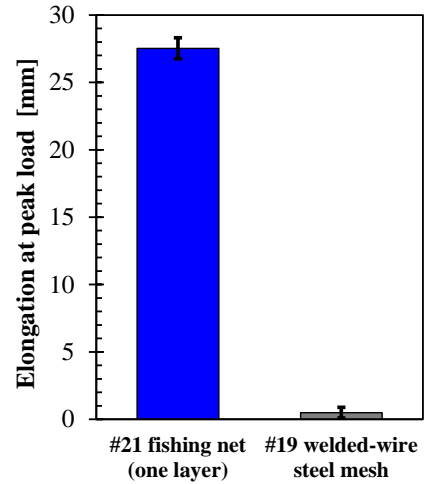
c) Elongation at failure load of fishing net- and steel mesh-reinforced cementitious overlays

However, unlike steel mesh-reinforced overlays, fishing net-reinforced overlays also offer high deformability as highlighted by the 27.5 ± 3.84 mm average elongation at maximum load (Figure 5c). This capability is desirable in instances where energy dissipation is sought such as to resist seismic forces and impact of flying debris. In particular, the latter is a major safety concern under windstorms.

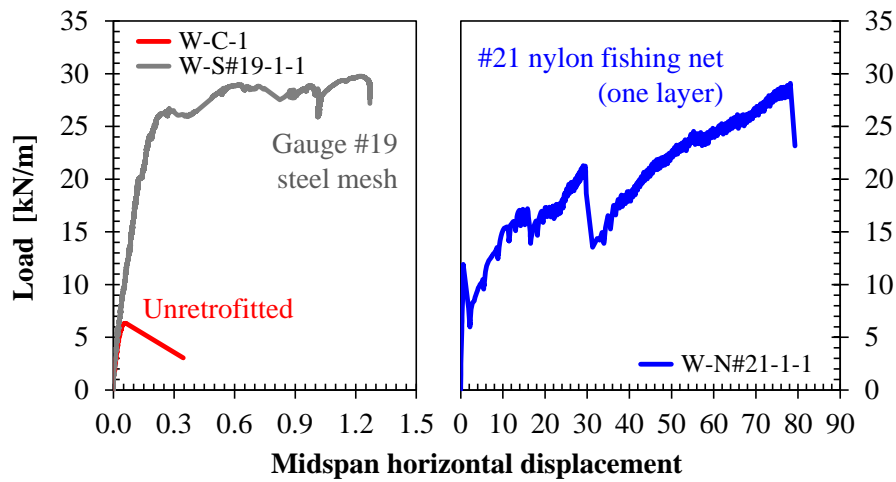
Figure 6: Load-midspan horizontal displacement response of cinder-block masonry specimens.

The salient results of the proof-of-concept load tests are summarized in Table 1. Figure 6 presents the applied load as a function of the midspan horizontal displacement data for the three test specimens.

The results presented in Table 1 and Figure 6 also highlight the fundamentally different deformability of the retrofitted specimens. In fact, the use of a fishing net-reinforced overlay resulted in an over 60-fold increase in midspan horizontal displacement compared to the steel mesh-reinforced counterpart. The full extent of the deformation might not be relied upon without undermining stability. However, it is clear that the proposed fishing net-reinforced overlay holds promise as a locally-appropriate and structurally effective means of retrofitting against high-wind loads, ranging from wind pressures to impact of flying debris.
