Hillside geophysics report

Location The site is located at the front of 4,5 & 6 Hillside, Lancaster, LA1 1YH.

Survey Methods Ground penetrating radar (GPR).

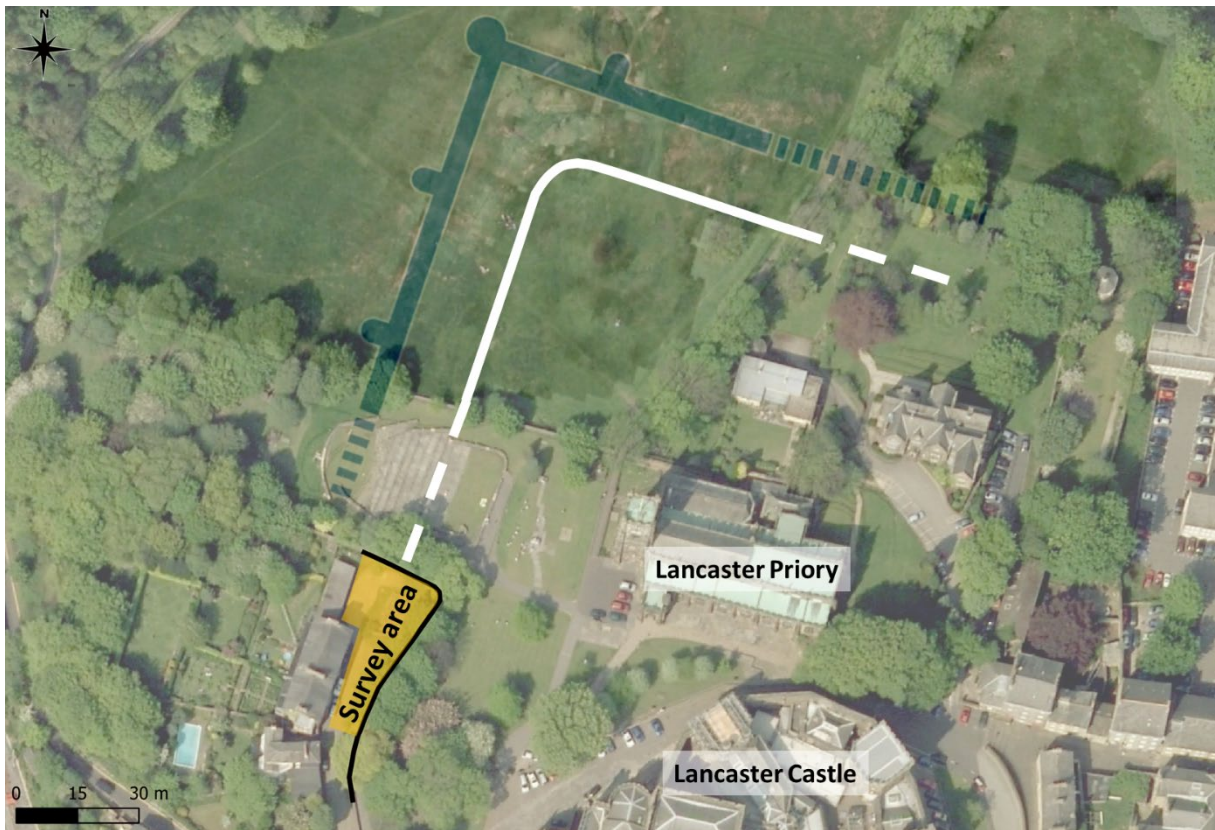
Figure 1: Location of survey area. Also shown is the proposed north/west extent of the earlier (1st/2nd century) and later (4th century) Roman fort boundaries (after Wood, 2021).

- 1.1 The survey was requested by Nigel Neil on behalf of the Lancaster and District Heritage Group (LDHG). The site is adjacent to Scheduled Monument (National Heritage List no. 1020668) '*Part of a Roman fort and its associated vicus and remains of a pre-Conquest monastery and a Benedictine priory on Castle Hill*'. Archaeological excavations had been carried out in two plots at the site (2017 & 2019), revealing possible evidence of historic ditches that could have an alignment with western defences of the Lancaster Roman forts (see Collins, 2020). Wood (2021) outlines current views on the likely north/west extent of the forts. Figure 1 shows the survey area in relation to the Roman fort outlines proposed by Wood (2021).

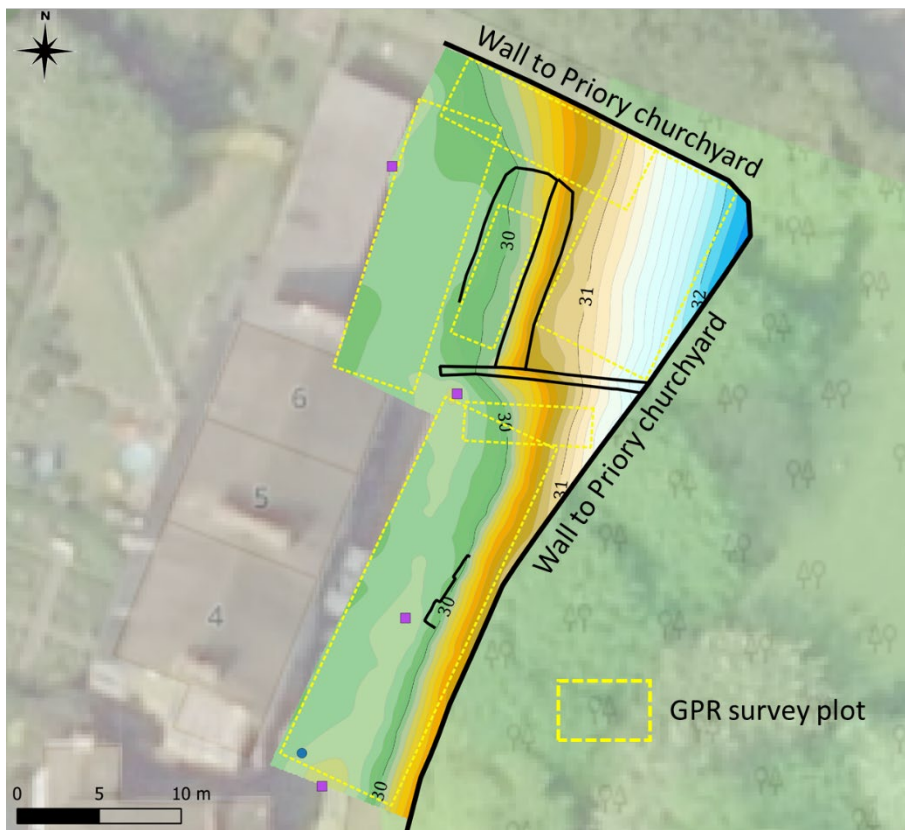
Figure 6: Topographic variation over the site. Contour labels in maOD.

- 1.8 From numerous spot elevation measurements, a topographic map was produced (see Figure 6). Over 2m elevation change in ground level is evident.
- 1.9 Figure 7 shows a panoramic photograph of the site; Figure 8 shows a number of photographs taken during GPR surveys.

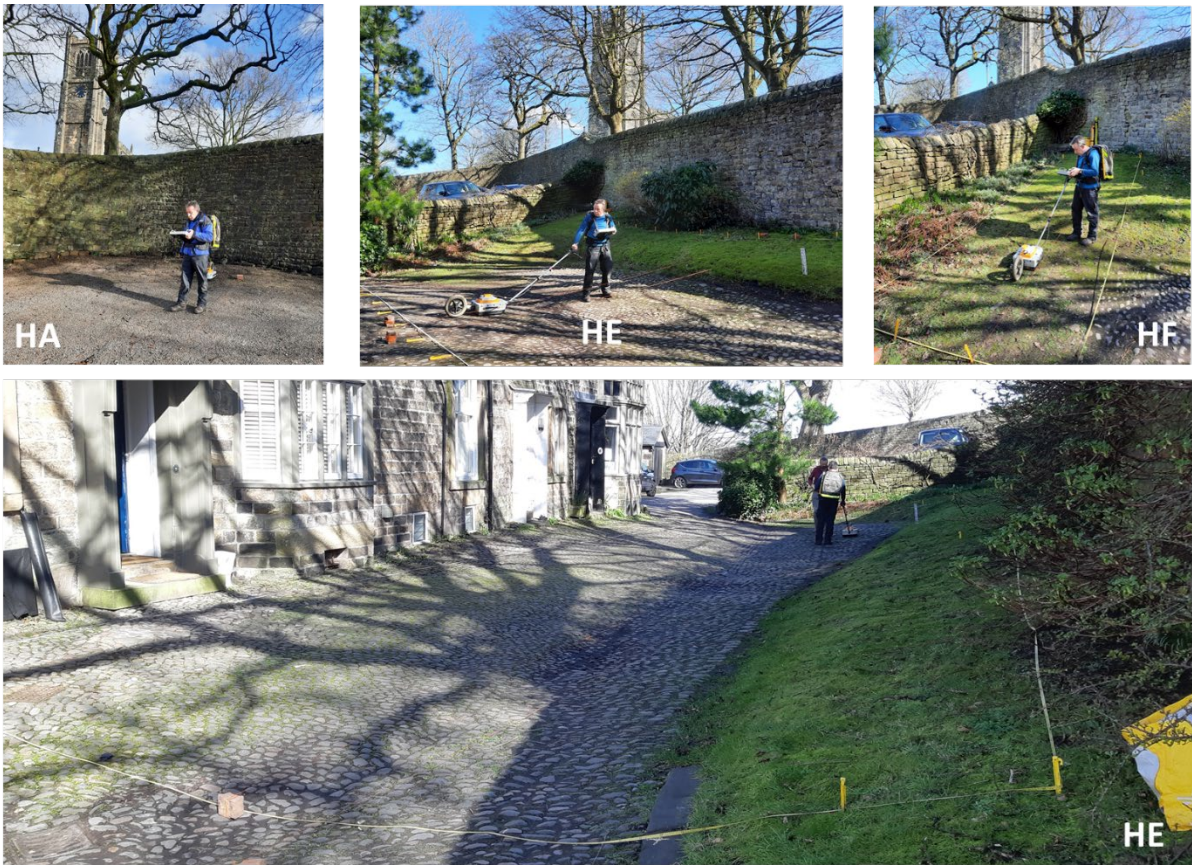
Figure 8: Site photographs taken during 500MHz GPR surveys.

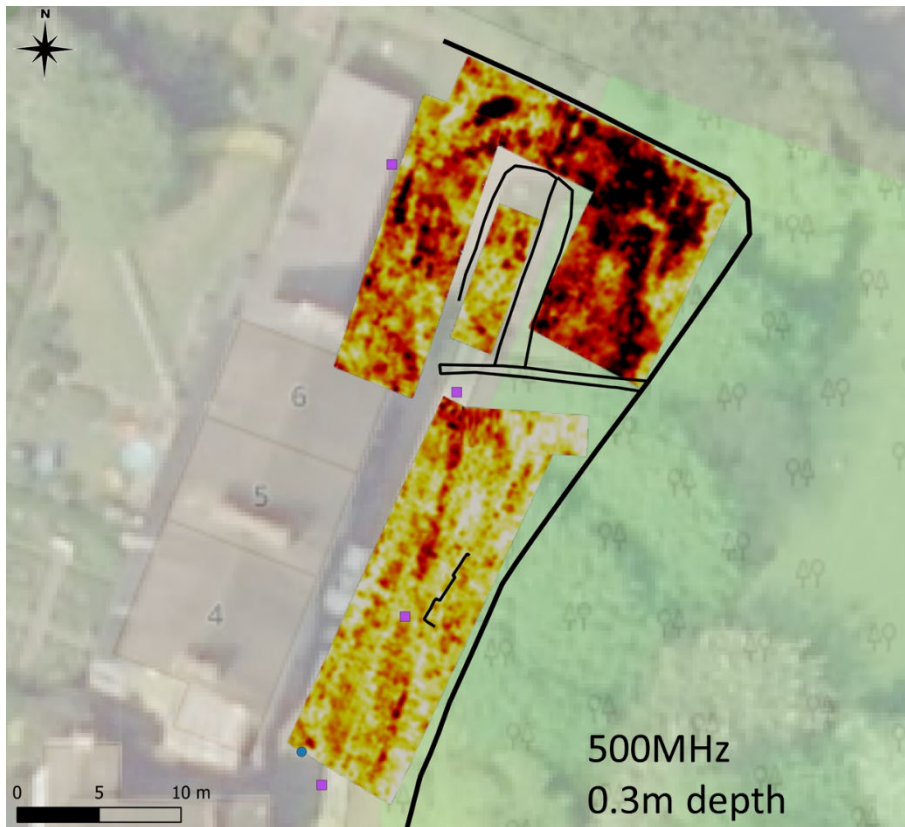
Figure 9: Horizontal slice of 500MHz GPR model at 0.3m below ground level. Darker colours indicate stronger reflected signals.

- 2.1 Figure 9 shows a horizontal slice of the composite GPR model of the 500MHz data at a depth of 0.3m below ground level. A few features are worthy of note. (1) Stronger reflections are seen in the northeast area of the site (which corresponds to higher elevation of ground level); (2) a linear feature (approx. 10m x 2m) is evident in the northeast area, further north is an almost square shaped anomaly; (3) two patches of strong reflections are seen adjacent to the garages to the northeast of the plot; (4) the reflections are generally weak in plots HD, HE and HF; (5) a near-linear reflection anomaly is seen connecting the two drains in the centre of the site (in plot HE), which appears to marry with the surface gully highlighted in Figure 3.

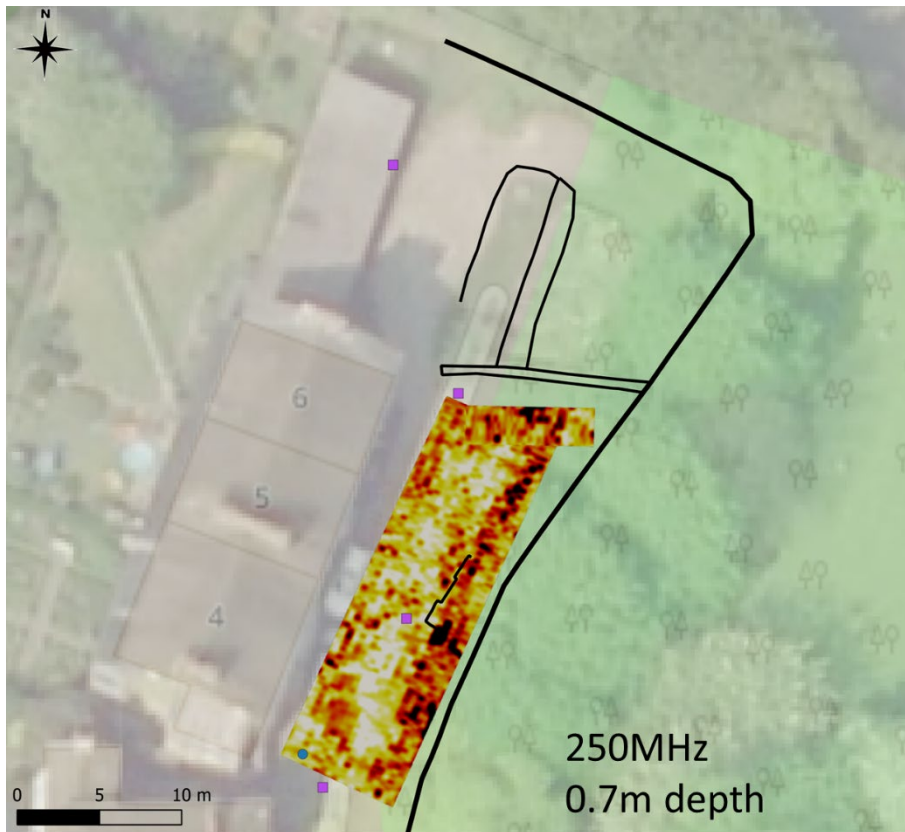
Figure 11: Horizontal slice of 250MHz GPR model at 0.3m below ground level (GPR plots HE & HF). Darker colours indicate stronger reflected signals.

- 2.3 The 250MHz surveys (plots HE and HF), unlike the 500MHz surveys, involved measurements made only in one orientation. This coupled with the fact that antenna footprint is much larger than the 500MHz antenna, the 250MHz data offer little additional information. Figure 11 shows an example depth slice (0.7m) for the 250MHz GPR model.

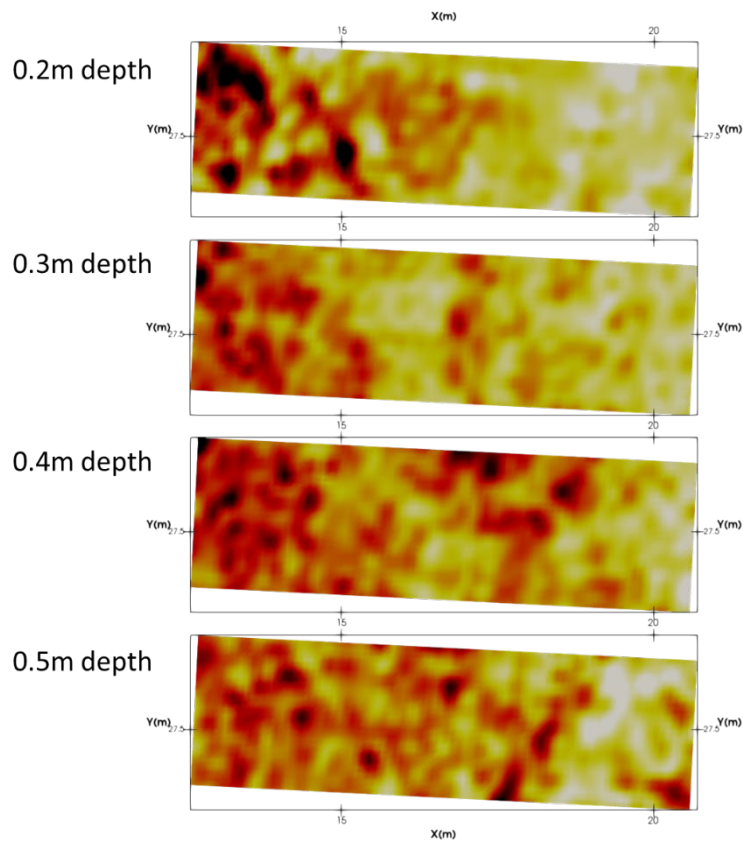
Figure 12: Horizontal slice of 800MHz GPR model (plot HF – see Figure 5) at 0.2m, 0.3m, 0.4m and 0.5m below ground level. X is Easting minus 347260m; Y is Northing minus 461890m. Darker colours indicate stronger reflected signals.

- 2.4 The 800MHz survey (plot HF), again, offers little additional information but does show supporting evidence of the NNE-SSW reflection pattern (noted in the 500MHz data) at 0.4m and 0.5m depths (Figure 12).

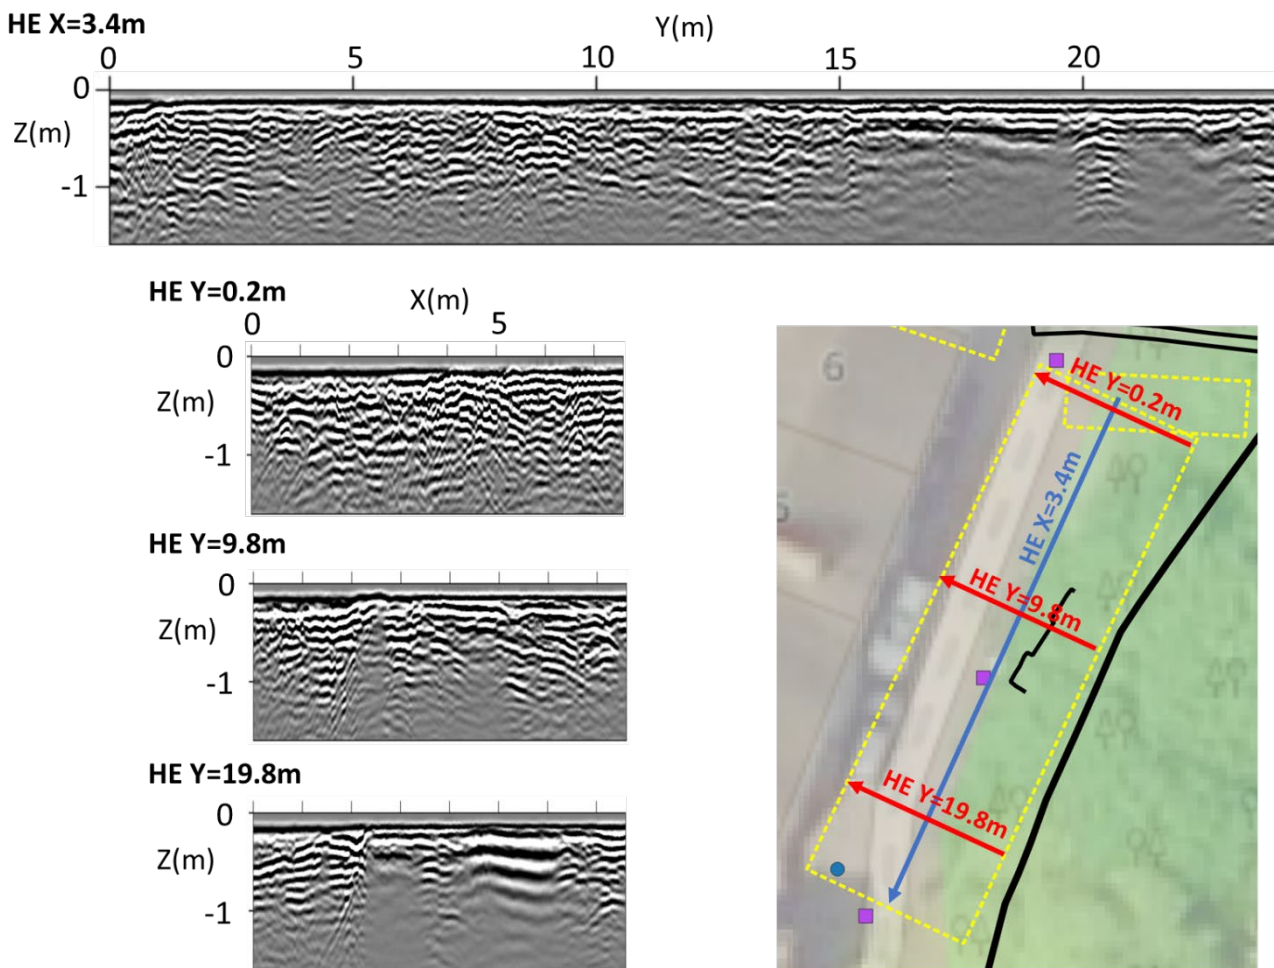
Figure 14: Example 2D vertical slices of 500MHz data in plot HE showing weak/null reflection patterns.

- 2.6 The same features noted above are also evident in surveys in plot HE – see examples in Figure 14 (note the striking change in reflection pattern in the lower sub-plot (HE Y=19.8m) between X=4.5m and 6.5m). Figure 15 shows some of the HE plot profiles with topographic correction to further illustrate the lateral contrast in GPR reflections. The reflection patterns on the left of some of the GPR images hint at the possibility of extension of the ditch noted in the smaller LDHG trench (position also marked in Figure 15), but are also aligned with the exposed dressed stone (also marked on Figure 15) and so could be due to burials or demolition of the malefactors' burial boundary wall.

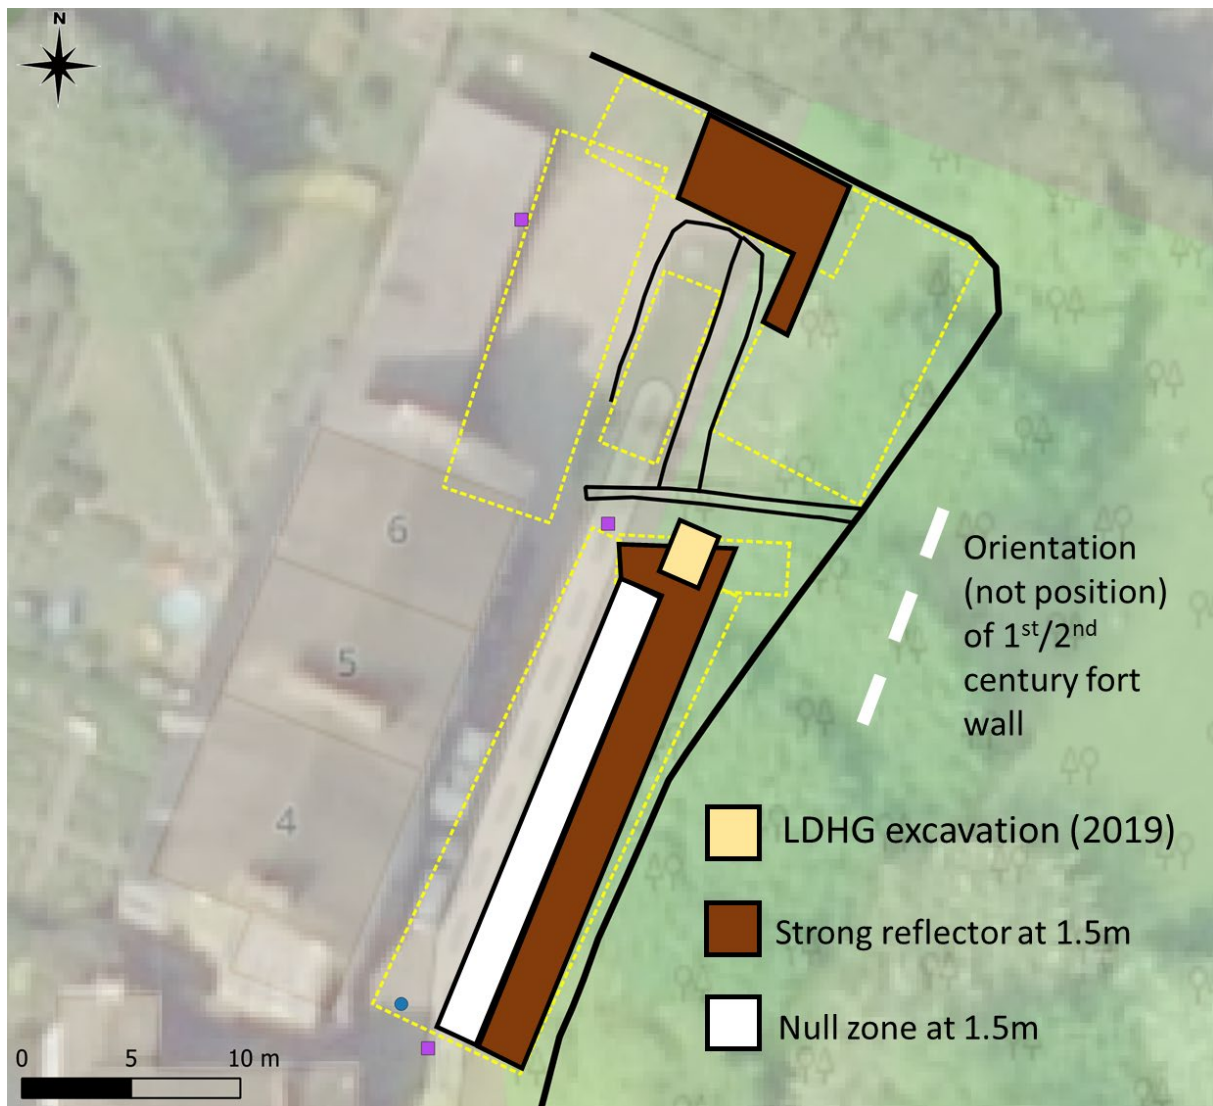
Figure 17: Summary interpretation of deep features. The areas outlined have been highlighted because of their strength or linearity in shape. The approximate orientation of the Roman fort wall (after Wood, 2021) is also shown for reference.

- 2.10 Figure 17 shows a summary of deeper features. It should be noted that attenuation of GPR signal at shallow depth results in nulling at further depths and thus the 'null anomaly' in Figure 16 at a depth of 1.5m does not necessarily equate to a feature at this depth – it means that a feature at a depth above it results in the attenuation. However, this figure has been included to illustrate the linearity of the contrast between weak and strong GPR signals. Furthermore, observations from the LDHG excavation (approximate position in Figure 16) revealed the presence of a ditch structure (Collins, 2020), adding more support for the interpretation of the presence of former defensive earthworks.
