## **CULTURAL IMPORTANCE ASSESSMENT OF MODERNIST BUILDINGS – THE CENTRAL LIBRARY OF UNIVERSITY OF BRASILIA**

### **Abstract**

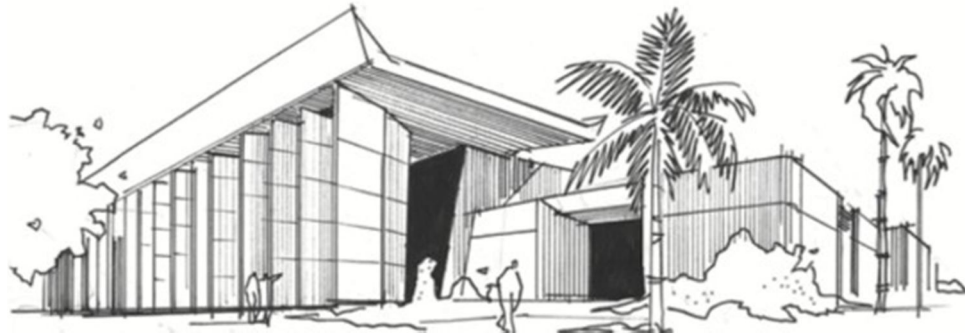
**Figure 1** - Representation of the Central Library. Source: N. Cavalcante (2015)

Conceived at the same time as Brasília, it can be said that the University of Brasília (UnB) emerged, in part, as a response to the vocation defined for the new capital, which should establish itself as a pole of cultural and intellectual irradiation. According to Cavalcante N. et al. (2015), the Central Library (figures 1 and 2), responsible for providing information to the University's Teaching, Research and Extension activities since the 1970s, when it was inaugurated, is one of the buildings which represents the vision of the capital's modern architecture and the break with the concept of other libraries.

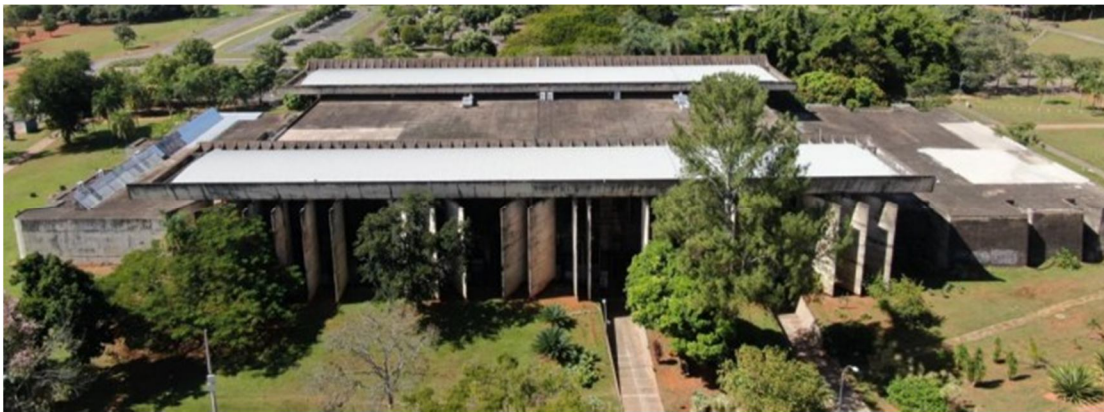
**Figure 2** - Central Library, University of Brasília. Source: Authors, 2023.

Influenced by modern architecture, especially from Le Corbusier, in addition to the use of fair-faced concrete in the brise-soleils and external vertical fences, the building has its own identity and is very representative of the Campus's architectural ensemble. During the 50 years of use of the Central Library, aspects necessary for interventions in the building due to the natural wear of materials or external factors were identified. Thus, leading to the need for more frequent building inspections to assess the conservation of the building's state of use and significance values. (Oliveira, et al. 2022).

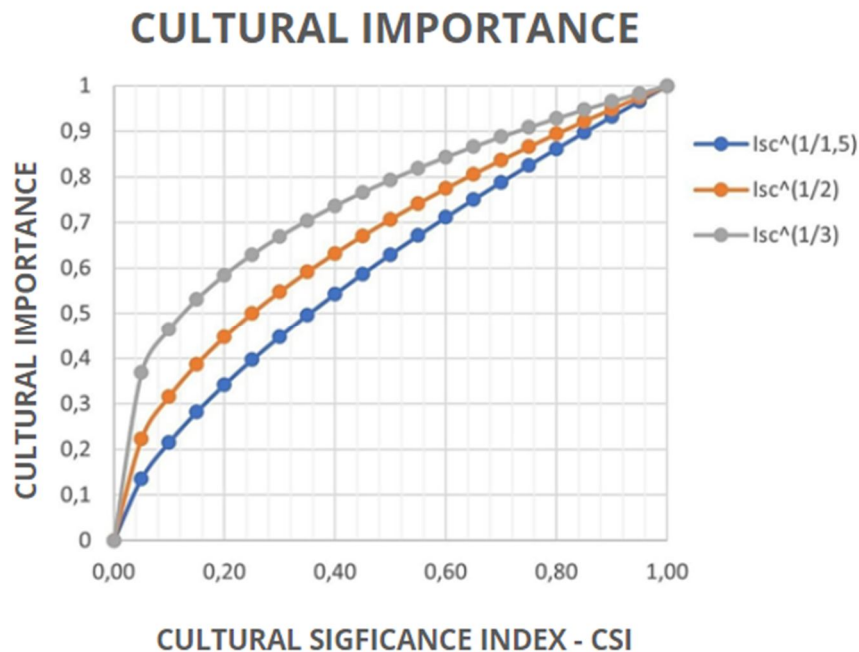
**Figure 4 -** Graph of Cultural Significance Index (CSI) x Cultural Importance. Source: Authors.

By summarizing the table with the detailed values and inspecting each structural attribute of the Central Library, it is possible to define the actions necessary for its conservation and maintenance. For this, it was necessary to use specific equipment for each approach as suggested by the Building Inspection Standard - ABNT NBR 16747:2020. The Central Library inspection, therefore, took place based on the use of data already obtained through sensory and visual analyzes and thus associated with the table to finally obtain the Cultural Significance Index, which is valued through a graph, shown in Figure 4, showing the Cultural Importance value of the building.

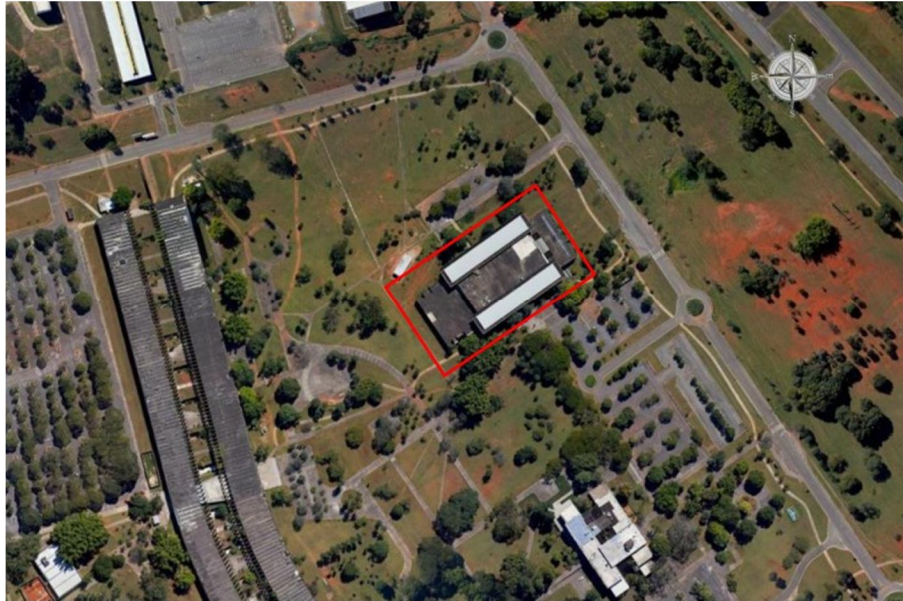
**Figure 5** - University of Brasilia's Central Library. Source: Google Earth, 2023.

The Central Library of the University of Brasília is located on the Darcy Ribeiro Campus in Plano Piloto, very close to the rectory and several courses hosted at the ICC (Figure 5).

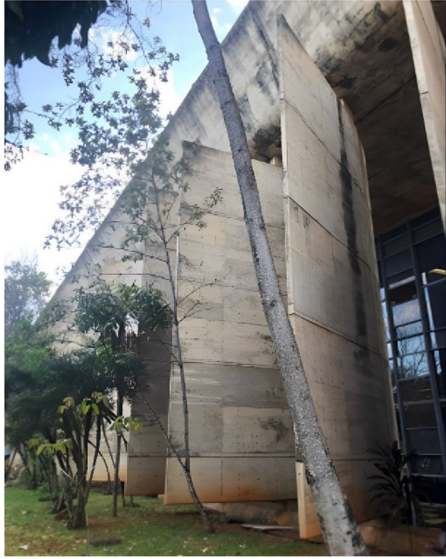
**Figure 8** - Front facade. Source: Authors.

In terms of Form and Project, the building was analyzed as a complete work of art, verifying the presence of all values, except the symbolic, due to it being a building with a formalized identity, without current or representative interference, to which the architects José Galbinski and Miguel Pereira designed the project, figures 8 and 9. In the Coverage attribute, structural parts with main values in use were inspected; economic and antique, in which, except for the waterproofing, it did not present an antique value because it did not belong to another era, this being a part of the building that needs to be constantly updated and attention must be paid to inspections and properly checked to avoid possible damage.

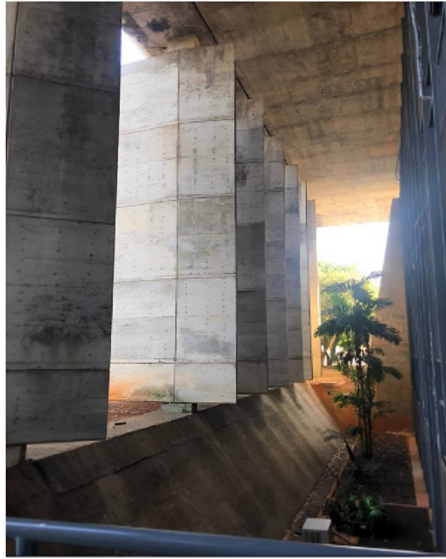
**Figure 9** - Concrete brise-soleils. Source: Authors.

The Internal and External Vertical Seals has an important emphasis on exposed concrete brise-soleils, which together with the signs and handrails have 5 values. The use value was the main one in all the attributes of the fences, as they all meet the conditions of use of the university community, followed by the historical value, which in both cases was due to being related to the development of significant instruments, techniques, and technologies. According to Silva (2022), the use of Unmanned Aerial Vehicles (UAVs) has proven to be an excellent solution for generating photographic products due to their greater flexibility, lower operational costs, and reduced susceptibility to human intervention errors compared to traditional models. This is because algorithms of a technology are employed in these processes for product generation. In the water/sanitary installations, it gave the value of use in all, and the economic value only in the fire-fighting instruments, as these tools can prevent medium to large material damage to the building, and, without them, there could be a total loss of the material assets.

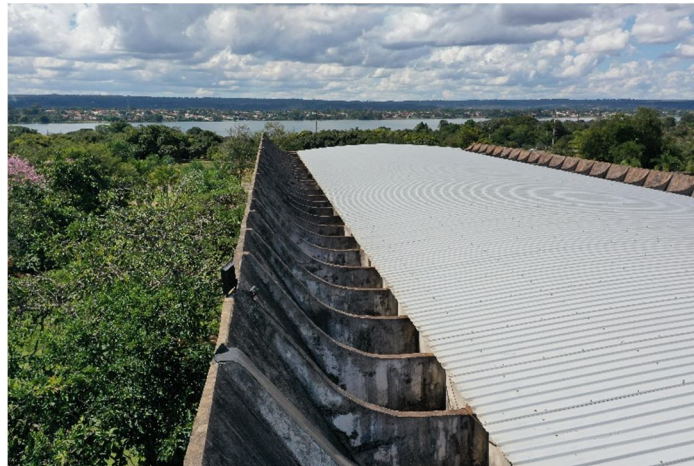
**Figure 10** - Library rooftop photo. Source: Authors.

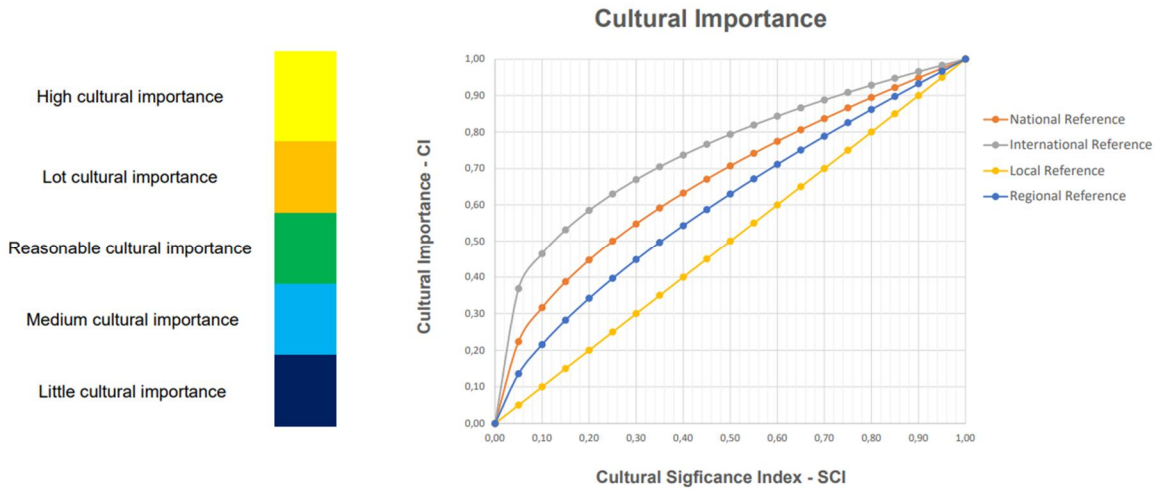
Figure 12 - Relationship between the Significance Index and Cultural Importance.

It was noted that the Central Library, despite not being categorized as heritage, has importance and values that reflect the need to be treated as such. Therefore, among the 3 CSI models, measured using the averages that each model has, as shown in figure 11, the regional reference model (blue) was identified as being the most appropriate to obtain the Cultural Importance value, as it does not have so much amplitude variation in its value, figure 12.

importance. This classification can be little, medium, reasonable, a lot or high, according to the table in figure 12. In addition to denoting the 4 types of reference that a building can be classified, namely: Local Reference, for example a shopping mall or low-rise building knowledge; Regional reference, such as the Brasília Hotel; National Reference, such as the National Library in Rio de Janeiro; and, finally, International Reference, such as the Brasilia’s Cathedral. The Central Library fits in because it is a regional reference building.

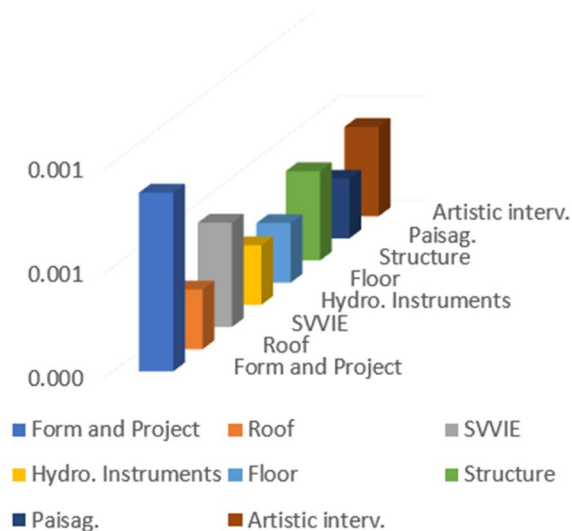
Figure 13 - Comparison of values in the analysis model. Source: Authors, 2023.

In figure 13 graph, the comparative variation of the attributes investigated in Central Library was identified, demonstrating the significance of each attribute as described and filled in the table.
