## Metallographic Failure Analysis on Bucket Elevator Conveyor Chain Links

### Abstract

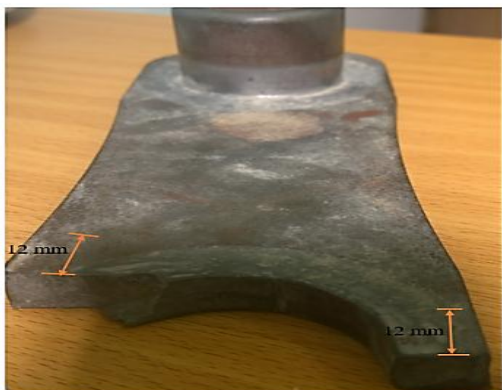
**Figure 2:** Sectioning of failed sample.

fractured samples. With the aid of a stereo microscope, the fractured surface was magnified to see more clearly the fractured surfaces and surface defects for analysis. Special attention was paid to anomalies such as scratches, fractures, unusual marks and wear. This step was to examine fracture surfaces and to identify whether the fracture is ductile or brittle. Chevron marks always appear at a fractured surface as a result of the fracture process. Chevron marks are very helpful because they can point to the crack origin. Before the fractured samples was examined by mounting under the stereo microscope, it was first sectioned 12mm from the fractured surface as shown in Fig. 2 with a hacksaw (low speed cutter) so as not to alter the micro-structure.

The sectioned samples were then mounted on a stereo microscope to observe the grains on the surface so as to deduce the type of fracture. Also the mechanism of failure was deduced by tracing the chevron mark on the surface as it shows the path for the failure.
