**ANNUAL ENVIRONMENTAL REPORT**

**RILTA ENVIRONMENTAL LTD.**

**BLOCK 402 GREENOGUE BUSINESS PARK**

**JANUARY 2018 – DECEMBER 2018**

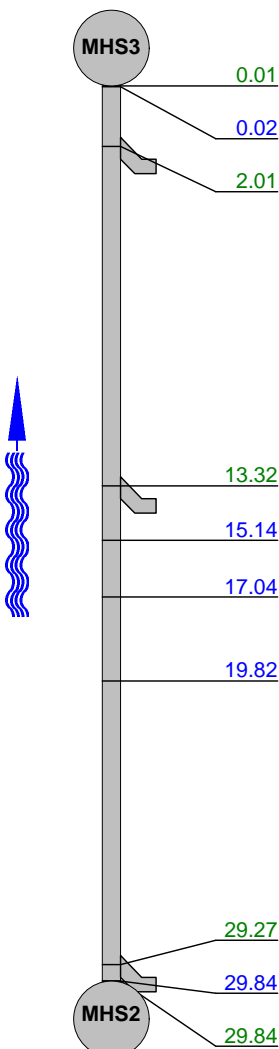
0.01	MH	Start node type, manhole, reference number : MH3	00:00:00		(Constr) 0
	0.02	WL	Water level, 5% of the vertical dimension			(Serv) 0
	2.01	CN	Connection other than junction, at 10 o'clock, diameter 150mm	00:01:02		(Constr) 0
	13.32	CN	Connection other than junction, at 10 o'clock, diameter 150mm	00:03:22		(Constr) 0
	15.14	WL	Water level, 0% of the vertical dimension	00:03:40		(Serv) 0
	17.04	WL	Water level, 5% of the vertical dimension	00:03:53		(Serv) 0
	19.82	WL	Water level, 0% of the vertical dimension	00:04:38		(Serv) 0
	29.27	CN	Connection other than junction, at 10 o'clock, diameter 150mm	00:06:28		(Constr) 0
	29.84	WL	Water level, 0% of the vertical dimension	00:06:45		(Serv) 0
	29.84	MHF	Finish node type, manhole reference number: MH2	00:06:48		(Constr) 0

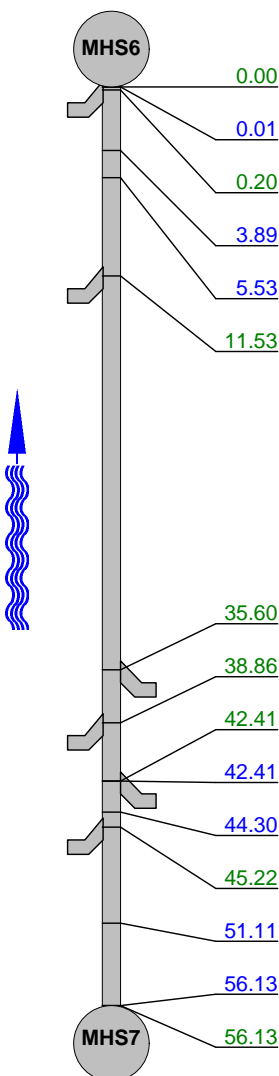
0.00	MH	Start node type, manhole, reference number : MHS6	00:00:00		(Constr) 0
	0.01	WL	Water level, 0% of the vertical dimension	00:00:25		(Serv) 0

0.20	CN	Connection other than junction, at 2 o'clock, diameter 150mm Remarks: Unknown Connection	00:00:28		(Constr) 0
	3.89	WLC	Clear water level, 5% of the vertical dimension	00:01:18		(Serv) 0

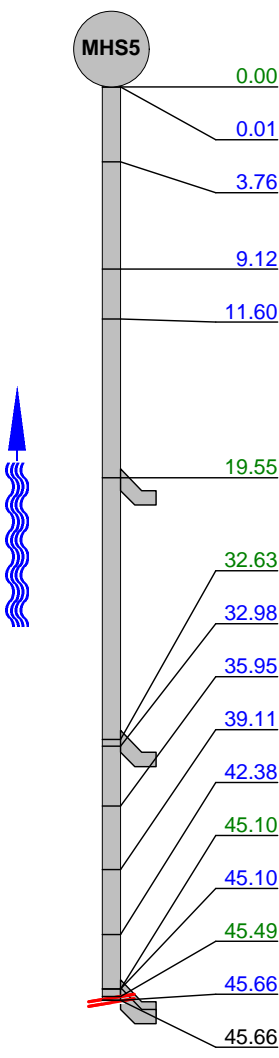
0.00	MH	Start node type, manhole, reference number : MHS5	00:00:00		(Constr) 0
	0.01	WL	Water level, 5% of the vertical dimension	00:00:00		(Serv) 0

3.76	WL	Water level, 0% of the vertical dimension	00:01:20		(Serv) 0
	9.12	WL	Water level, 10% of the vertical dimension	00:02:41		(Serv) 0
	11.60	WL	Water level, 0% of the vertical dimension	00:03:24		(Serv) 0

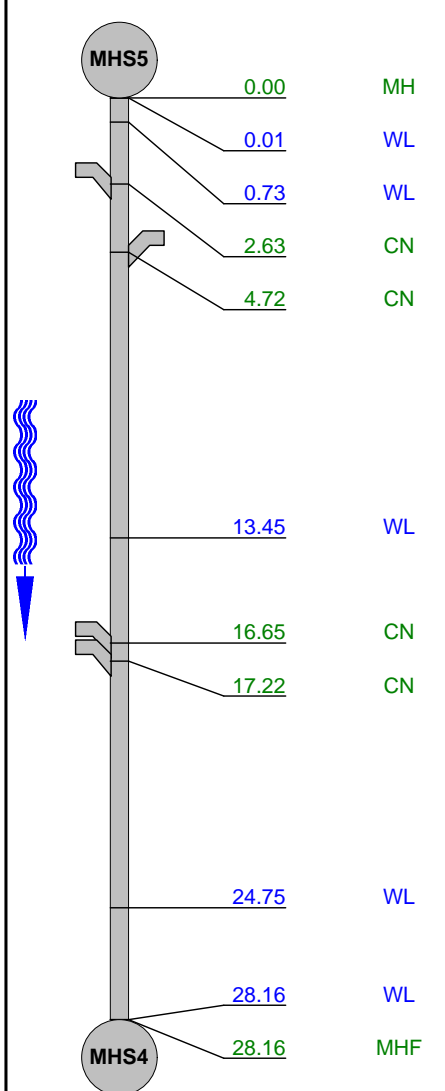
0.00	MH	Start node type, manhole, reference number : MHS5	00:00:02		(Constr) 0
	0.01	WL	Water level, 0% of the vertical dimension	00:00:04		(Serv) 0

0.73	WL	Water level, 5% of the vertical dimension	00:00:55		(Serv) 0
	2.63	CN	Connection other than junction, at 2 o'clock, diameter 100mm	00:02:28		(Constr) 0

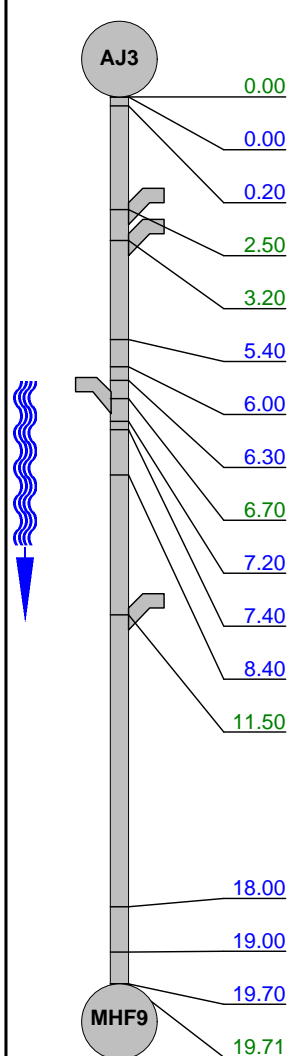
0.00	IC	Start node type, inspection chamber, reference number : AJ3	00:00:02		(Constr) 0
	0.00	WL	Water level, 0% of the vertical dimension	00:00:02		(Serv) 0

0.20	LL	Line deviates left	00:00:02		(Serv) 0
	2.50	CN	Connection other than junction, at 9 o'clock, diameter 100mm Remarks: From A04	00:00:30		(Constr) 0

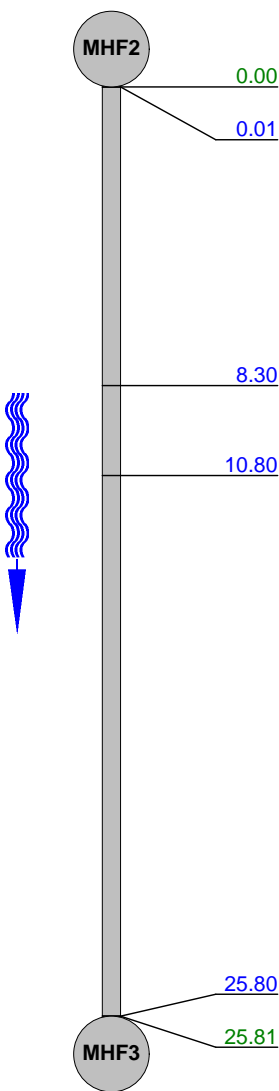
MH	Start node type, manhole, reference number : MHF2	00:00:02		(Constr) 0
	0.01	WL	Water level, 5% of the vertical dimension	00:00:02		(Serv) 0
	8.30	WLC	Clear water level, 10% of the vertical dimension	00:01:25		(Serv) 0
	10.80	WL	Water level, 5% of the vertical dimension	00:02:32		(Serv) 0
	25.80	WL	Water level, 5% of the vertical dimension	00:05:23		(Serv) 0
	25.81	MHF	Finish node type, manhole reference number: MHF3	00:05:23		(Constr) 0

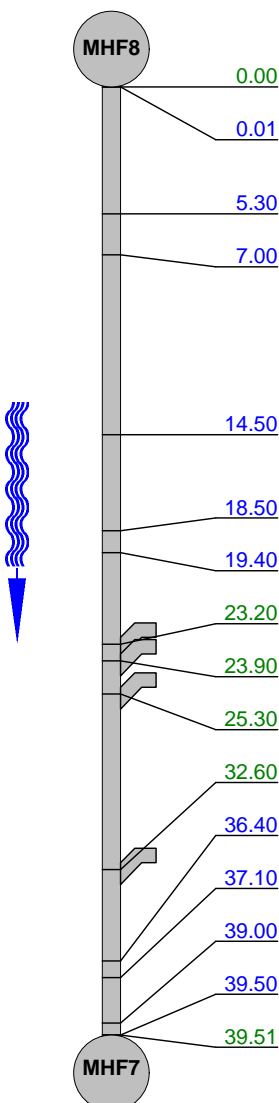
0.00	MH	Start node type, manhole, reference number : MHF8	00:00:00		(Constr) 0
	0.01	WL	Water level, 0% of the vertical dimension	00:00:00		(Serv) 0

5.30	WL	Water level, 5% of the vertical dimension	00:00:47		(Serv) 0
	7.00	WL	Water level, 10% of the vertical dimension	00:01:00		(Serv) 0
	14.50	WL	Water level, 5% of the vertical dimension	00:01:53		(Serv) 0

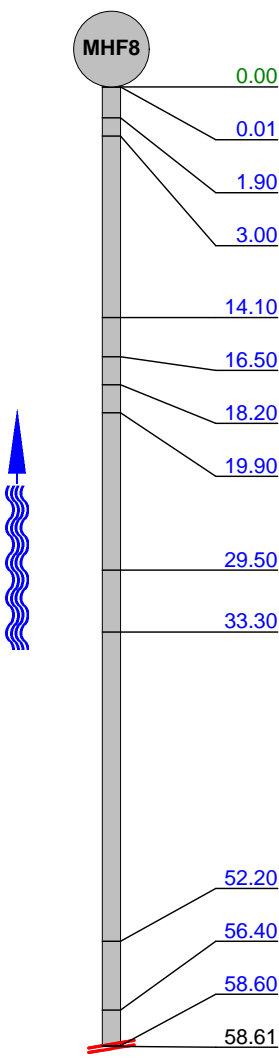
0.00	MH	Start node type, manhole, reference number : MHF8	00:00:00		(Constr) 0
	0.01	WL	Water level, 15% of the vertical dimension	00:00:00		(Serv) 0

1.90	WLC	Clear water level, 10% of the vertical dimension	00:00:24		(Serv) 0
	3.00	WL	Water level, 5% of the vertical dimension	00:00:45		(Serv) 0
	14.10	WLC	Clear water level, 10% of the vertical dimension	00:02:04		(Serv) 0

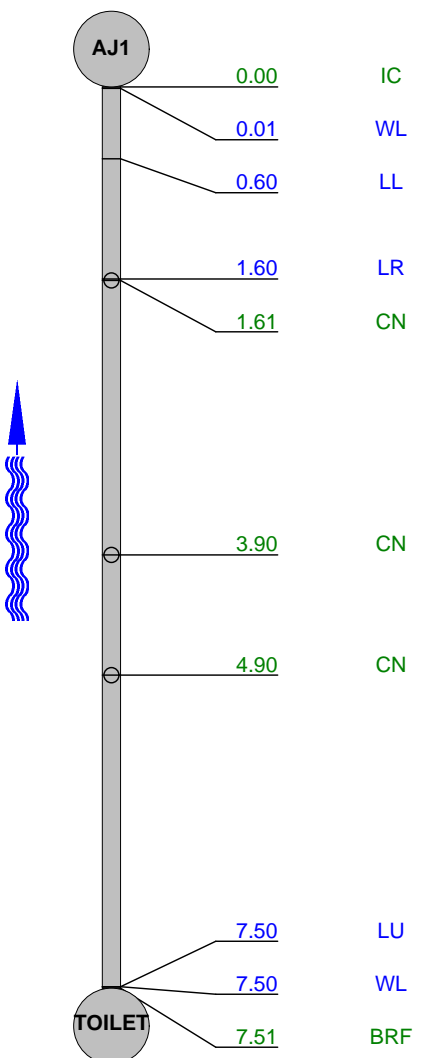
0.00	IC	Start node type, inspection chamber, reference number : AJ1	00:00:03		(Constr) 0
	0.01	WL	Water level, 0% of the vertical dimension	00:00:03		(Serv) 0
	0.60	LL	Line deviates left	00:00:14		(Serv) 0
	1.60	LR	Line deviates right	00:00:22		(Serv) 0
	1.61	CN	Connection other than junction, at 12 o'clock, diameter 100mm	00:00:22		(Constr) 0
	3.90	CN	Connection other than junction, at 12 o'clock, diameter 100mm	00:00:45		(Constr) 0
	4.90	CN	Connection other than junction, at 12 o'clock, diameter 100mm	00:00:57		(Constr) 0
	7.50	LU	Line deviates up	00:01:39		(Serv) 0
	7.50	WL	Water level, 0% of the vertical dimension	00:01:39		(Serv) 0
	7.51	BRF	Finish node type, major connection without manhole reference number: TOILET	00:01:39		(Constr) 0

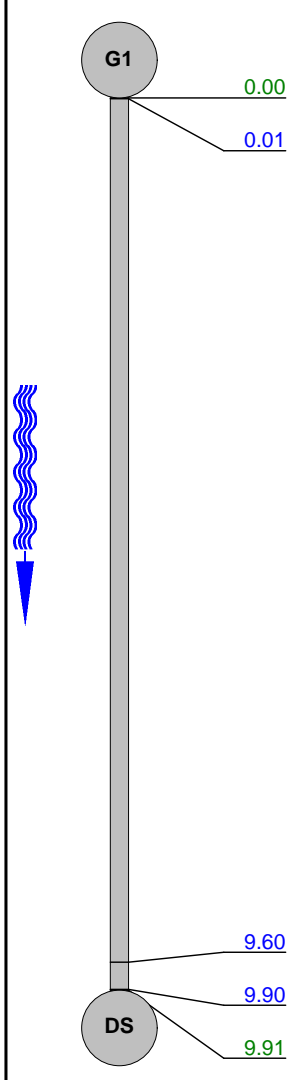
0.00	GY	Start node type, gully, reference number : G1	00:00:02		(Constr) 0
	0.01	WLC	Clear water level, 0% of the vertical dimension	00:00:02		(Serv) 0
	9.60	LD	Line deviates down	00:01:59		(Serv) 0
	9.90	WL	Water level, 0% of the vertical dimension	00:02:07		(Serv) 0
	9.91	BRF	Finish node type, major connection without manhole reference number: DS Remarks: Connected to drain from	00:02:07		(Constr) 0

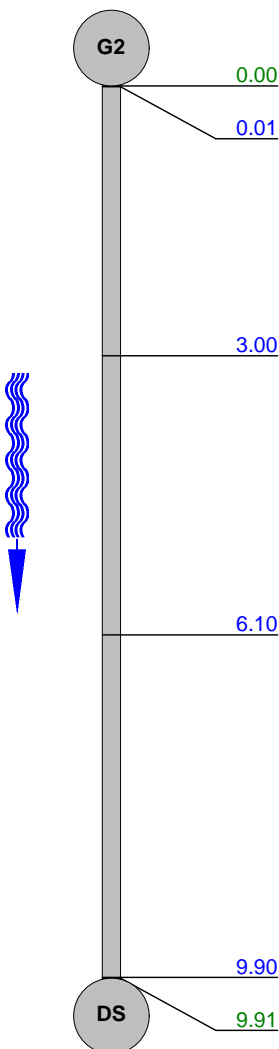
0.00	GY	Start node type, gully, reference number : G2	00:00:02		(Constr) 0
	0.01	WL	Water level, 0% of the vertical dimension	00:00:02		(Serv) 0
	3.00	WL	Water level, 5% of the vertical dimension	00:00:30		(Serv) 0
	6.10	WL	Water level, 0% of the vertical dimension	00:00:52		(Serv) 0
	9.90	LD	Line deviates down	00:01:18		(Serv) 0
	9.91	BRF	Finish node type, major connection without manhole reference number: DS Remarks: Connected to drain from	00:01:24		(Constr) 0

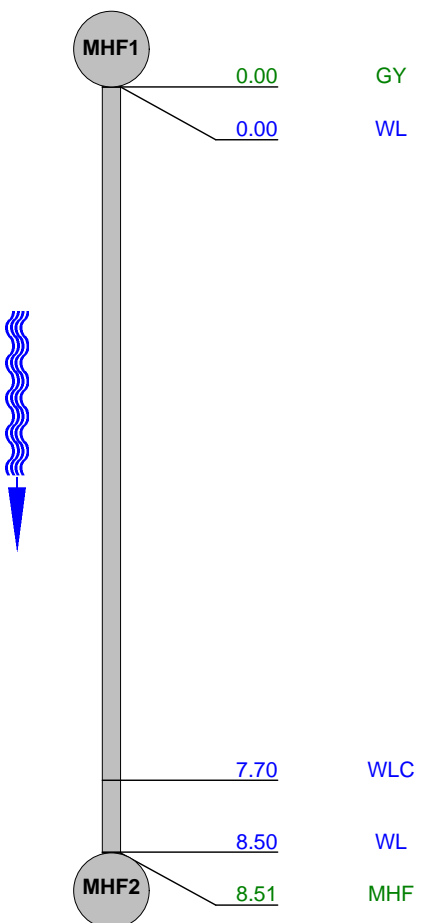
0.00	GY	Start node type, gully, reference number : MHF1	00:00:01		(Constr) 0
	0.00	WL	Water level, 0% of the vertical dimension	00:00:01		(Serv) 0
	7.70	WLC	Clear water level, 5% of the vertical dimension	00:01:19		(Serv) 0
	8.50	WL	Water level, 0% of the vertical dimension	00:01:25		(Serv) 0
	8.51	MHF	Finish node type, manhole reference number: MHF2	00:01:25		(Constr) 0

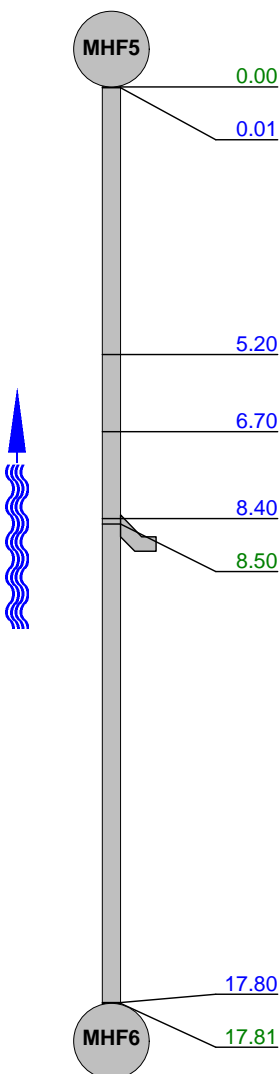
0.00	MH	Start node type, manhole, reference number : MHF5	00:00:02		(Constr) 0
	0.01	WL	Water level, 5% of the vertical dimension	00:00:02		(Serv) 0
	5.20	WL	Water level, 10% of the vertical dimension	00:00:49		(Serv) 0
	6.70	WL	Water level, 5% of the vertical dimension	00:01:10		(Serv) 0
	8.40	WL	Water level, 0% of the vertical dimension	00:01:31		(Serv) 0
	8.50	CN	Connection other than junction, at 10 o'clock, diameter 100mm Remarks: From toilets	00:01:30		(Constr) 0
	17.80	WL	Water level, 0% of the vertical dimension	00:03:46		(Serv) 0
	17.81	MHF	Finish node type, manhole reference number: MHF6	00:03:46		(Constr) 0

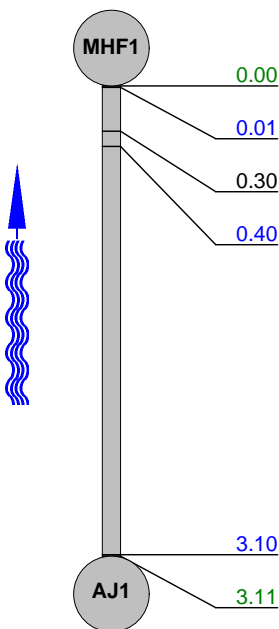
MH	Start node type, manhole, reference number : MHF1	00:00:02		(Constr) 0
		WL	Water level, 5% of the vertical dimension	00:00:02		(Serv) 0
		SCC	Shape changes to circular, 100mm high	00:00:00		0
		WLC	Clear water level, 0% of the vertical dimension	00:00:15		(Serv) 0
		WLC	Clear water level, 0% of the vertical dimension	00:00:39		(Serv) 0
		ICF	Finish node type, inspection chamber reference number: AJ1	00:00:39		(Constr) 0

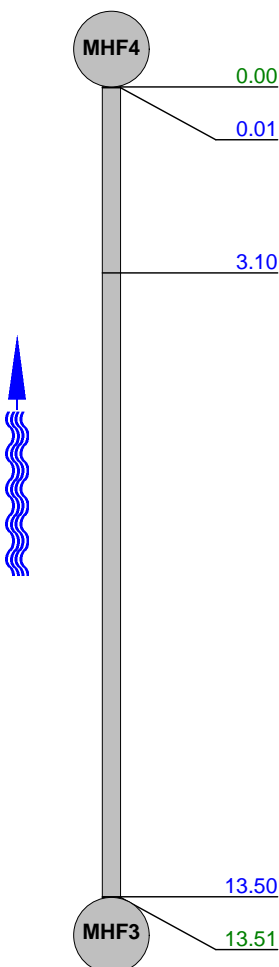
0.00	MH	Start node type, manhole, reference number : MHF4	00:00:02		(Constr) 0
	0.01	WL	Water level, 0% of the vertical dimension	00:00:02		(Serv) 0
	3.10	WL	Water level, 5% of the vertical dimension	00:00:38		(Serv) 0
	13.50	WL	Water level, 5% of the vertical dimension	00:02:55		(Serv) 0
	13.51	MHF	Finish node type, manhole reference number: MHF3	00:02:55		(Constr) 0

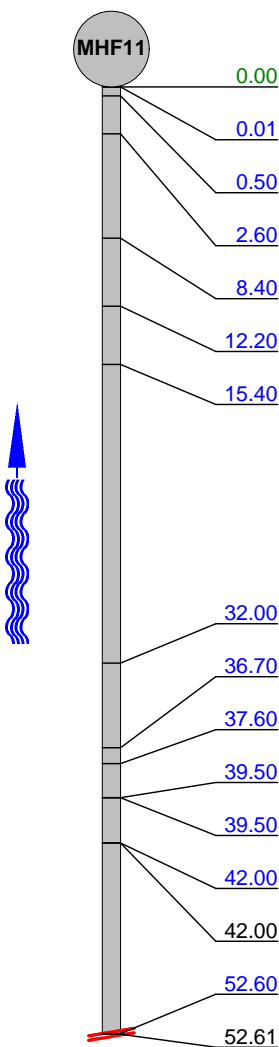
0.00	MH	Start node type, manhole, reference number : MHF11	00:00:01		(Constr) 0
	0.01	WL	Water level, 0% of the vertical dimension	00:00:01		(Serv) 0

0.50	LL	Line deviates left	00:00:05		(Serv) 0
	2.60	WL	Water level, 5% of the vertical dimension	00:00:28		(Serv) 0
	8.40	WL	Water level, 0% of the vertical dimension	00:04:28		(Serv) 0

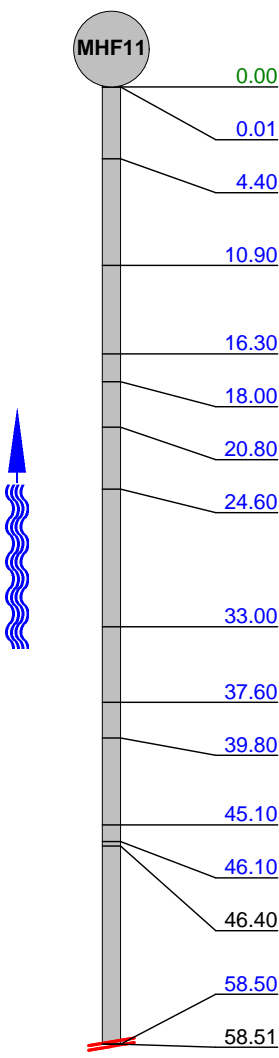
0.00	MH	Start node type, manhole, reference number : MHF11	00:00:02		(Constr) 0
	0.01	WL	Water level, 0% of the vertical dimension	00:00:02		(Serv) 0

4.40	WL	Water level, 5% of the vertical dimension	00:00:49		(Serv) 0
	10.90	WL	Water level, 10% of the vertical dimension	00:01:28		(Serv) 0
	16.30	WL	Water level, 15% of the vertical dimension	00:02:12		(Serv) 0

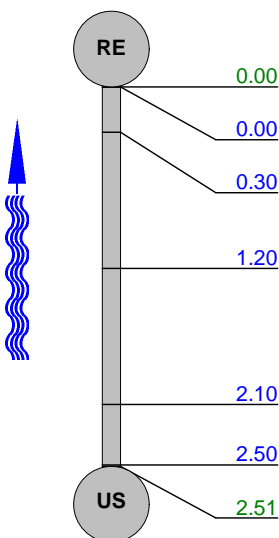
0.00	RE	Start node type, rodding eye, reference number : RE	00:00:02		(Constr) 0
	0.00	WL	Water level, 0% of the vertical dimension	00:00:02		(Serv) 0
	0.30	WL	Water level, 5% of the vertical dimension	00:00:05		(Serv) 0
	1.20	WL	Water level, 0% of the vertical dimension	00:00:10		(Serv) 0
	2.10	LU	Line deviates up	00:00:19		(Serv) 0
	2.50	WLC	Clear water level, 0% of the vertical dimension	00:00:40		(Serv) 0
	2.51	BRF	Finish node type, major connection without manhole reference number: US Remarks: WWTP	00:00:40		(Constr) 0

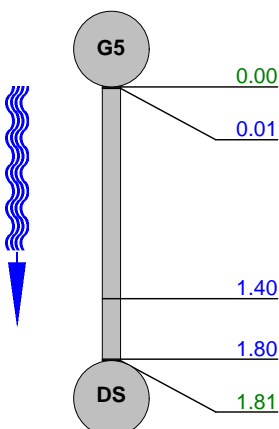
0.00	GY	Start node type, gully, reference number : G5	00:00:01		(Constr) 0
	0.01	WL	Water level, 0% of the vertical dimension	00:00:01		(Serv) 0
	1.40	LD	Line deviates down	00:00:13		(Serv) 0
	1.80	WLC	Clear water level, 0% of the vertical dimension	00:00:15		(Serv) 0
	1.81	BRF	Finish node type, major connection without manhole reference number: DS Remarks: This drain is connected t	00:00:15		(Constr) 0

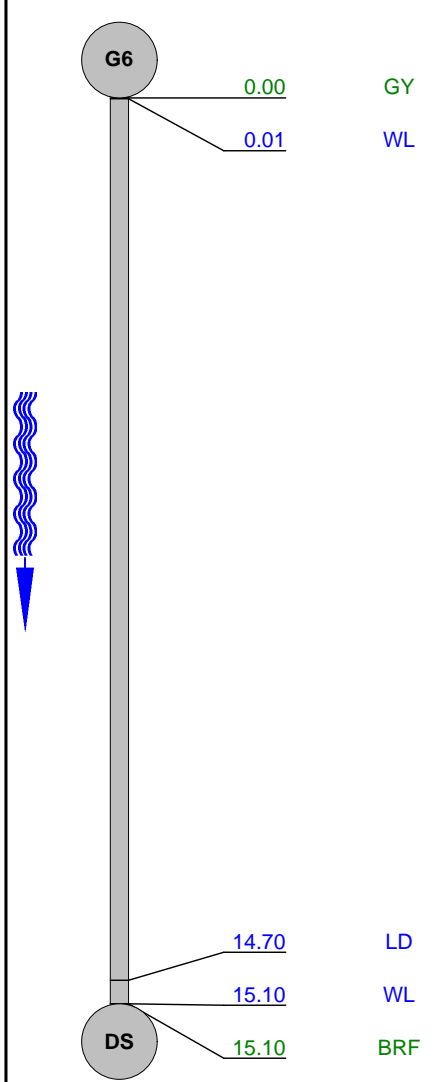
0.00	GY	Start node type, gully, reference number : G6	00:00:01		(Constr) 0
	0.01	WL	Water level, 0% of the vertical dimension	00:00:01		(Serv) 0
	14.70	LD	Line deviates down	00:02:09		(Serv) 0
	15.10	WL	Water level, 0% of the vertical dimension	00:02:15		(Serv) 0
	15.10	BRF	Finish node type, major connection without manhole reference number: DS Remarks: This pipe is connected to	00:02:15		(Constr) 0

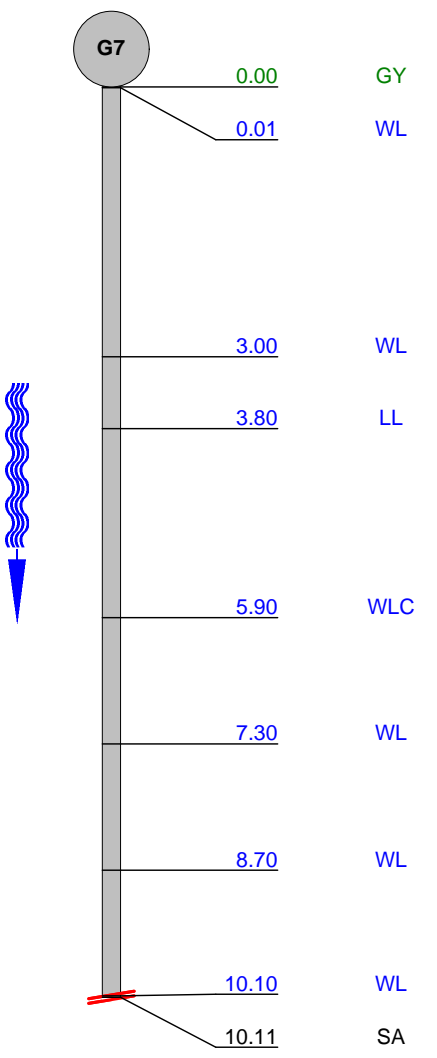
0.00	GY	Start node type, gully, reference number : G7	00:00:00		(Constr) 0
	0.01	WL	Water level, 0% of the vertical dimension	00:00:00		(Serv) 0
	3.00	WL	Water level, 5% of the vertical dimension	00:00:27		(Serv) 0
	3.80	LL	Line deviates left	00:00:34		(Serv) 0
	5.90	WLC	Clear water level, 10% of the vertical dimension	00:00:50		(Serv) 0
	7.30	WL	Water level, 0% of the vertical dimension	00:01:09		(Serv) 0
	8.70	WL	Water level, 5% of the vertical dimension	00:01:25		(Serv) 0
	10.10	WL	Water level, 0% of the vertical dimension	00:02:05		(Serv) 0
	10.11	SA	Survey abandoned Remarks: Survey could not be completed due to a sharp bend on this pipe.	00:02:05		(Misc) 0

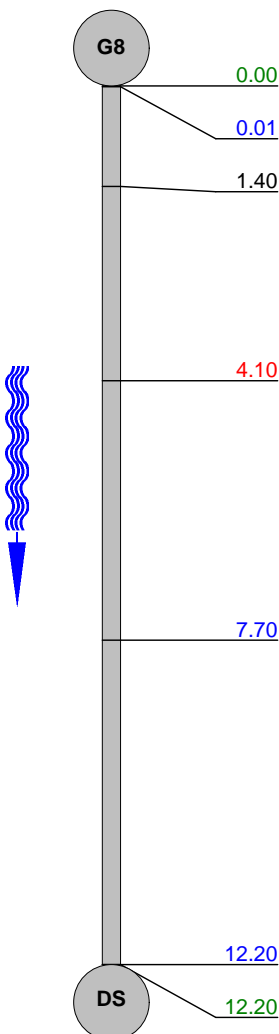
0.00	GY	Start node type, gully, reference number : G8	00:00:00		(Constr) 0
	0.01	WL	Water level, 0% of the vertical dimension	00:00:00		(Serv) 0
	1.40	REM	General remark Remarks: Socket of this pipe is connected against the stream.	00:00:15	42_3A	(Misc) 0
	4.10	SZ	Surface damage, dent, from 4 to 5 o'clock Remarks: A	00:00:36	42_4A	(Struct) 0
	7.70	LR	Line deviates right Remarks: 45 Deg.	00:01:07		(Serv) 0
	12.20	WL	Water level, 0% of the vertical dimension	00:01:39		(Serv) 0
	12.20	BRF	Finish node type, major connection without manhole reference number: DS Remarks: This pipe is connected to	00:01:39		(Constr) 0

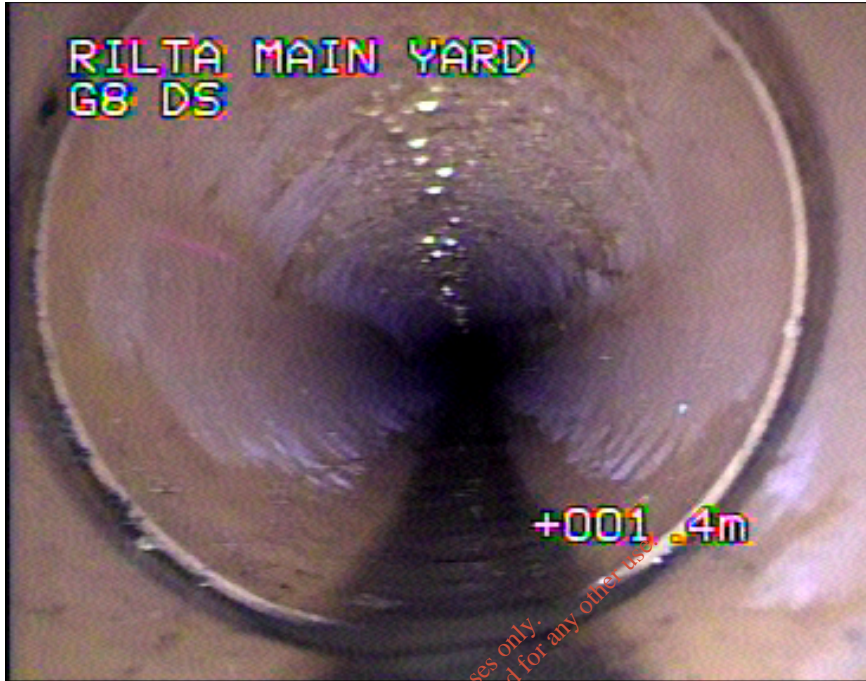
Section number :  
**42**

Photo: 42\_3A, MPEG #: 280217\_1, 00:00:15  
 1.4m, General remark

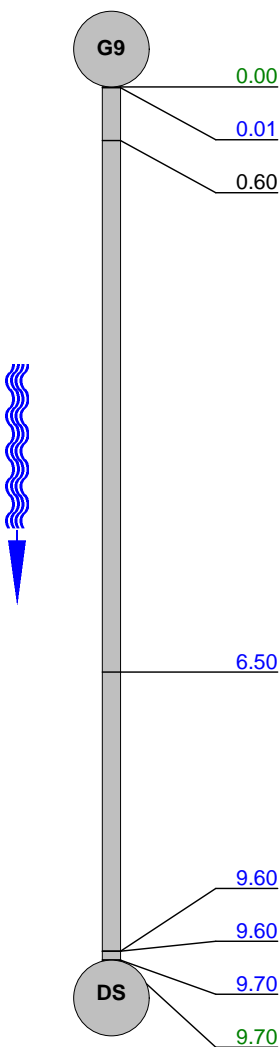
0.00	GY	Start node type, gully, reference number : G9	00:00:00		(Constr) 0
	0.01	WL	Water level, 0% of the vertical dimension	00:00:00		(Serv) 0
	0.60	REM	General remark Remarks: Sockets of this pipe are connected against the stream.	00:00:08	43_3A	(Misc) 0
	6.50	LL	Line deviates left Remarks: 45 Deg.	00:00:56		(Serv) 0
	9.60	LR	Line deviates right	00:01:23		(Serv) 0
	9.60	LD	Line deviates down	00:01:23		(Serv) 0
	9.70	WL	Water level, 0% of the vertical dimension	00:01:27		(Serv) 0
	9.70	BRF	Finish node type, major connection without manhole reference number: DS Remarks: This pipe is conneted to t	00:01:27		(Constr) 0

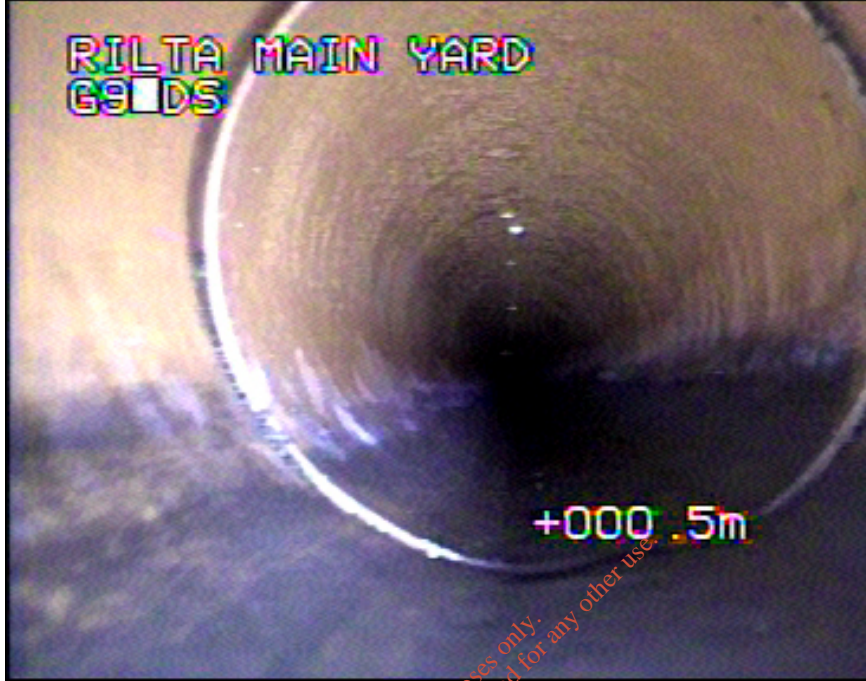
Section number :  
**43**

Photo: 43\_3A, MPEG #: 280217\_1, 00:00:08  
 0.6m, General remark

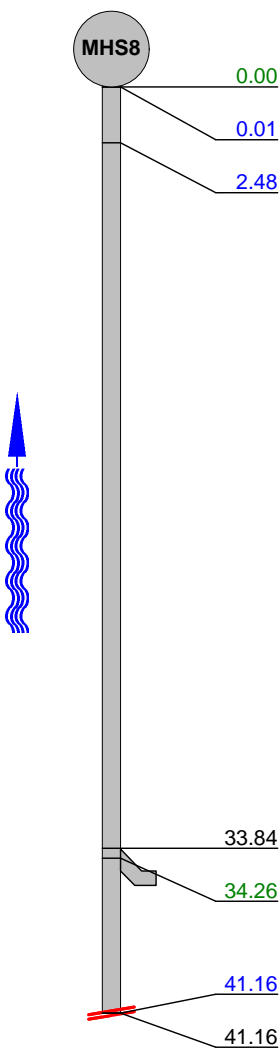
0.00	MH	Start node type, manhole, reference number : MHS8	00:00:00		(Constr) 0
	0.01	WL	Water level, 0% of the vertical dimension			(Serv) 0
	2.48	WL	Water level, 5% of the vertical dimension	00:01:25		(Serv) 0
	33.84	REM	General remark Remarks: manhole	00:13:01		(Misc) 0
	34.26	CN	Connection other than junction, at 11 o'clock, diameter 100mm Remarks: gully conoction	00:14:05		(Constr) 0
	41.16	WL	Water level, 0% of the vertical dimension	00:17:36		(Serv) 0
	41.16	SA	Survey abandoned Remarks: Survey could not be completed due to sharp bend on this pipe	00:17:36		(Misc) 0

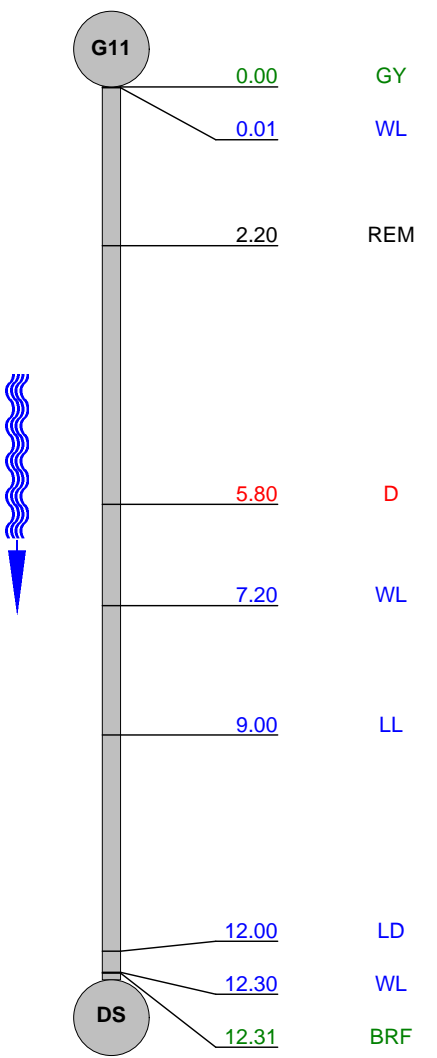
0.00	GY	Start node type, gully, reference number : G11	00:00:02		(Constr) 0
	0.01	WL	Water level, 0% of the vertical dimension	00:00:19		(Serv) 0
	2.20	REM	General remark Remarks: Dents	00:00:59	47_3A	(Misc) 0
	5.80	D	Deformed sewer/drain, 10%	00:01:48	47_4A	(Struct) 4
	7.20	WL	Water level, 5% of the vertical dimension	00:02:05		(Serv) 0
	9.00	LL	Line deviates left	00:02:25		(Serv) 0
	12.00	LD	Line deviates down	00:02:52		(Serv) 0
	12.30	WL	Water level, 0% of the vertical dimension	00:02:57		(Serv) 0
	12.31	BRF	Finish node type, major connection without manhole reference number: DS Remarks: This drain is connected t	00:02:57		(Constr) 0

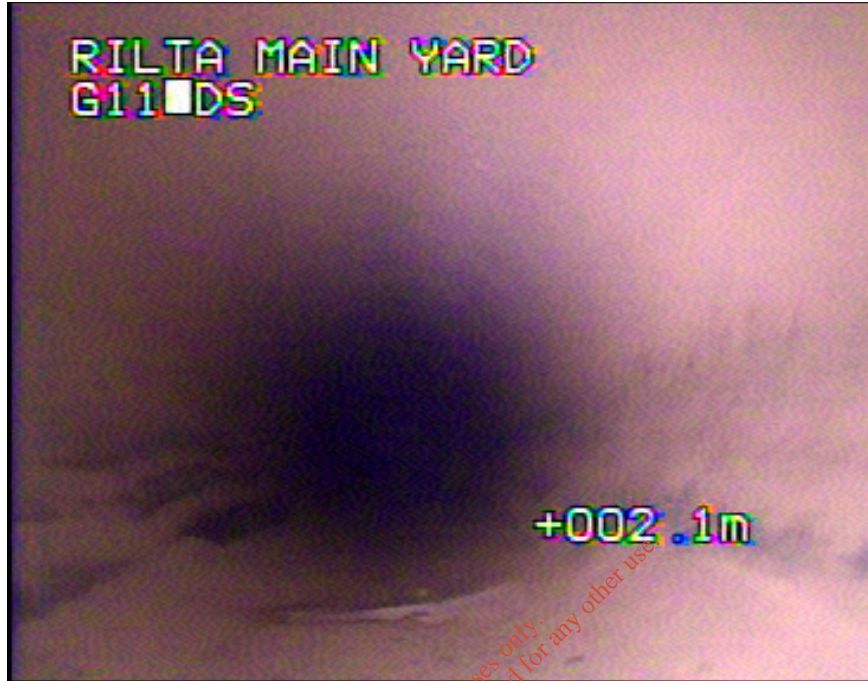
Section number :  
**47**

Photo: 47\_3A, MPEG #: 280217\_1, 00:00:59  
 2.2m, General remark
