Structural Assessment of the Barrô Romanesque Church

Built on the left bank of the Douro River, halfway of the slope, the Romanesque Church of Barrô was founded in the 12th century. This church underwent many changes during its service years, where the major concerns were the water infiltration and the belltower, which have led to many problems. Throughout the visual inspection, a major crack in the front façade and bulging of the lateral wall was observed, therefore doubts were raised on their causes. An effort has been made to perform photogrammetry on the structure, further enhanced with a detailed drawing survey to observe and localize the damages.

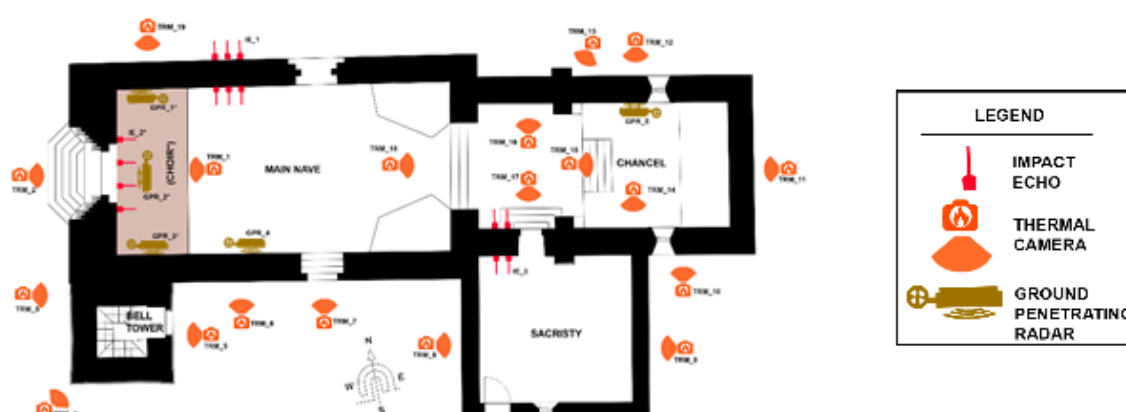
Figure 5. Non-destructive test locations (*for the tests in the Choir level)

thermal camera several measurements were performed in the church. Figure 5 presents the locations of these measurements together with the location of the other tests performed. Some of the most representative examples of thermal pictures are shown in Figure 6, which are names respectively to their location on Figure 5.

From TRM_7, it can be observed that on the left side there is a clear separation of the arch above the door to the stone filling underneath, not clearly visible to the naked eye. Additionally, from TRM_11 another distinct separation between the sculpture stand and the rest of the wall can be seen. TRM_15 shows material differences between the altar and the stone vault, which has a clear thermal separation line at the apex. This separation comes from the orientation of the church where the left side (of this picture) is the northern side whereas the right side is the southern side, which at the time of measurement was constantly in contact with the sun.

Ground penetrating radar was utilized in order to understand the inner constitution of the walls, identify any presence of damage and to measure the thickness of the walls and the vault. The measurements were carried out with an 800 MHz antenna and the locations are shown in Figure 5. The GPR_1 radargram (Figure 7a) shows an internal view of the crack in that part of the wall. Patterns of hyperbolas show a specific trend rather than being random as they would be on a normal wall and this explains the cracks as the consequence of detachment. From the GPR_2 radargram (Figure 7b) one can observe a difference in amplitude from the rest of the wall that is at the inner layer and the external interior masonry, which indicates a thicker separation between the layers and thus explaining the out-of-plane deformation perceived. On the southern wall in the choir level (GPR_3) a clear separation between the nave wall and the tower wall can be seen from the radargram in Figure 7c.

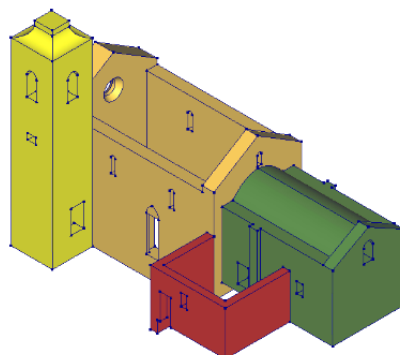
Figure 11. 3D visualization of the FEA model;

Due to the complex geometry and the present condition of the church, some assumptions were made in the numerical model, such as, the roofing system of the main nave was not considered in the FEA model, only the equivalent loading for the roofing system was considered [5]. A constant thickness of 500mm was considered for the vault due to some geometric unknowns; this thickness was considered based on the findings from the GPR test. A lightweight filling of 1800 kg/m³ was considered at the top of the vault. Due to the sloping nature of the resting ground, the base of the walls was considered in a continuous stepped way as it was witnessed on site. Considering the geometry and these assumptions, the FEA model considered for further analysis is shown in Figure 11.
